**RE: Termination Request
for the Rice Operating Company's
EME Jct M-13 Site
Unit Letter M, Section 13, T20S, R36E, NMPM, Lea County, New Mexico
Remediation Plan (1R427-332) Termination**

RE: Termination Request
EME Jct. M-13 (1R427-332): UL/M, Sec. 13, T20S, R36E
RICE Operating Company – Eunice Monument Eumont SWD System

**RICE OPERATING COMPANY
JUNCTION BOX FINAL REPORT**

EME Jct. M-13 (1R427-332)

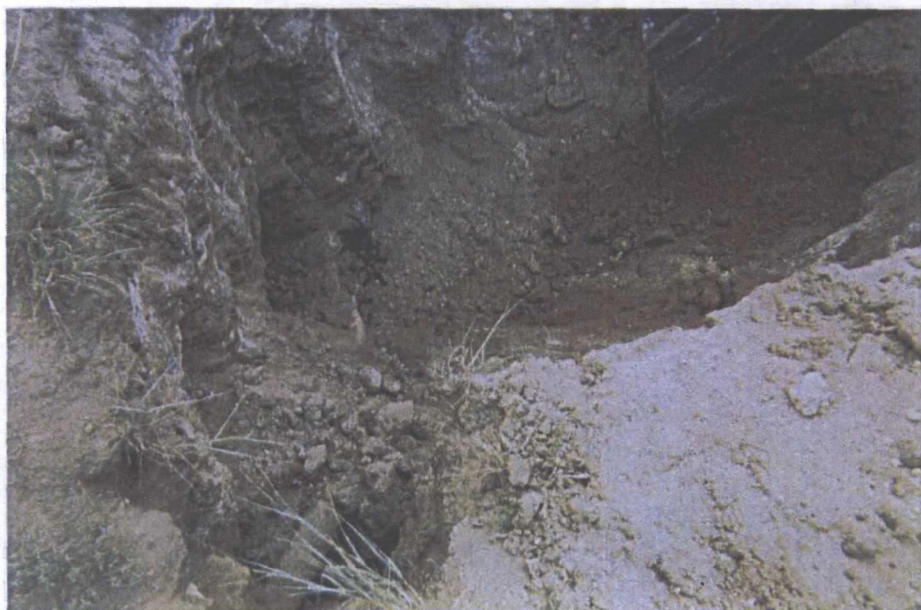
Site prior to excavating

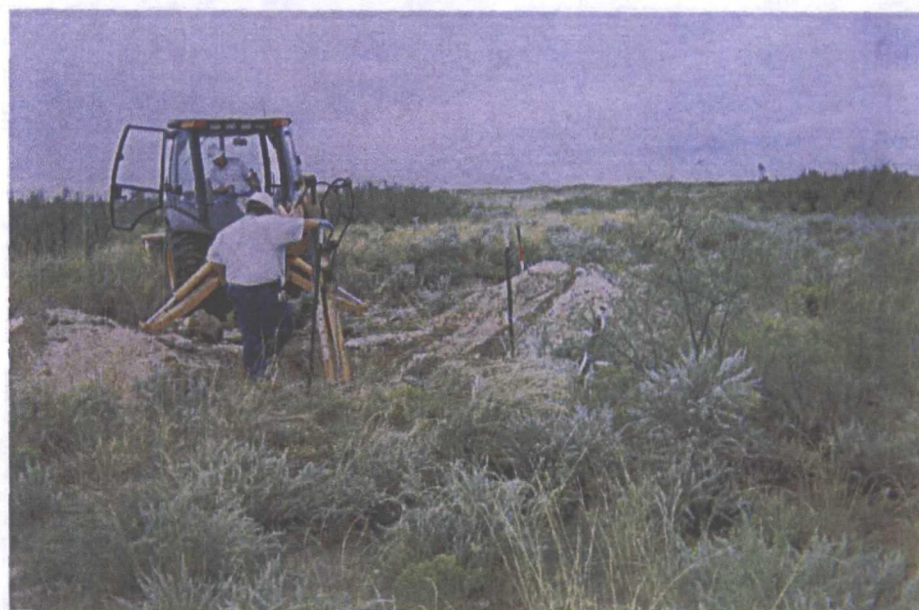
Delineation trench being excavated

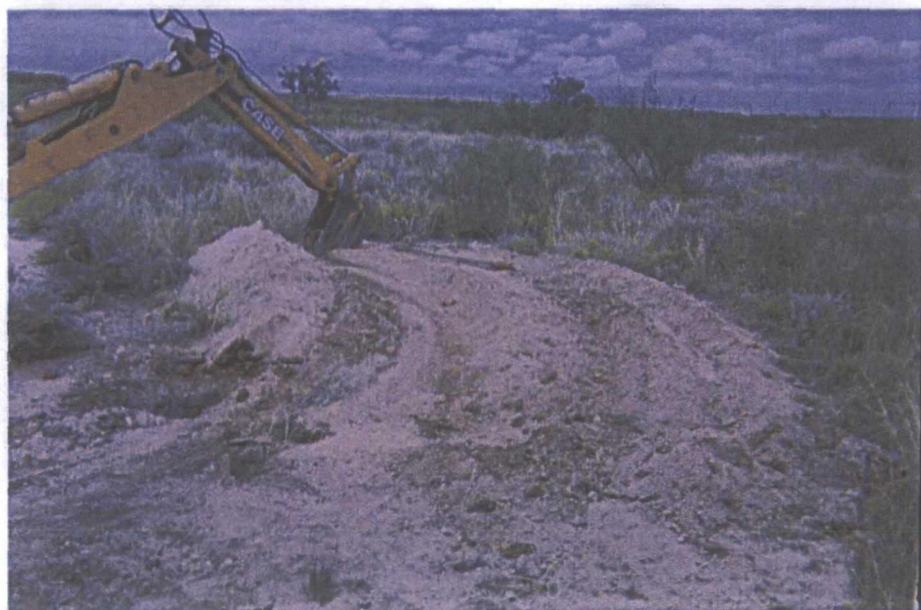
Backfilling excavation

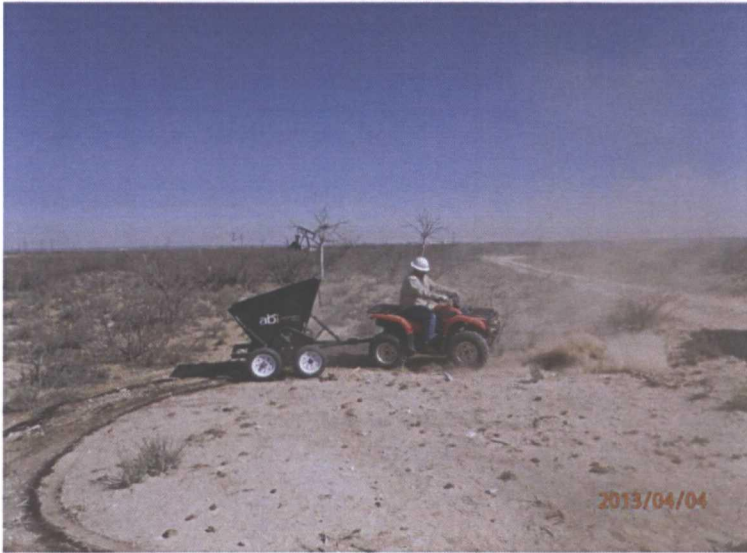
Spreading amendments, facing north

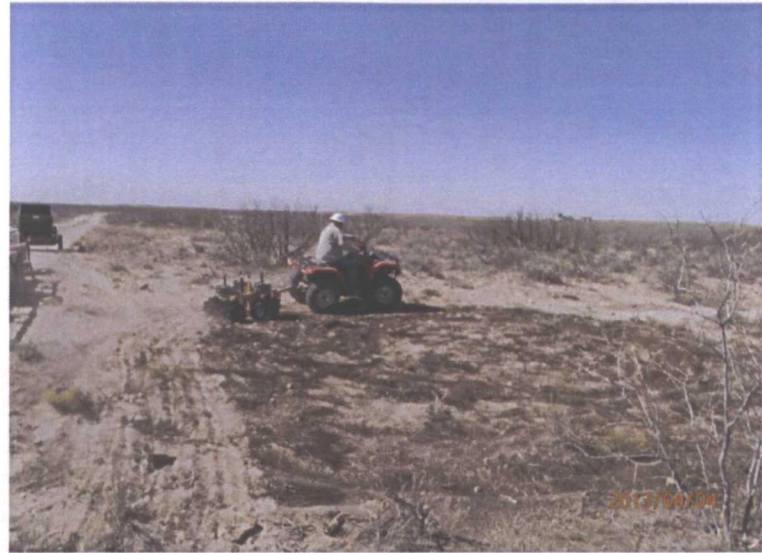
Tilling site, facing south

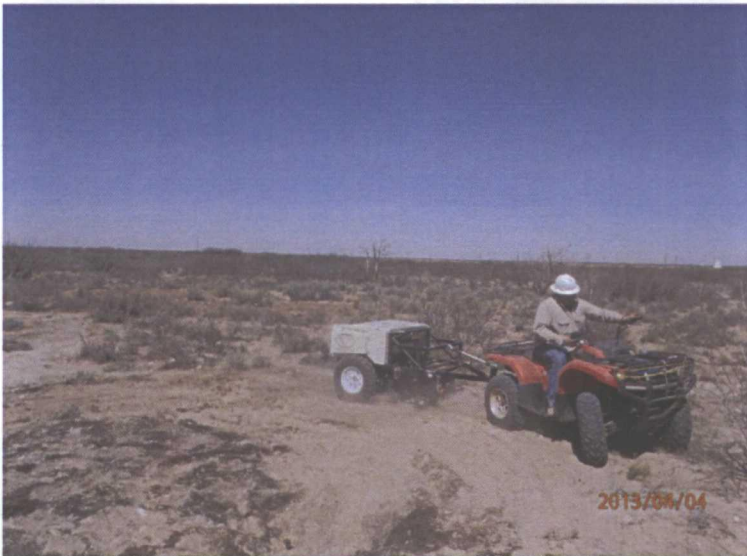
Seeding site, facing west

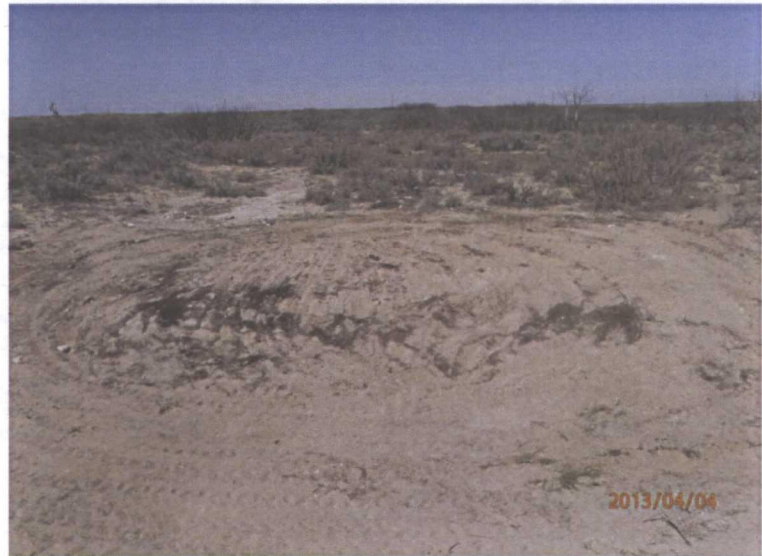
Site complete, facing west
