RE: Termination Request
EME J-25 EOL (1R427-322): UL/J, Sec. 25, T20S, R36E
RICE Operating Company – Eunice Monument Eumont SWD System

**RICE OPERATING COMPANY
JUNCTION BOX FINAL REPORT**

EME J-25 EOL

EME J-25 EOL (1R427-322)

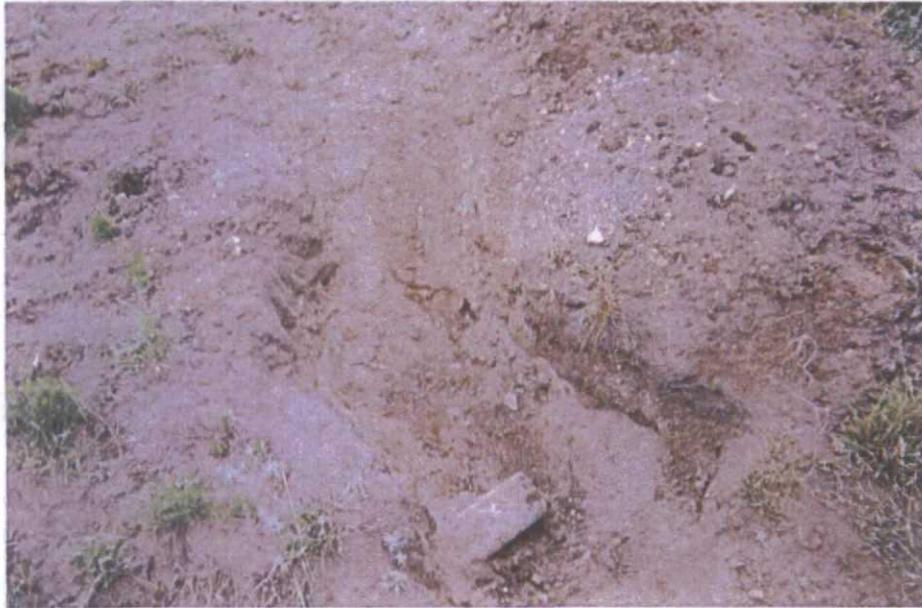
4/15/2010

Site prior to excavation

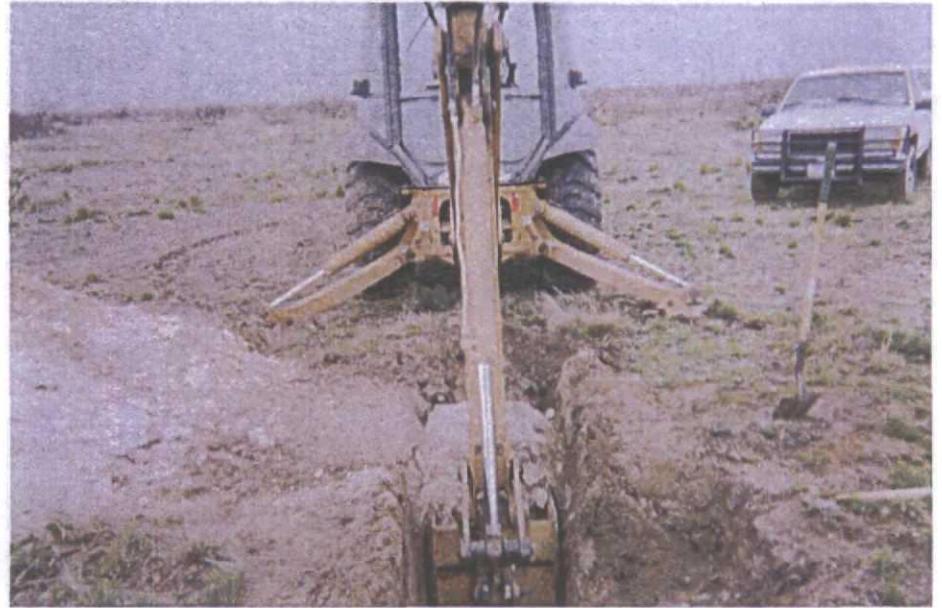
4/15/2010

Delineation trench being excavated

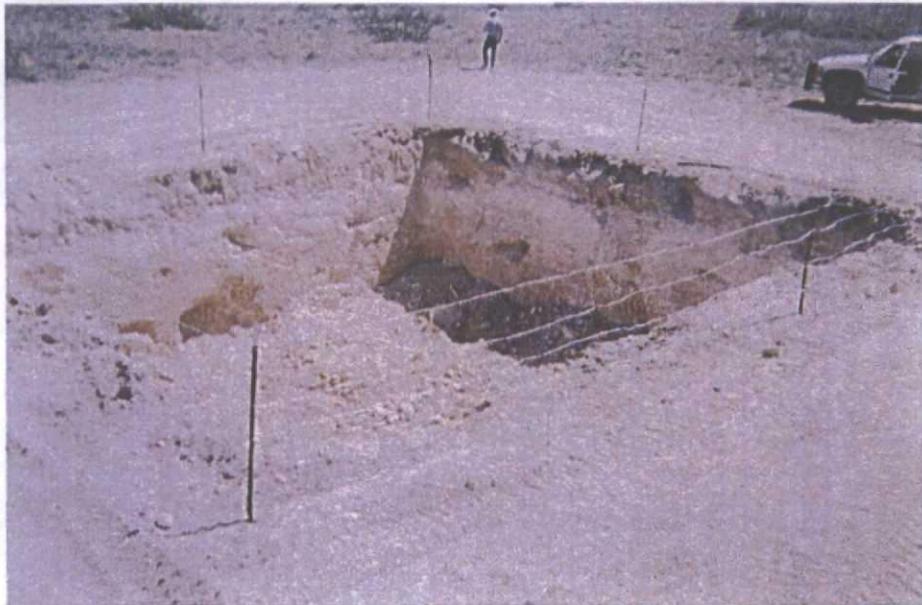
5/05/2010

Final excavation

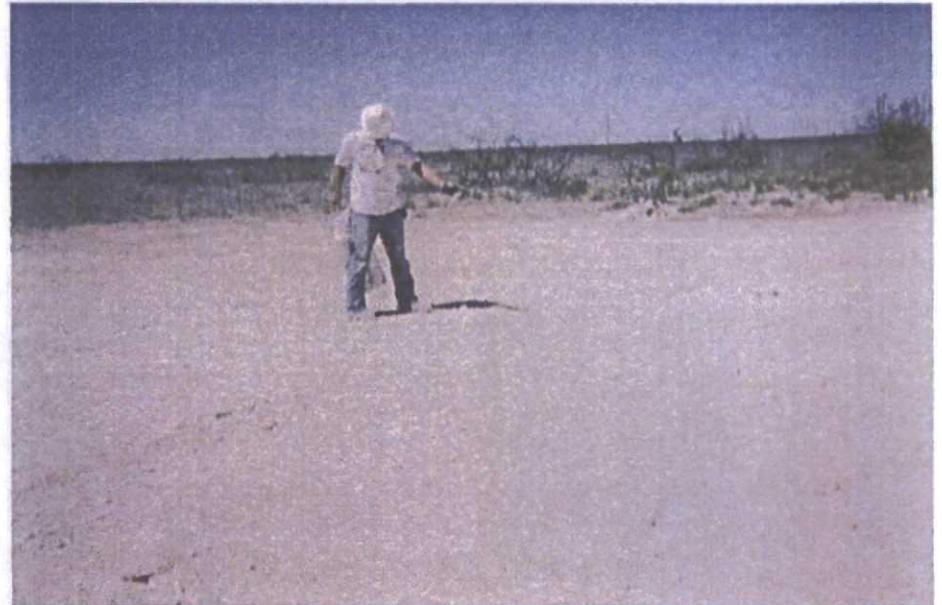
5/19/2010

Seeding excavation

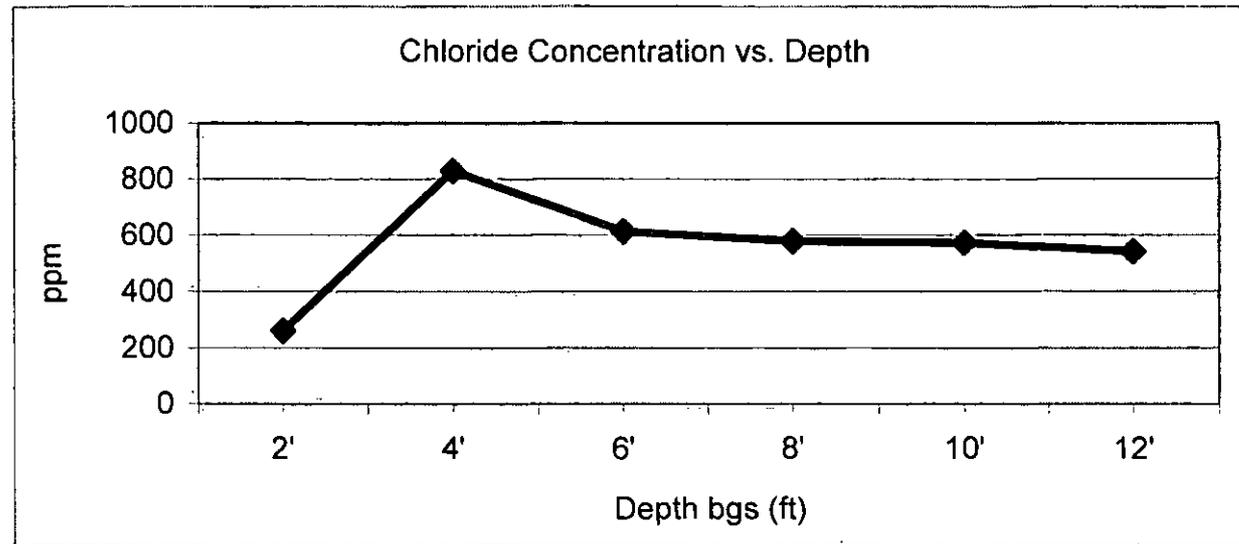
Backhoe samples 15 ft. west of the junction (source)

Depth:bgs'(ft)	[Cl ⁻],ppm'
2'	262
4'	829
6'	614
8'	579
10'	574
12'	543

Groundwater = 106 ft

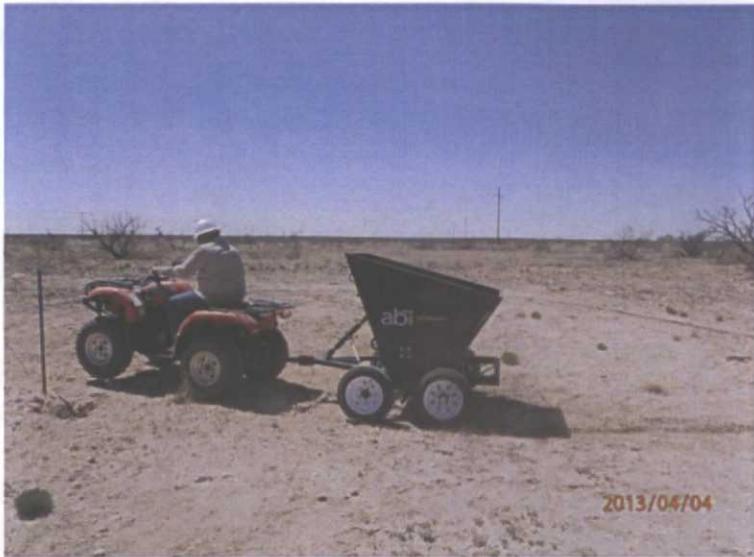
4/4/2013

Spreading amendments, facing west

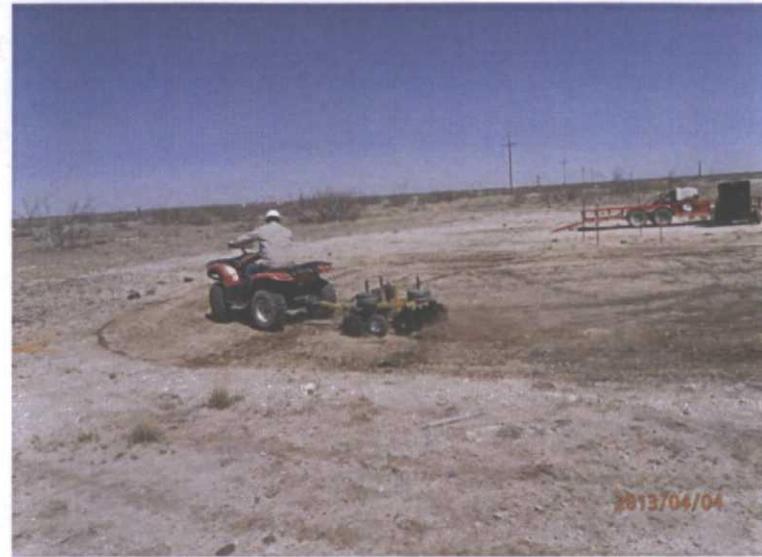
4/4/2013

Tilling site, facing east

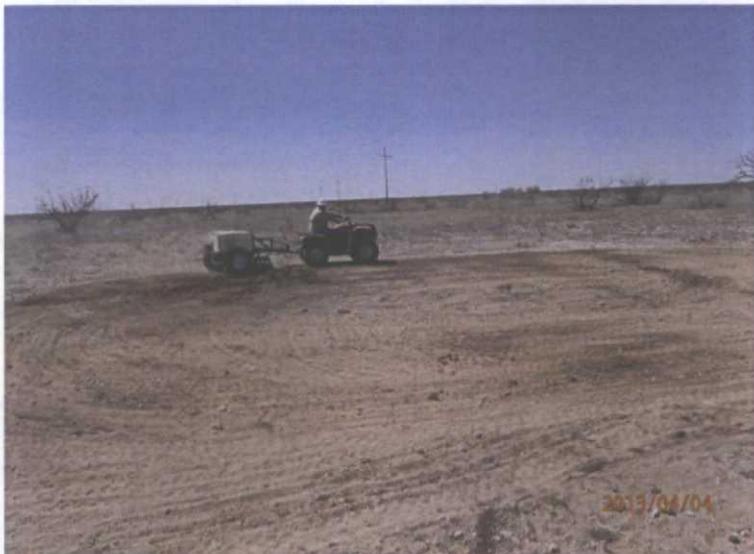
4/4/2013

Seeding site, facing west

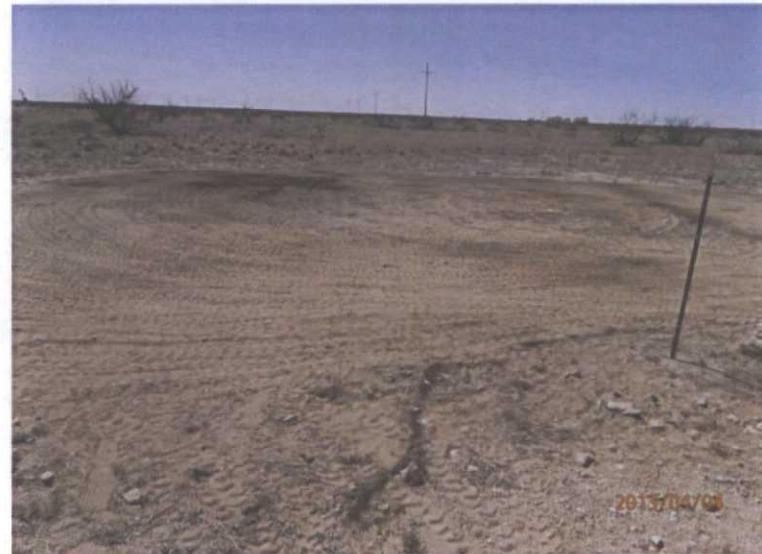
4/4/2013

Site complete, facing west
