RE: Termination Request
EME C-10 EOL (1R427-360): UL/C, Sec. 10, T21S, R36E
RICE Operating Company – Eunice Monument Eumont SWD System

Junction Box Report

**RICE OPERATING COMPANY
JUNCTION BOX FINAL REPORT**

EME C-10 EOL

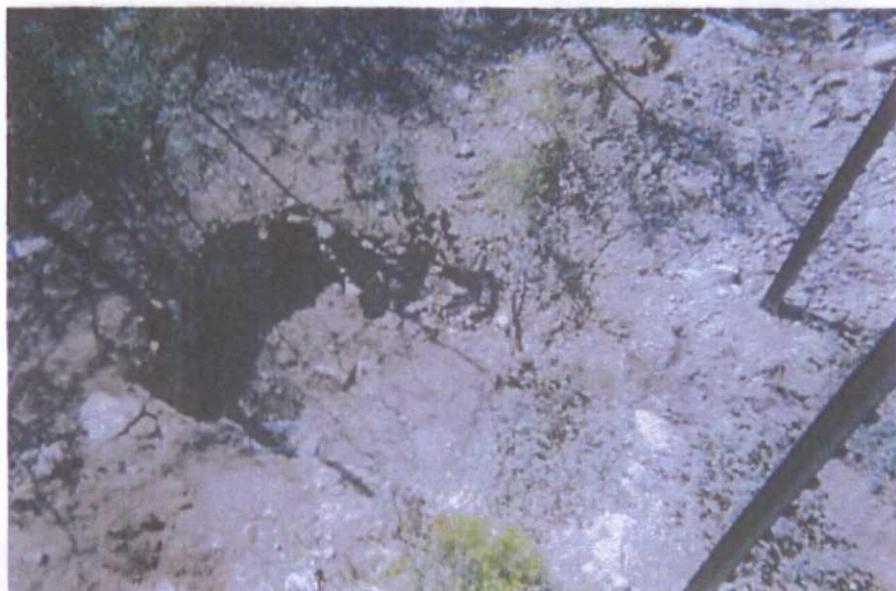
9/29/2010

Site prior to delineation

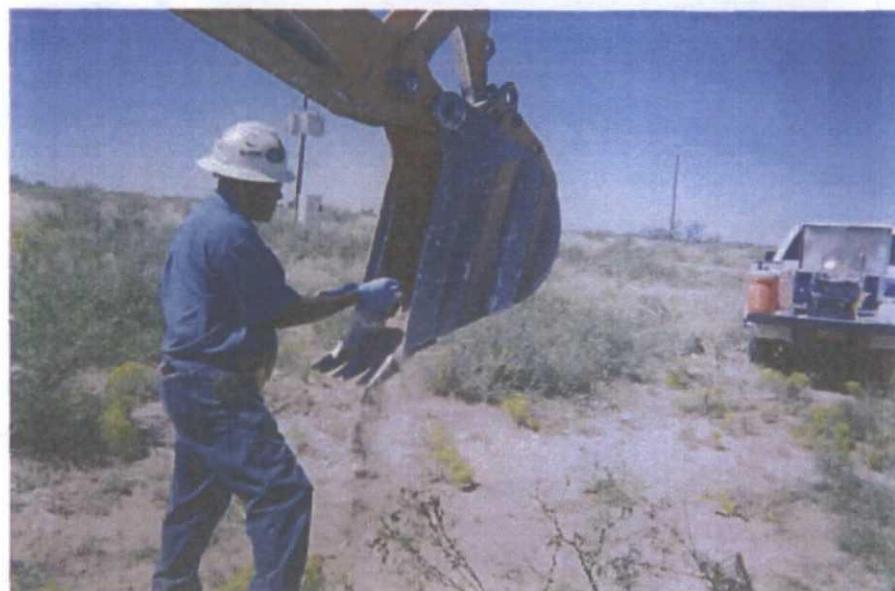
9/29/2010

Collecting sample

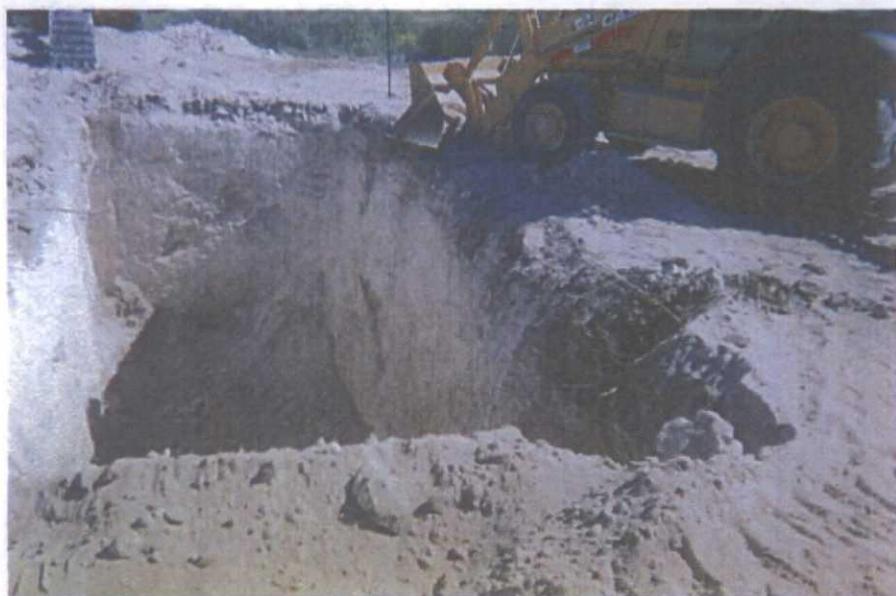
10/5/2010

Final delineation trench

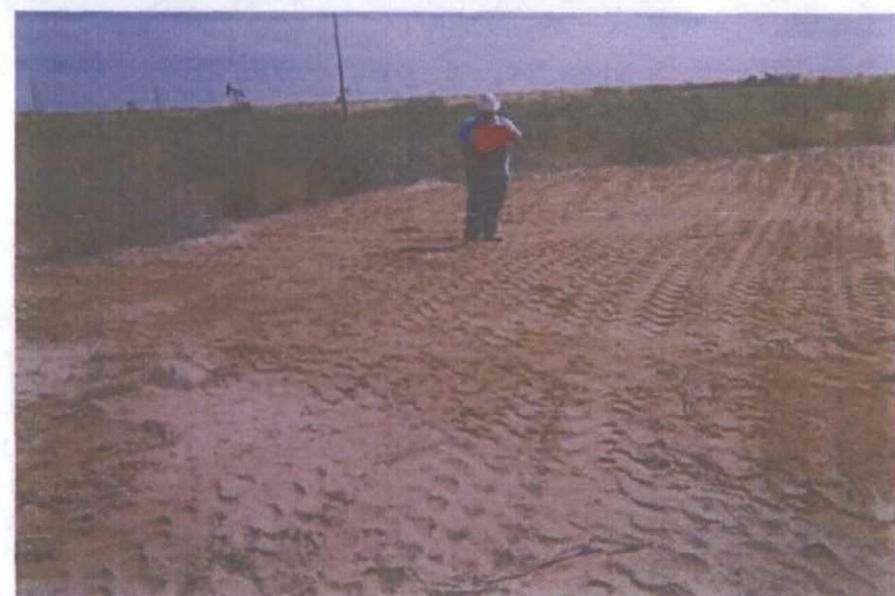
10/27/2010

Covering seed

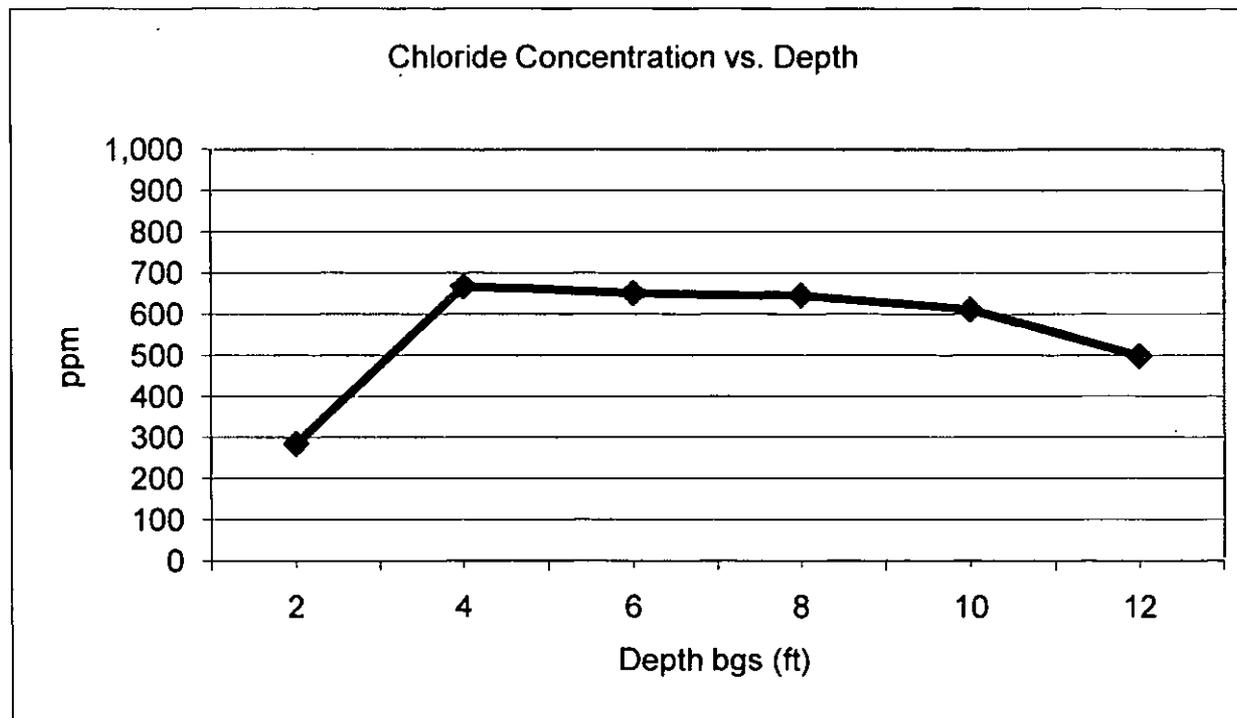
EME C-10 EOL

Backhoe samples at 5' south of the junction (source)

Depth bgs (ft)	[Cl] ppm
2	285
4	668
6	651
8	645
10	612
12	499

Groundwater = 200 ft

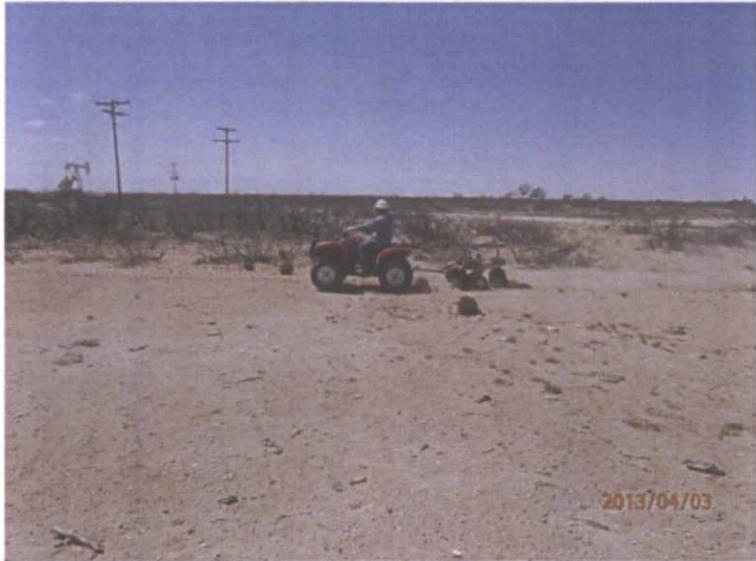
4/3/2013

Tilling site, facing west

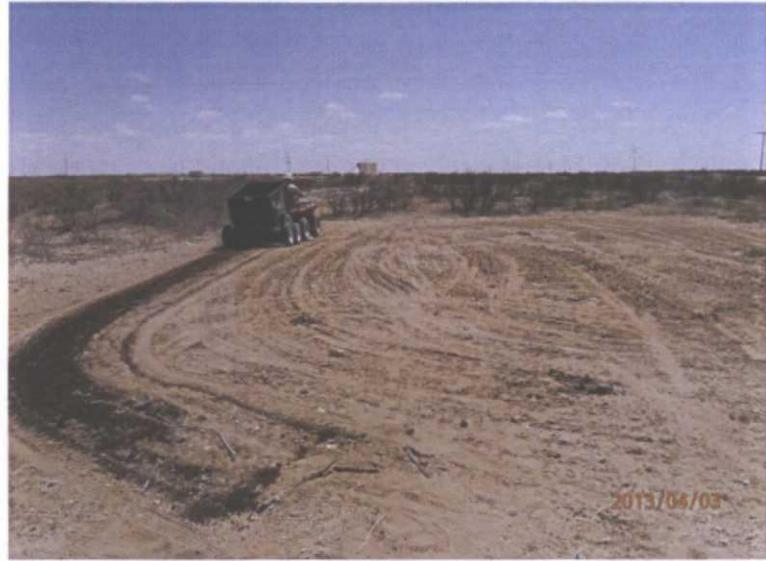
4/3/2013

Spreading amendments, facing east

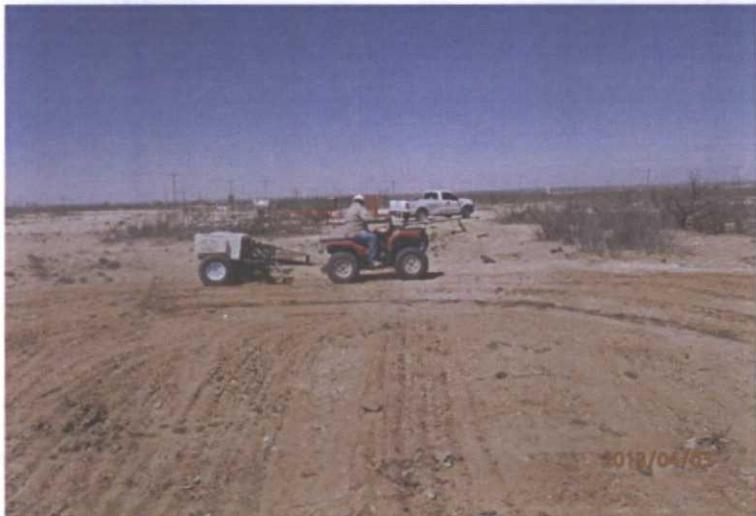
4/3/2013

Seeding site, facing west

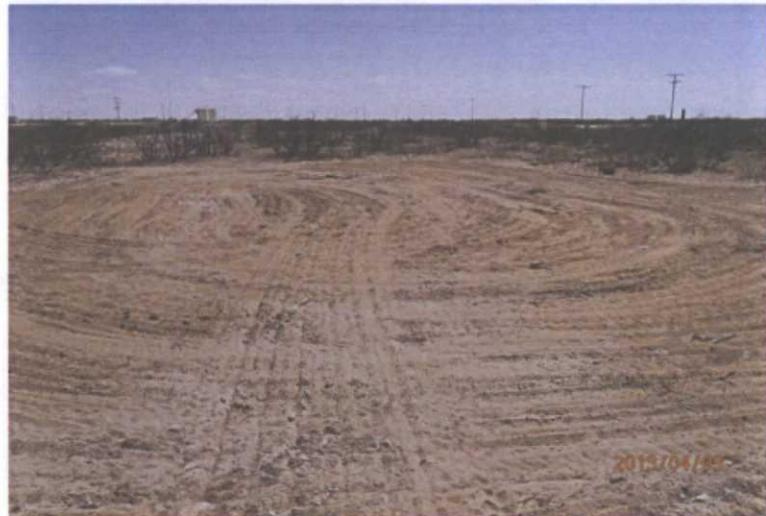
4/3/2013

Site complete, facing south
