# WORKPLANS

**RE: Corrective Action Plan (CAP) Addendum  
Rice Operating Company – BD SWD System  
BD jct. C-23-1 (1R426-279): UL/C sec. 23 T22S R37E**

## *BD jct. C-23-1*

NMOCD Case #: 1R426-279

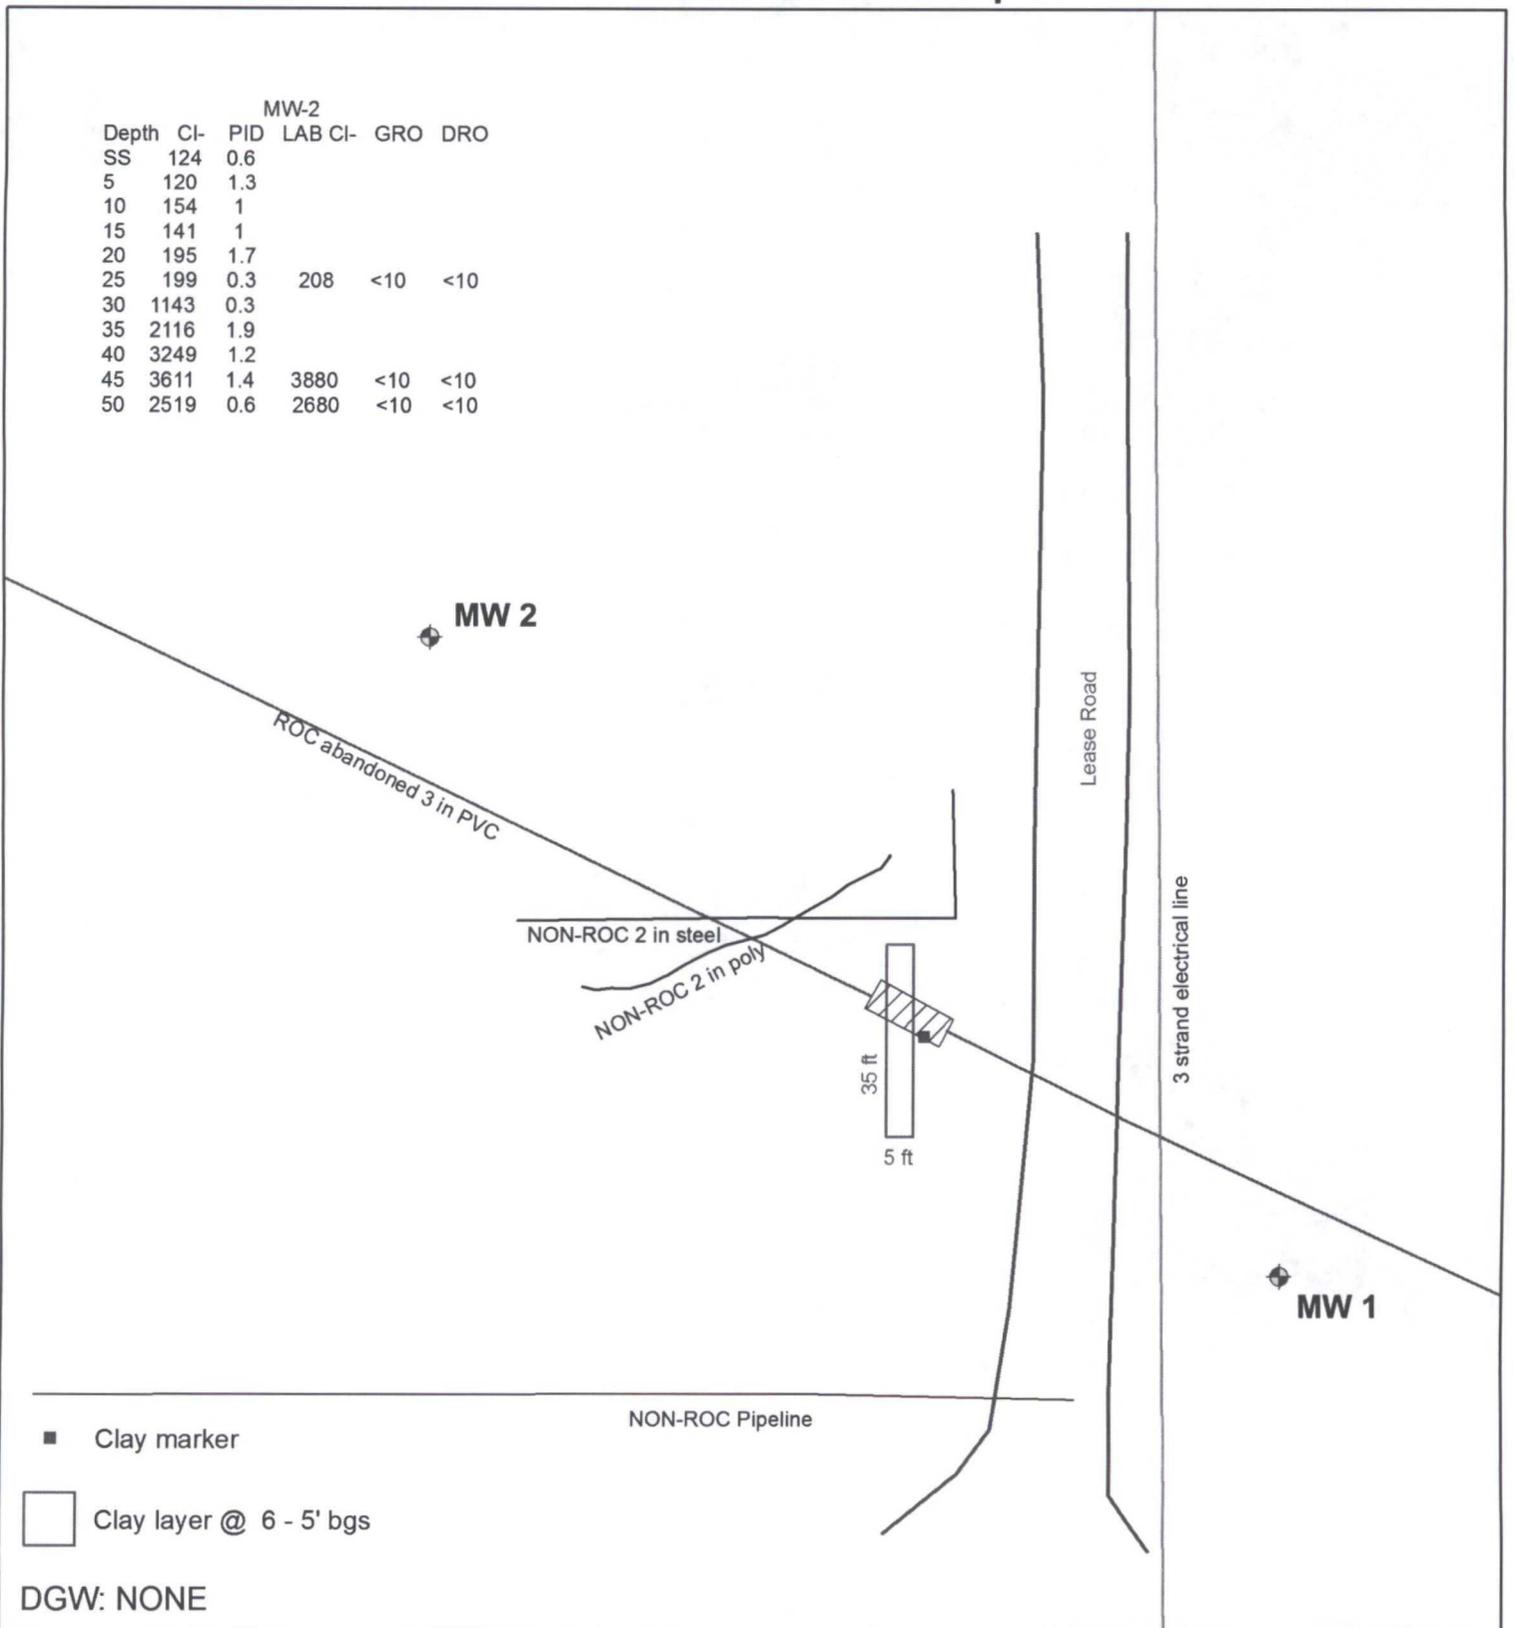
**Figure 2**

On March 20<sup>th</sup>, 2013, ROC submitted a Corrective Action Plan (CAP) to NMOCD which was approved on April 23<sup>rd</sup>, 2013. As part of CAP, RECS reported on the installation of two monitor wells at the site (Figure 2). The two monitor wells were installed at the site on February 12<sup>th</sup>, 2013. MW-1 was installed 71 ft southeast of the former junction box site and MW-2 was installed 92 ft northwest of the former junction box site. No sampling was conducted as MW-1 was installed. MW-2 was field sampled to determine background soil concentrations of chlorides and hydrocarbons. Representative samples from the bore were taken to a commercial laboratory for analysis. Background concentrations in MW-2 showed chloride values of 208 mg/kg at 25 ft bgs, 3,880 mg/kg at 45 ft bgs and 2,680 mg/kg at 50 ft bgs. GRO and DRO values at all depth were non-detect.

# MW Installation Map

MW-2						
Depth	CI-	PID	LAB CI-	GRO	DRO	
SS	124	0.6				
5	120	1.3				
10	154	1				
15	141	1				
20	195	1.7				
25	199	0.3	208	<10	<10	
30	1143	0.3				
35	2116	1.9				
40	3249	1.2				
45	3611	1.4	3880	<10	<10	
50	2519	0.6	2680	<10	<10

As an addendum to the CAP, RECS recommends that ROC plug and abandon MW-1 and MW-2 at the site. The wells will be plugged with a 1-3% bentonite/concrete slurry with a 3 ft concrete cap. Per a conversation between ROC and NMOCD on June 19, 2013, ROC will proceed with the plugging the two monitoring wells (MW-1 and MW-2) at this site.
