West H.E. B #4 Battery – West B #38
2RP-1715

Termination Request

**Linn Energy – West H.E. B #4 Battery – West B #38 (2RP-1715)
UL/F sec. 10 T17S R31E
API No. 3001526001**

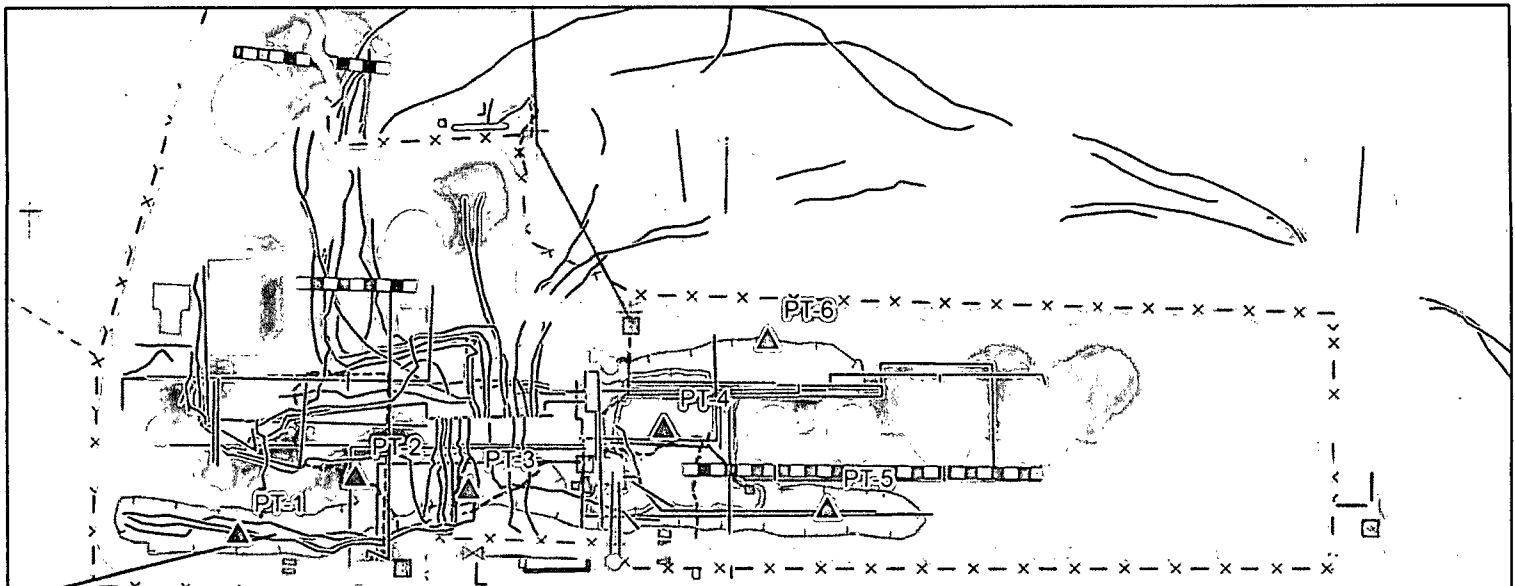
Figure 1

Initial Sampling Data

Point 1	CI-	PID	GRO	DRO	B	T	E	X	BTEX	Point 2	CI-	PID	GRO	DRO	B	T	E	X	BTEX
Surface	1589	258.3								Surface	2825	139.2							
1.5'	486	830.6								1.5'	1811	7							
2'	968	1260								2'	2240	5.6	<10	683	<0.05	<0.05	<0.05	<0.15	<0.3
2.5'	719	1166								2.5'	1490	4.1							
3'	279	884.7								3'	771	4							
3.5'	237	841								3.5'	627	4.6							
4'	284	203.5								4'	810	2.7							
4.5'	329	614.6								4.5'	662	3.3							
5'	358	294.1								5'	658	2.1							
5.5'	340	274.4								5.5'	600	2.4							
6'	359	16.2								6'	611	347							
6.5'	446	61.7								6.5'	658	304.3							
7'	435	114.2								7'	602	161							
7.5'	454	91.1								7.5'	604	174.9							
8'	483	67.5								8'	616	63.3							
8.5'	502	197.3								8.5'	480	106.3							
9'	624	41.6	<10	10.3	<0.05	<0.05	<0.05	<0.15	<0.3	9'	464	37	<10	33.9	<0.05	<0.05	<0.05	<0.15	<0.3

Point 3 CI- PID
Surface 909 268.8

Point 4 CI- PID
Surface 224 141.6

Point 5 CI- PID
Surface 166 96.3

Point 6 CI- PID
Surface 858 139.6

RECS received this site from another environmental company. When RECS took over site remediation, the release in the battery had already been excavated to a depth of approximately 1.5 - 3 ft bgs, depending on the area (Figure 1). On September 4th, 2013, RECS personnel were on site to sample the excavated area. The surface of the excavation was sampled at six points, and two points, Point 1 and Point 2, were sampled to determine the depth of contamination. All samples were field tested for chlorides and for organic vapors using a PID meter. Representative samples were taken to a commercial laboratory for analysis (Appendix B). Point 1 and Point 2 were hand augured to a depth of 9 ft bgs and laboratory analysis showed chloride results below 1,000 mg/kg at 9 ft bgs. Gasoline Range Organics (GRO) and BTEX readings were non-detect in both augurs at all depths. Diesel Range Organics (DRO) showed slightly elevated readings in both augurs at all depths, but were below regulatory standards and declined with depth.

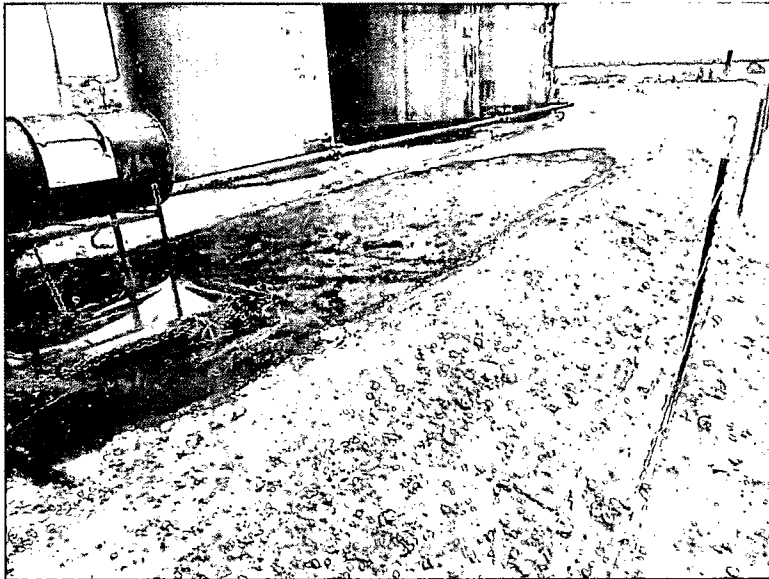
Initial release area, facing southwest

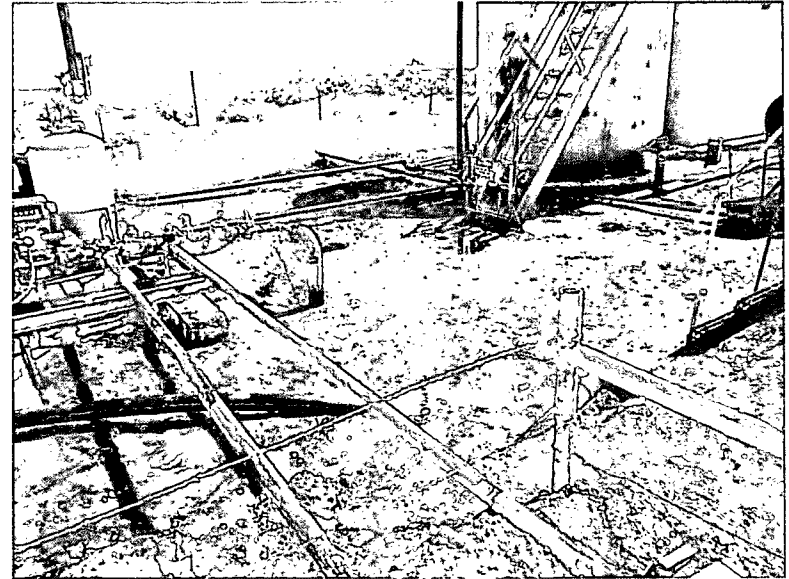
Initial release area, facing northeast

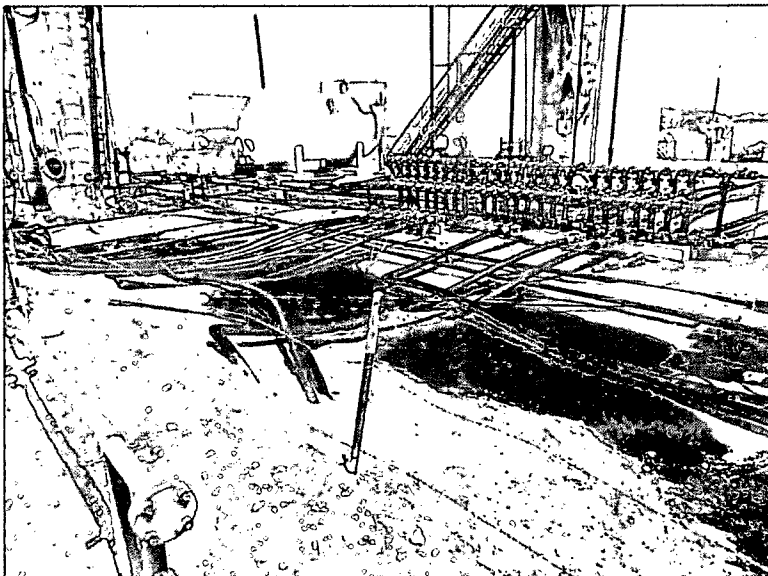
Initial release area, facing northwest

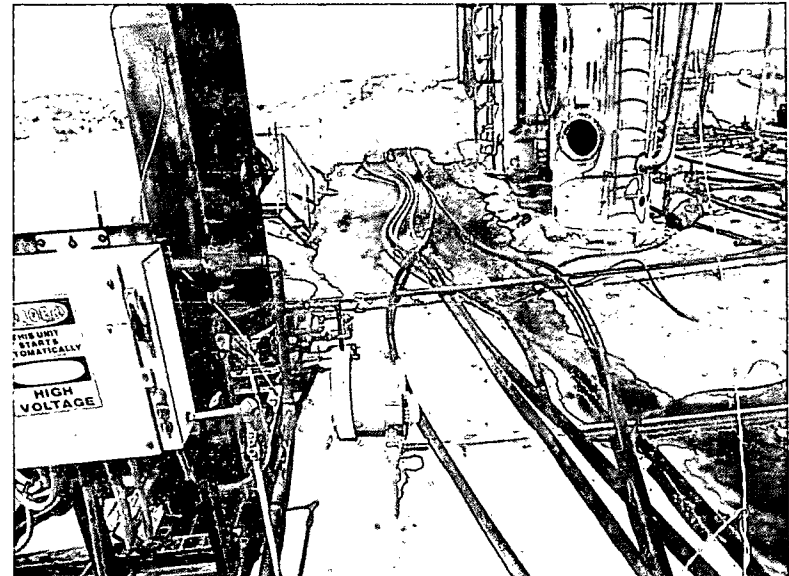
Initial release area, facing west

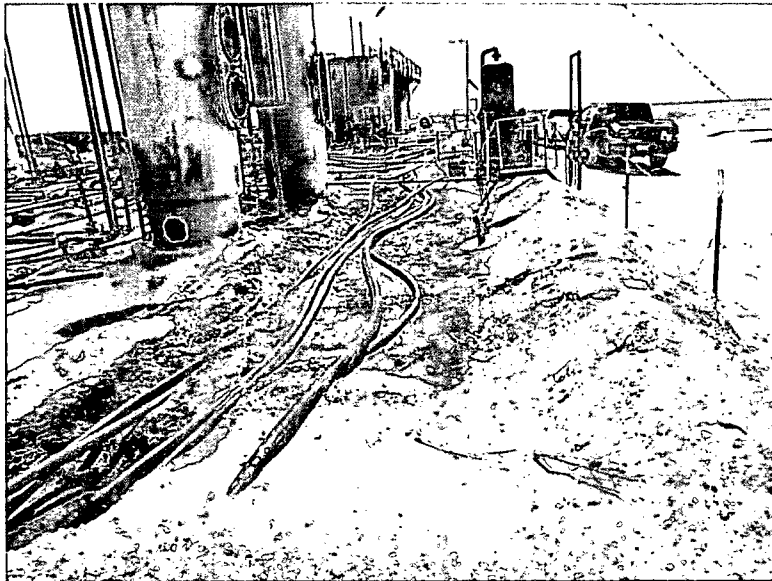
Initial release area, facing northeast

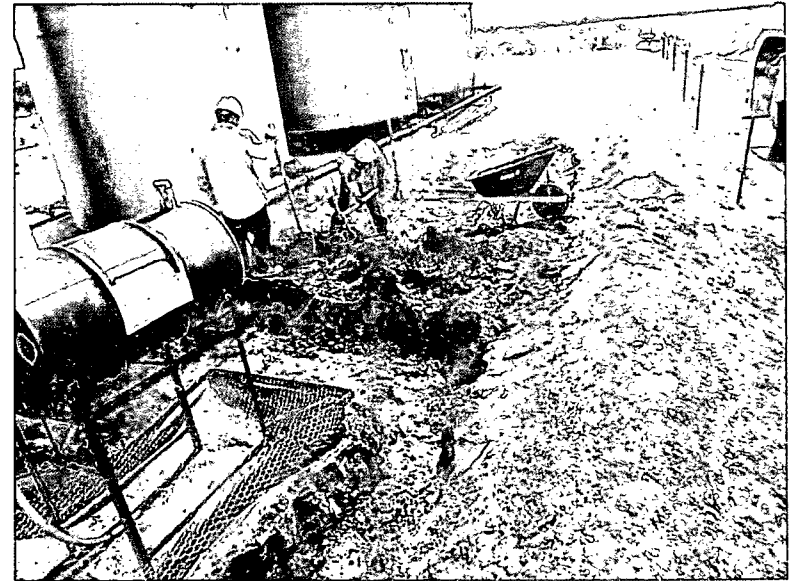
Excavating site by hand, facing southwest

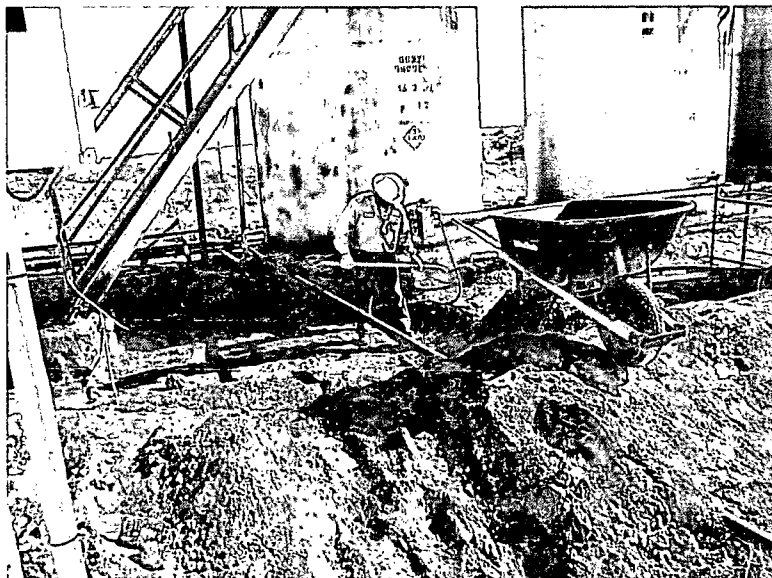
Excavating the site by hand, facing north

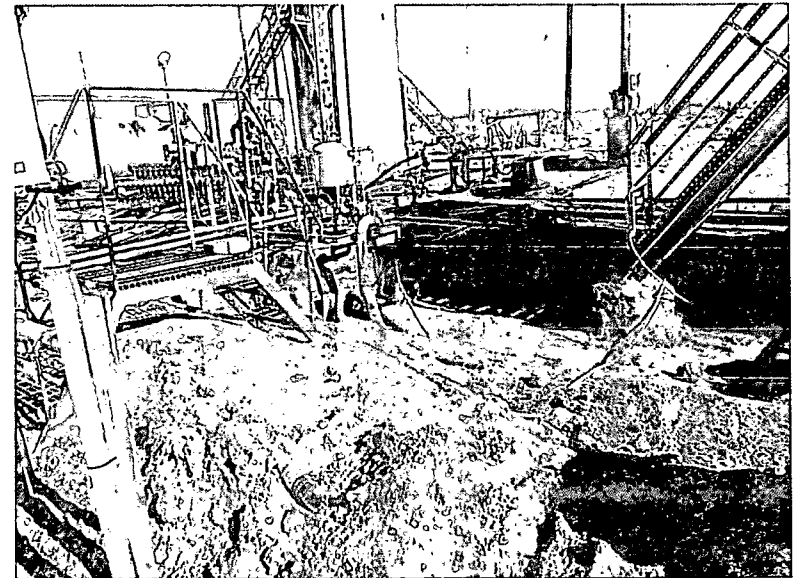
Excavation completed, facing northwest

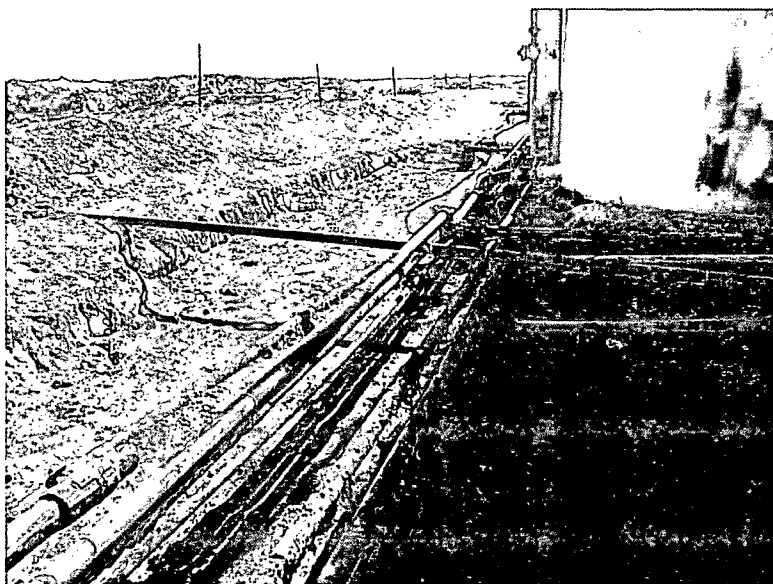
Excavation completed, facing east

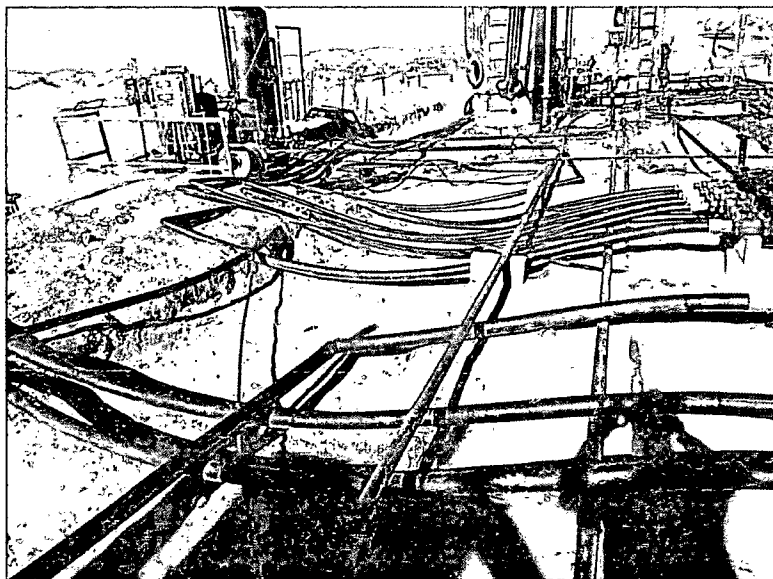
Excavation completed, facing west

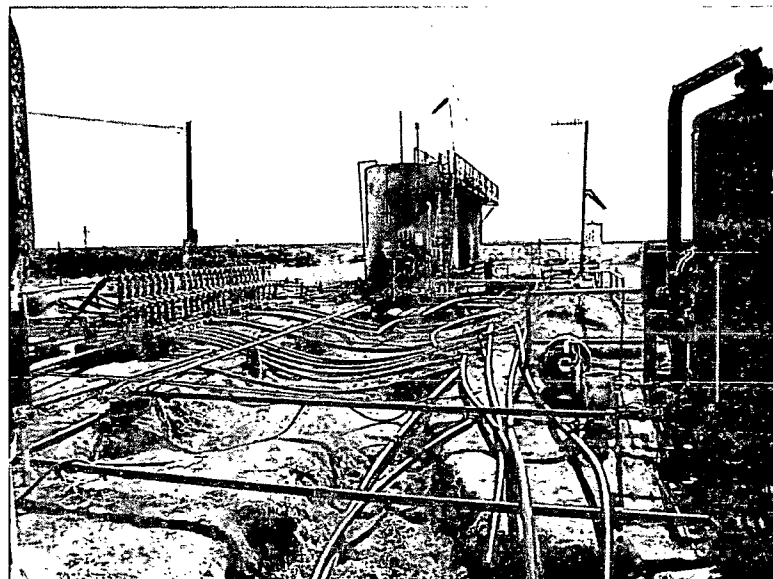
Excavation completed, facing east

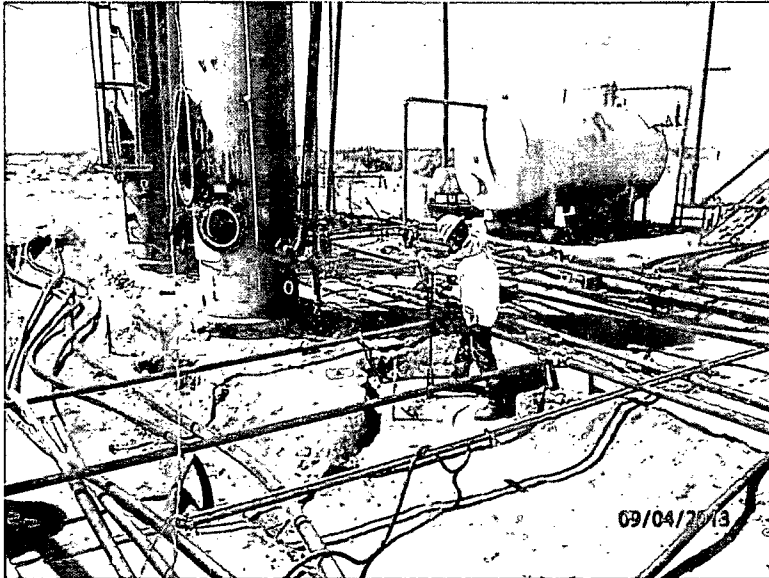
Hand auguring for depth, facing northwest 9/4/13

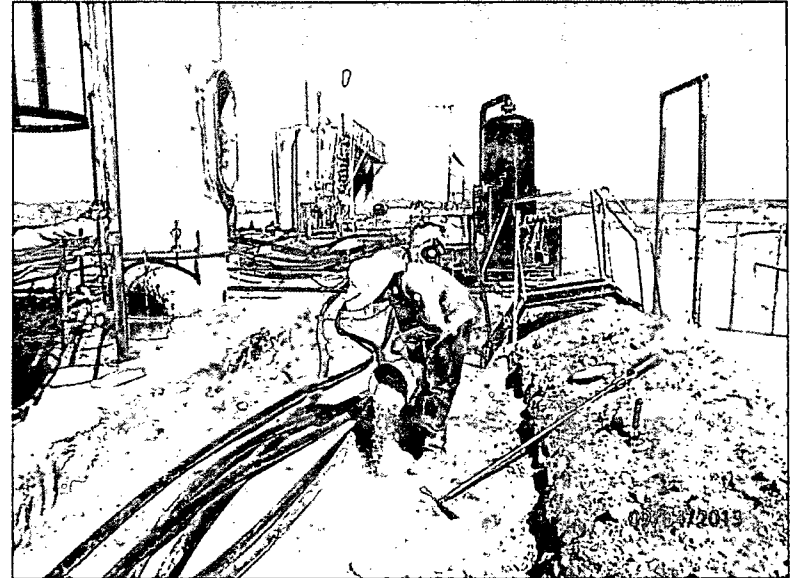
Plugging auger point in total with bentonite, facing east 9/4/13

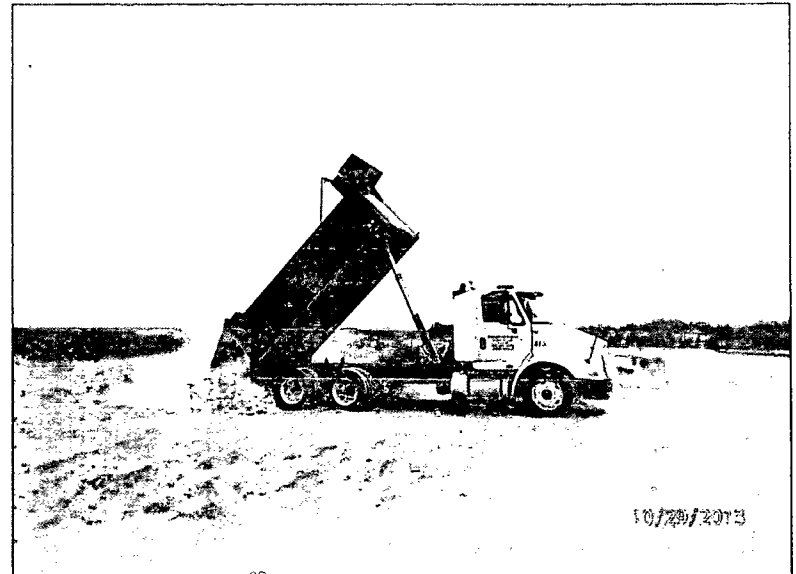
Importing caliche, facing northwest 10/29/13

On October 29th, 2013, 108 yards of caliche was imported to the site to serve as backfill. A sample of the imported soil was taken to a commercial laboratory for analysis and returned a chloride result of non-detect (Appendix C). The site was backfilled with the caliche and contoured to the surrounding location.

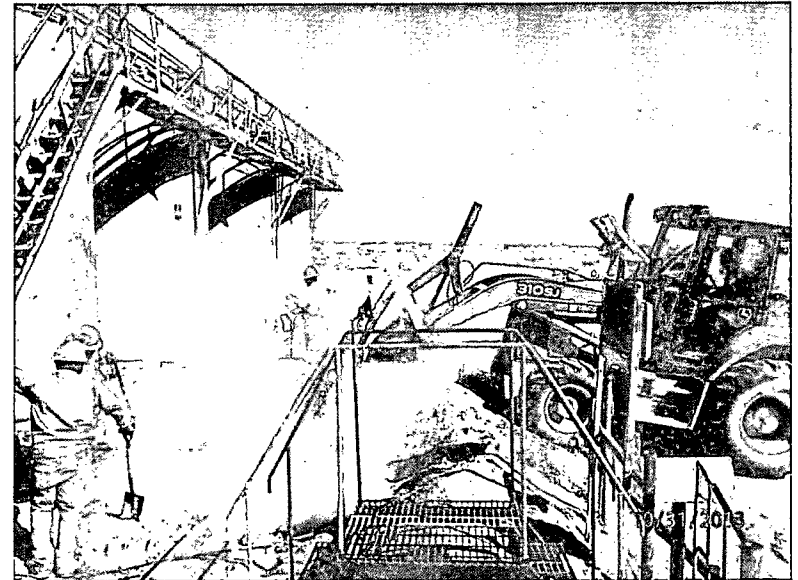
Backfilling site, facing east 10/31/13

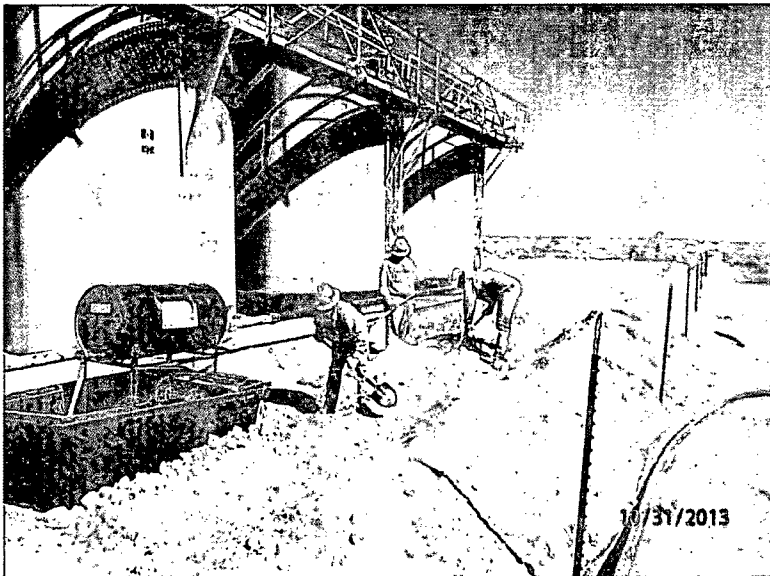
Backfilling site, facing northeast 10/31/13

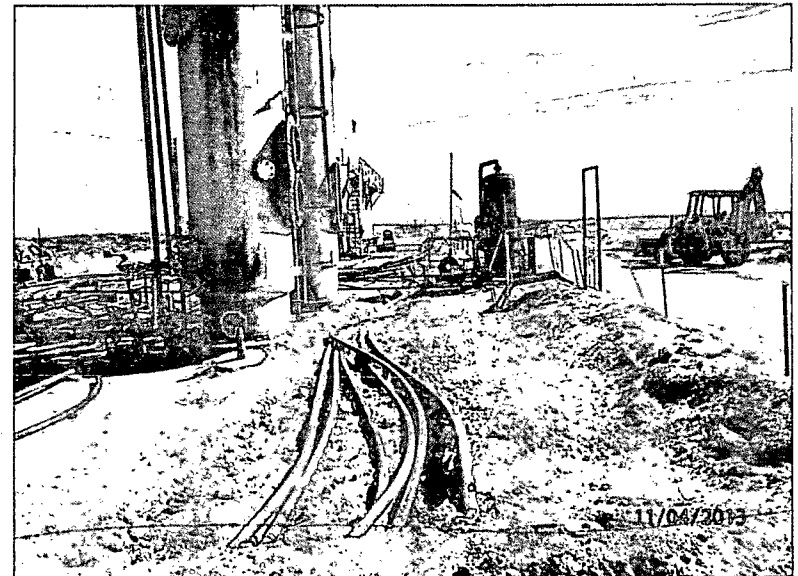
Backfill completed, facing west 11/4/13

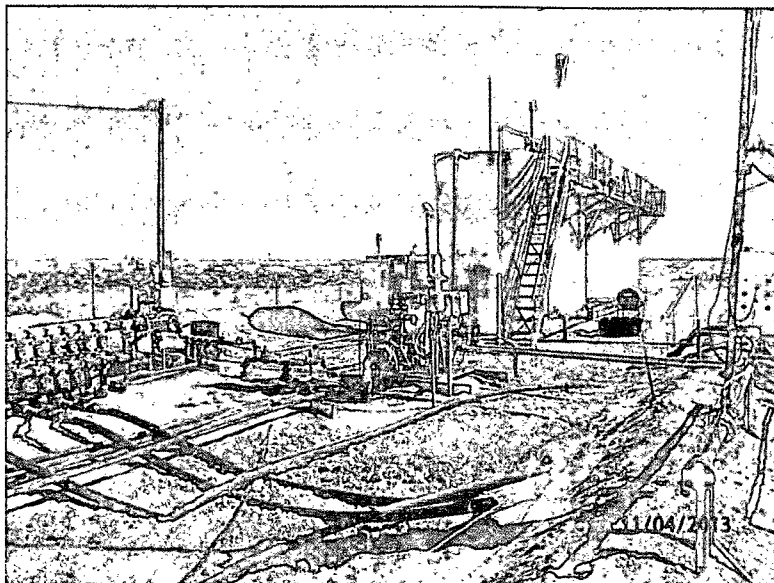
Backfill completed, facing northeast

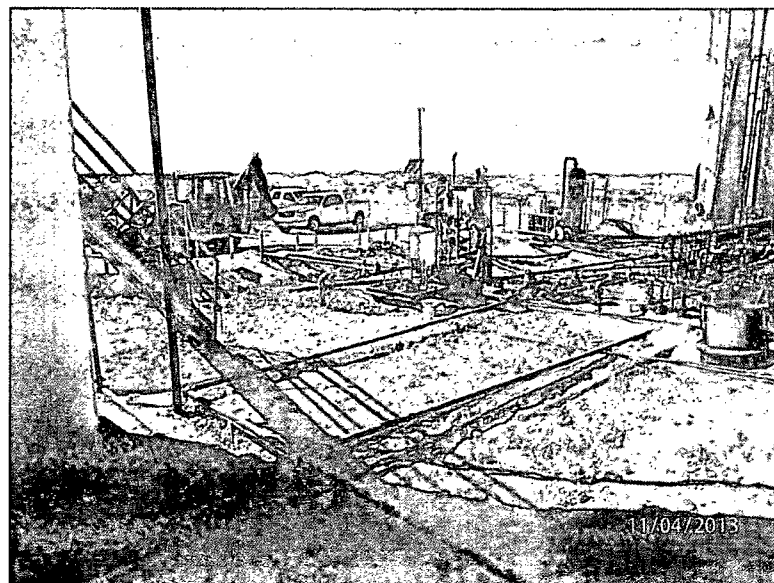
Backfill completed, facing southwest
