REMEDIATION SUMMARY

AND RISK-BASED SITE CLOSURE REQUEST

BOPCO, LP

POKER LAKE UNIT #188Y Eddy County, New Mexico Unit Letter "C" (NE/NW), Section 5, Township 24 South, Range 30 East Latitude 32.25196° North, Longitude 103.90815° West NMOCD Reference # 2RP-____

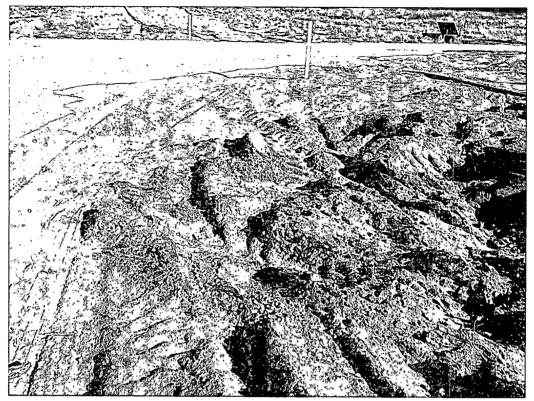
Photograph of the initial release at the PLU #188Y Release Site.

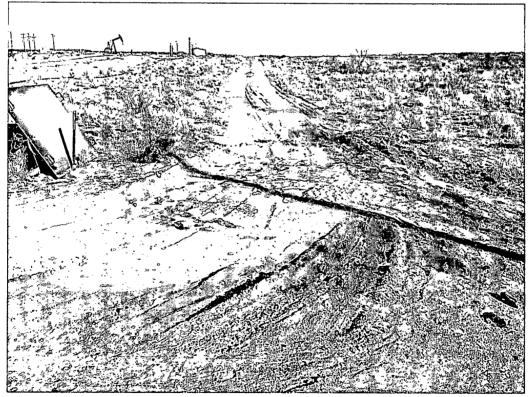
Photograph of the initial release at the PLU #188Y Release Site.

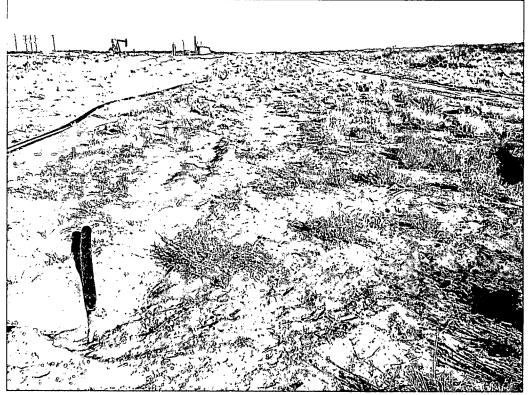
Photograph of the initial release at the PLU #188Y Release Site.

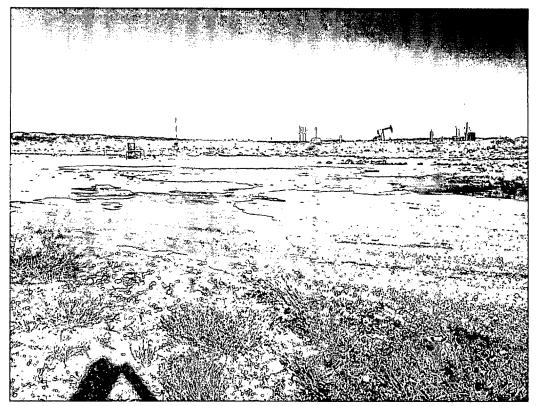
Photograph of the initial release and affected well pad at the PLU #188Y Release Site.

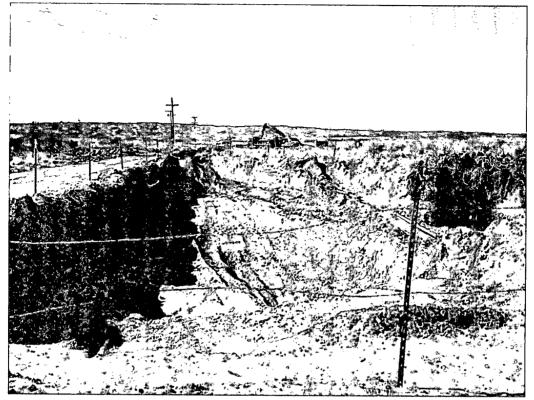
Photograph of the excavated release point area at the PLU #188Y Release Site.

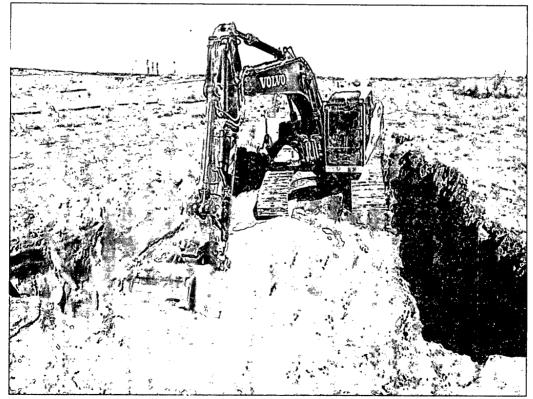
Photograph of the advancement of delineation trench in Excavation #3 at the PLU #188Y Release Site.

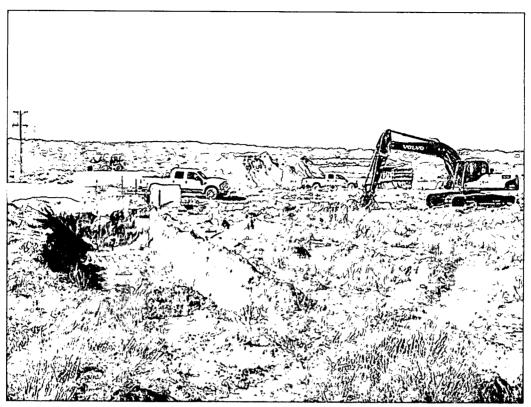
Photograph of Excavation #4 at the PLU #188Y Release Site.

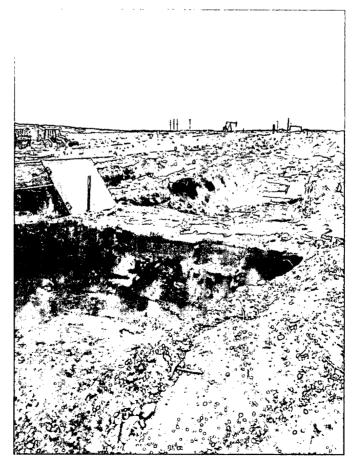
Photograph of Excavations #3 and #5 at the PLU #188Y Release Site.

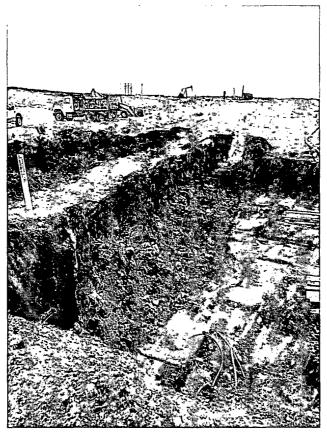
Photograph of Excavation #6 at the PLU #188Y Release Site.

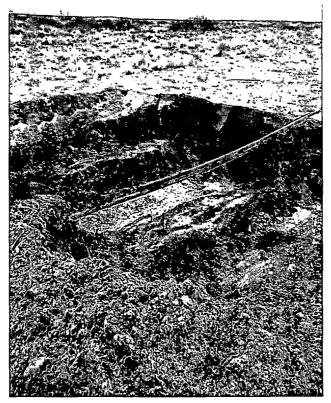
Photograph of Excavation #6 at the PLU #188Y Release Site.

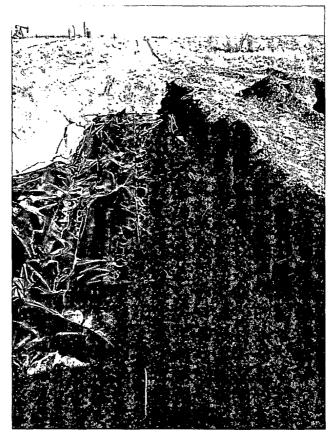
Photograph of the installation of 20-mil liner in Excavation #3 at the PLU #188Y Release Site.

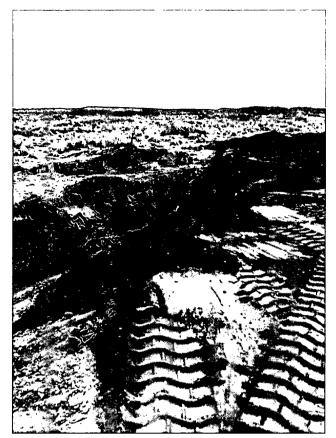
Photograph of backfilling activities at the PLU #188Y Release Site.

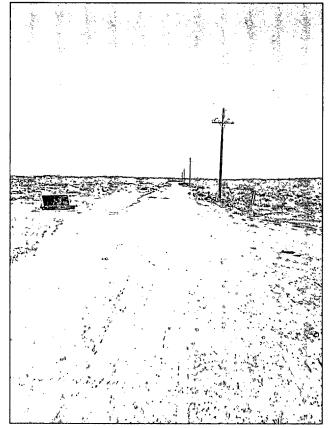
Photograph of the PLU #188Y Remediation Site after backfilling activities.
