Poker Lake Unit #114

CLOSURE REPORT

2RP-1100-0

December 12, 2013

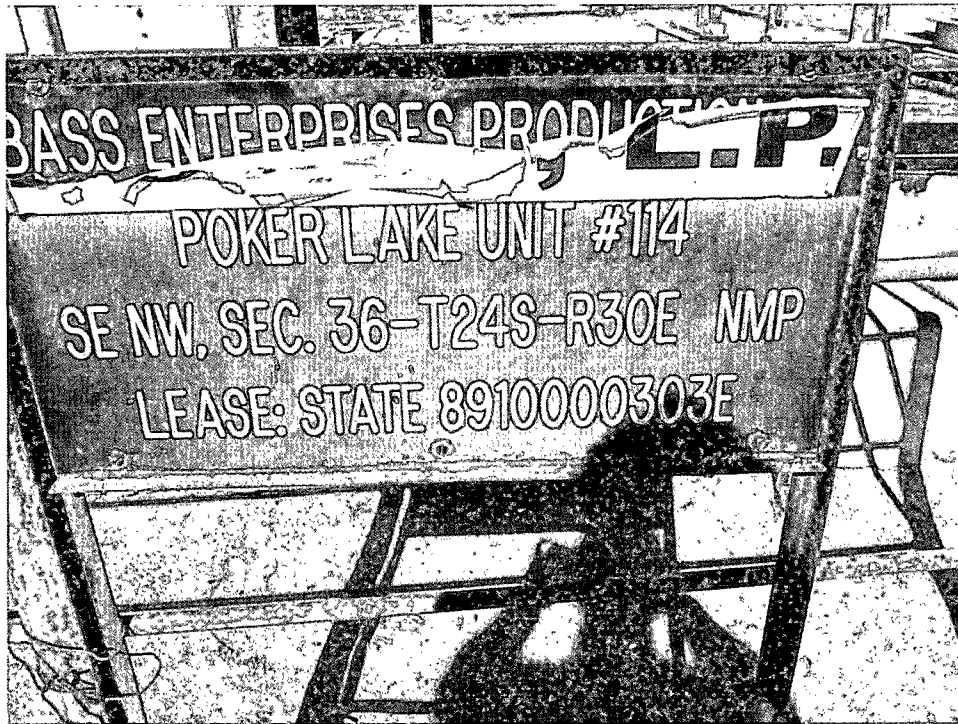
Sign marking location 10/26/13

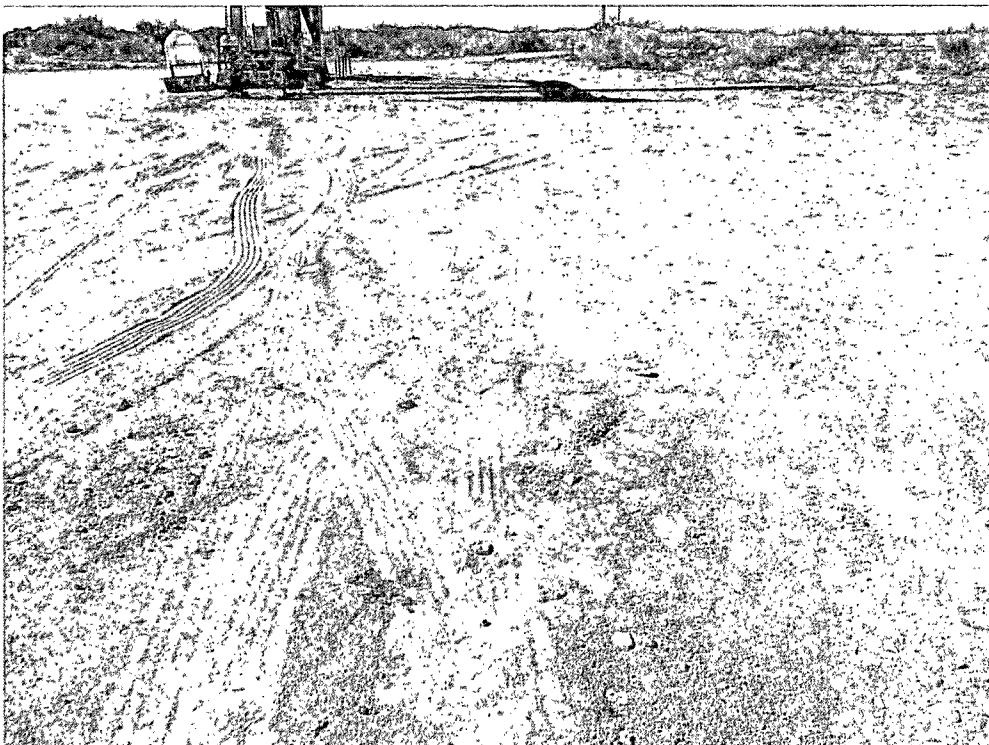
Spill location SW of lease road 10/26/13

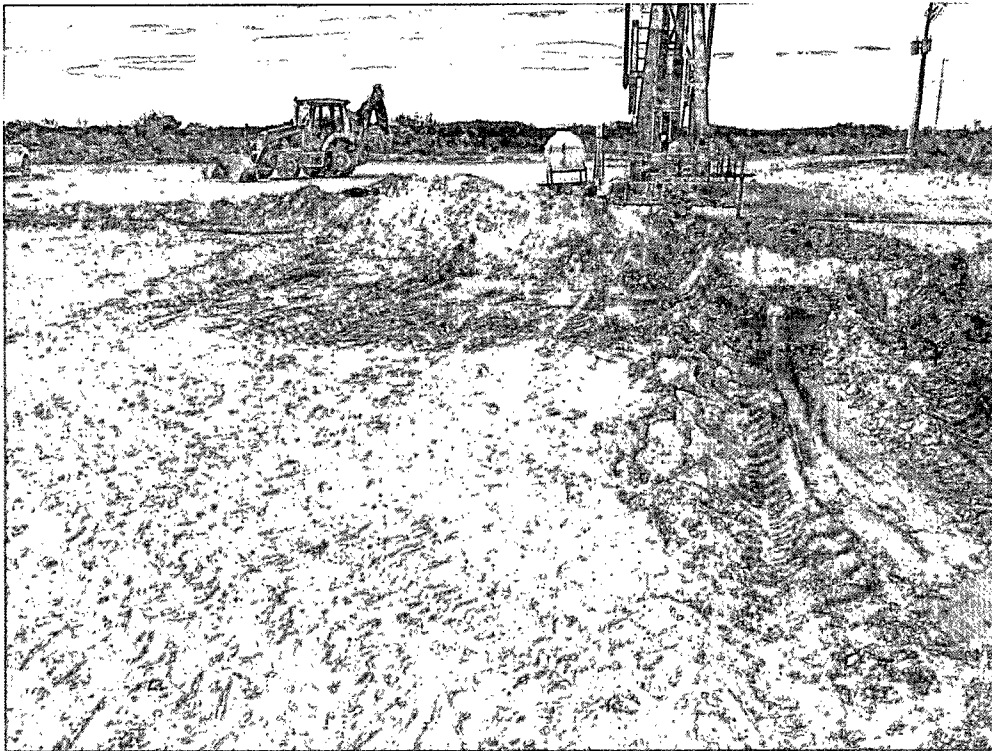
Soil excavation 11/02/13

DFSI personnel excavated the site to 2 feet bgs and installed a reinforced 20 mil plastic liner at that depth. Impacted soils were removed to a NMOCD approved disposal facility. The excavation was backfilled with a 1 foot lift of pad sand above the plastic liner. The excavation was capped with a 1 foot lift of caliche, and the site was leveled. Photographs of site activities can be viewed in Appendix II.

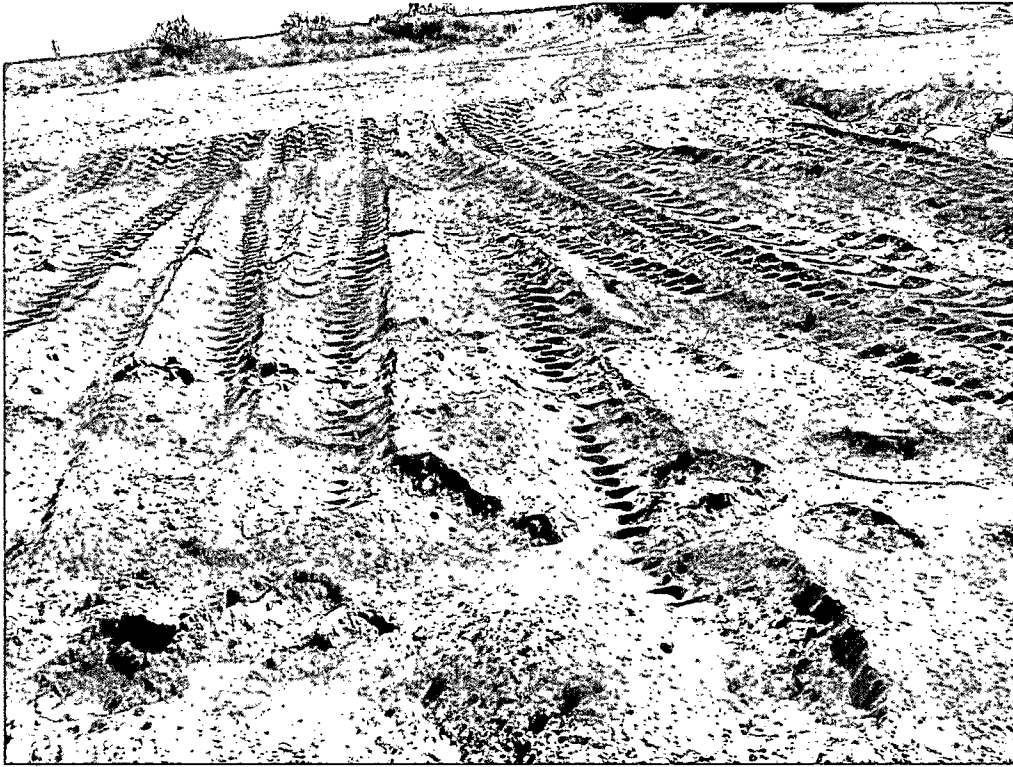
Backfill of lined area 11/16/13
