H.E. West B #85
2RP-1865

Termination Request

RE: Termination Request

Linn Energy – H.E. West B #85 (2RP-1865)

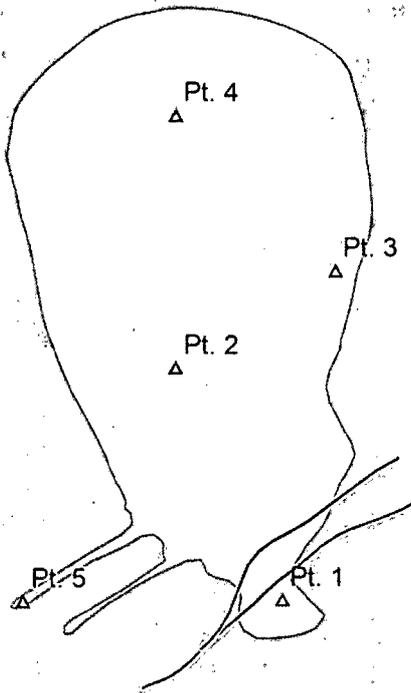
Figure 1

Initial Sampling Data

Point 1	Cl-	PID	GRO	DRO	B	T	E	X	BTEX
SS	6480	19.1	<10	594	<0.05	<0.05	<0.05	<0.15	<0.3
6"	544	60.2	<10	<10	<0.05	<0.05	<0.05	<0.15	<0.3
1'	128	16.5	<10	<10	<0.05	<0.05	<0.05	<0.15	<0.3

Point 2	Cl-	PID	GRO	DRO	B	T	E	X	BTEX
SS	2240	2.6	<10	160	<0.05	<0.05	<0.05	<0.15	<0.3
6"	160	3.8	<10	<10	<0.05	<0.05	<0.05	<0.15	<0.3
1'	80	10.3	<10	<10	<0.05	<0.05	<0.05	<0.15	<0.3

Point 4	Cl-	PID
SS	339	7.2
6"	144	2.5

Point 3	Cl-	PID	GRO	DRO	B	T	E	X	BTEX
SS	1800	1.1	<10	257	<0.05	<0.05	<0.05	<0.15	<0.3
6"	195	2.6							
1'	1071	2.5							
1.5'	48	7.8	<10	<10	<0.05	<0.05	<0.05	<0.15	<0.3
2'	16	3.6	<10	<10	<0.05	<0.05	<0.05	<0.15	<0.3

Point 5	Cl-	PID
SS	2497	18
6"	328	5.8
1'	168	8.7

RECS personnel were on site beginning on August 21st, 2013 to assess the site (Figure 1). Samples from the surface and at depth were taken from five points throughout the release and representative samples from three of the points were taken to a commercial laboratory for analysis (Appendix B). Laboratory chloride levels dropped to below regulatory standards by 1 ft bgs at Pt. 1, by 6 inches at Pt. 2 and by 1.5 ft at Pt. 3. Gasoline Range Organics (GRO) and BTEX were non-detect at all points and all depths. Diesel Range Organics (DRO) were present at all points at the surface but dropped to non-detect at all depths below the surface.

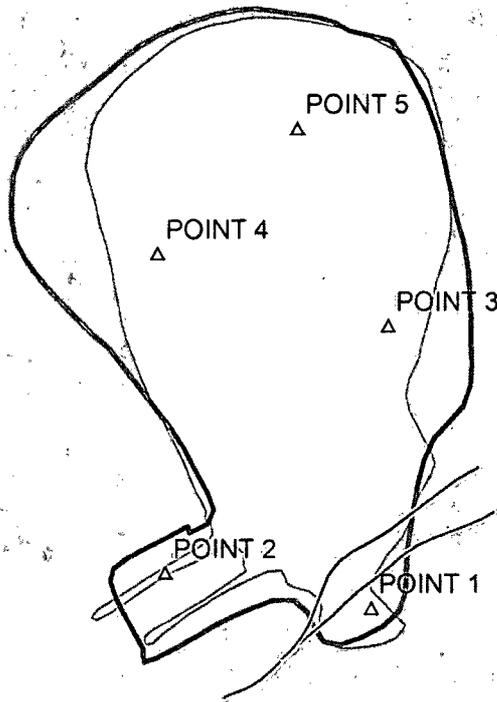
Figure 2

Final Sampling Data

Sample Description	CI-	PID	GRO	DRO	B	T	E	X	BTEX
5 Point Bottom Composite	124	1.9	<10	<10	<0.05	0.123	0.059	0.301	0.483

CAP activities began on October 29th, 2013. The release was scraped to a depth of 6 inches bgs and a total of 68 yards of soil was taken to a NMOCD approved facility for disposal. At the base of the scrape a 5 point bottom composite was obtained and sent to a commercial laboratory for analysis (Figure 2). The 5 point bottom composite returned a chloride result of 124 mg/kg GRO and DRO results of non-detect and a BTEX result of 0.483 mg/kg (Appendix C). A total of 24 yards of caliche was imported to the site to backfill the lease road. A sample of the caliche was taken to a commercial laboratory and returned a chloride result of non-detect (Appendix C). On November 4th, 2013, BLM and NMOCD approved the final laboratory sampling and allowed the site to be backfilled. The pasture area was contoured with the remaining soil on site and the lease road was backfilled with the imported caliche. On November 14th, 2013, soil amendments were added to the pasture area and the site was seeded with LPC mix.

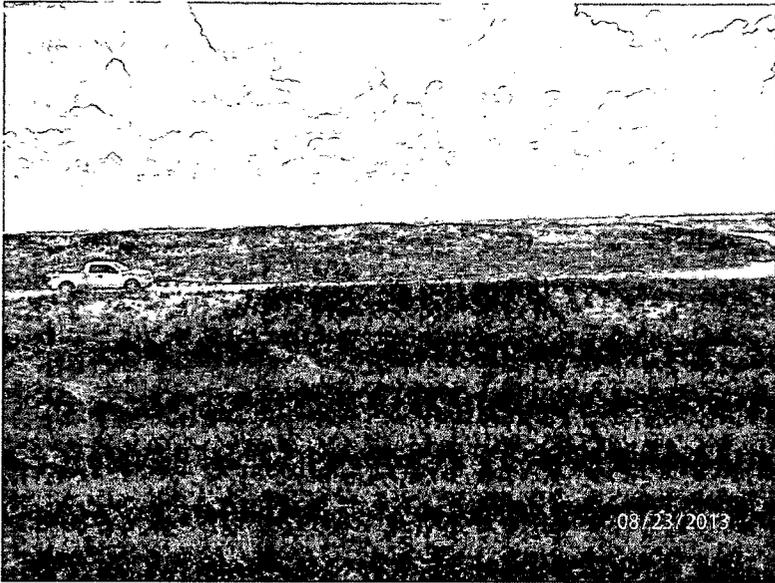
Initial release area, facing south

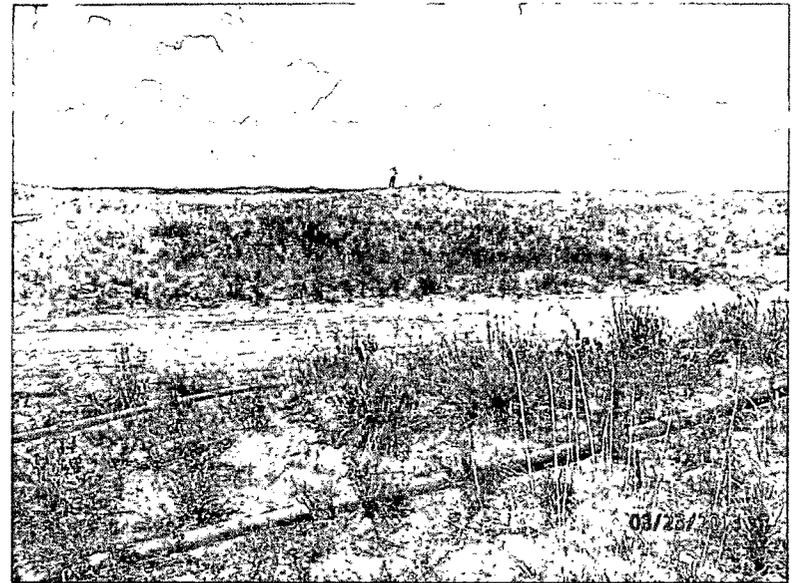
Initial release area, facing north

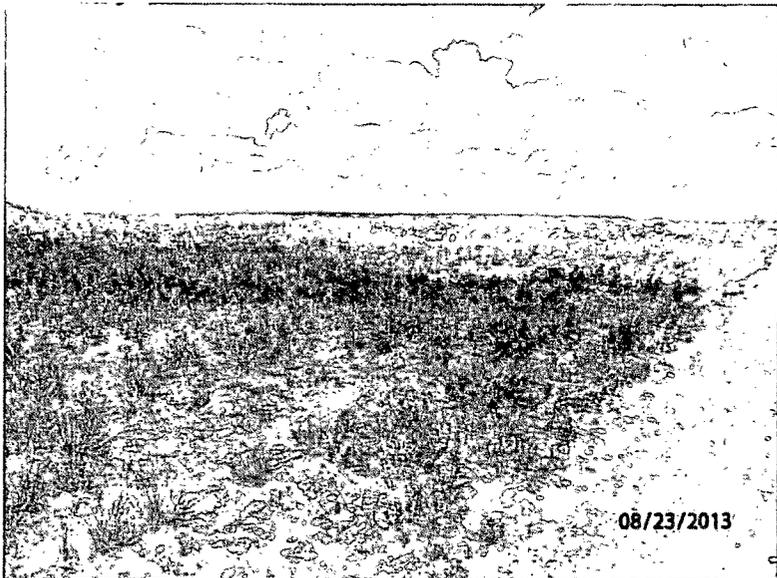
Initial release area, facing northeast

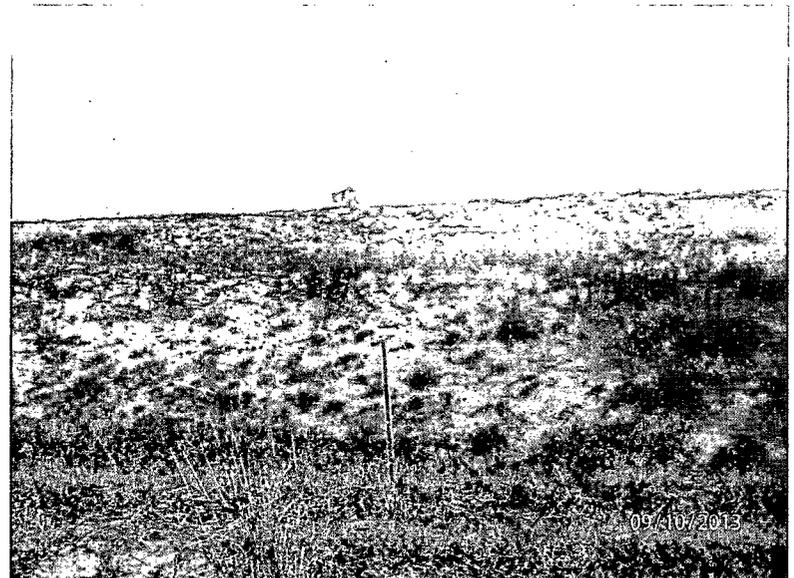
Auguring for depth, facing southeast

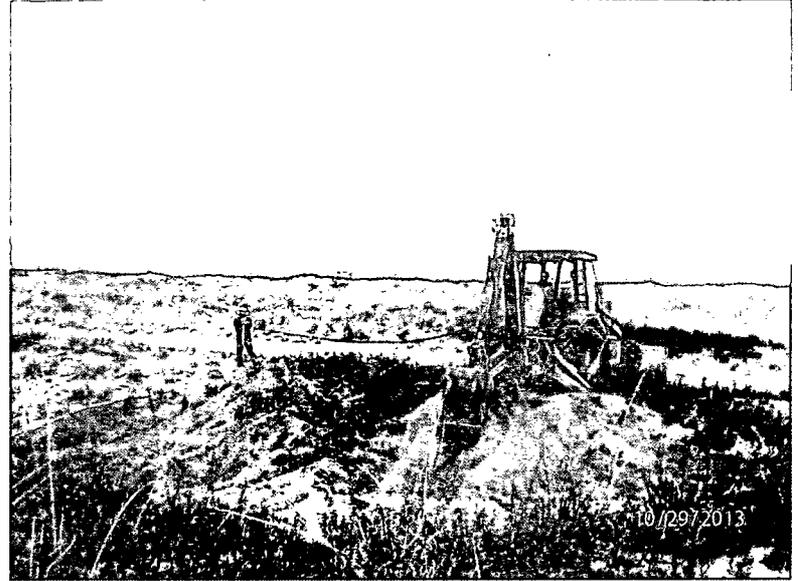
Excavating release area, facing southeast 10/29/13

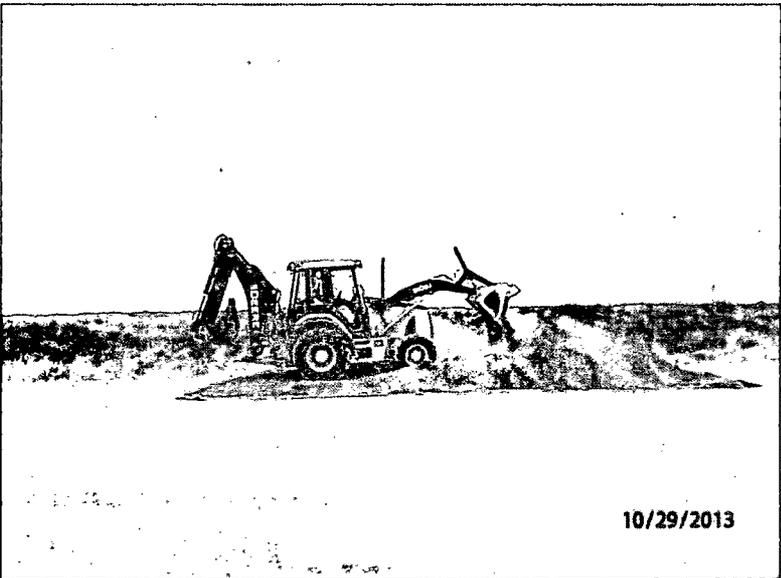
Building spoil pile, facing north 10/29/13

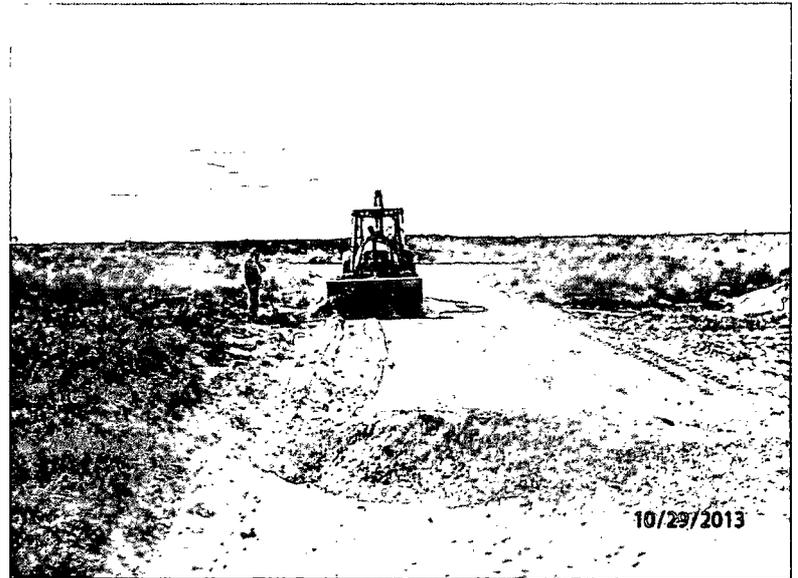
Excavating release, facing west 10/29/13

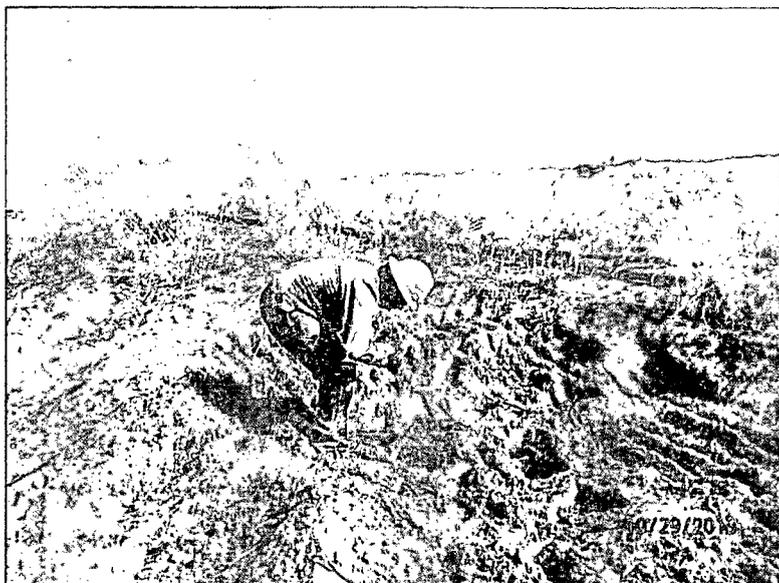
Collecting sample, facing southeast 10/29/13

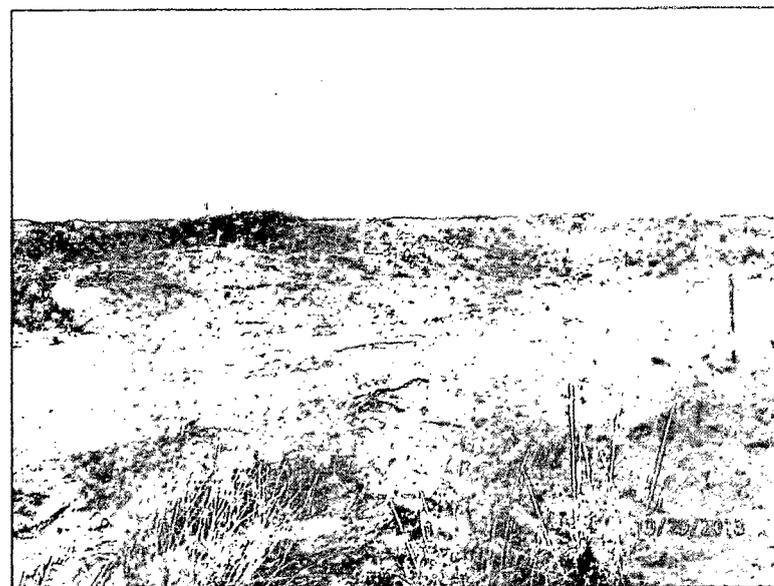
Scrape completed, facing northeast 10/29/13

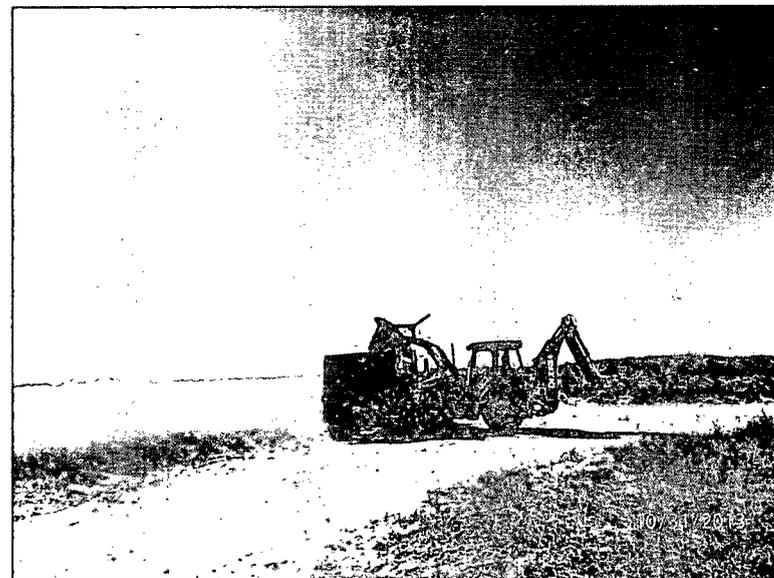
Exporting soil, facing west 10/31/13

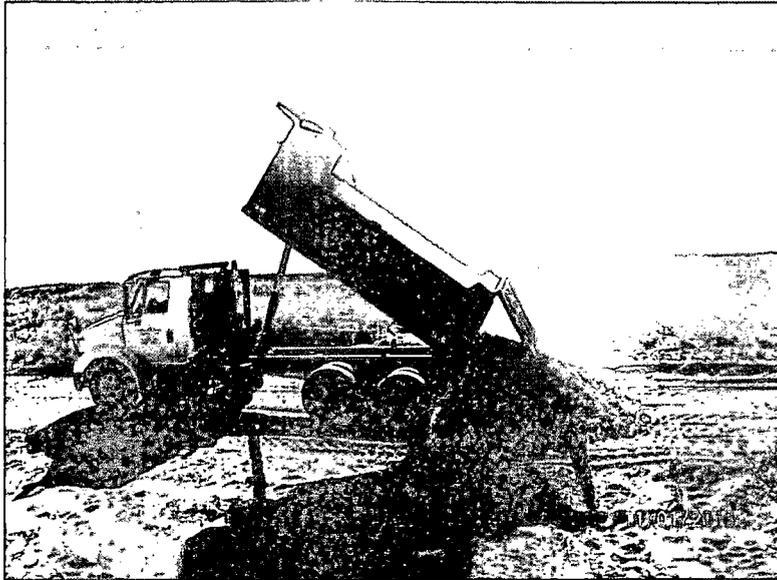
Importing caliche, facing south

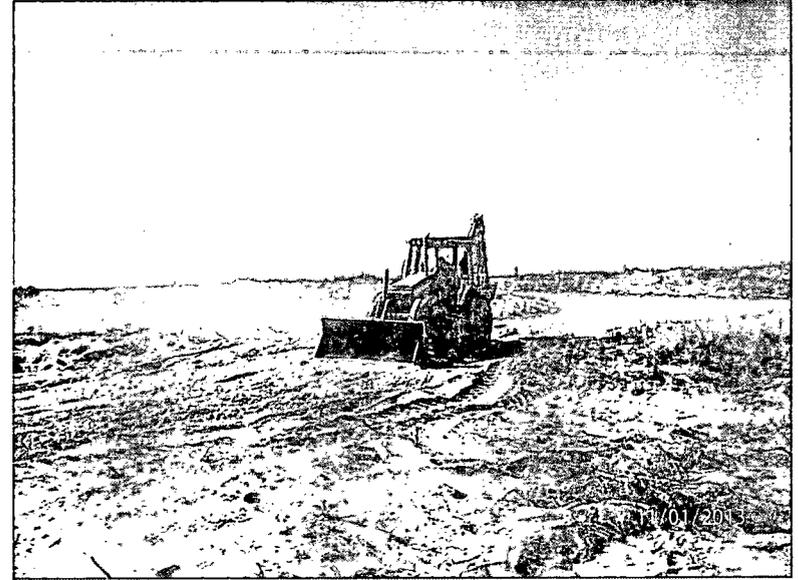
Backfilling road, facing southwest

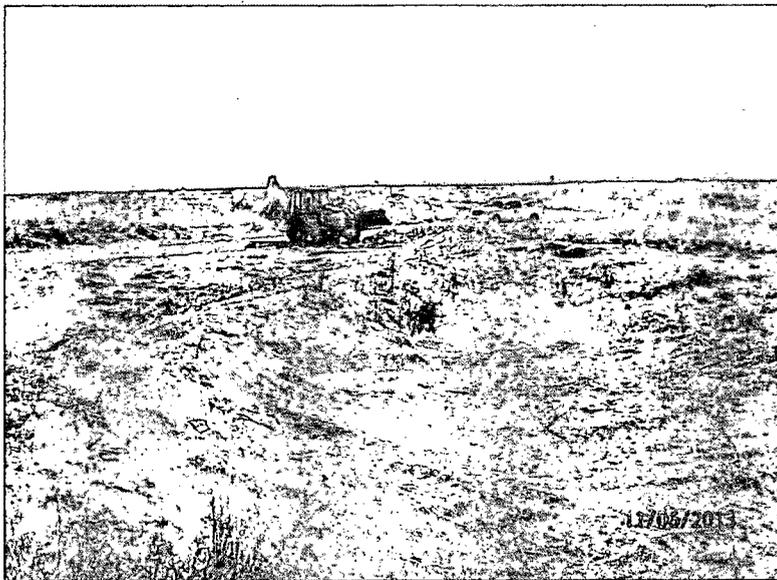
Contouring the pasture, facing southwest

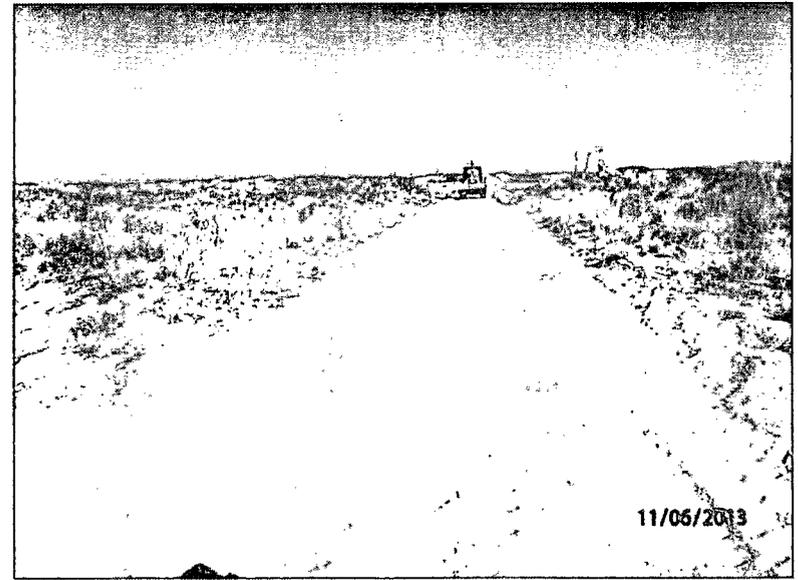
Backfilling of road completed, facing east

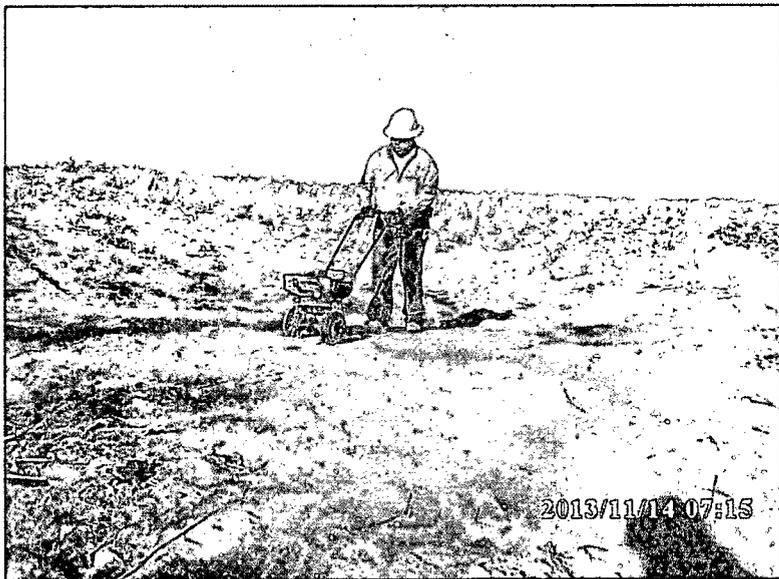
Seeding site, facing north
11/14/13
