**Release Notification and Corrective Action**

NEDU Satellite #2  
1RP-9-13-2949

## Termination Request

**RE: Termination Request  
Apache Corporation – NEDU Satellite #2 (IRP-9-13-2949)  
UL/E sec. 10 T21S R37E  
API No. 3002506461**

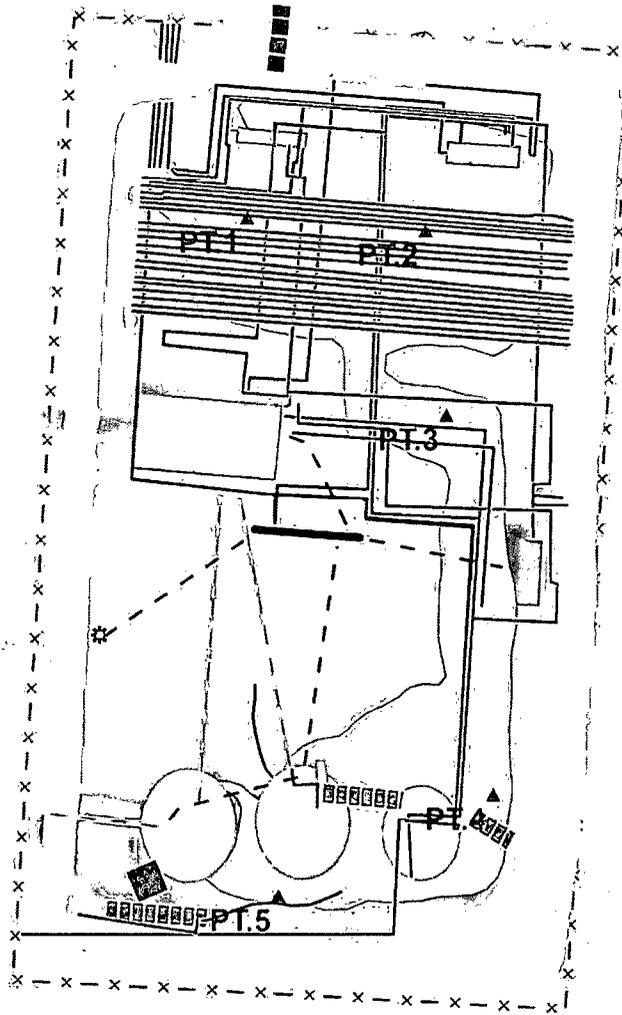
Figure 1

RECS personnel were on site beginning on May 10<sup>th</sup>, 2013 to assess the release. Surface samples were taken throughout the release and field tested for chlorides and hydrocarbons (Figure 1). The samples were then taken to a commercial laboratory for analysis and returned results of elevated chlorides, Gasoline Range Organics (GRO) and Diesel Range Organics (DRO) (Appendix B).

# Initial Sampling Map

CI-	PID	Lab CI-	GRO	DRO
<b>PT.1</b>					
<b>SURFACE</b>	<b>358</b>	<b>800.8</b>	<b>1010</b>	<b>11300</b>	<b>41900</b>
<b>PT.2</b>					
<b>SURFACE</b>	<b>1904</b>	<b>2420</b>	<b>2040</b>	<b>11000</b>	<b>24500</b>
<b>PT.3</b>					
<b>SURFACE</b>	<b>852</b>	<b>3030</b>	<b>1520</b>	<b>13600</b>	<b>44400</b>

CI-	PID	Lab CI-	GRO	DRO
<b>PT.4</b>					
<b>SURFACE</b>	<b>821</b>	<b>2916</b>	<b>2020</b>	<b>13700</b>	<b>49300</b>

CI-	PID	Lab CI-	GRO	DRO
<b>PT.5</b>					
<b>SURFACE</b>	<b>1652</b>	<b>3477</b>	<b>1860</b>	<b>11800</b>	<b>33700</b>

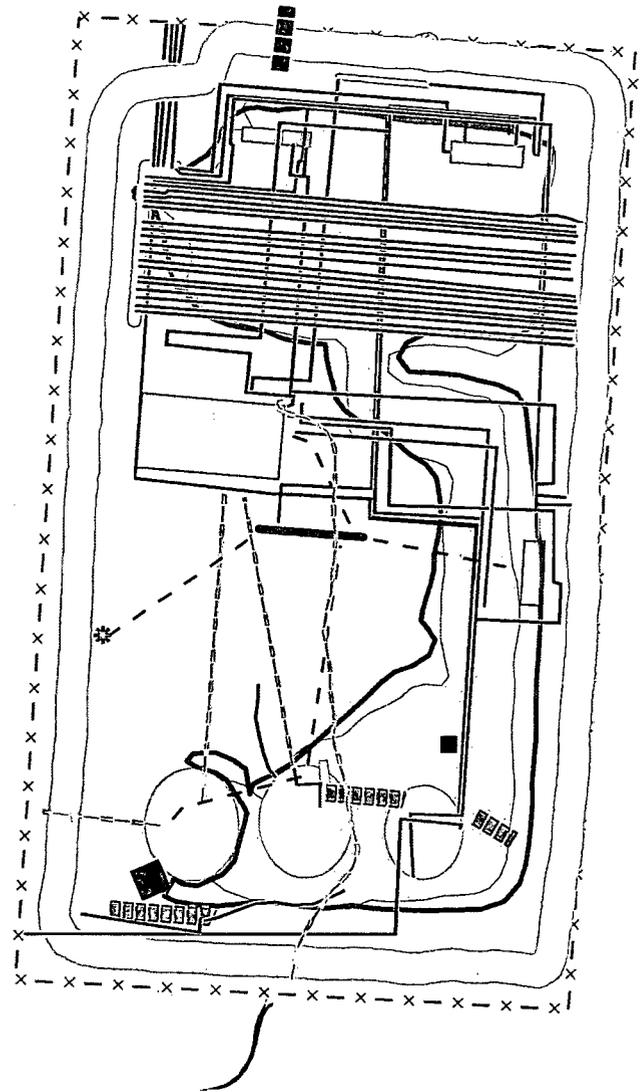
**Figure 2**

The facility tanks were washed down and the site was excavated using a hydrovac followed by hand digging to 6 inches bgs (Figure 2). A total of 122 yards of excavated soil was taken to a NMOCD approved facility for disposal. A vertical was installed on August 21<sup>st</sup>, 2013 and was advanced to 10.5 feet. As the vertical was advanced, samples were taken every half foot and field tested for chlorides and hydrocarbons. Representative samples from the vertical were taken to a commercial laboratory for analysis (Appendix C).

# Vertical Map

Depth	CI-	PID	GRO	DRO	B	T	E	X	BTEX
surface	146	58.5							
6"	155	404.2							
1'	146	1969							
18"	32	3836	1060	7670	0.125	3.61	8.78	24.4	36.9
2'	152	307.4							
30"	200	1783							
3'	181	1363							
42"	172	66.8							
4'	253	315							
54"	281	65.4							
5'	298	332.6							
5.5'	308	65.6							
6'	261	319.1							
6.5'	343	43.6							
7'	236	197.3							
7.5'	274	52.6							
8'	241	244.9							
8.5'	208	4.9							
9'	227	31.4							
9.5'	307	124.3							
10'	240	4.7	<10	<10					
10.5'	256	4.6	<10	<10

Based on the vertical data, on September 6<sup>th</sup>, 2013, NMOCD verbally approved the excavated area be backfilled with 1 inch of bentonite chips, which would be tamped and watered down. The bentonite would provide an infiltration barrier for the site that would inhibit the downward migration of constituents to groundwater. The bentonite would then be covered with 3 inches of clean, imported caliche.

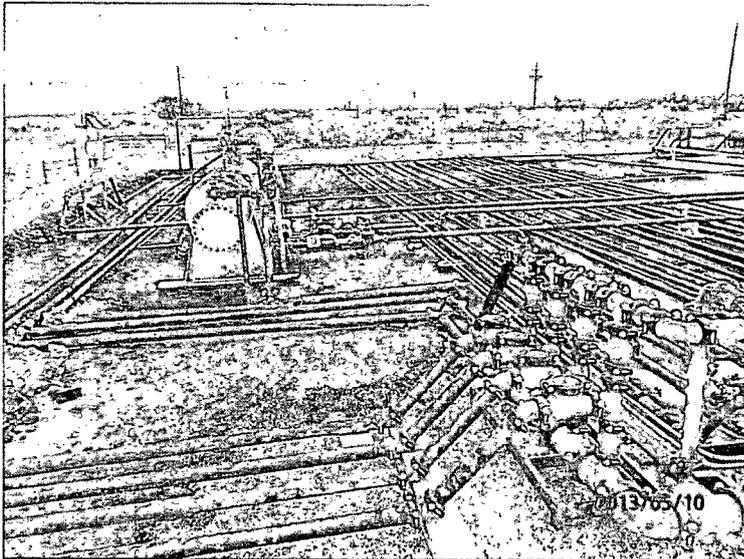
Initial release area, facing northeast

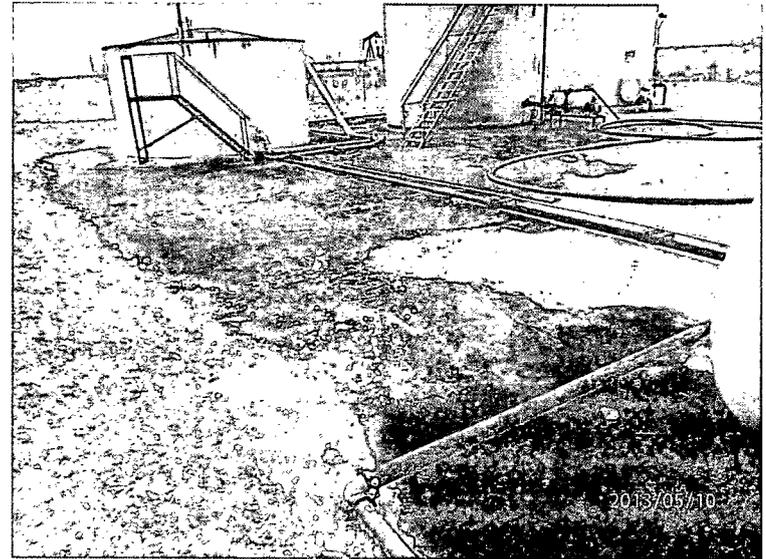
Initial release area, facing southeast

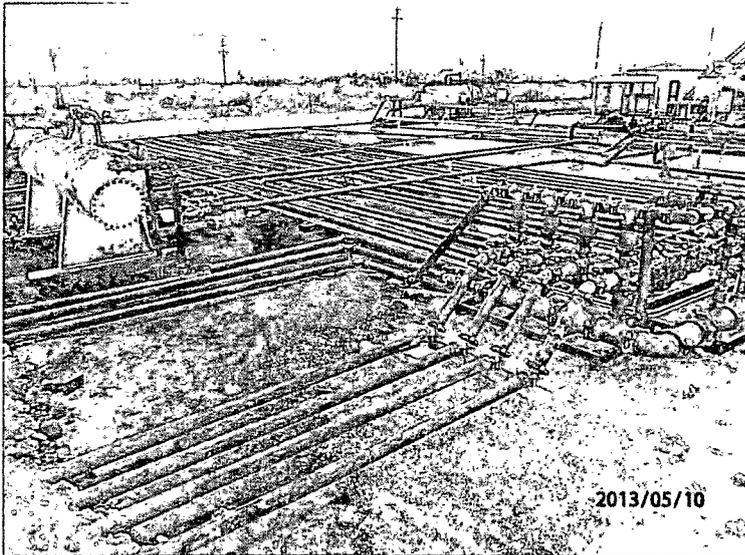
Initial release area, facing northwest

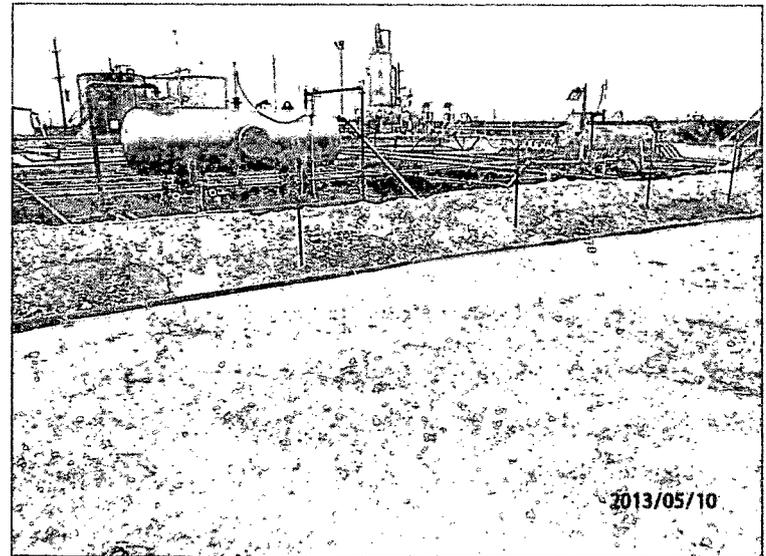
Initial release area, facing south

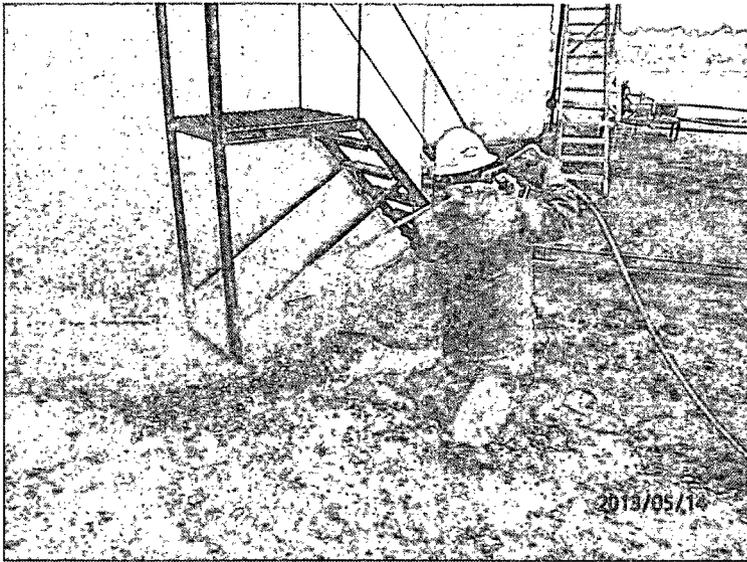
Washing down the tanks, facing west 5/14/13

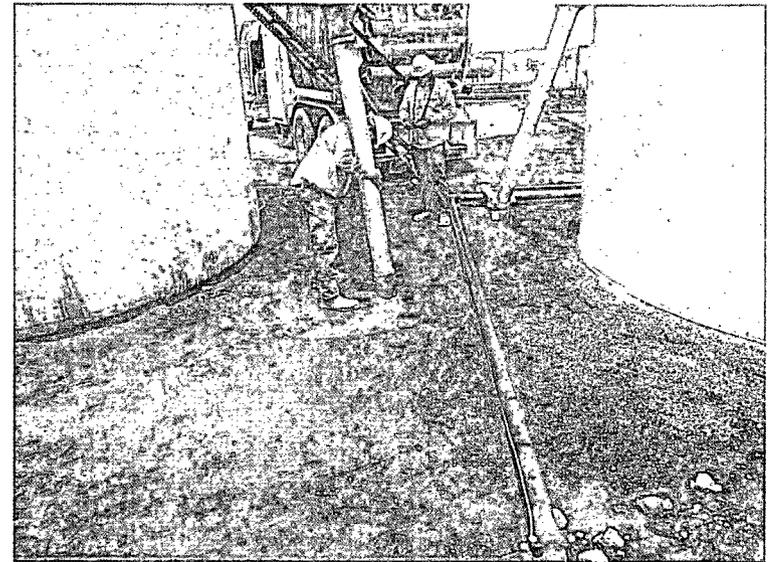
Using the hydro-vac to clean up release, facing north 5/15/13

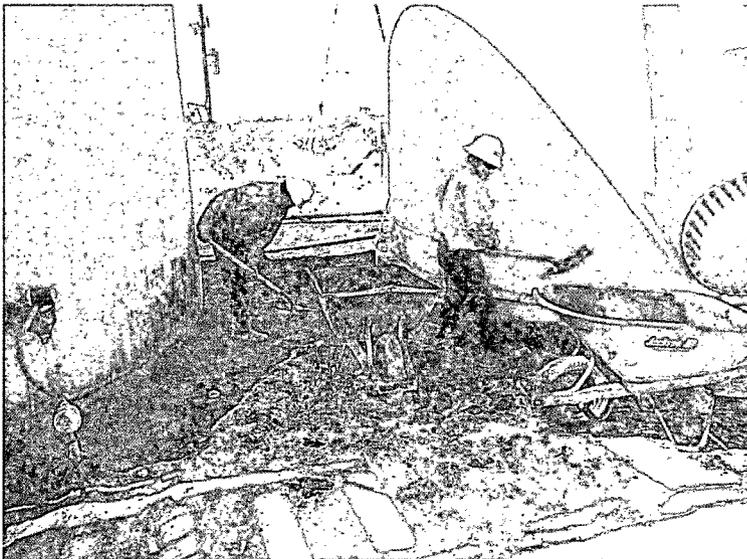
Hand dig release to 6 in bgs, facing south 5/17/13

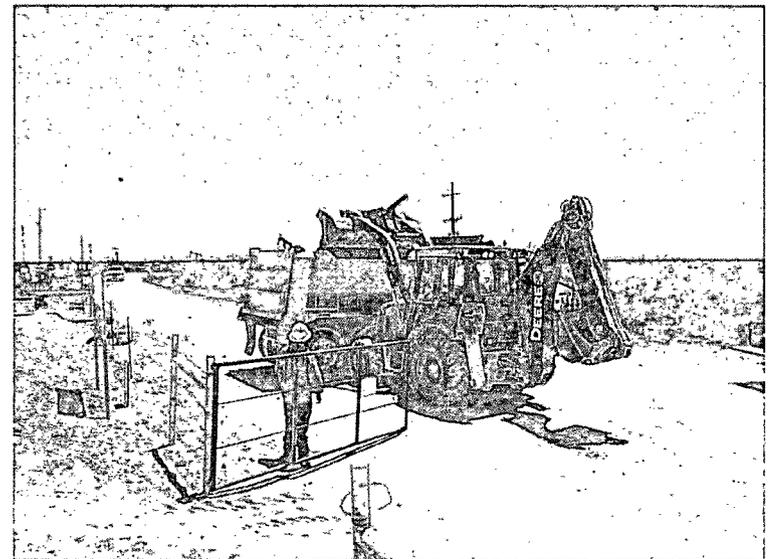
Exporting soil, facing south 5/20/13

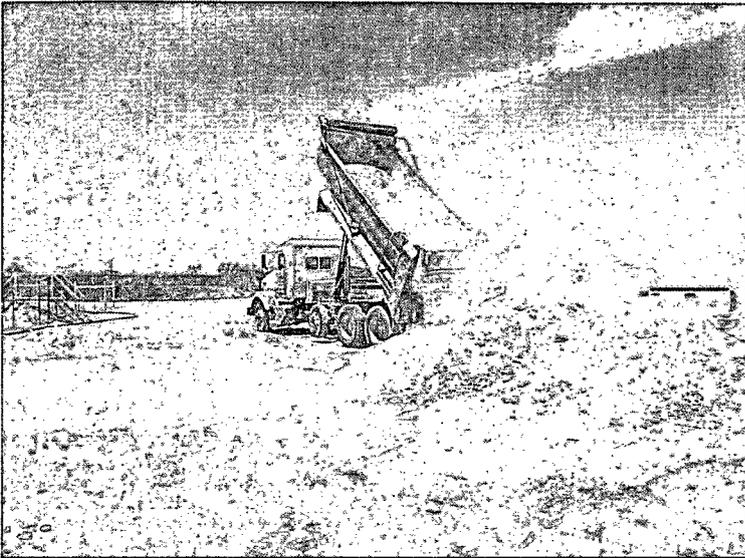
Importing caliche, facing west

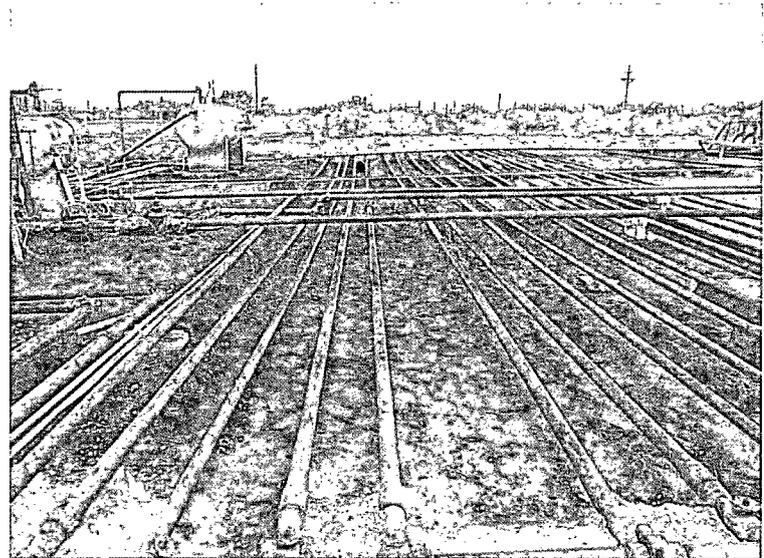
6 in scrape completed, facing north

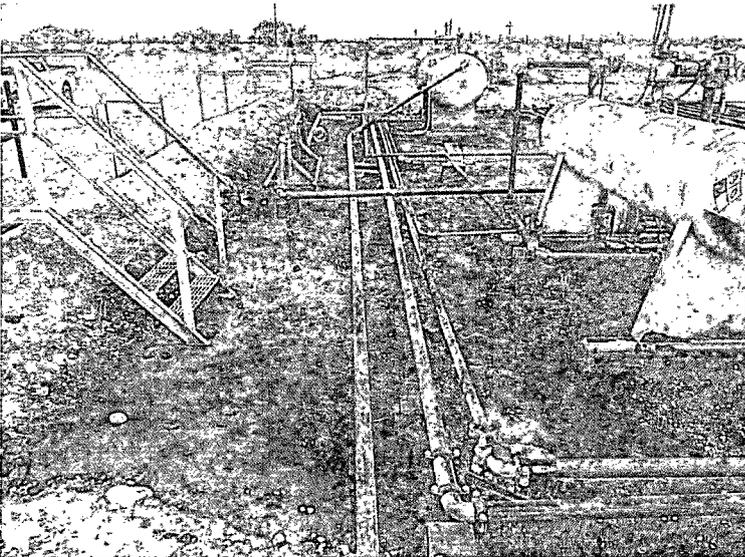
6 in scrape completed, facing north

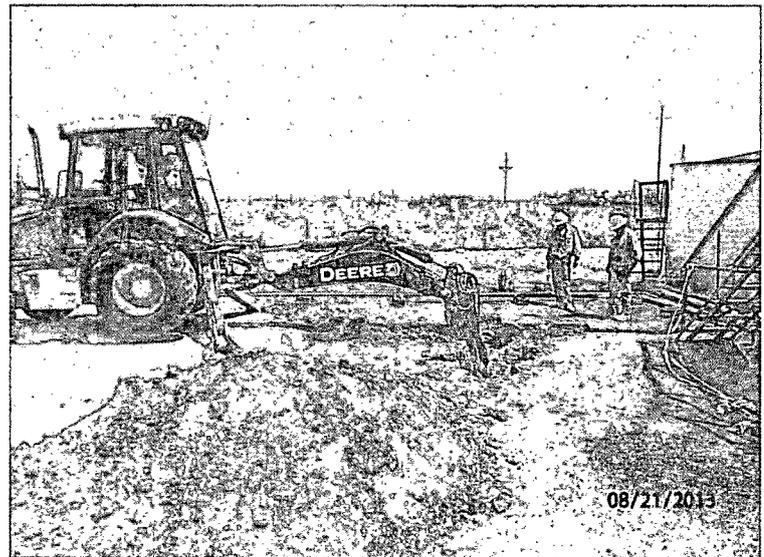
Digging vertical, facing east

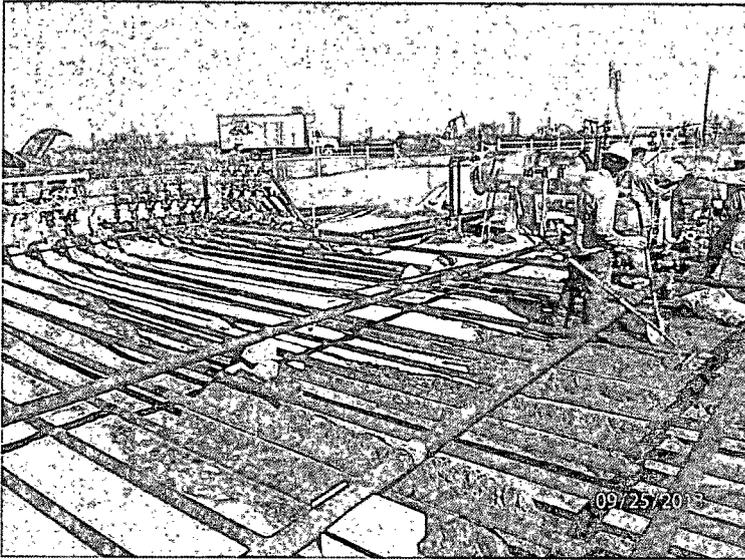
Spreading 6 in of bentonite over release area, facing northwest 9/25/13

RECS began these actions on September 25<sup>th</sup>, 2013. A total of 9 pallets of bentonite were used to cover the release area to a depth of 1 inch. The bentonite was tamped down and watered. A 3 inch layer of clean, imported caliche was then spread over the bentonite.

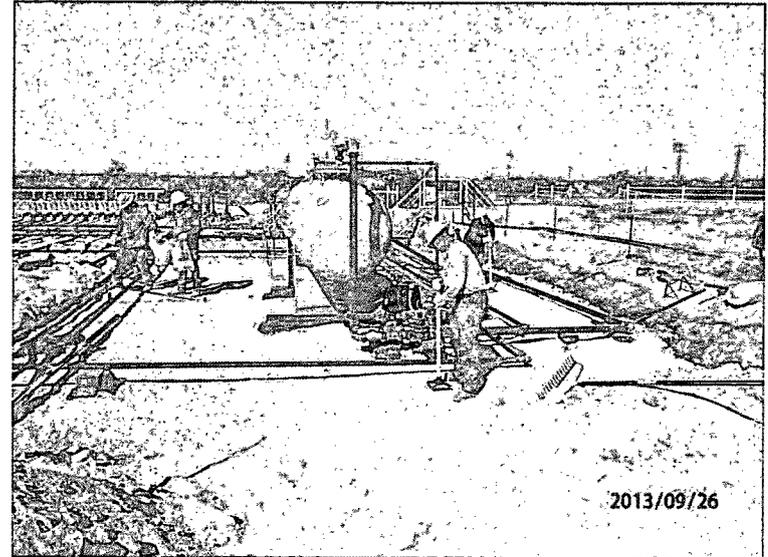
Tamping bentonite, facing west 9/26/13

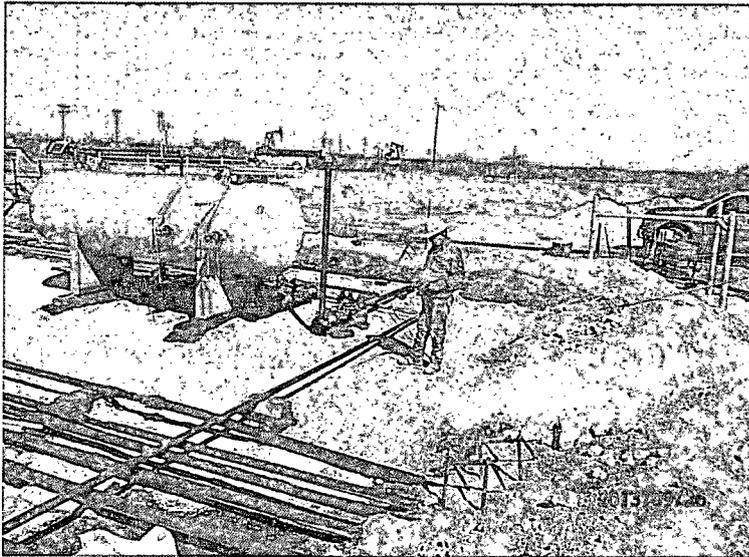
Watering down bentonite, facing northwest 9/26/13

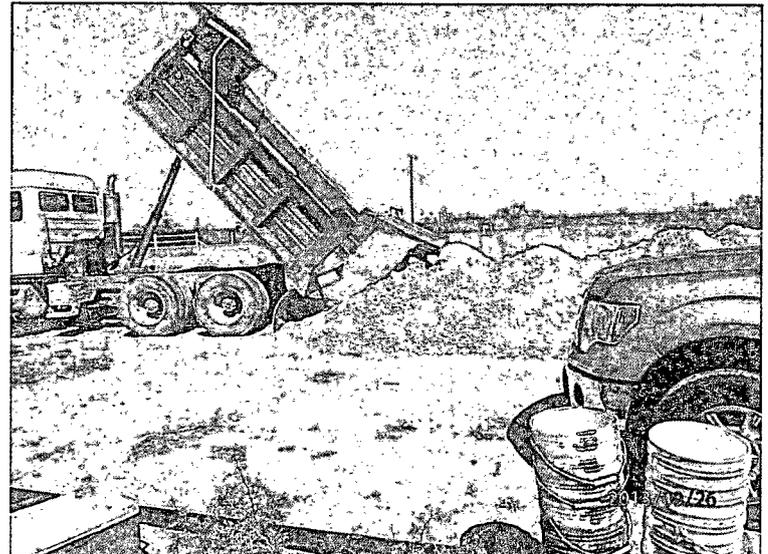
Importing caliche, facing north 9/26/13

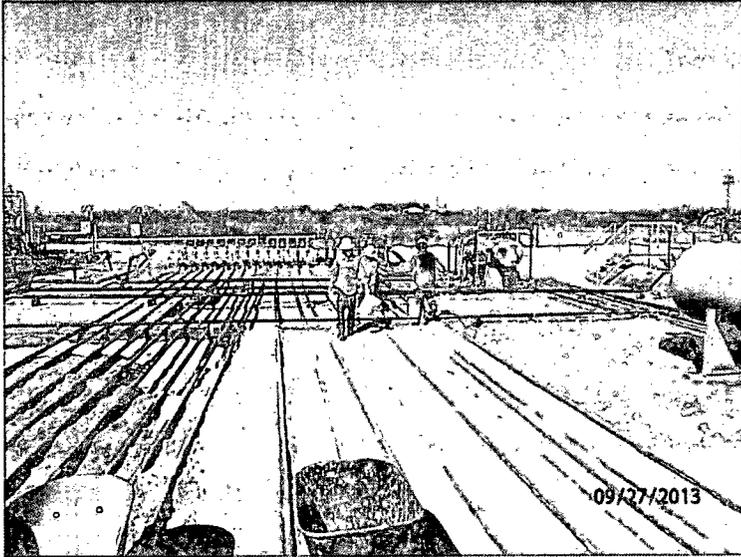
Backfilling the site with 3 inches of caliche, facing west  
9/27/13

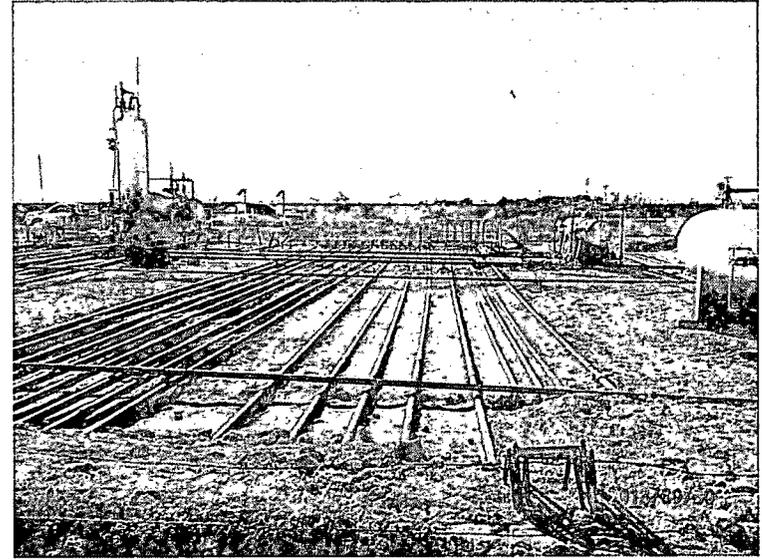
Site completed, facing west  
9/30/13

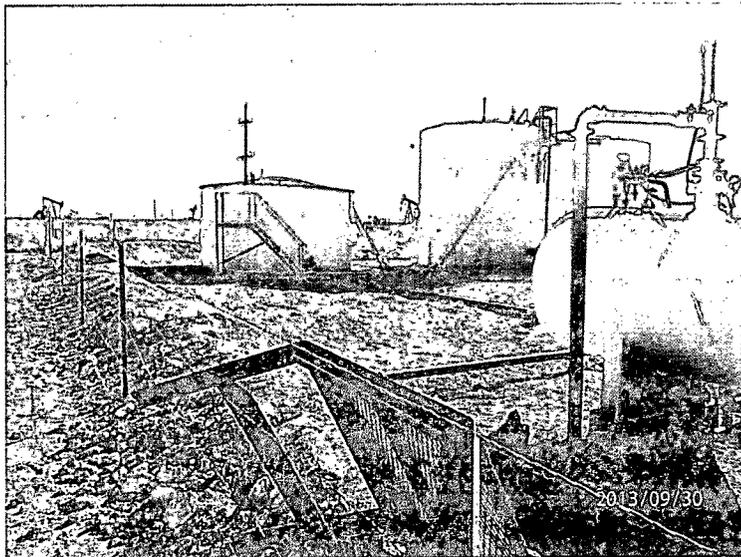
Site completed, facing south  
9/30/13

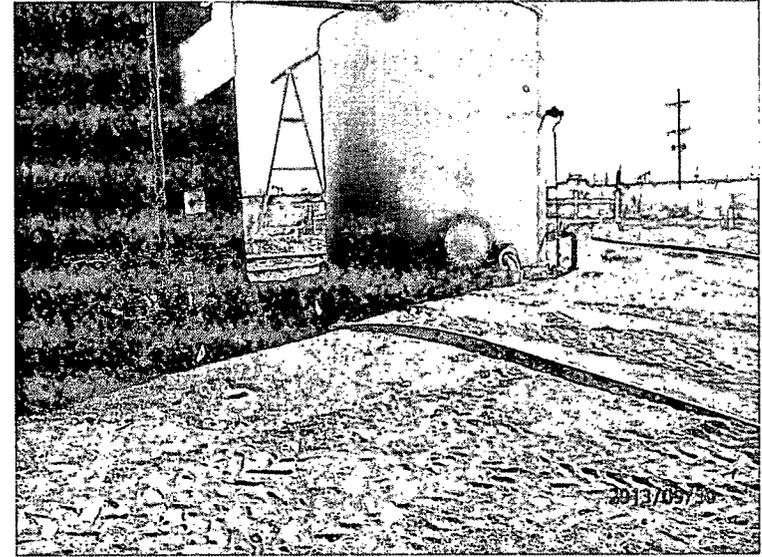
Site completed, facing southwest  
9/30/13
