Release Notification and Corrective Action

Argo #7
(1RP-9-13-2952)

Termination Request

**RE: Termination Request
Apache Corporation – Argo #7 (IRP-9-13-2952)
UL/L sec. 15 T21S R37E
API No. 30-025-09915**

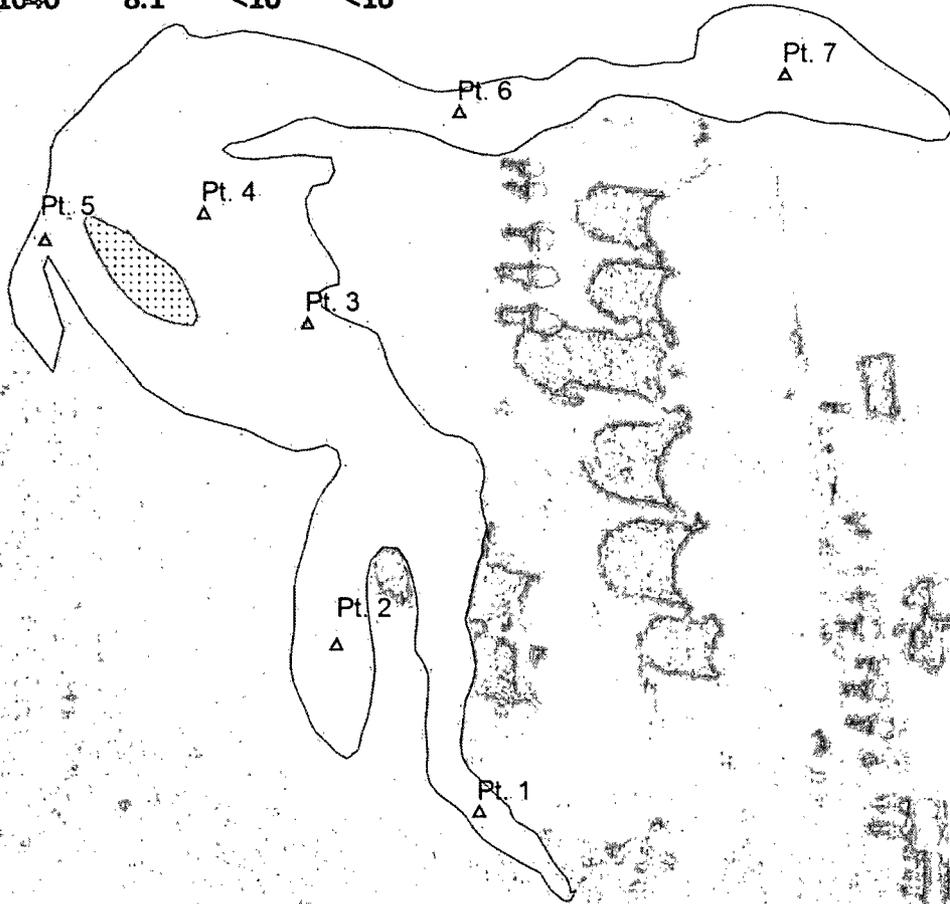
Figure 1

Initial Sampling Data

Cl-	PID	GRO	DRO
Point 1 Surface	2560	5.8	<10	<10
Point 2 Surface	2600	28.4	<10	<10
Point 3 Surface	1380	13.1	<10	14.9
Point 4 Surface	1600	17.6	<10	60.5
Point 5 Surface	1570	14.3	<10	<10
Point 6 Surface	1360	11.2	<10	<10
Point 7 Surface	1640	8.1	<10	<10

- ▲ SAMPLE POINTS
- STAIN (12,461 sq ft)
- ▨ NO STAIN

RECS personnel were on site beginning on September 10th, 2013 to assess the site. Seven points throughout the surface of the release were field tested for chlorides and organic vapors using a PID meter (Figure 1). The samples were then taken to a commercial laboratory for analysis (Appendix B). Chloride values at all seven points were elevated, Gasoline Range Organics (GRO) readings were non-detect and Diesel Range Organics (DRO) readings were either non-detect or below regulatory standards.

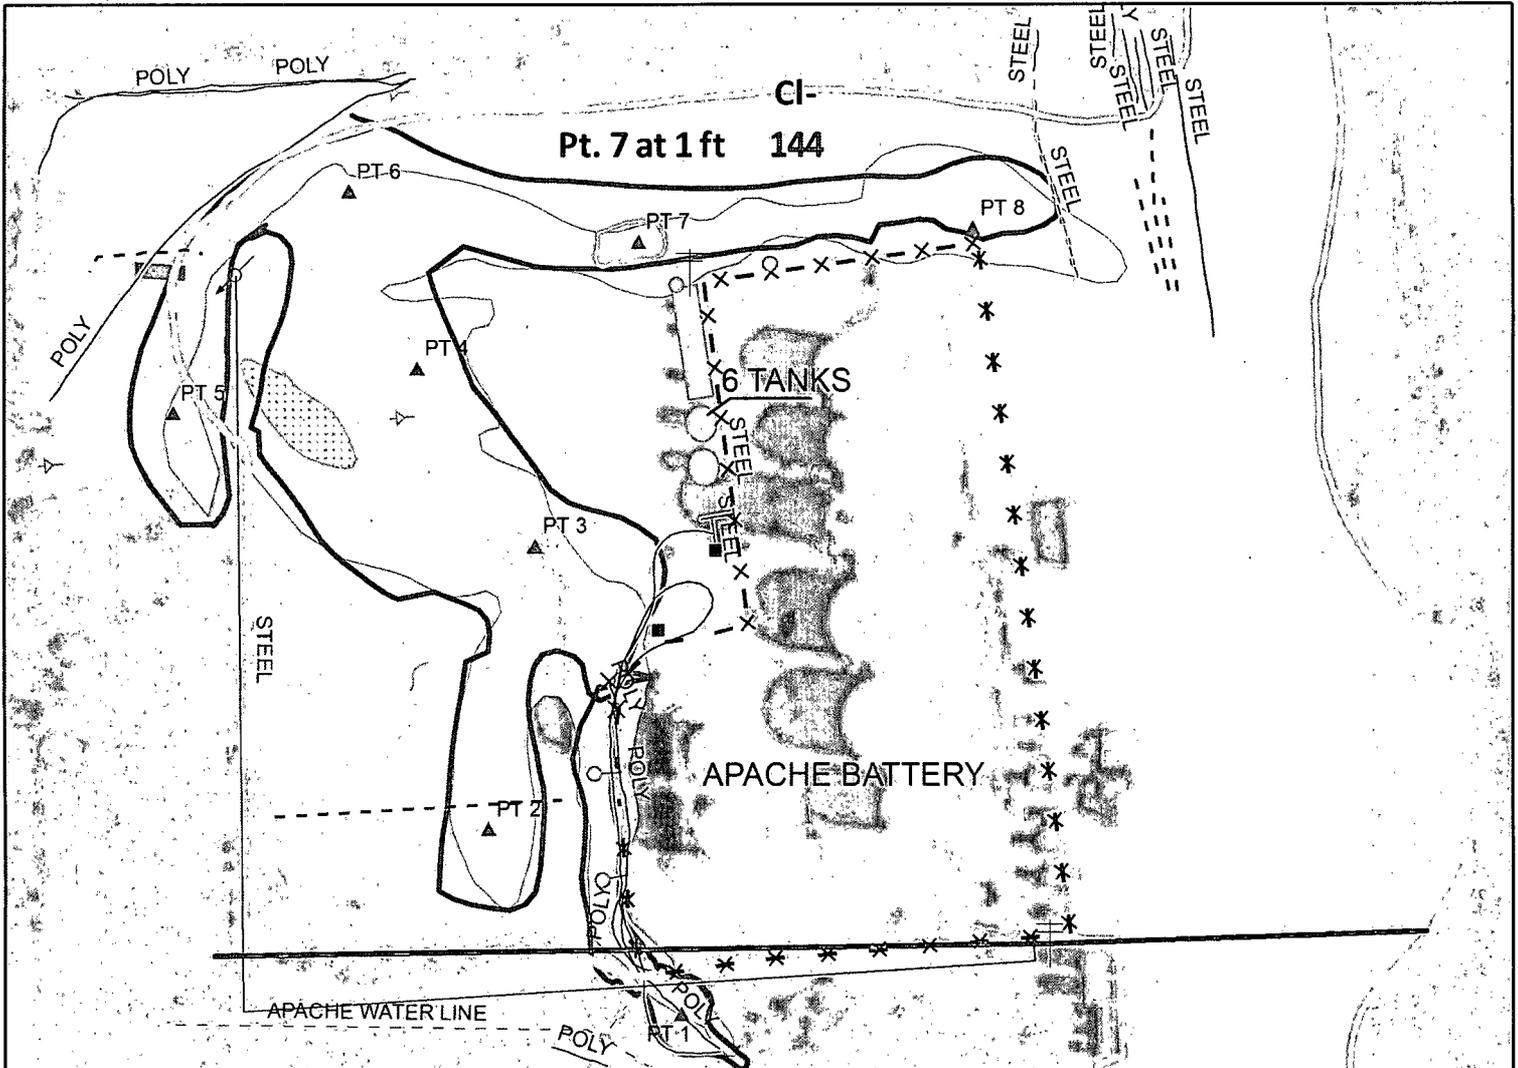
Figure 2

Excavation Data

CI- **PID** **GRO** **DRO**
8 Pt. Comp **224** **1.5** **<10** **17.3**

Legend		
▲ FINAL SAMPLE POINTS	--- BURIED PIPELINE	▨ CONCRETE
○ 50 GAL DRUM	X - FENCE	□ VALVE BOX
○ CONTAINMENT	- - - LINEFINDER HIT	▨ STAIN (12,461 sq ft)
▣ CONTROL BOX	— OVERHEAD ELECTRIC LI	▨ NO STAIN
⚡ DEADMAN	▬ PAD/ROAD EDGE	CI- FIELD DATA
⚡ ELECTRIC POLE	— SURFACE PIPELINE	CI- LAB DATA
⊕ INJECTION WELLHEAD	▭ SCRAPE AT PT. 7	
X PIPE END	▭ SCRAPE	
	▭ CHEMICAL TANK

The site was scraped down six inches and a total of 204 yards of excavated soil was sent to a NMOCD approved facility for disposal. An 8 point bottom composite sample was taken from the base of the scrape and sent to a commercial laboratory for analysis. The composite returned a chloride value of 224 mg/kg, a GRO value of non-detect and a DRO value of 17.3 mg/kg. A request to backfill the site was sent to NMOCD on September 25th, 2013. NMOCD responded that Pt. 7, which had a field chloride reading of 497 mg/kg, needed to be scraped down to 1 ft bgs and then Apache had permission to backfill

the site. Pt. 7 was scraped down another 6 inches and a sample from the bottom of the Pt. 7 scrape was taken to a commercial laboratory for analysis of chlorides and returned a result of 144 mg/kg (Figure 2).

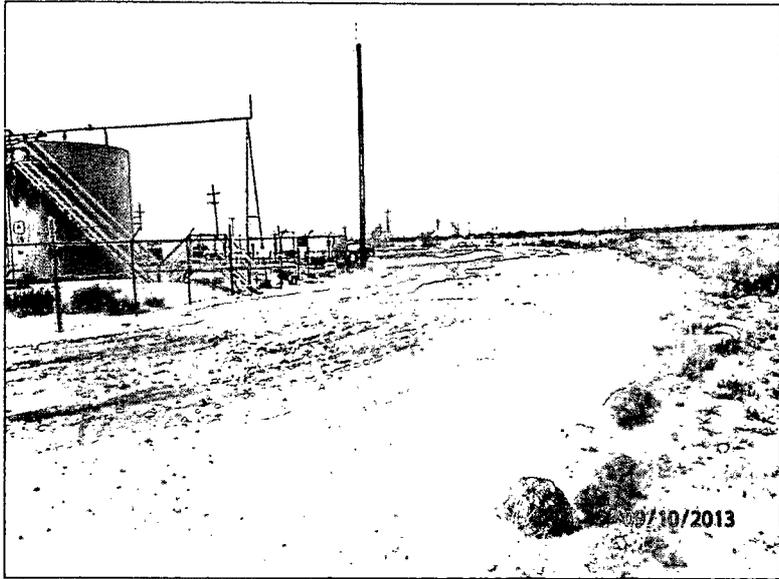
Initial release area, facing west 9/10/13

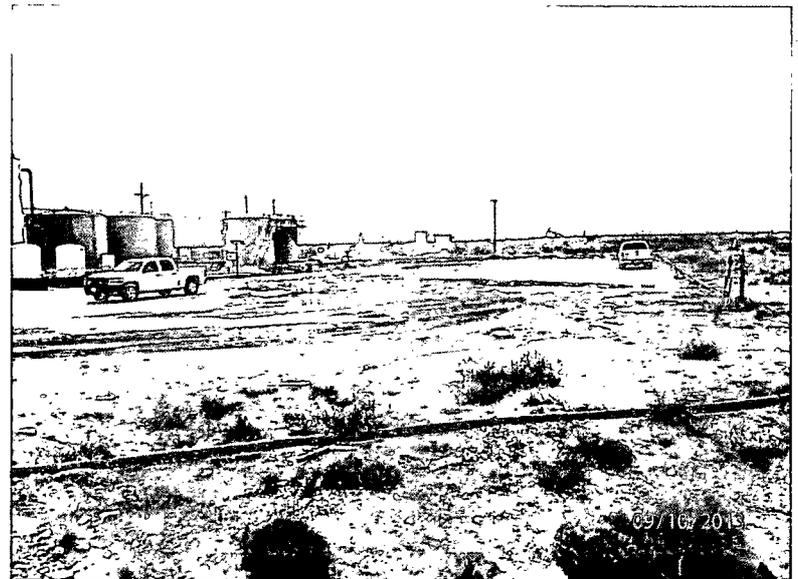
Initial release area, facing southeast 9/10/13

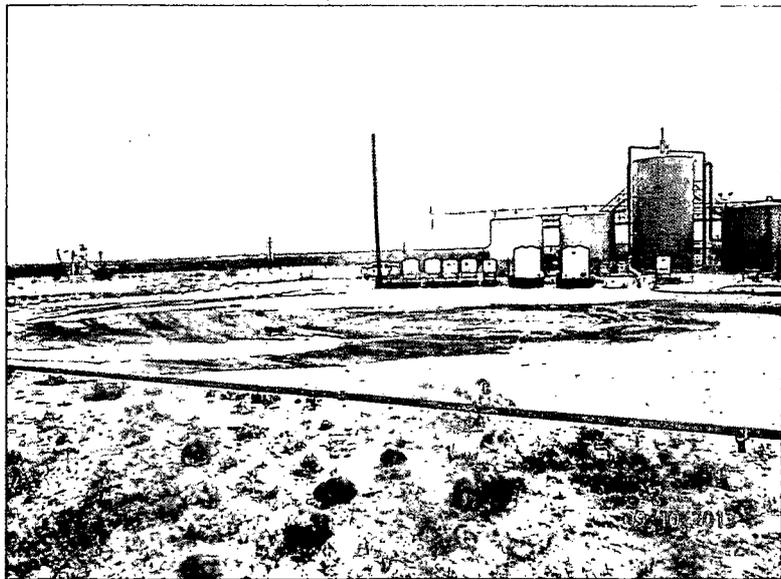
Initial release area, facing northeast 9/10/13

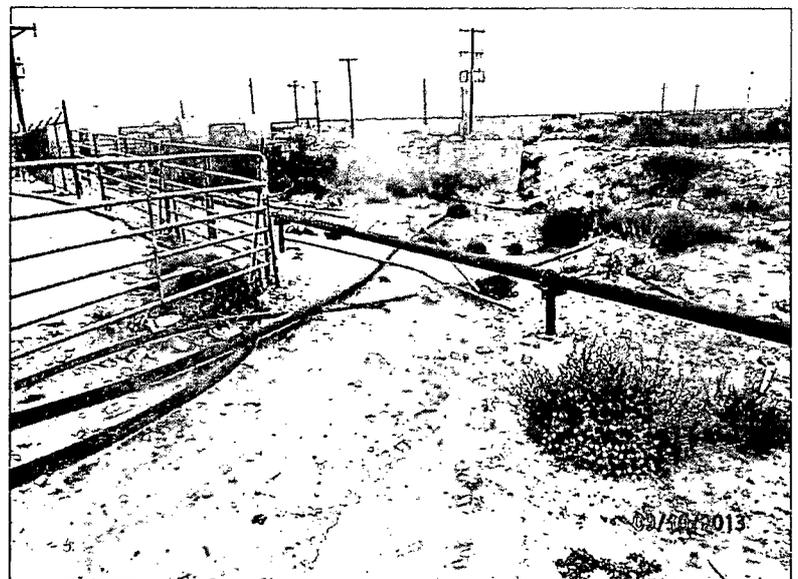
Initial release area, facing southeast 9/10/13

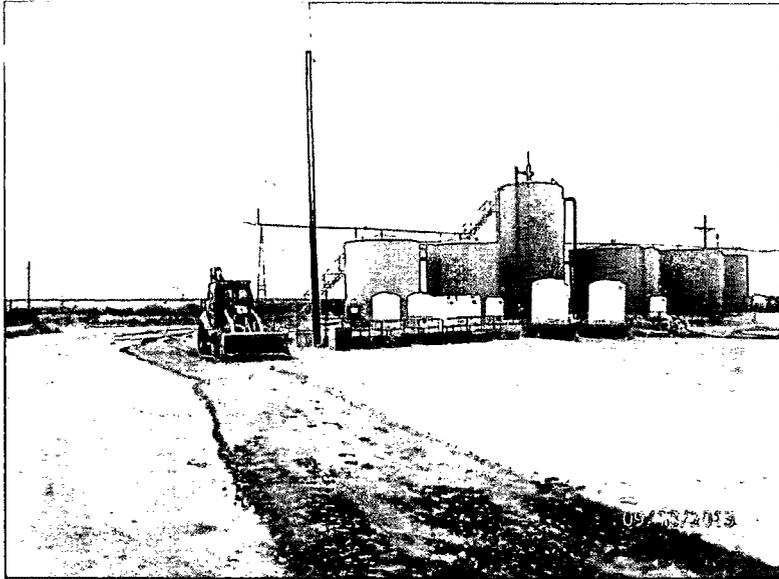
Scraping release area, facing southeast 9/18/13

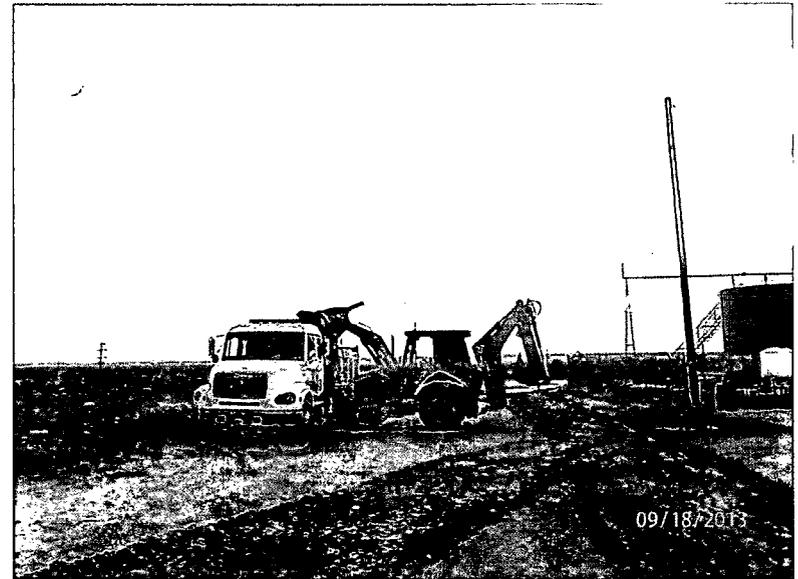
Exporting soil, facing east 9/18/13

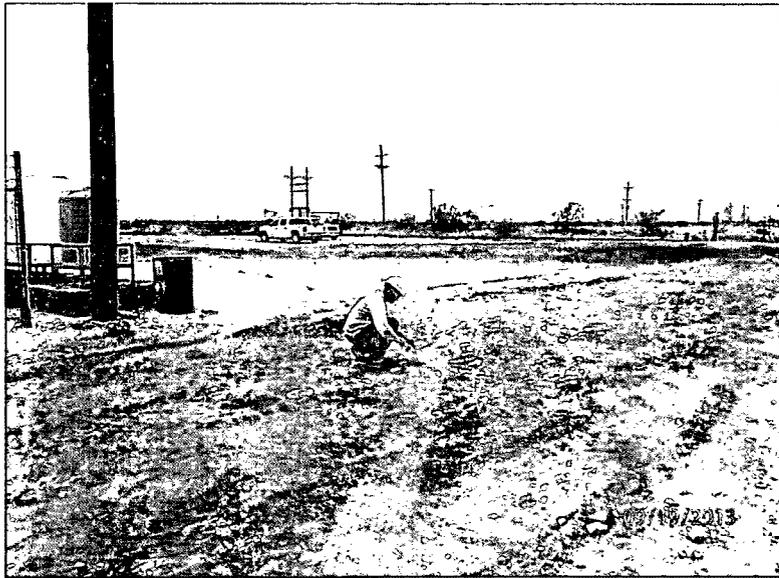
Sampling scrape, facing southwest 9/19/13

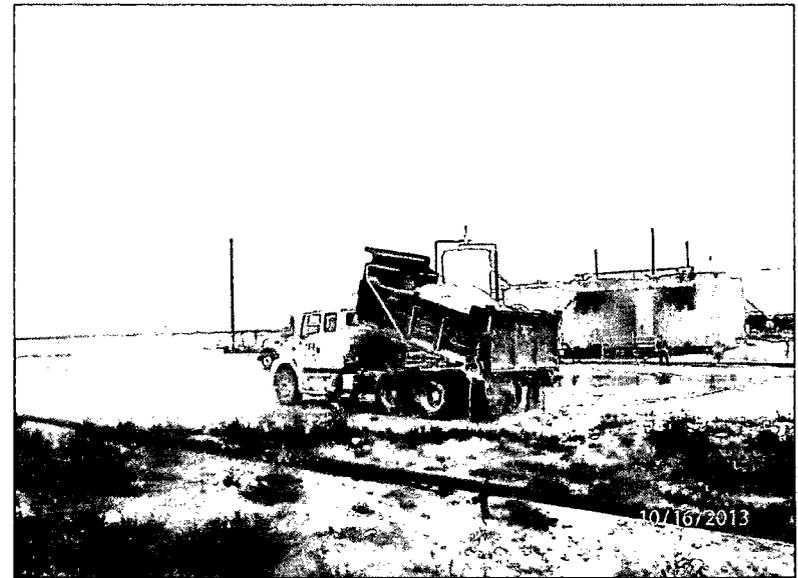
Importing caliche, facing northeast 10/16/13

A total of 252 yards of soil was imported to the site to serve as backfill. A 5 point composite sample of this backfill was taken to a commercial laboratory for analysis and returned a chloride, GRO and DRO result of non-detect (Appendix C). The site was backfilled, watered down and roller packed.

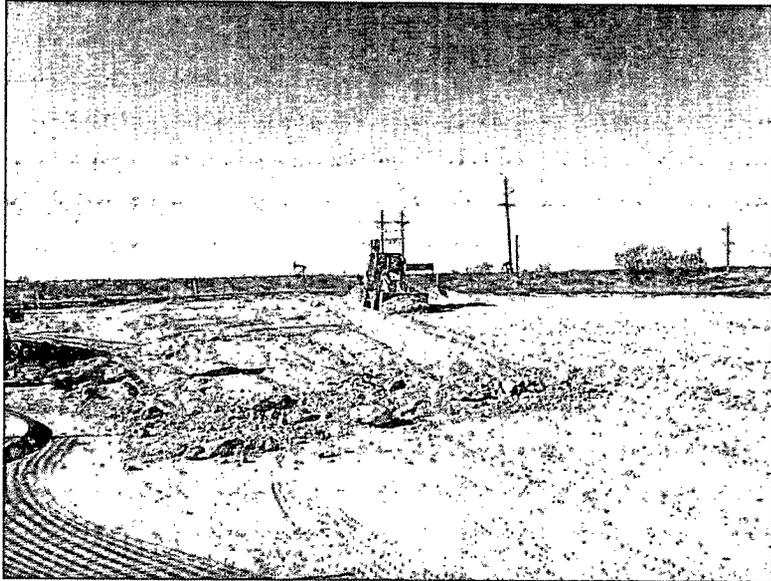
Backfilling site, facing south

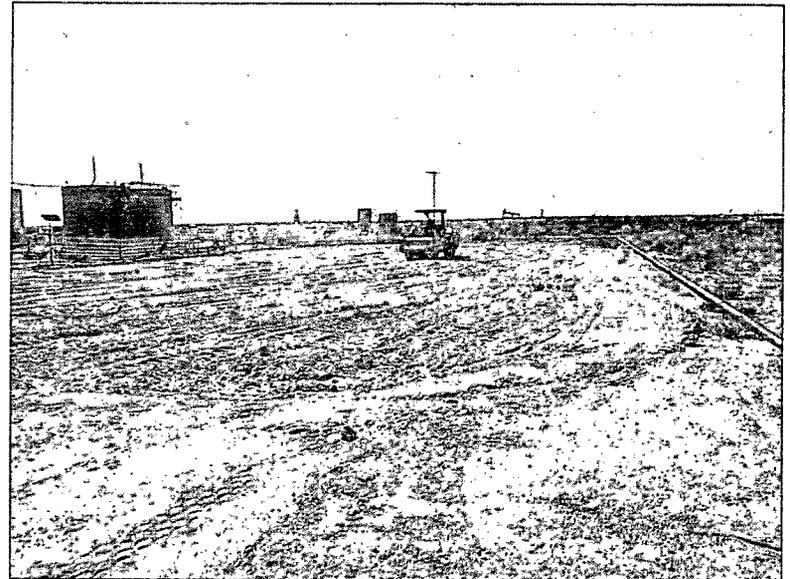
Using roller to compact caliche, facing south 11/1/13

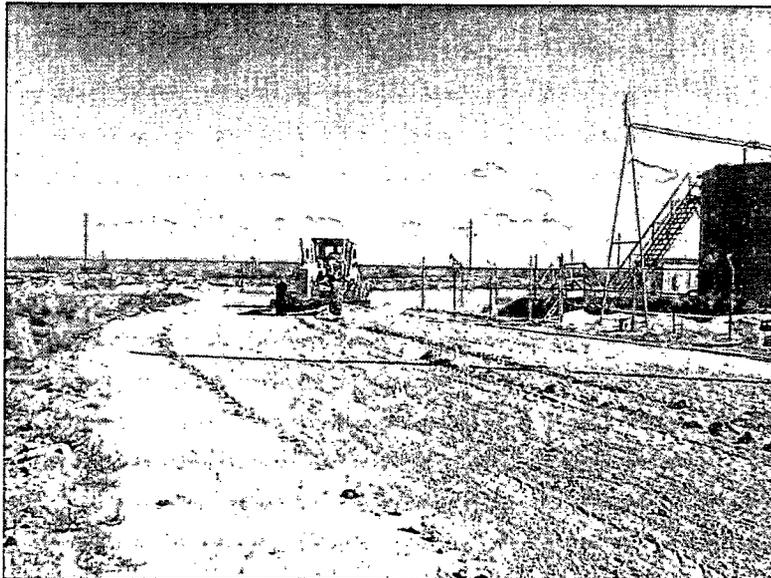
Using maintainer on road, facing east

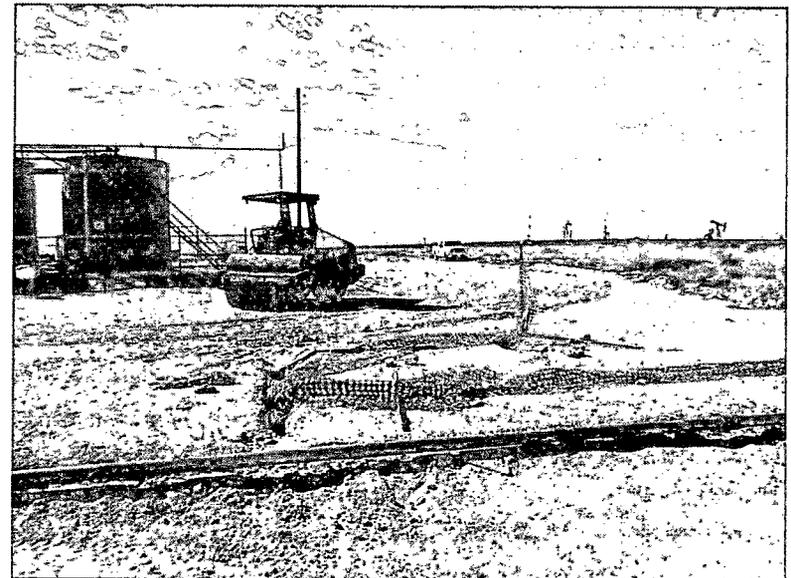
Using roller to compact road, facing west

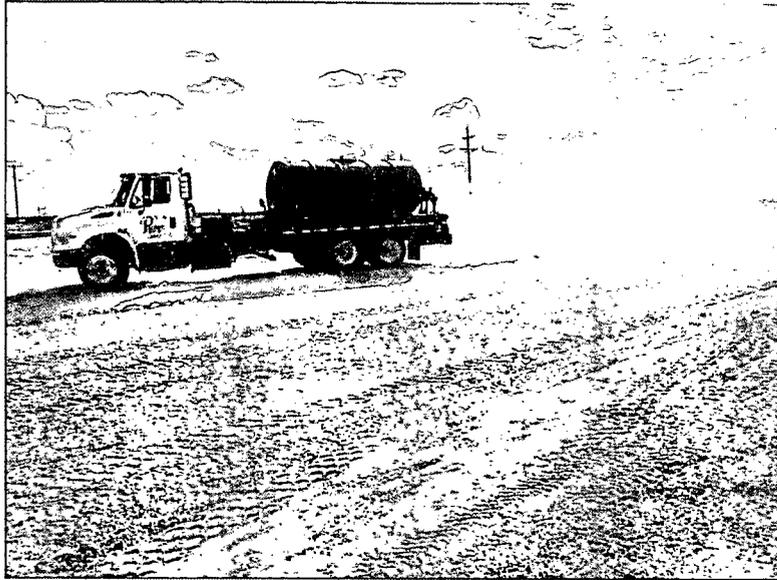
Watering location, facing southwest

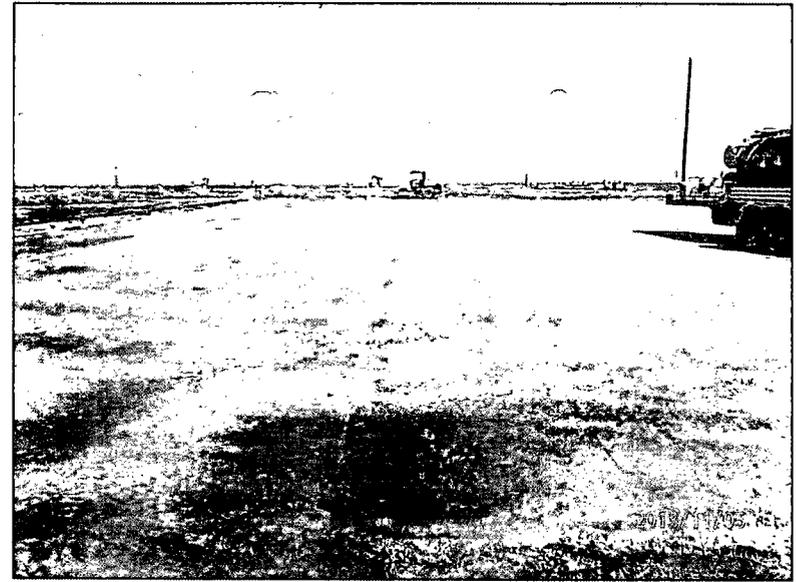
Site completed, facing north

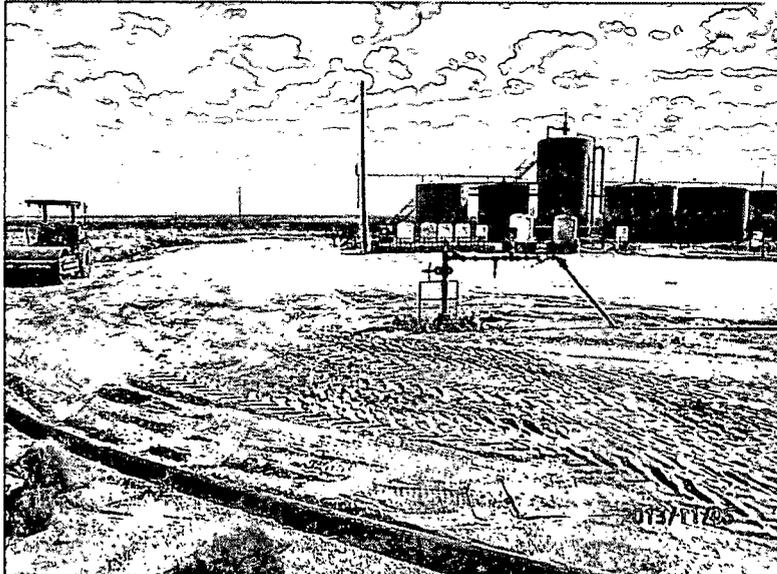
Site completed, facing east

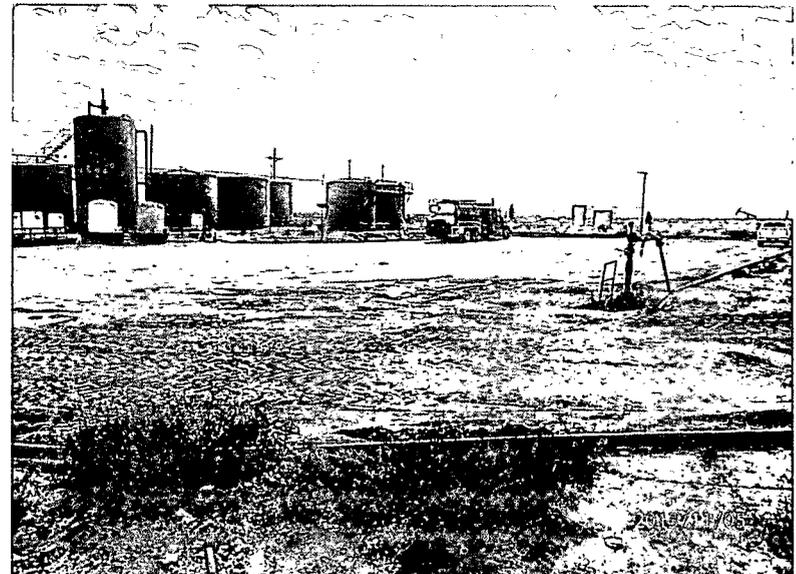
Site completed, facing southeast
