RE: Termination Request

Apache Corporation

Lou Wortham #20 AD (1R0711-2726): UL/F sec. 11 T22S R37E

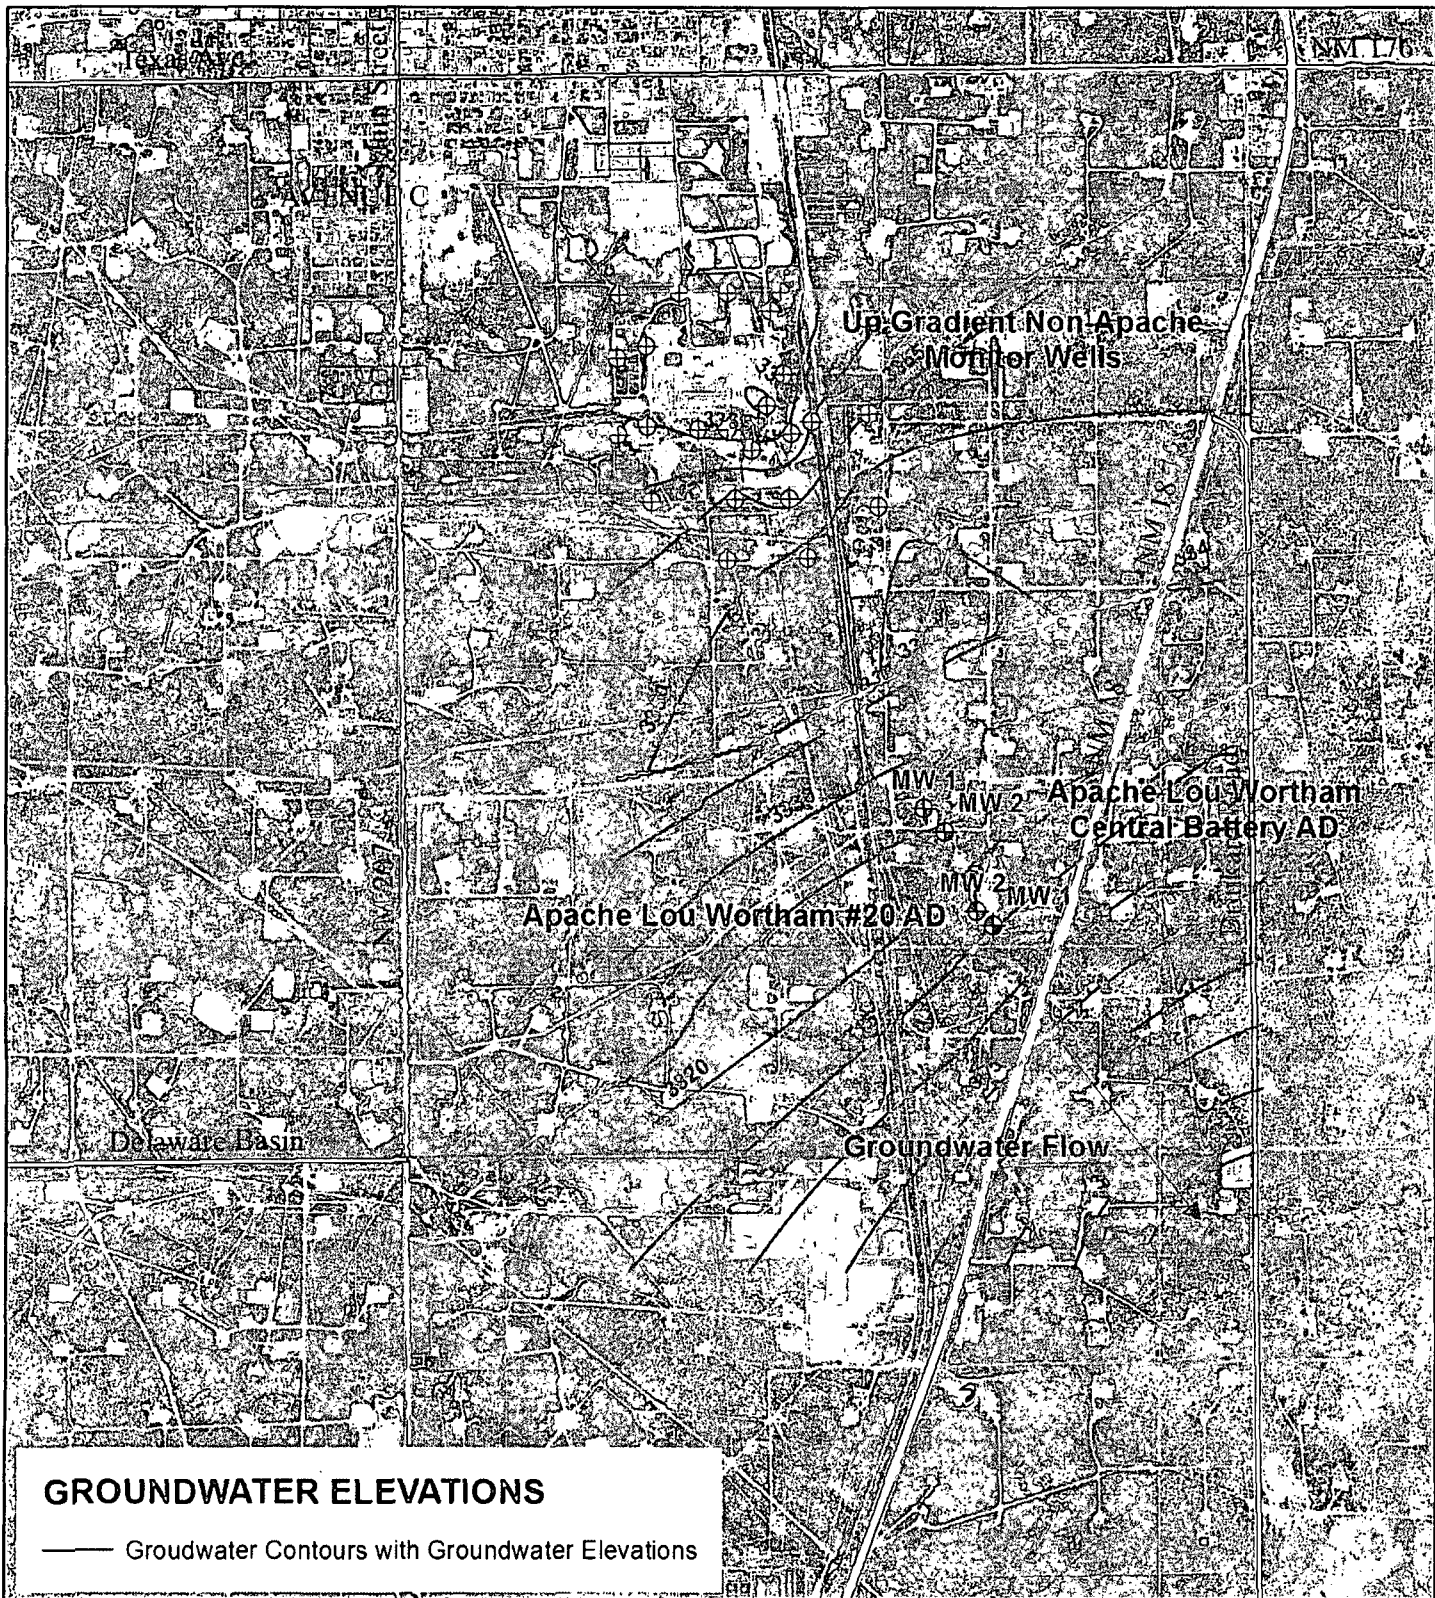
Figure 4

Regional Potentiometric Map

LEGALS: sec. 2, 3, 10 & 11
T22S R37E
