RE: **Termination Request**
Burnett Oil Company – Gissler B-2 Battery
(2RP-2242)
UL/I&J sec. 23 T17S R30E
API No. Lease # NMNM2748

Burnett Oil Company (Burnett) has retained Rice Environmental Consulting and Safety (RECS) to address potential environmental concerns at the above-referenced site.

Background and Previous Work

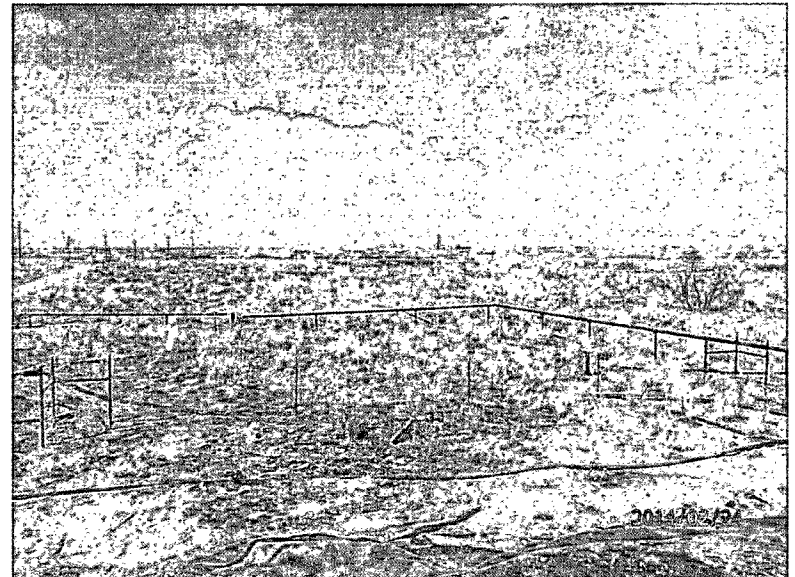
Initial release area, facing northwest

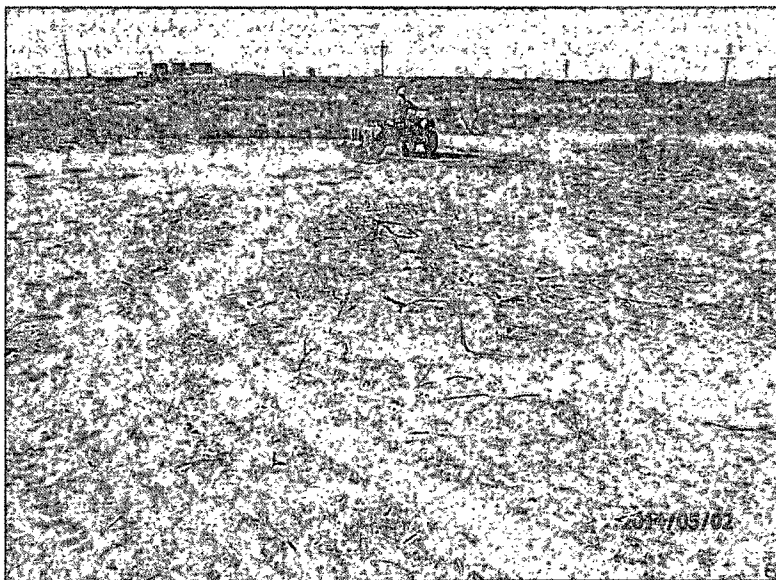
Preparing seed bed by tilling, facing west
