REMEDIATION SUMMARY & SITE CLOSURE REQUEST

**BOPCO, LP
REMUDA BASIN UNIT #1 WATER TRANSFER LINE
Eddy County, New Mexico
Unit Letter "I" (NE/SE), Section 24, Township 23 South, Range 29 East
Latitude 32.288222° North, Longitude 103.9322289° West
NMOCD Reference #: 2RP-1258**

March 2014

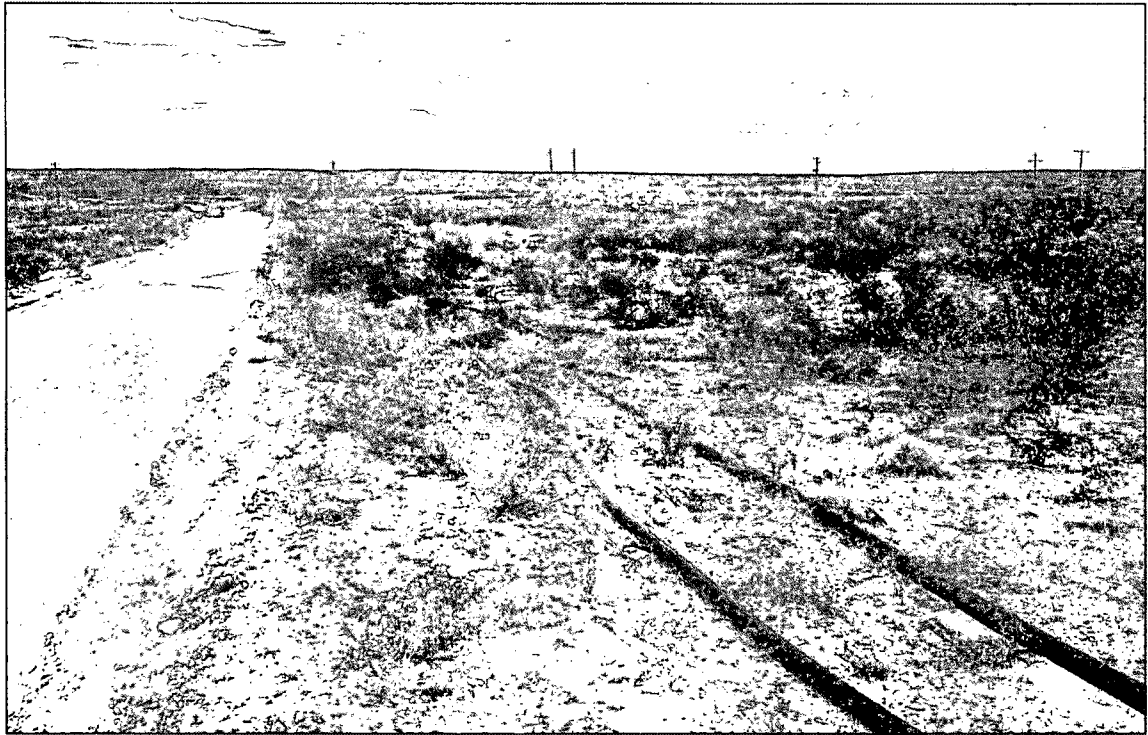
Remuda Basin Battery #1 Water Transfer Line – Release Site

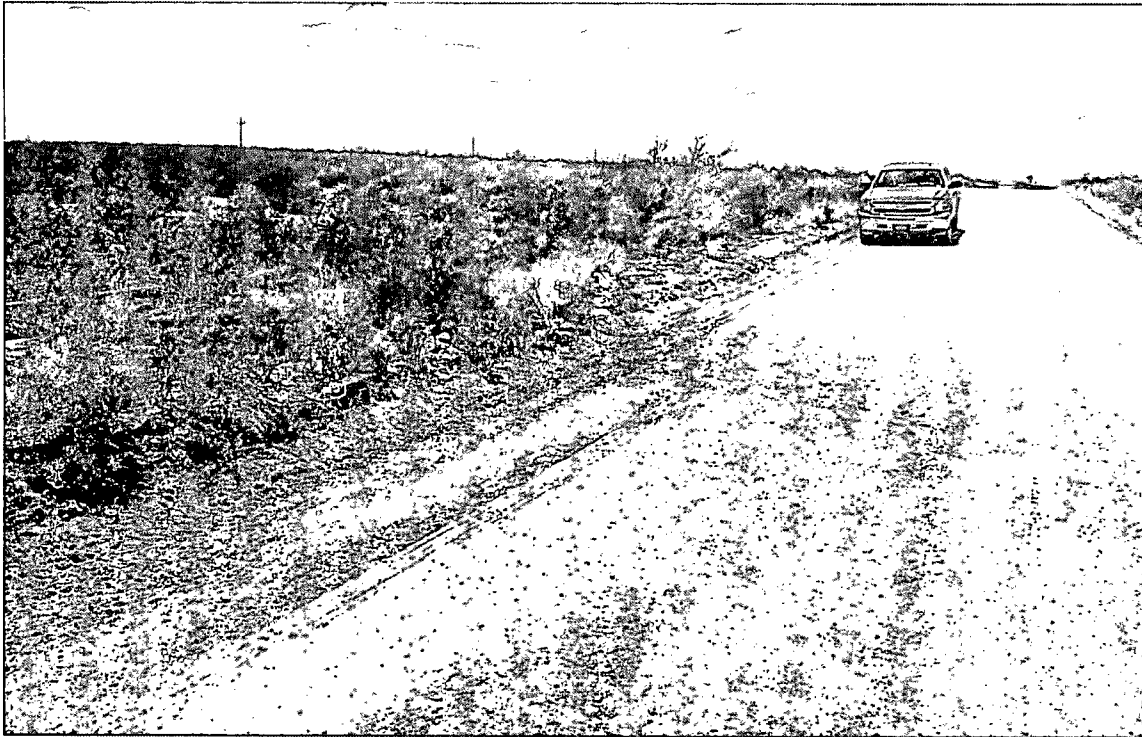
Remuda Basin Battery #1 Water Transfer Line – Flow Path

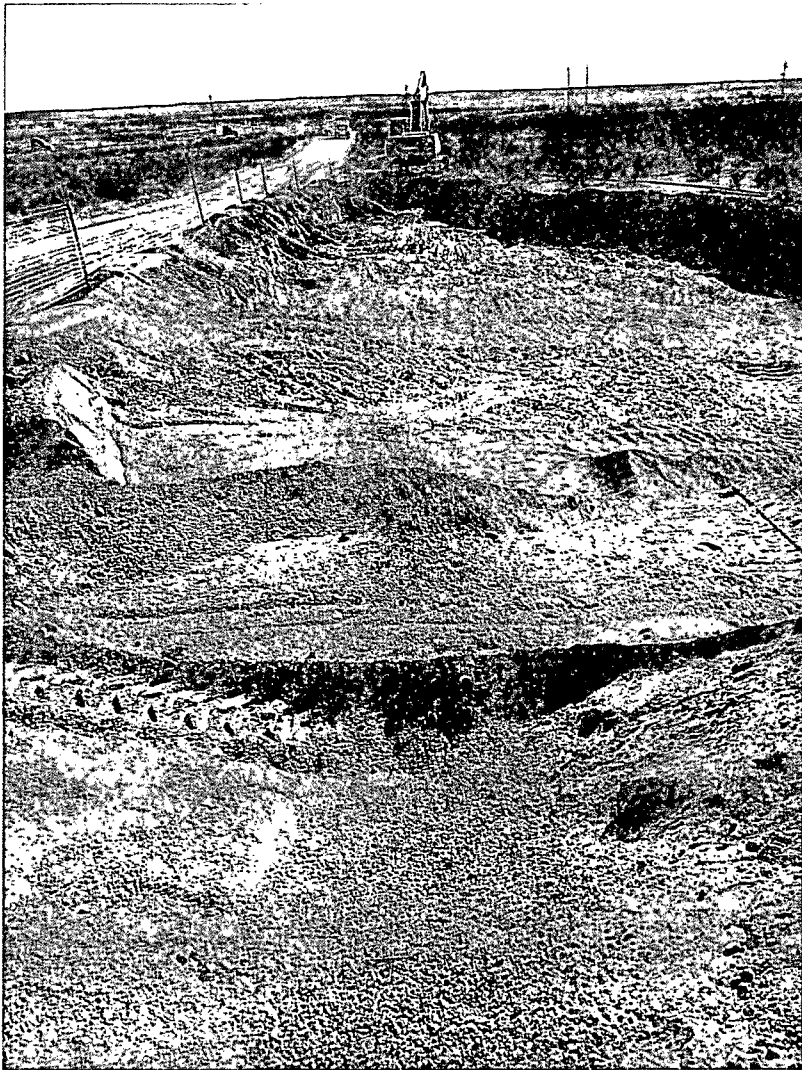
Remuda Basin Battery #1 Water Transfer Line –
Excavation (Looking East)

On February 28, 2014, excavation of impacted soil commenced at the site. A chloride test kit was utilized to field-screen the horizontal extent of impacted soil and to guide the excavation. From February 28 through March 11, 2014, approximately one thousand, one hundred and forty cubic yards (1,140 yd³) of impacted soil was excavated and hauled to Lea Land, Inc. (NMOCD Permit # WM-01-035), for disposal.
