Release Notification and Corrective Action

CORRECTIVE ACTION REPORT

**Cohn #1 Pipeline Release (11/08/2014)
NE 1/4, S25 T29N R10W
San Juan County, New Mexico**

June 27, 2014

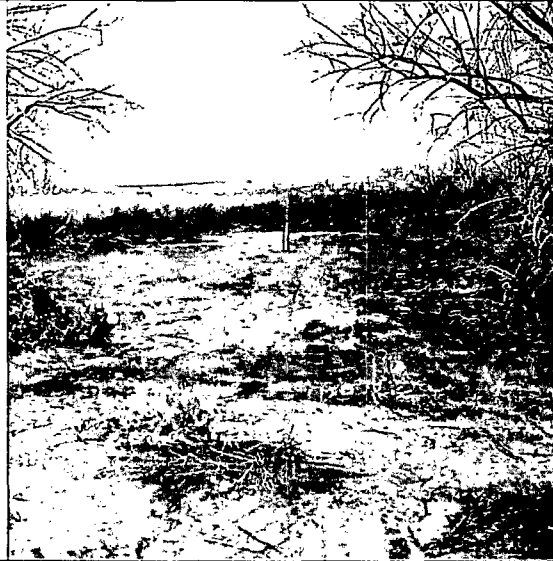
Photograph 1

Release area prior to excavation activities.

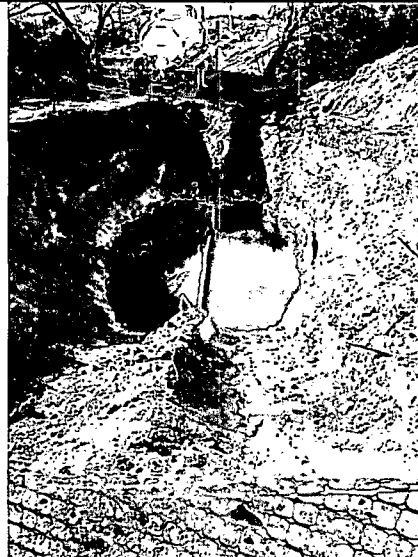
Photograph 2

Initial excavation after line repairs completed.

Excavation activities associated with the pipeline repair were completed on December 18th, 2013. Soil samples (S-1 to S-8) were collected subsequent to the pipeline repair activities on December 18th, 2013. The analyses of these initial soil samples demonstrated that hydrocarbon affected soils remained in place at the Site.

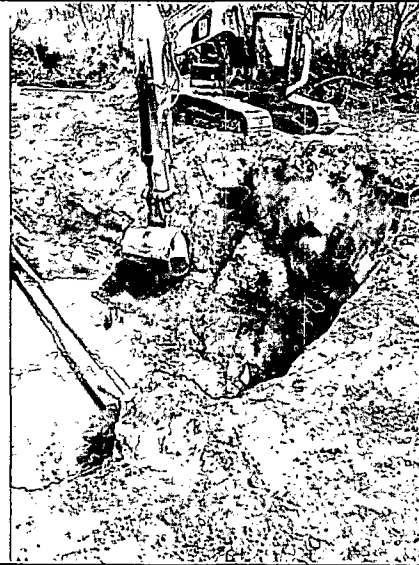
Photograph 4

Removing impacted material from northwest portion of excavation.

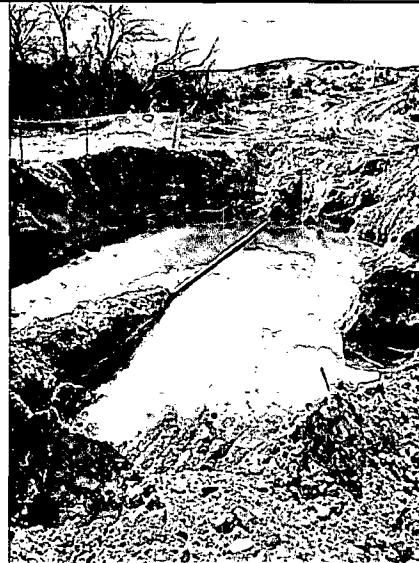
Photograph 5

Excavation prior to stripping back soil along pipeline.

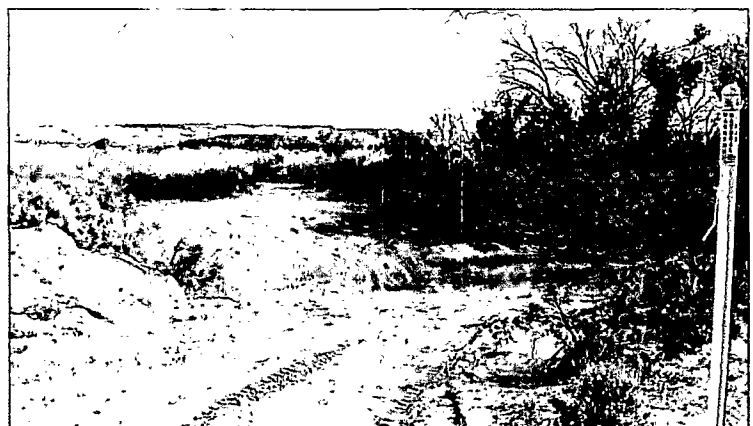
Photograph 6

General view of reclaimed area after excavation backfill.

Approximately 720 cubic yards of hydrocarbon affected soils were transported to the Envirotech, Inc. landfarm near Hilltop, NM for disposal/remediation. The executed C-138 forms are provided in Appendix B. The excavation was ultimately backfilled with clean imported fill and contoured to surrounding grade.
