**Release Report/ General
Correspondence**

Enterprise RA

**Enterprise Products
Lateral 2C-107 Pipeline Release
Latitude North 36.381594°, Longitude West -107.116924°
NE/SW (Unit K) Section 23 T25N R3W
Rio Arriba County, New Mexico
August 25, 2014**

Enterprise Products
McKenzie #2 Well Tie Release Site
Latitude North 36.38591°, Longitude West -107.416890°
Unit G (SW ¼, NE ¼) Section 24 T25N R6W
Rio Arriba County, New Mexico
July 9, 2014

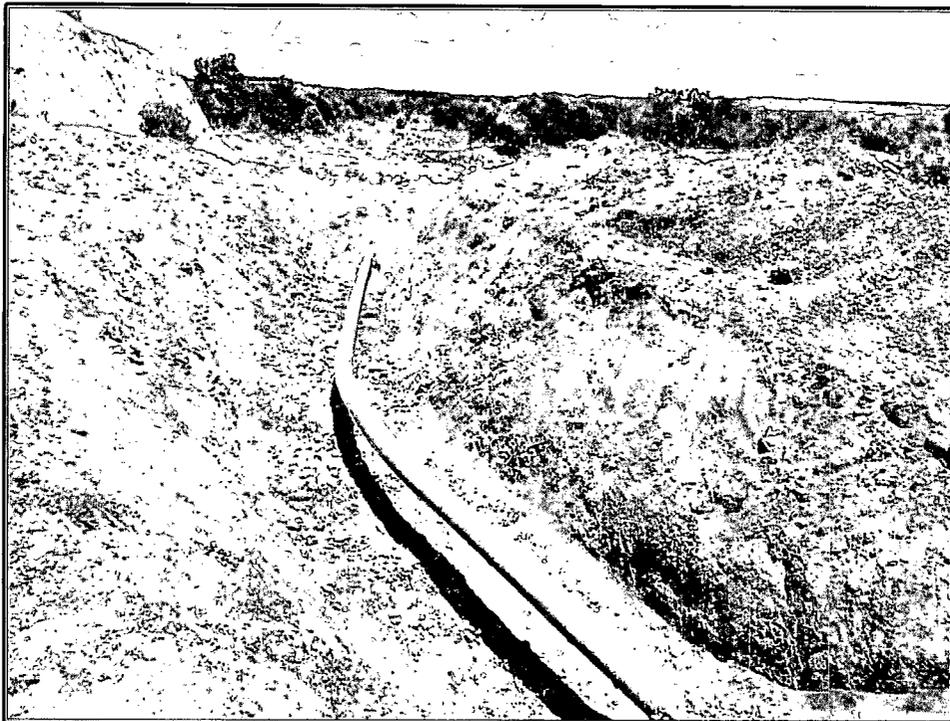
Photo 2: View of the repair activities of the Lateral 2C-107 Pipeline.

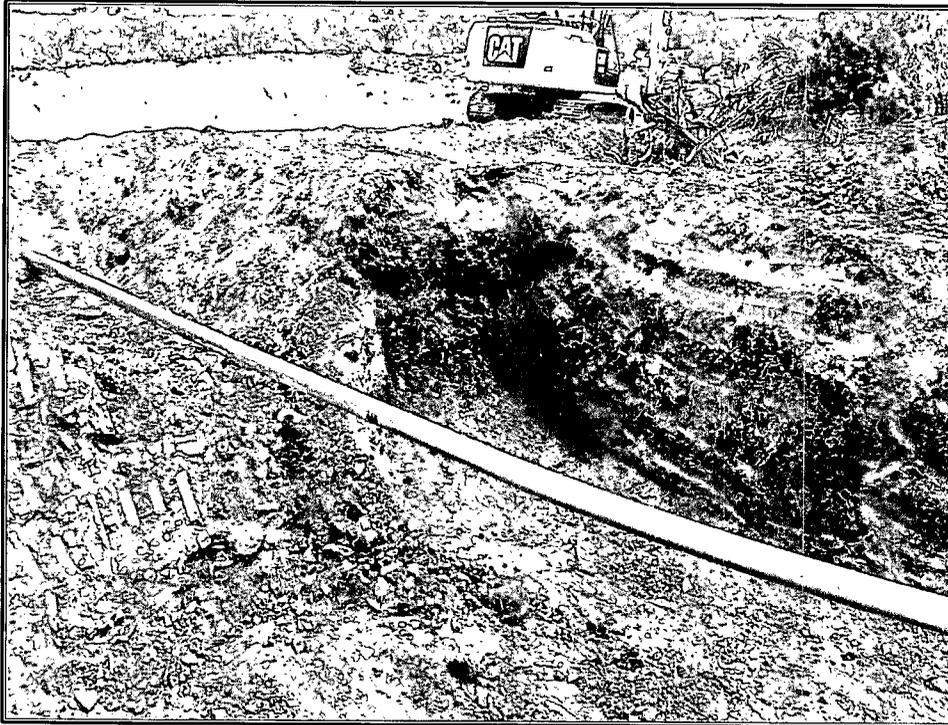
Photo 3: View of the excavation ending on July 31, 2014. facing northeast.

The final excavation dimensions were approximately 80 feet long by a maximum of 28 feet wide and up to 13 feet deep, covering an area of approximately 1,860 square feet. In total, approximately 600 cubic yards of material were excavated and hauled to T-N-T Landfarm near Dulce, New Mexico for proper disposal and replaced with clean backfill material. Soil disposal documentation is included in Appendix B.

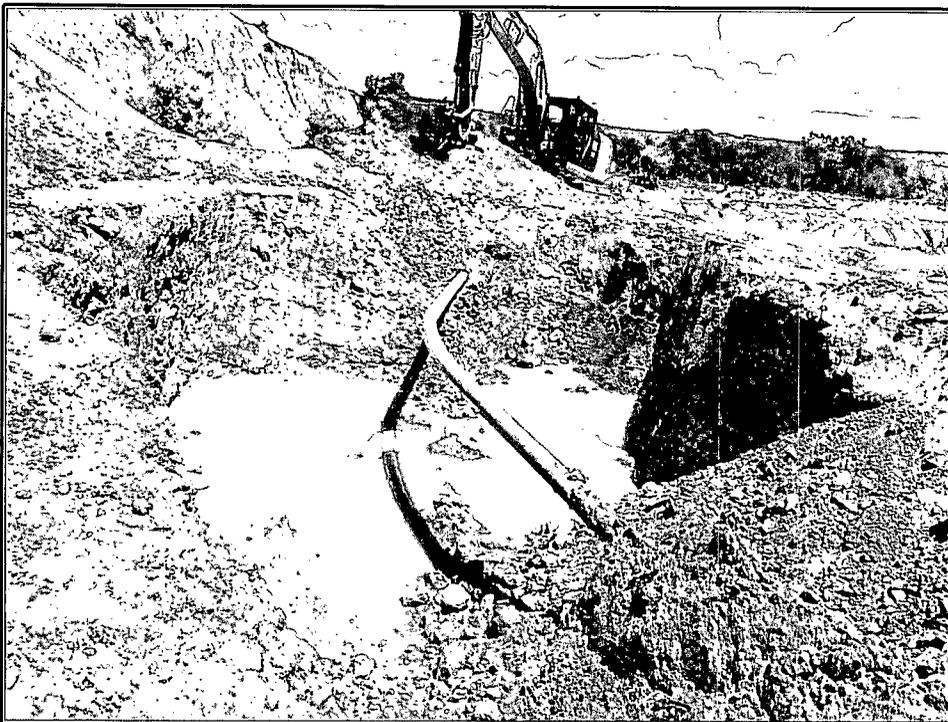
Photo 4: View of the final excavation activities on the northern half containing stormwater.

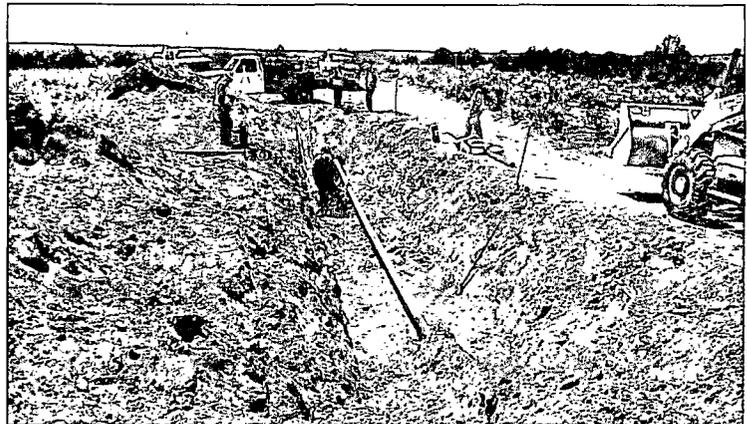
Photograph 2

General view of excavation during pipeline repair activities, facing west.

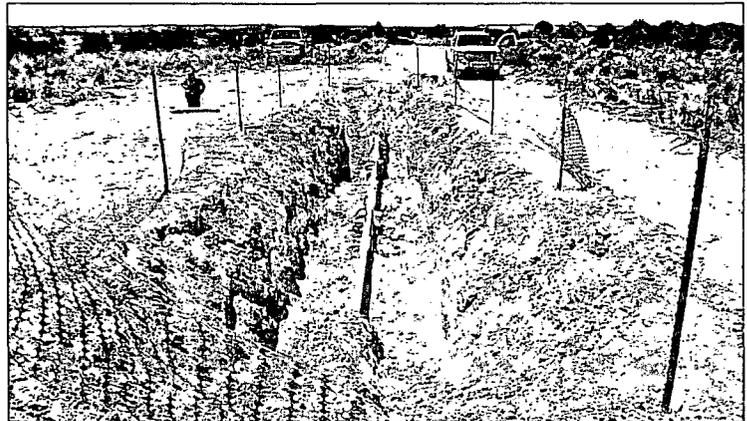
Photograph 3

General view of excavation during pipeline repair activities, facing west.

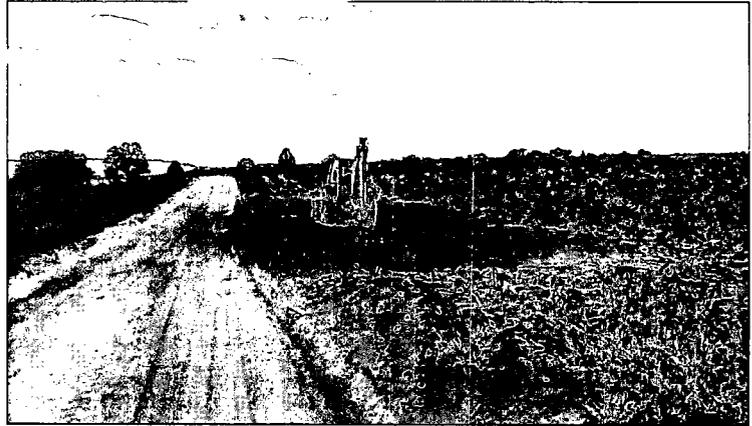
Photograph 4

View after the completion of corrective actions, facing east.

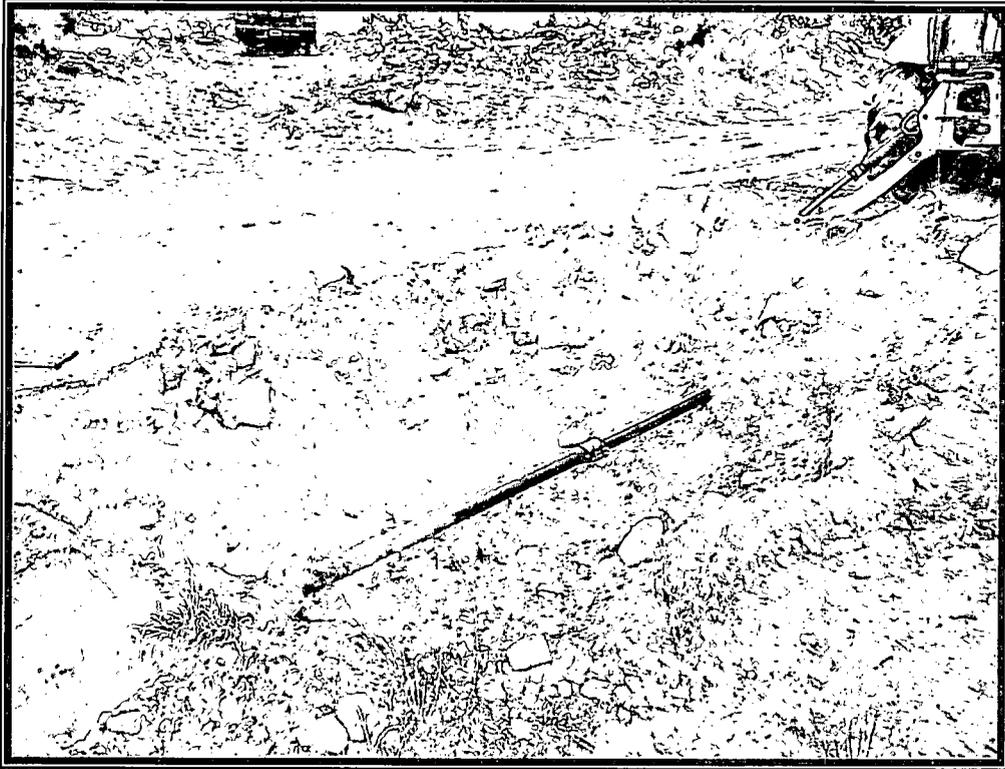
Photo #1: Clamp installed on pipeline at the McKenzie #2 Well Tie Release site.

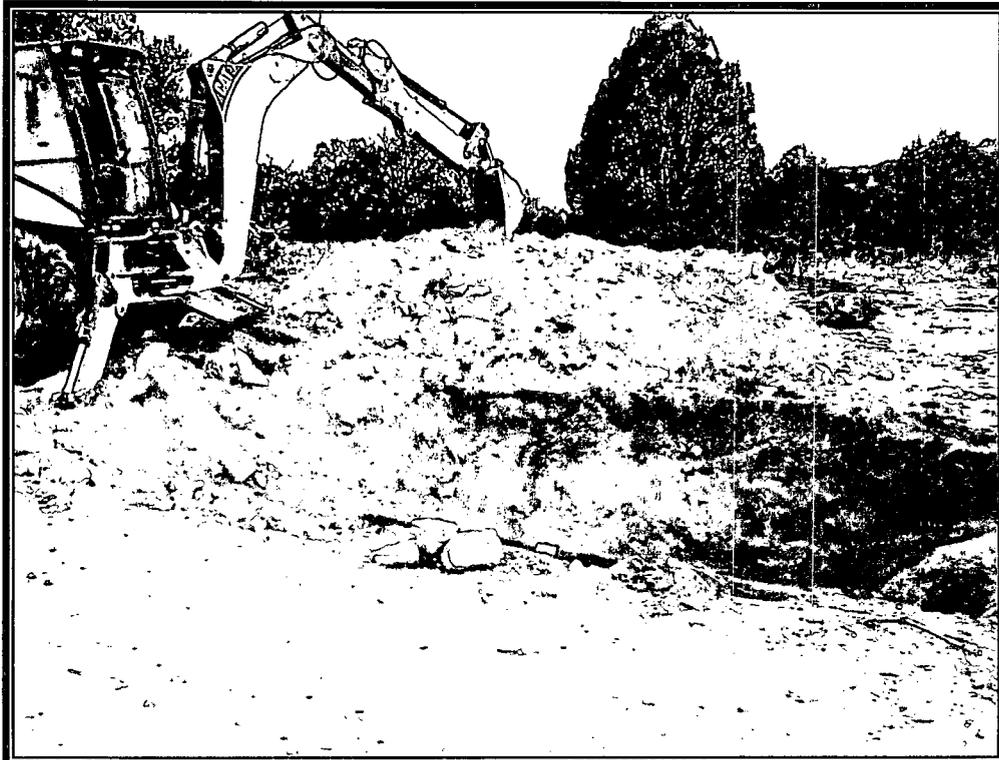
Photo #2: Excavation activities of the McKenzie #2 Well Tie Release site on 11/21/2013

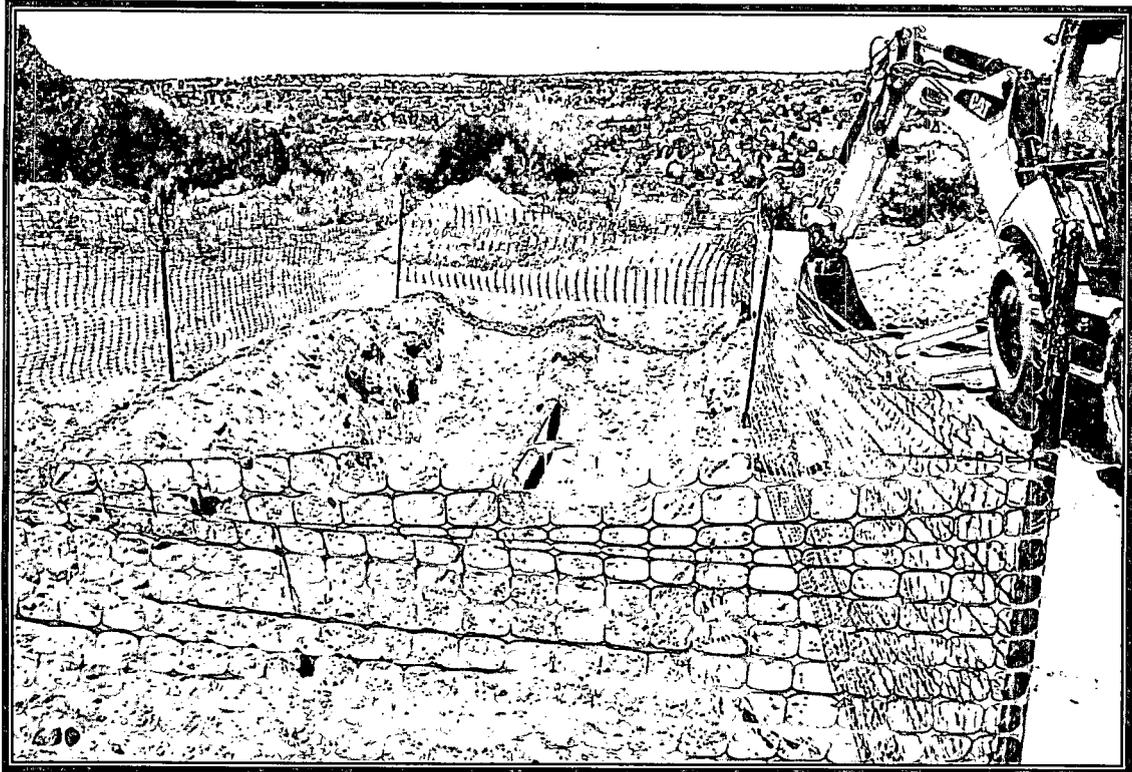
Photo #3: Excavation and stockpiled soil at the McKenzie #2 Well Tie Release site

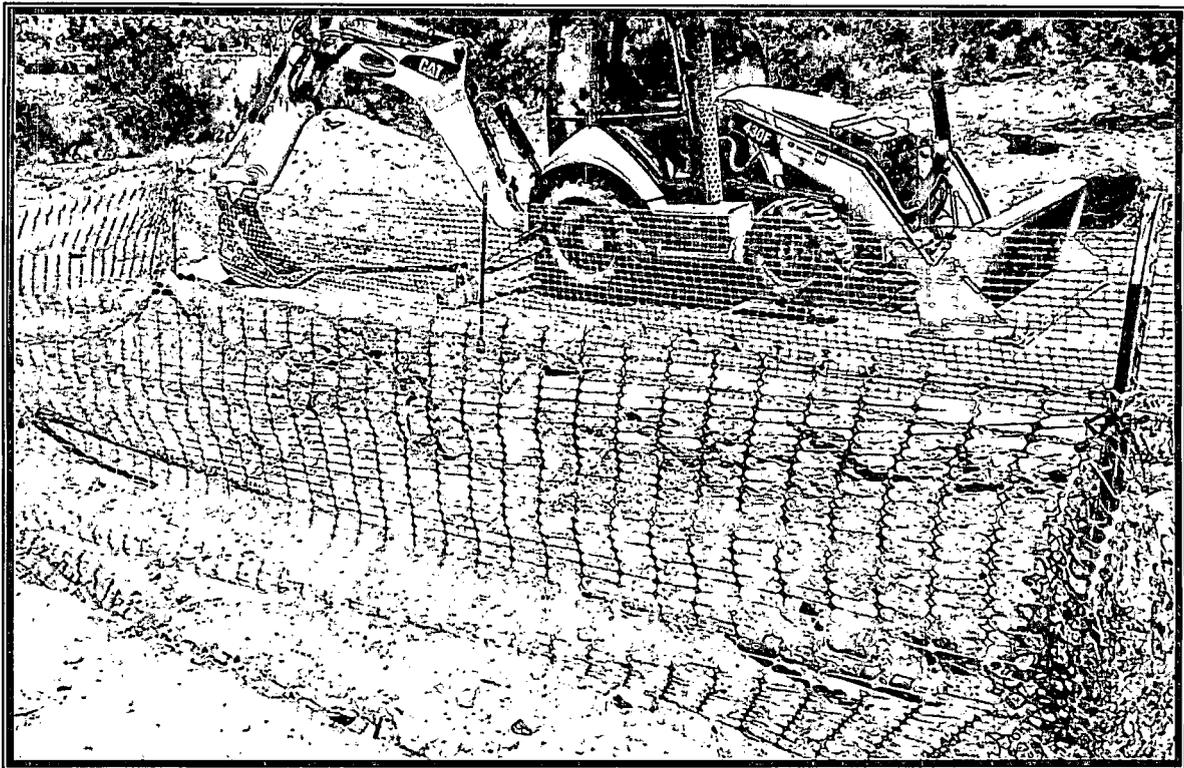
Photo #4: Final Excavation of the McKenzie #2 Well Tie Release site.

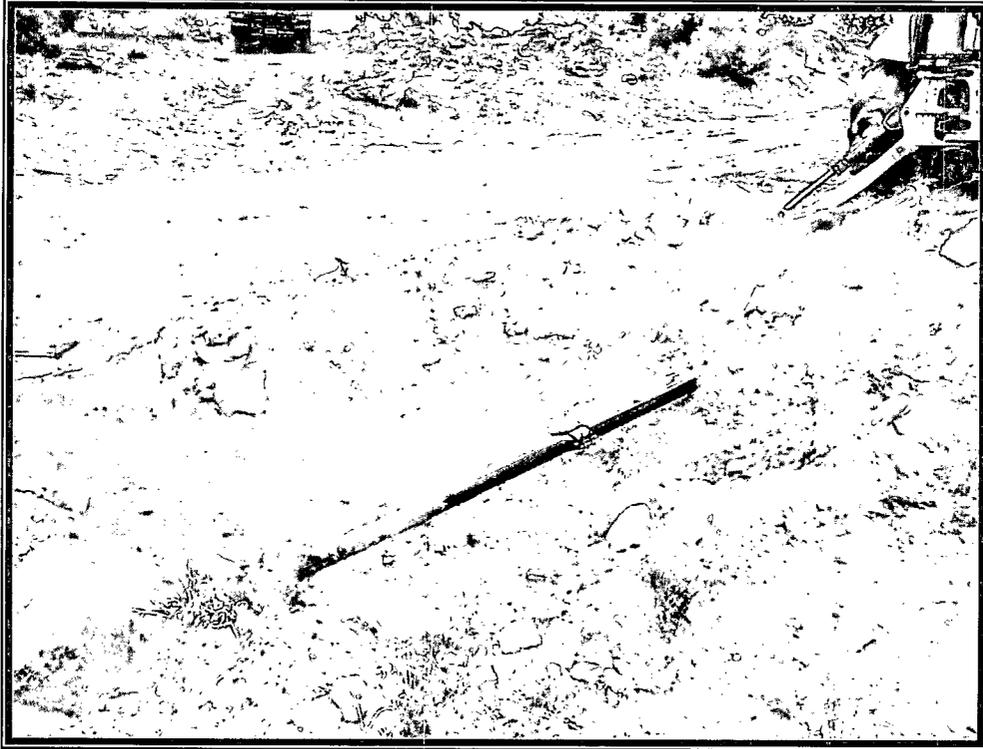
Photo 1: Clamp installed on pipeline at the McKenzie #2 Well Tie Release site.

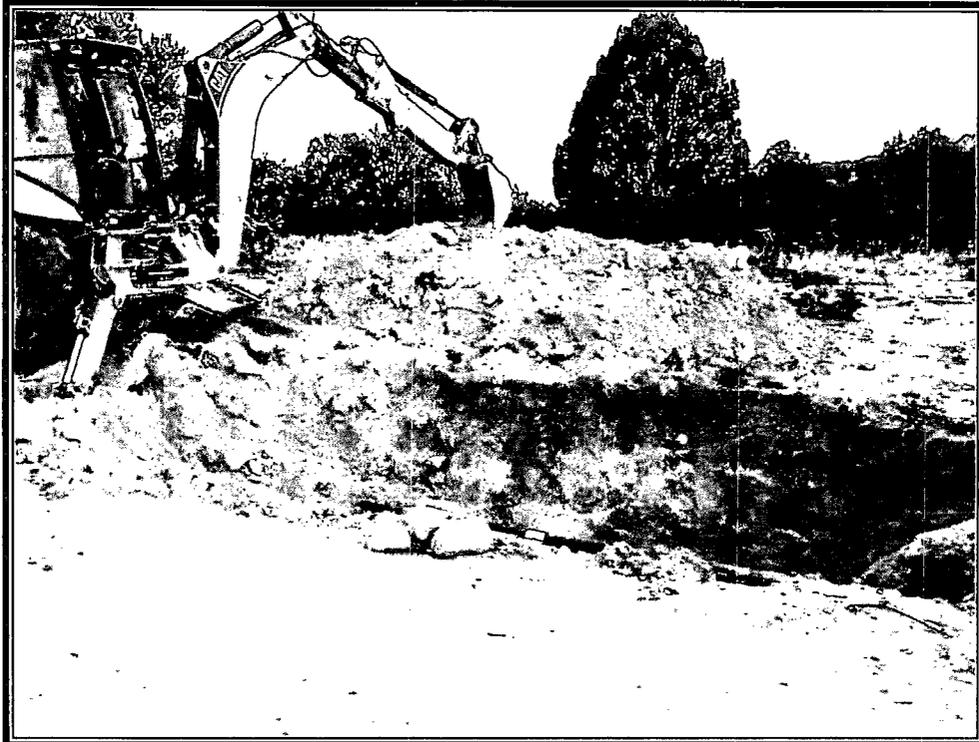
Photo #2: Excavation activities of the McKenzie #2 Well Tie Release site on 11/21/2013

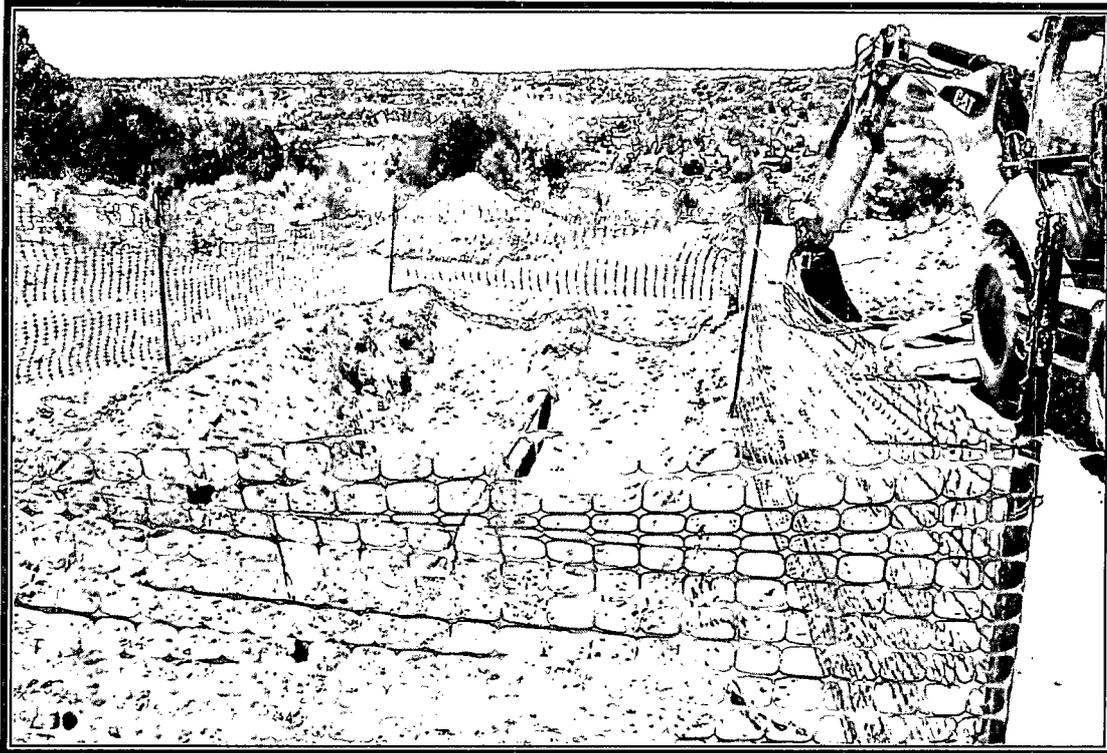
Photo #3: Excavation and stockpiled soil at the McKenzie #2 Well Tie Release site

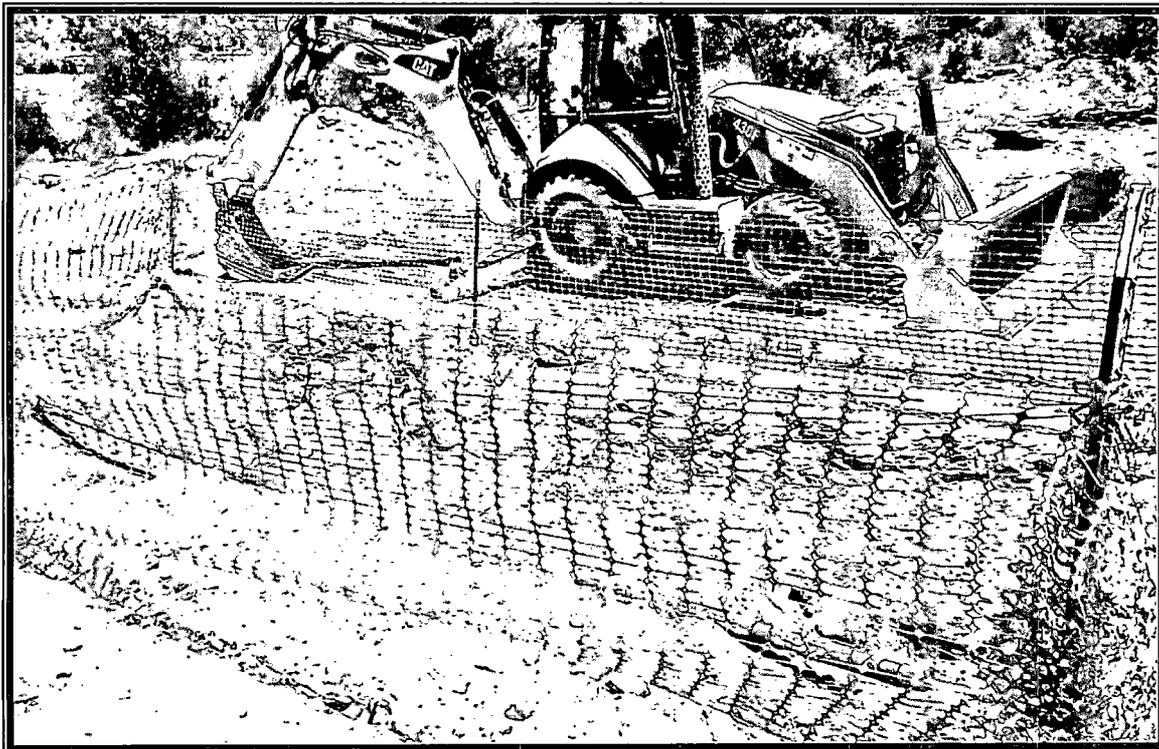
Photo #4: Final Excavation of the McKenzie #2 Well Tie Release site.
