Closing Report

Nagooltee Peak Satellite

API No. 3001524713

Eddy County, NM

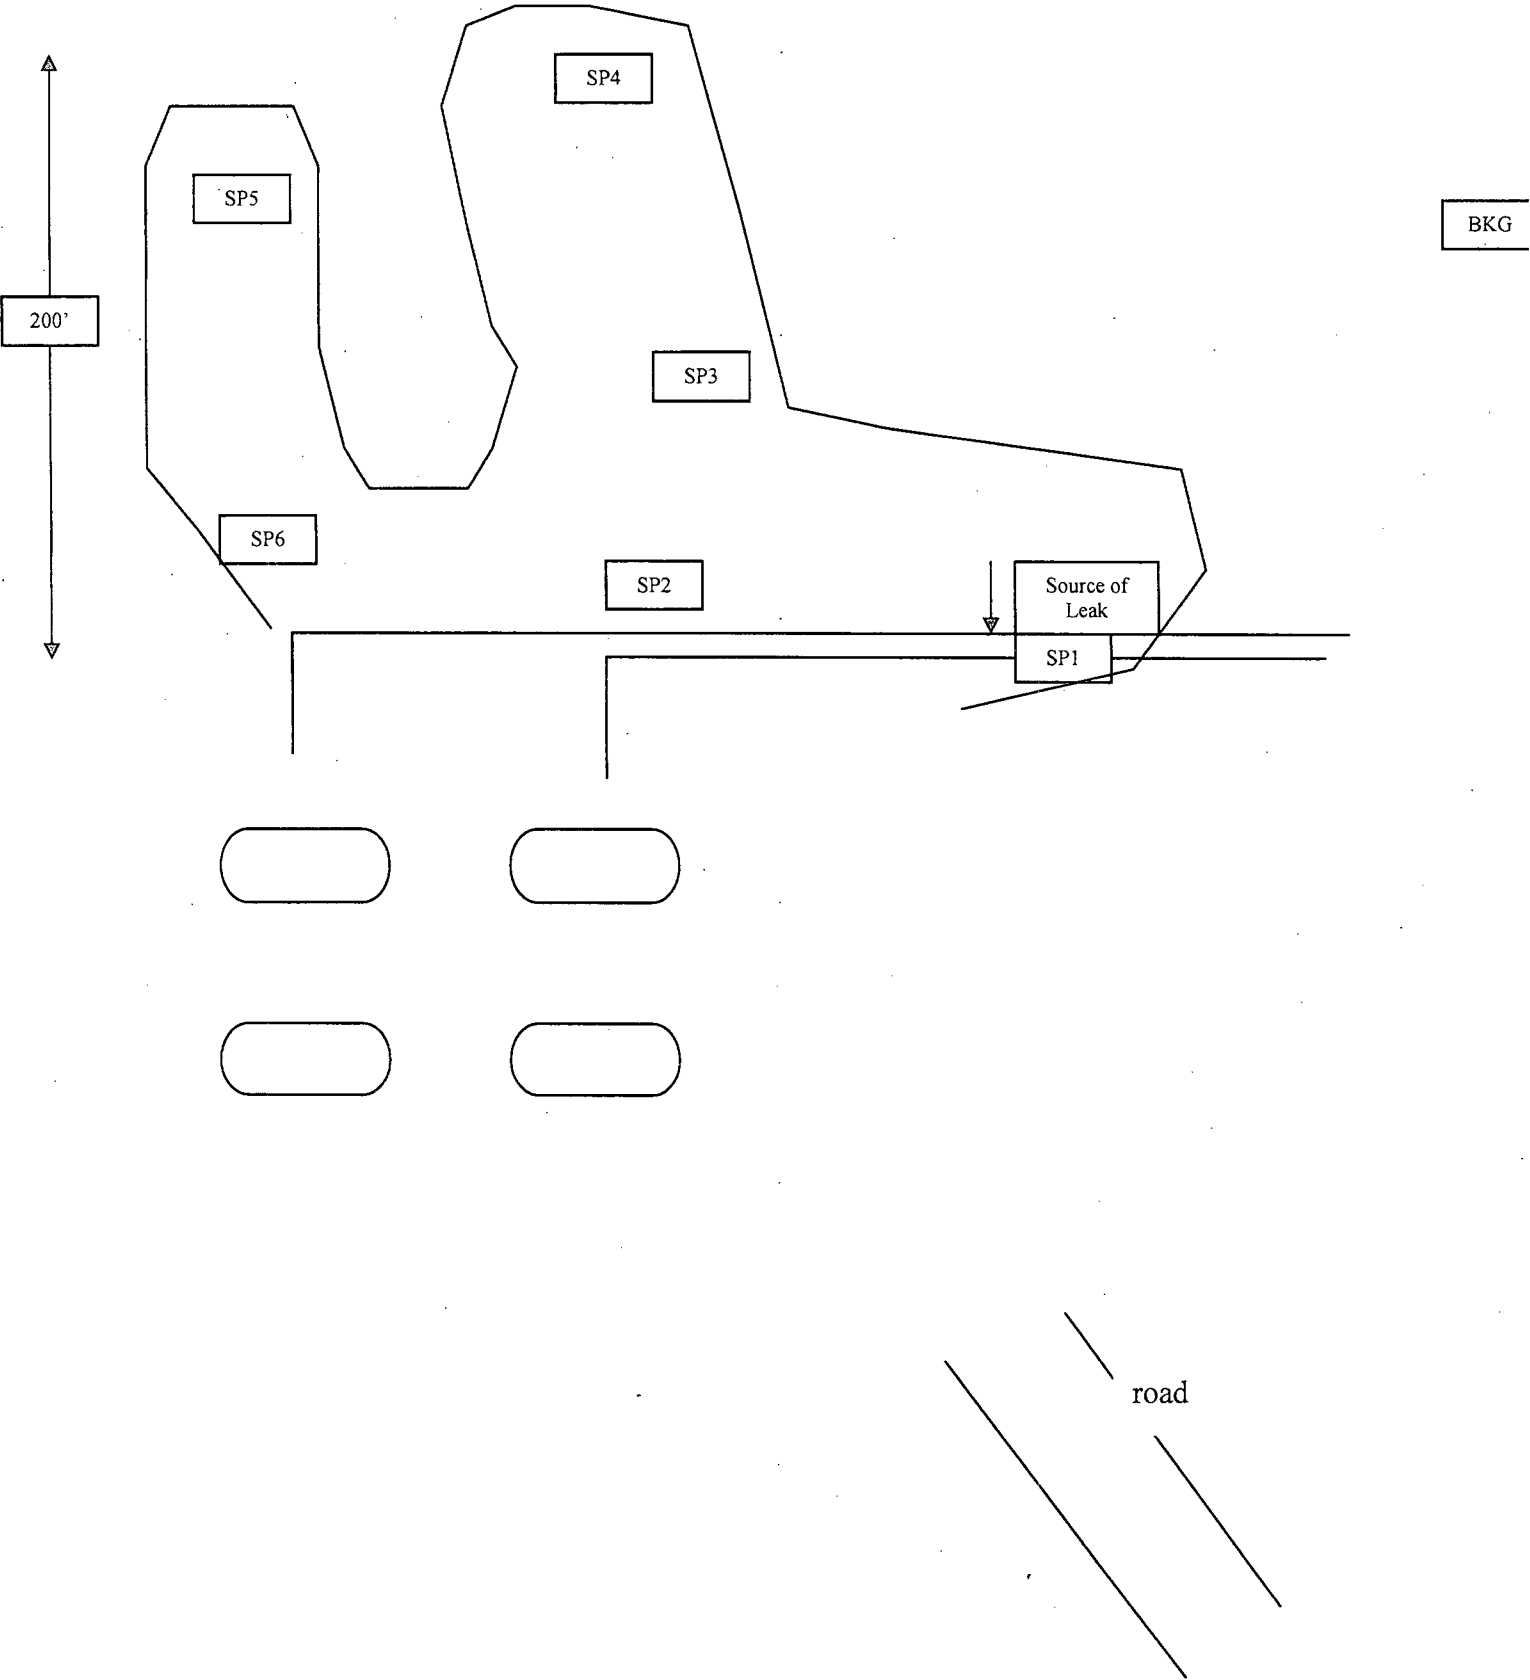
Plat Map / Nagooltee Peak Sat.

NAGOOOTEE PEAK SAT. SITE

5-T22S-R24E 11MPM

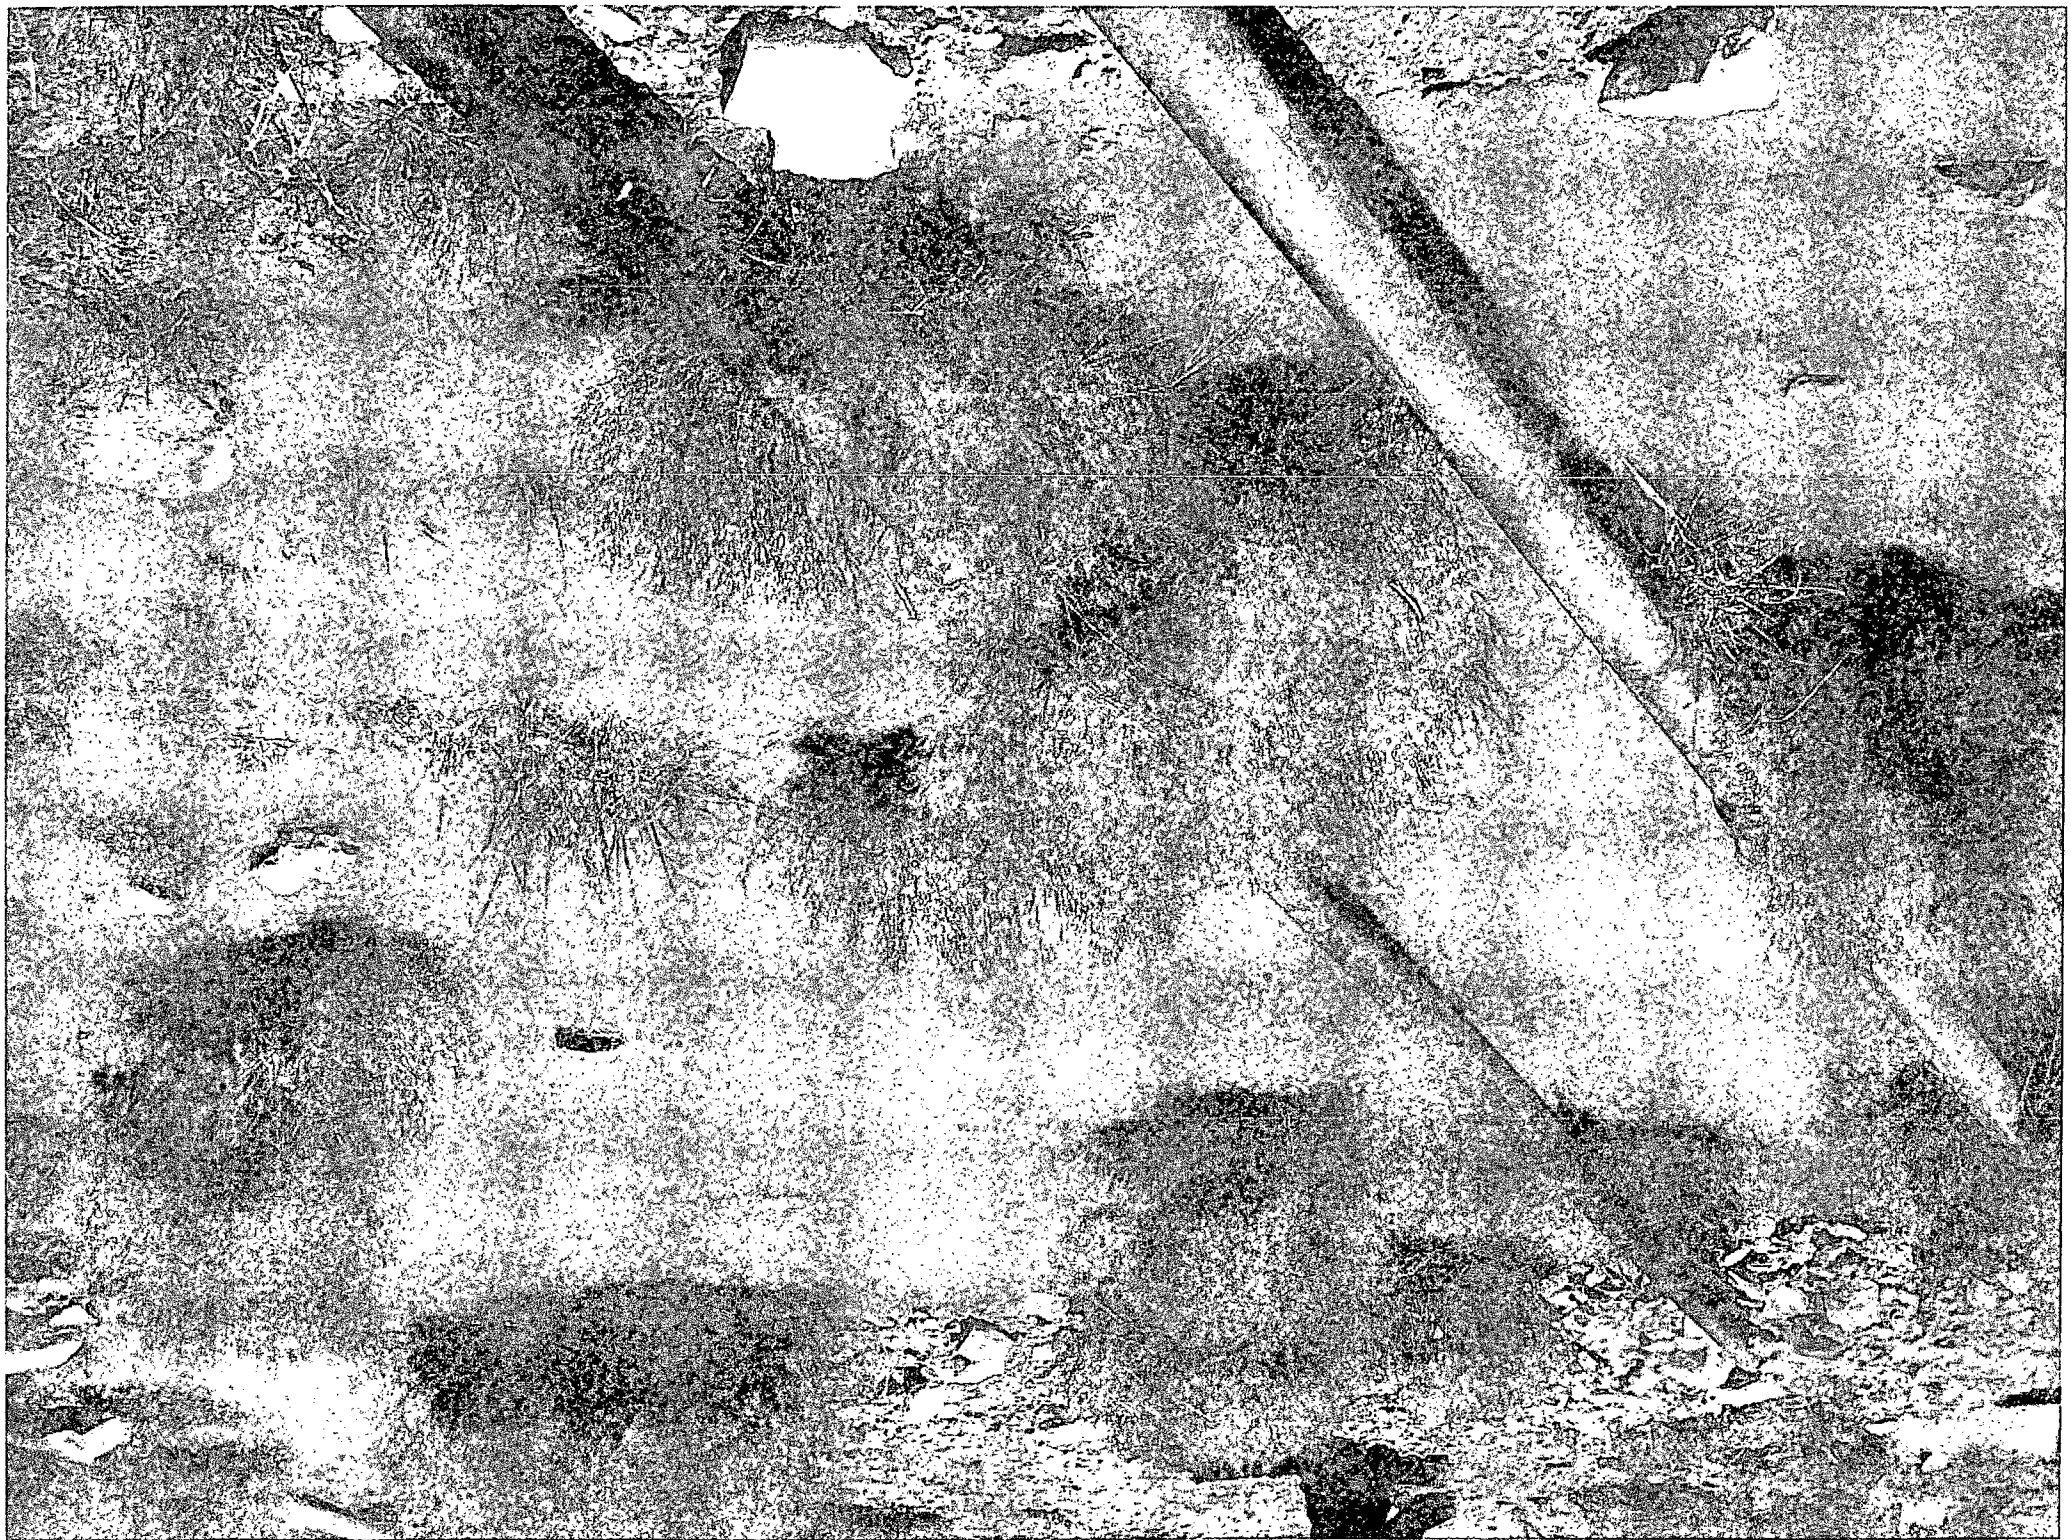
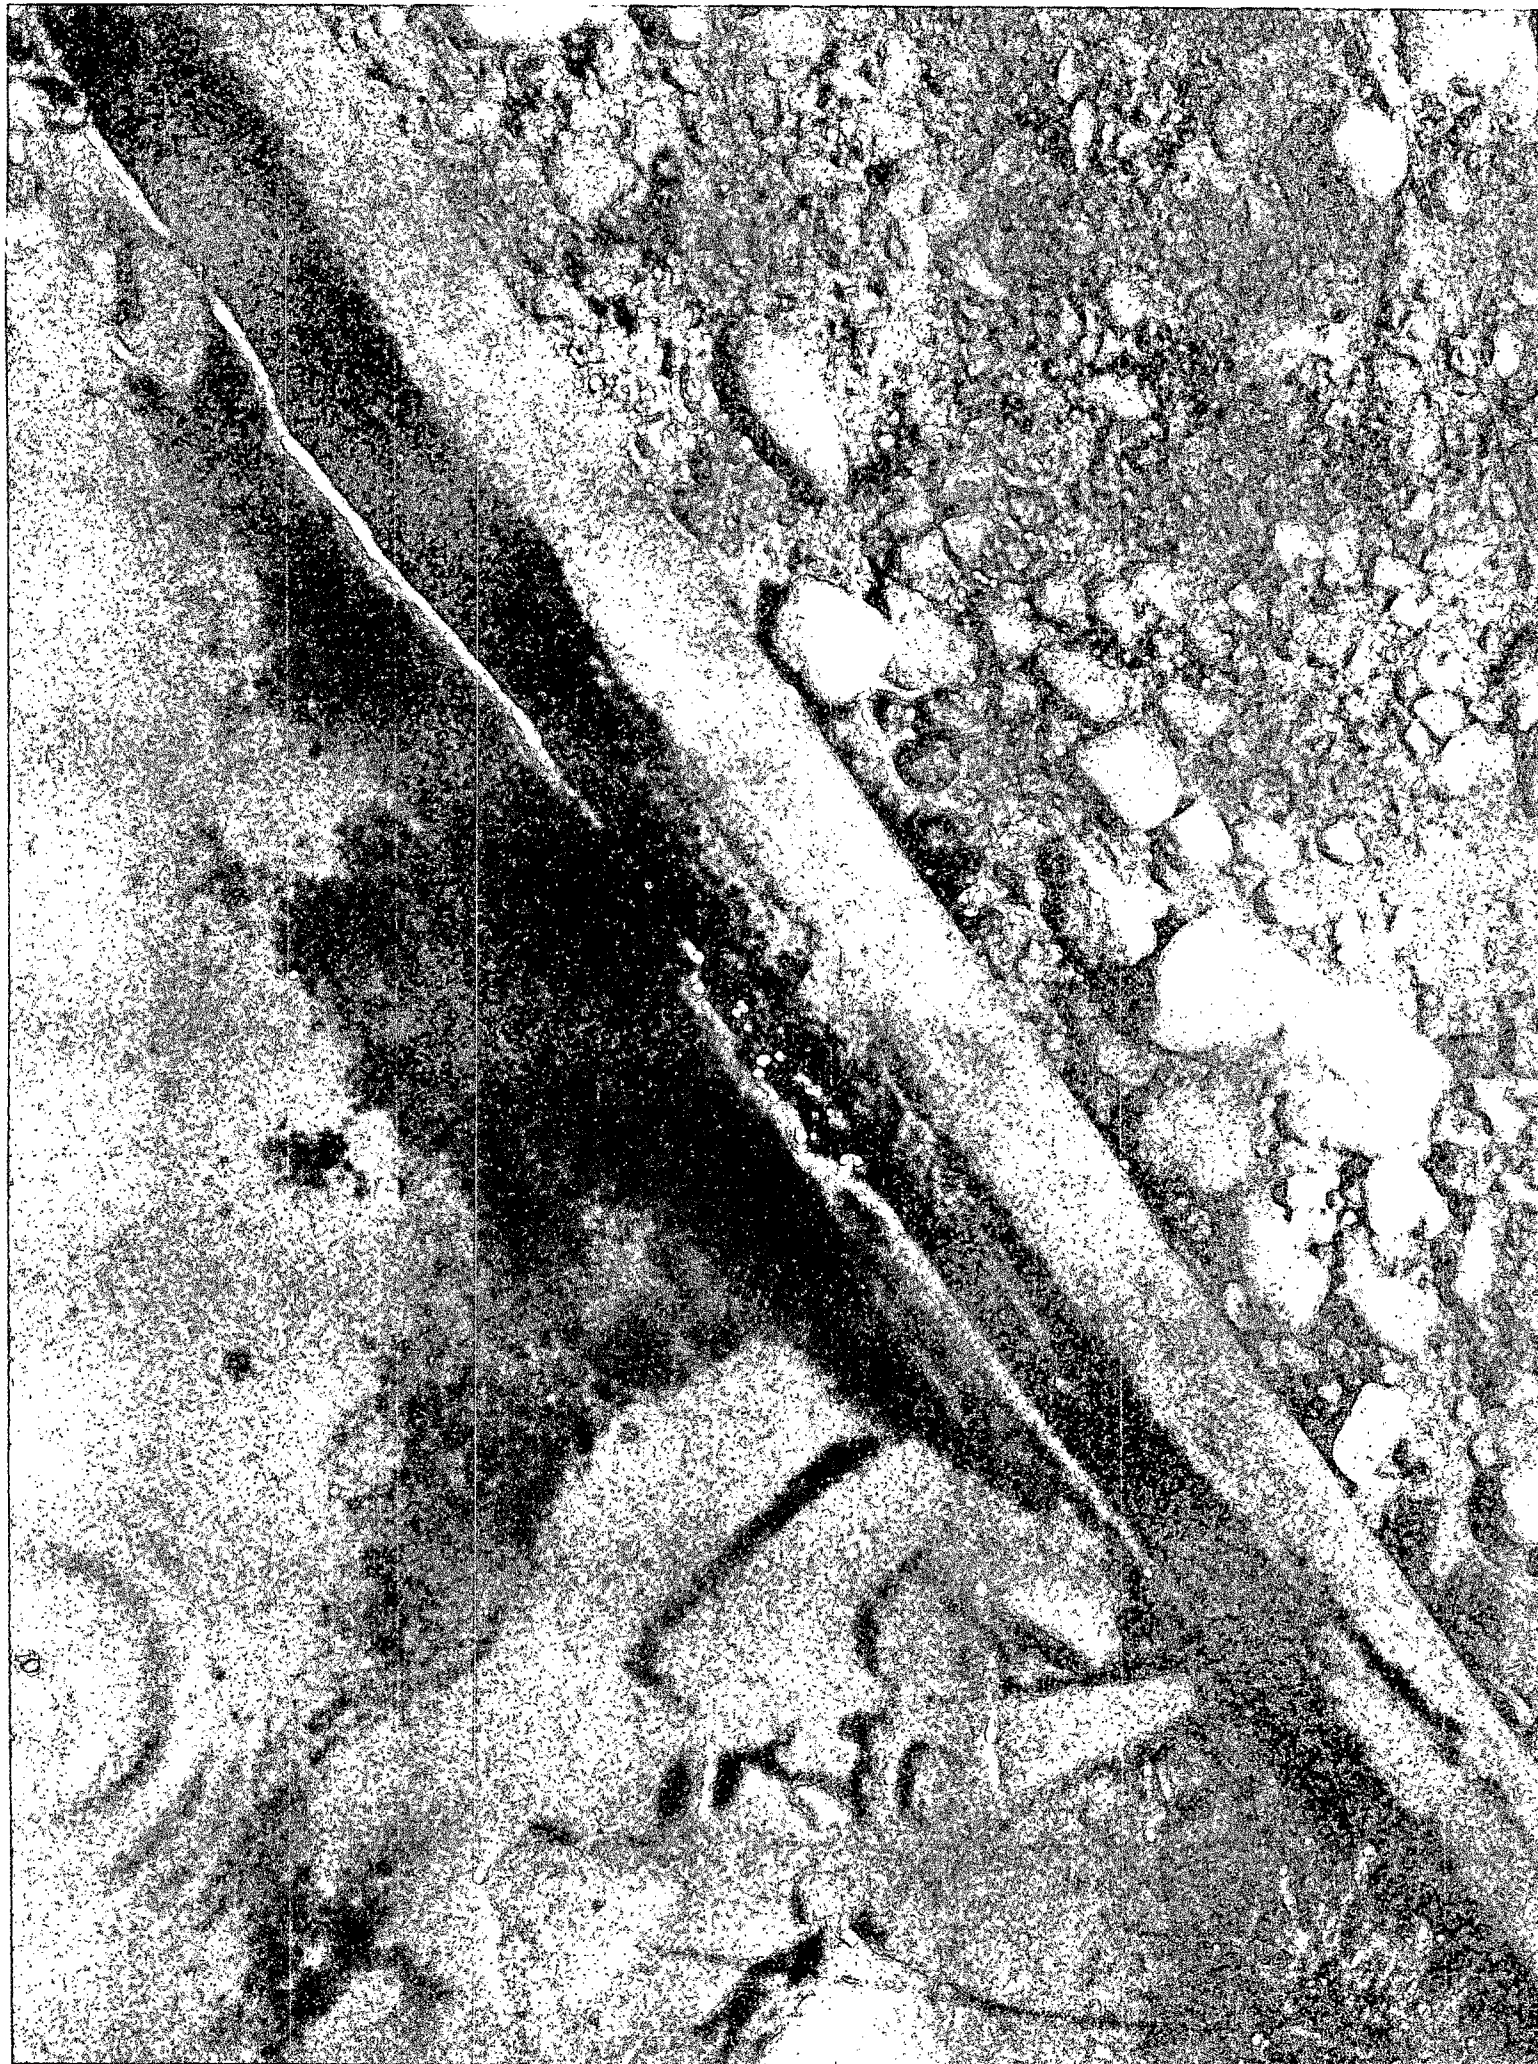
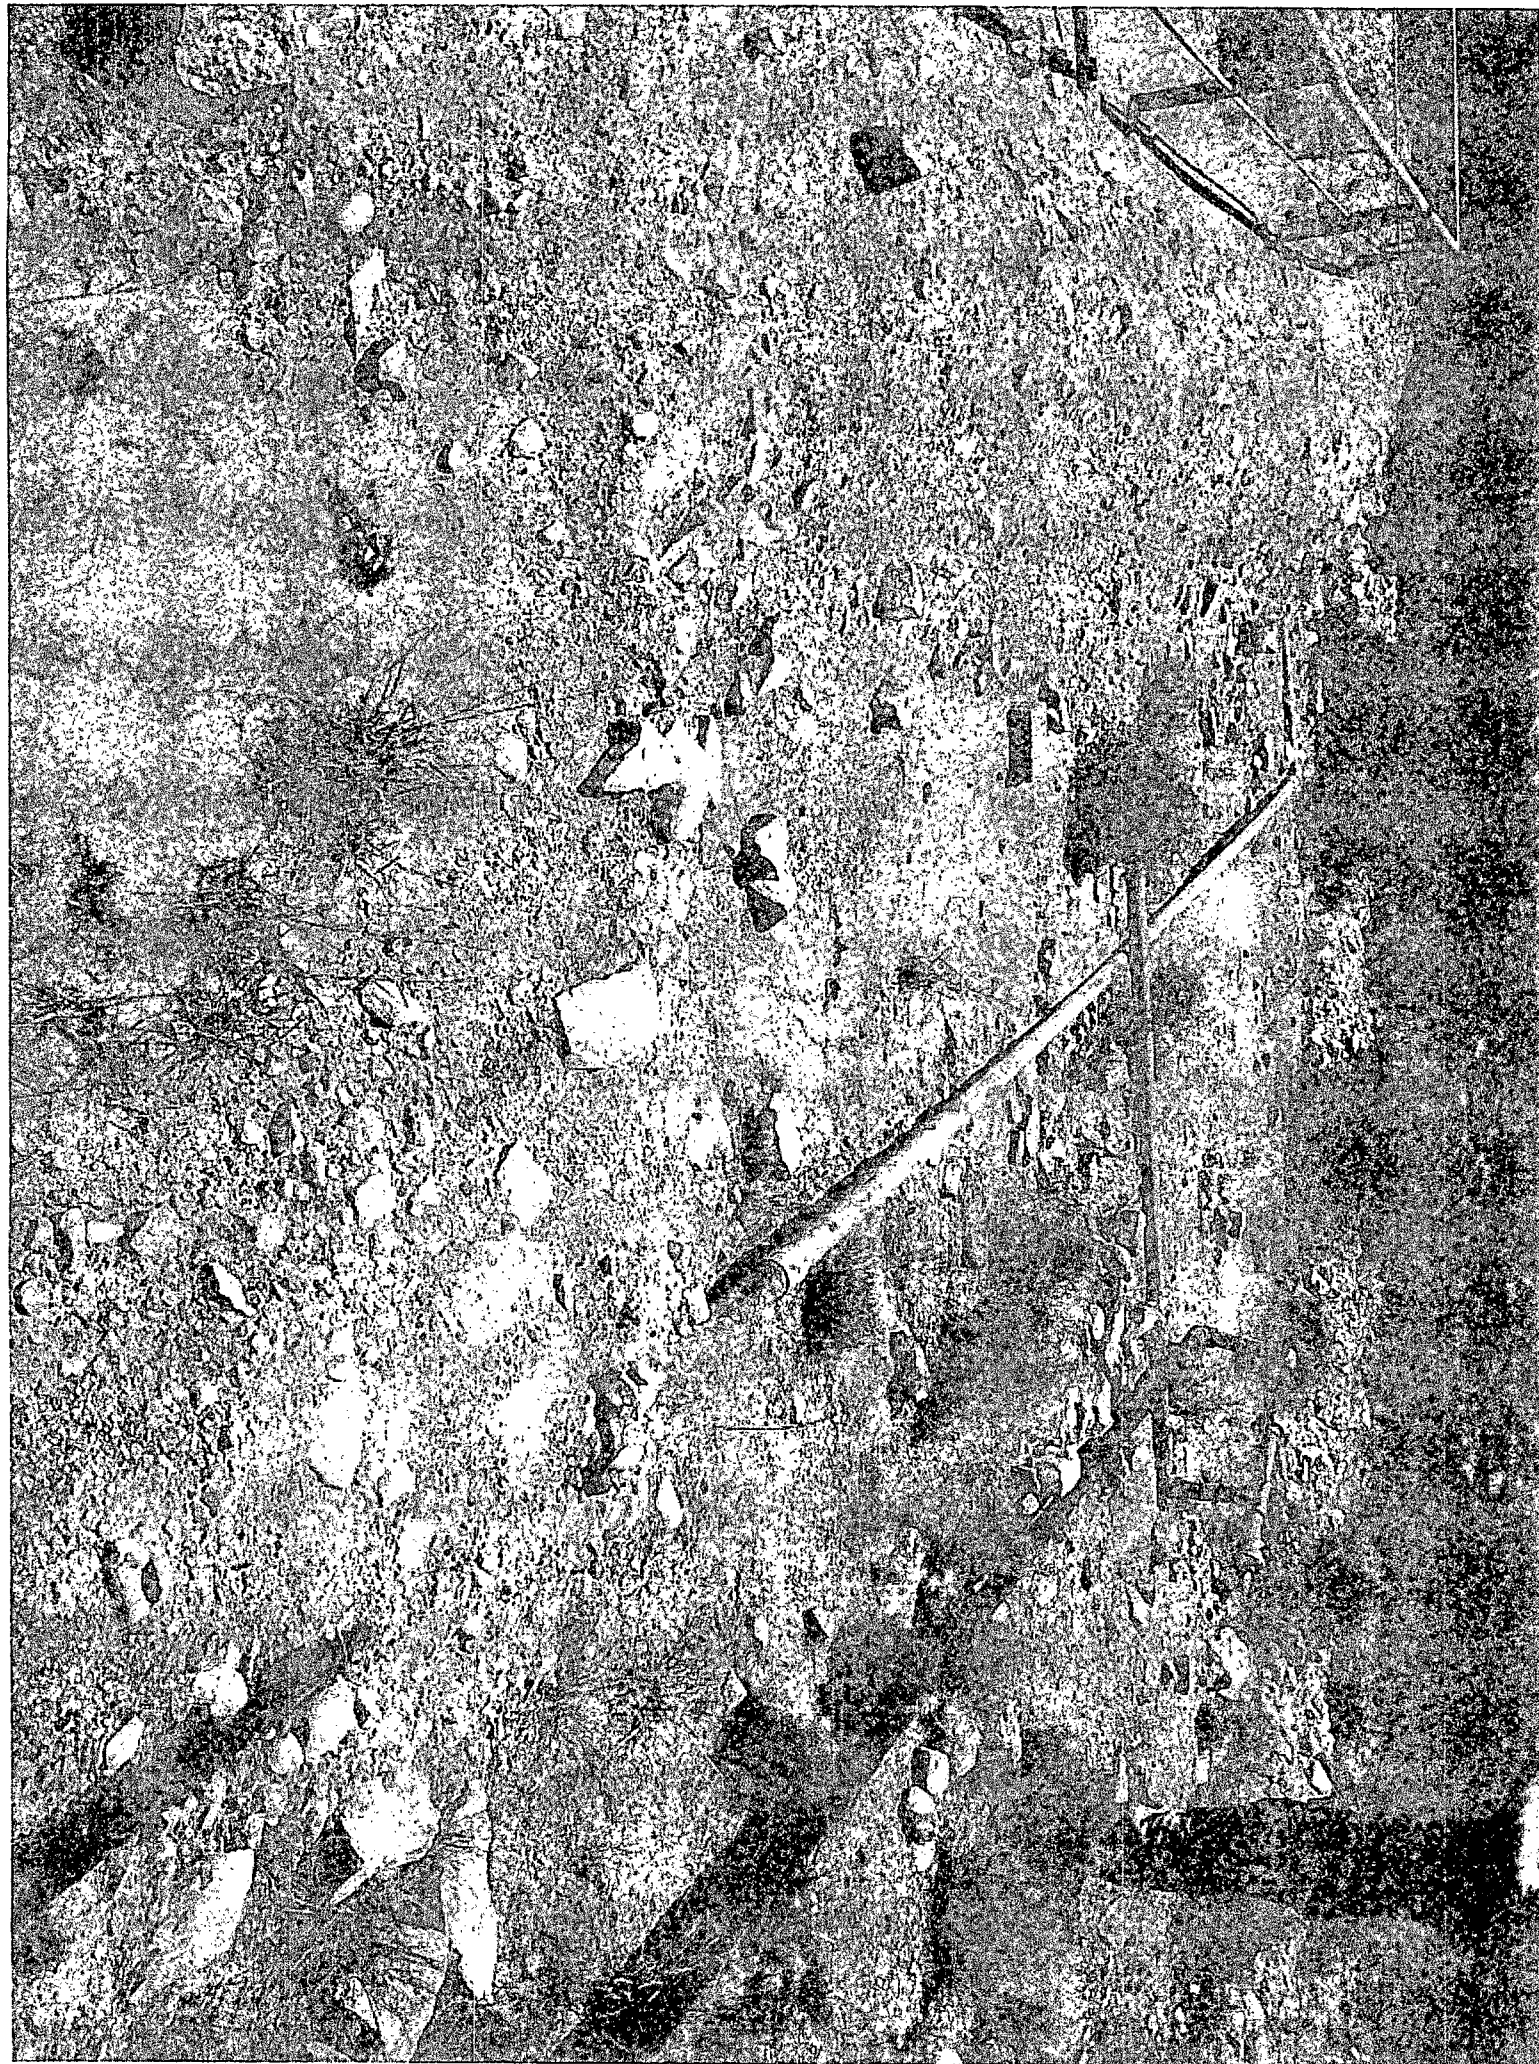
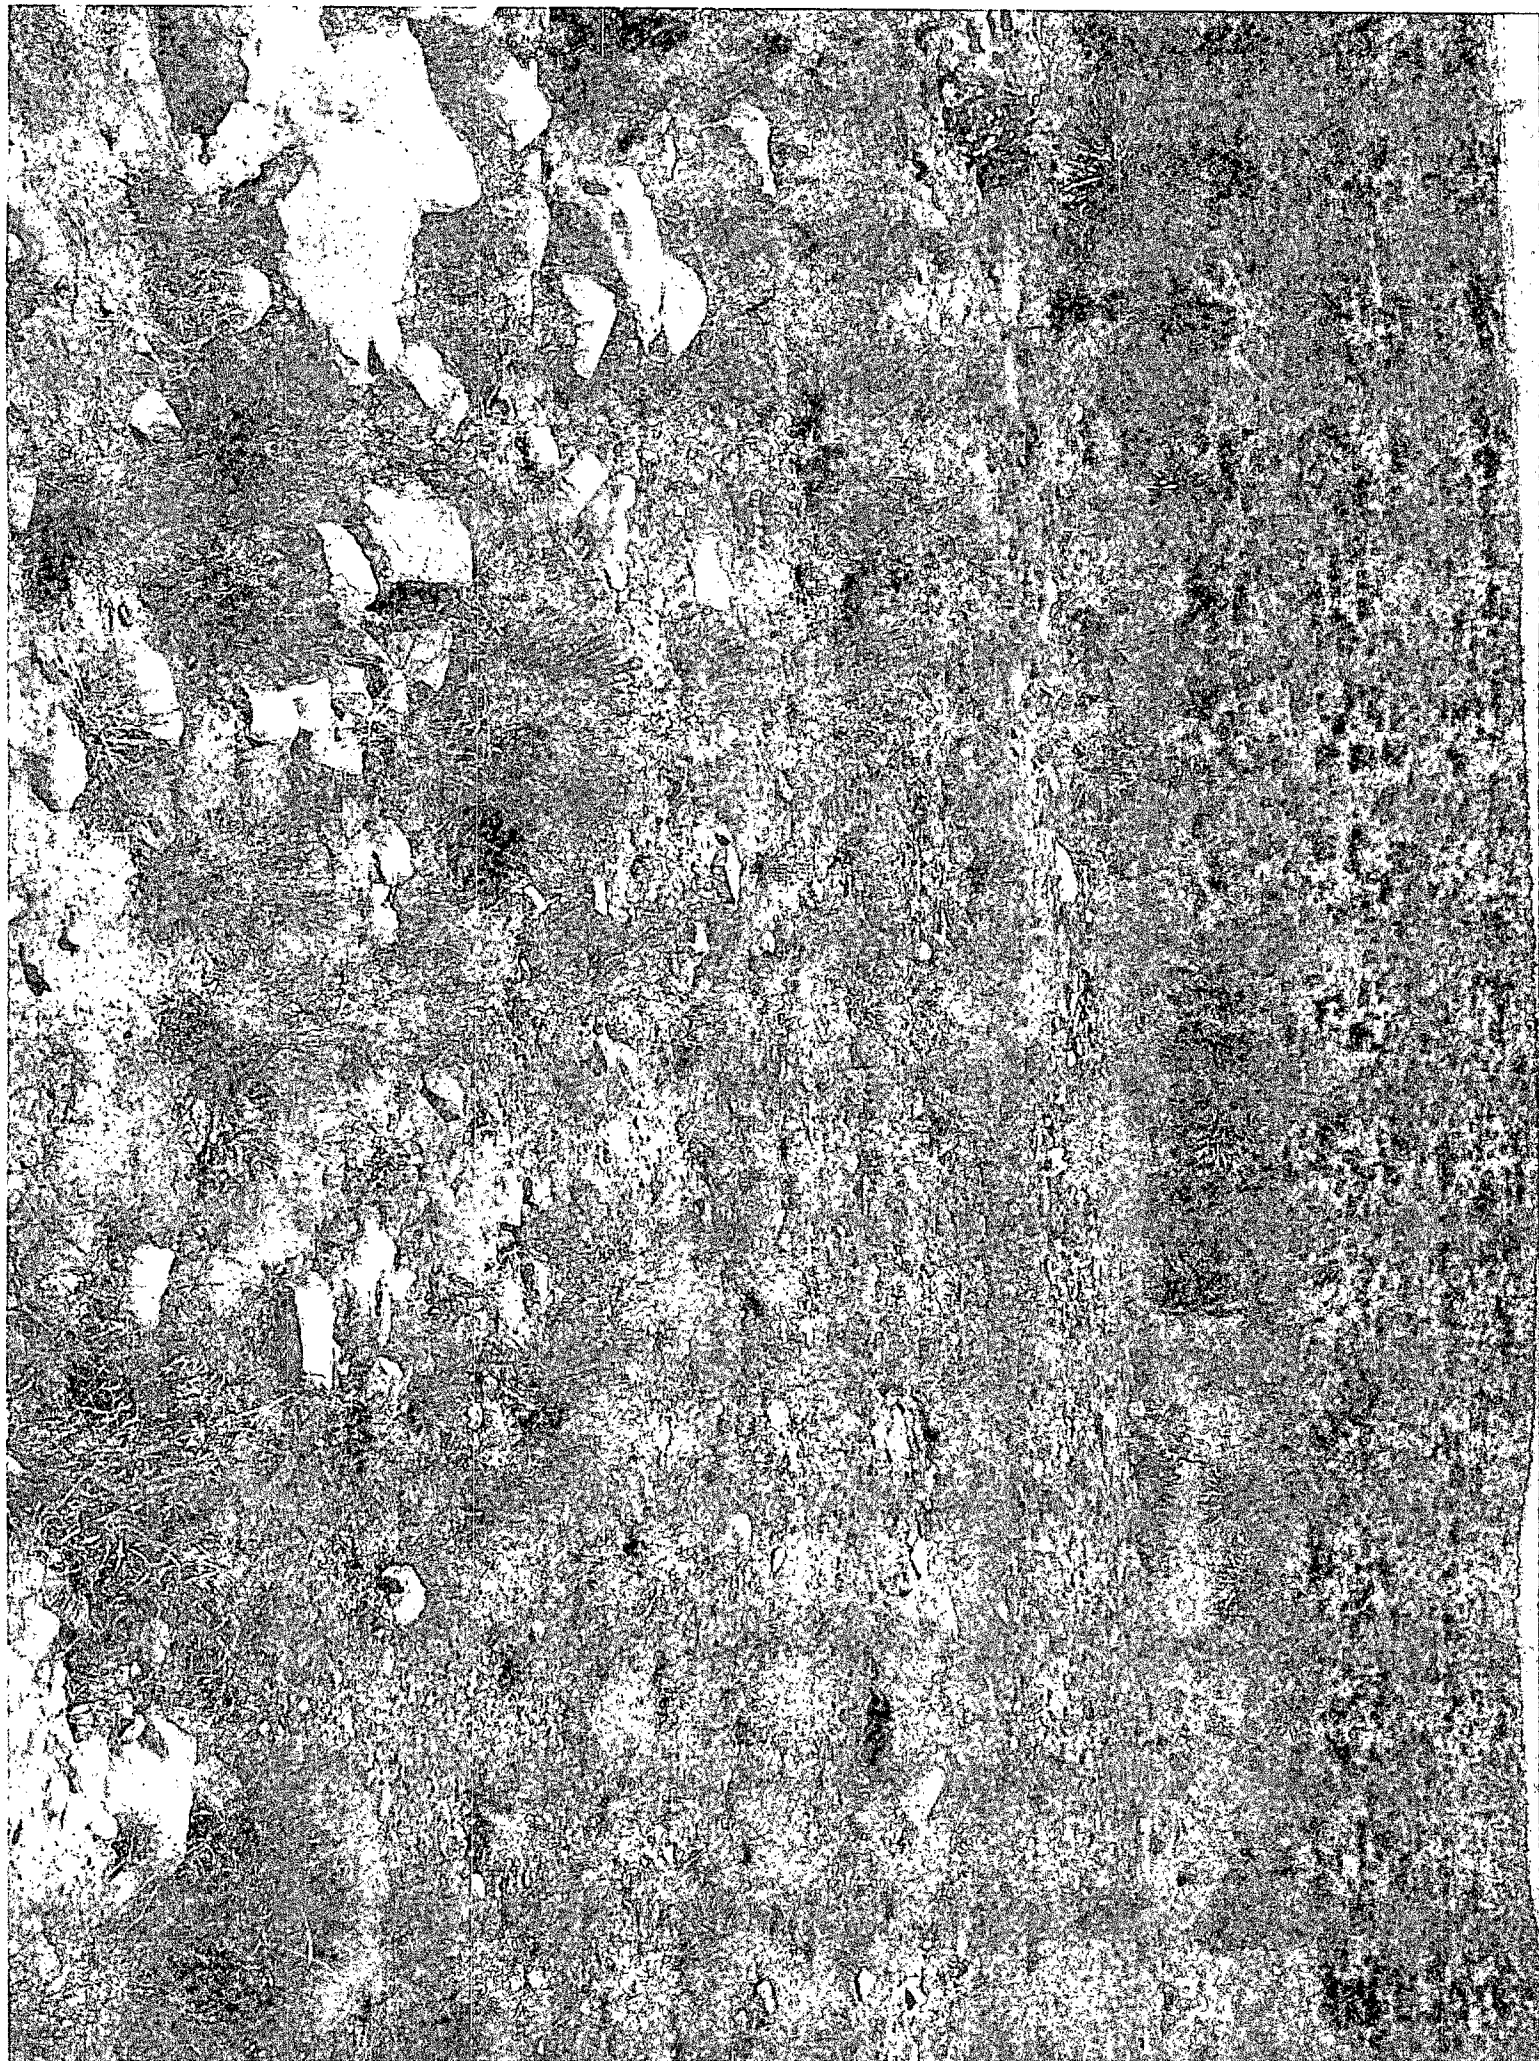
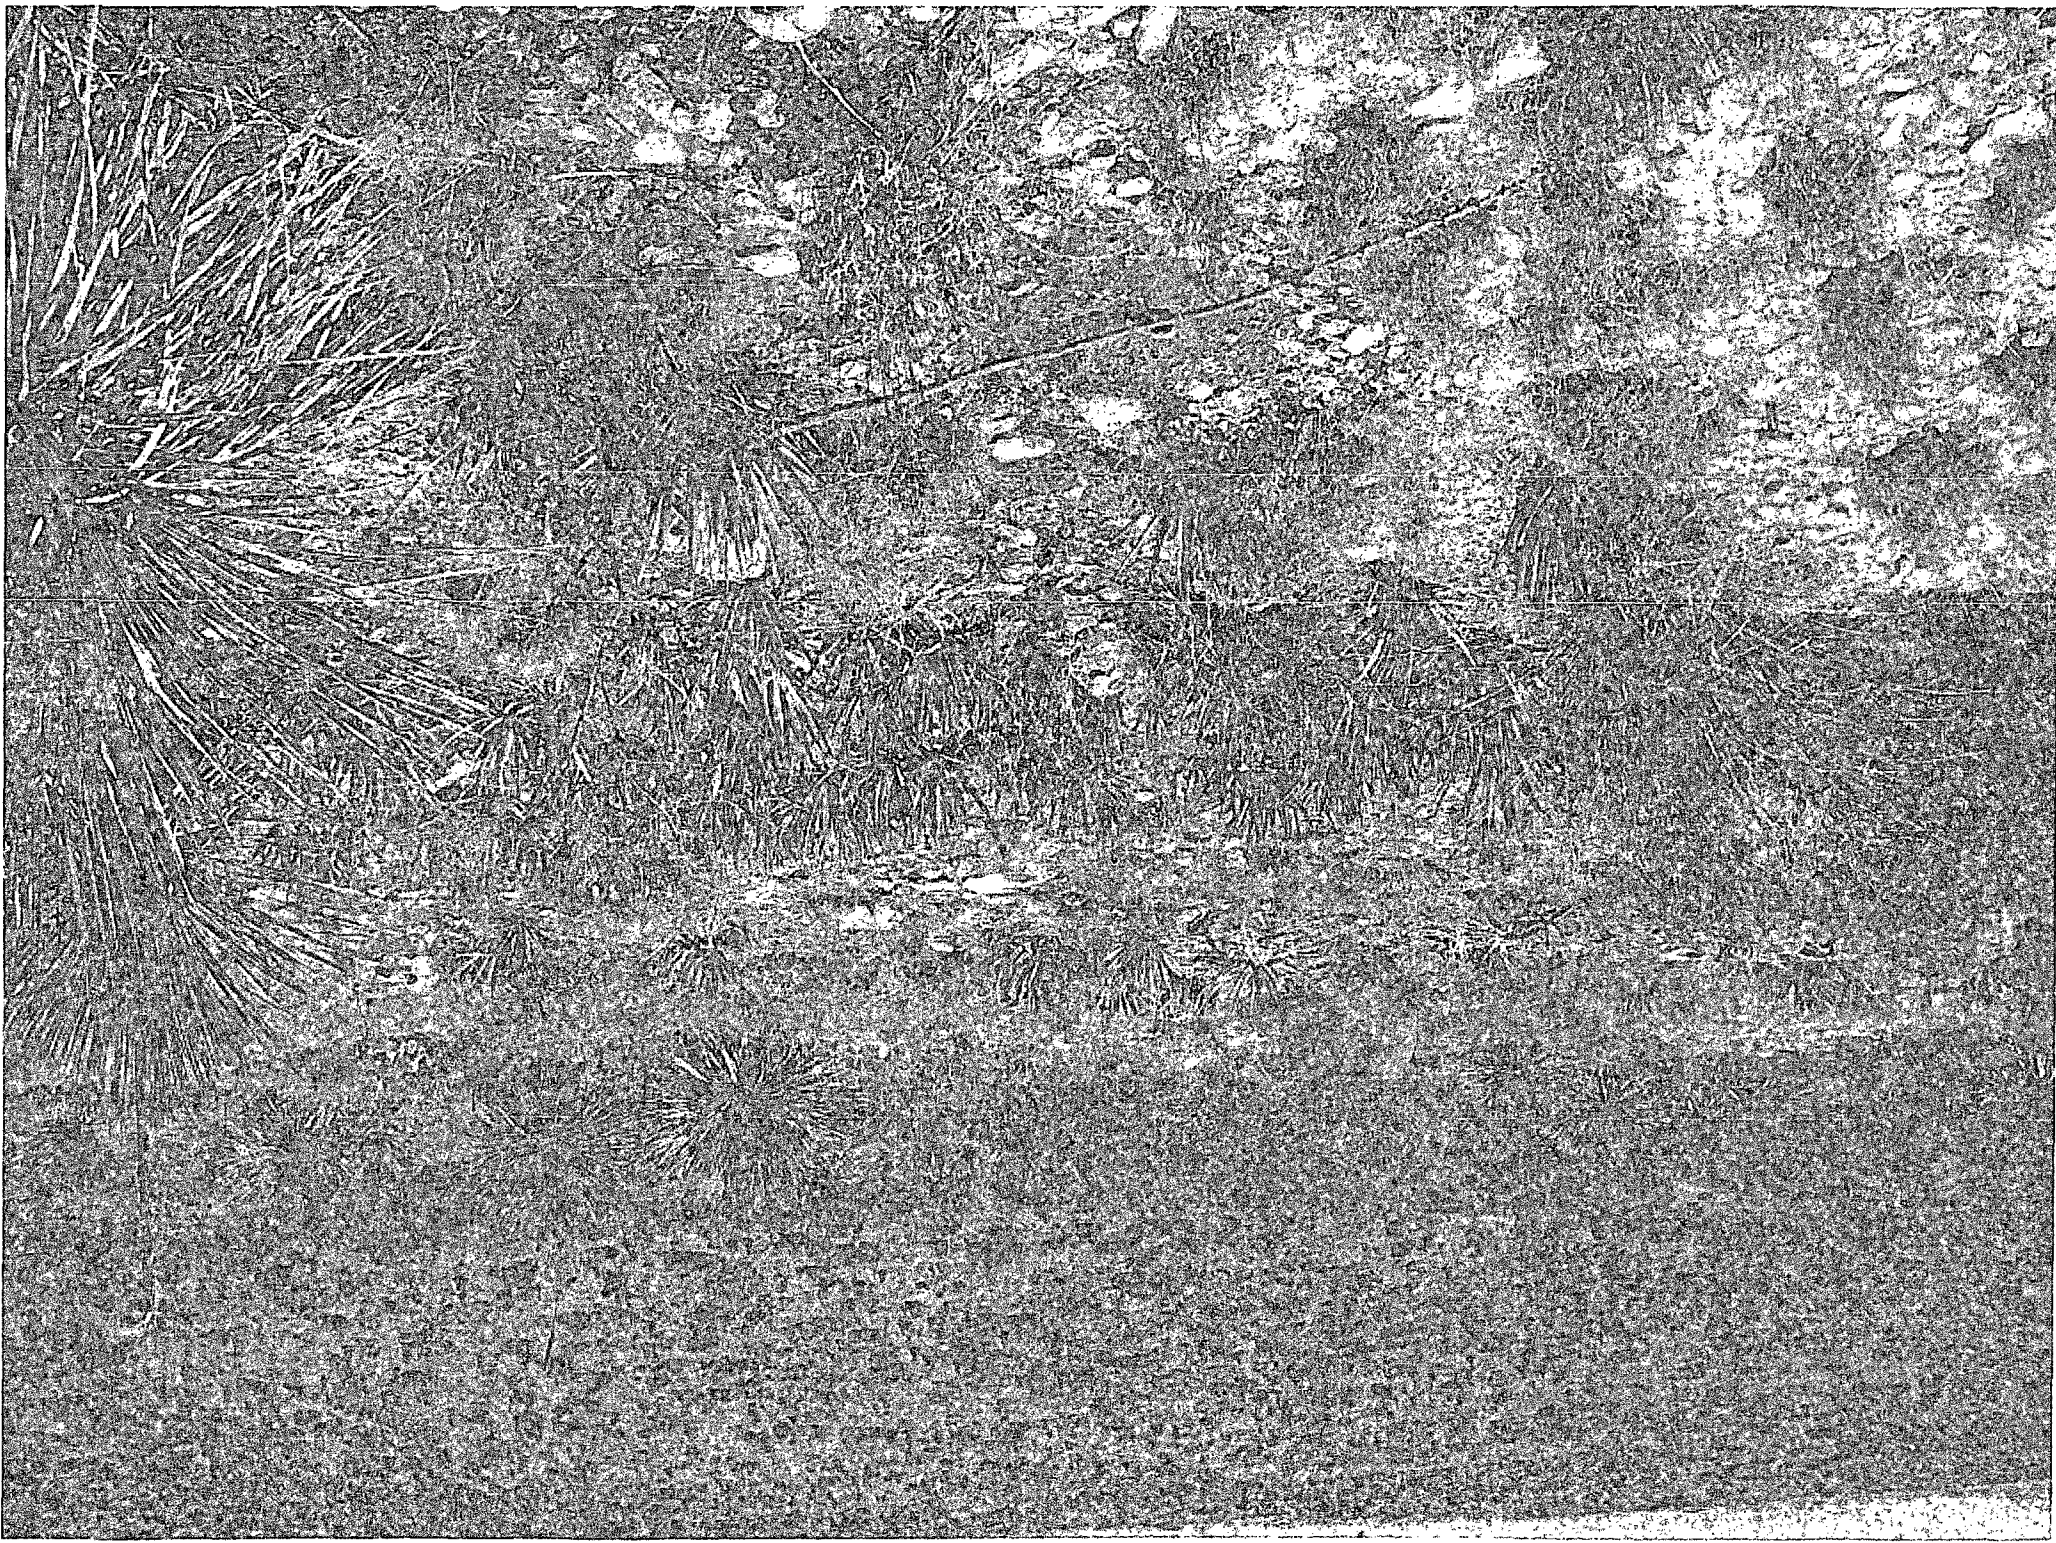
Initial Spill Pics

Steel tubing line from the Nagooltee Peak 5-2 corroded and leaked. **The API number is associated with Nagooltee Peak 5-1 because this is the closest well to the leak**.

Area affected was on the backside of the location behind the horizontal vessels and approx. 200 feet in the pasture. The chloride concentration for the water from this well is approx. 500ppm. Samples were taken and all levels were below RQ's. Analytical is attached to closing report. The area has re-established growth, therefore no further action will be taken. Final pictures of re-growth are attached to closing report. BLM was present when sampling occurred.
