Closing Report

Nagooltee Peak Satellite

API No. 3001524713

Eddy County, NM

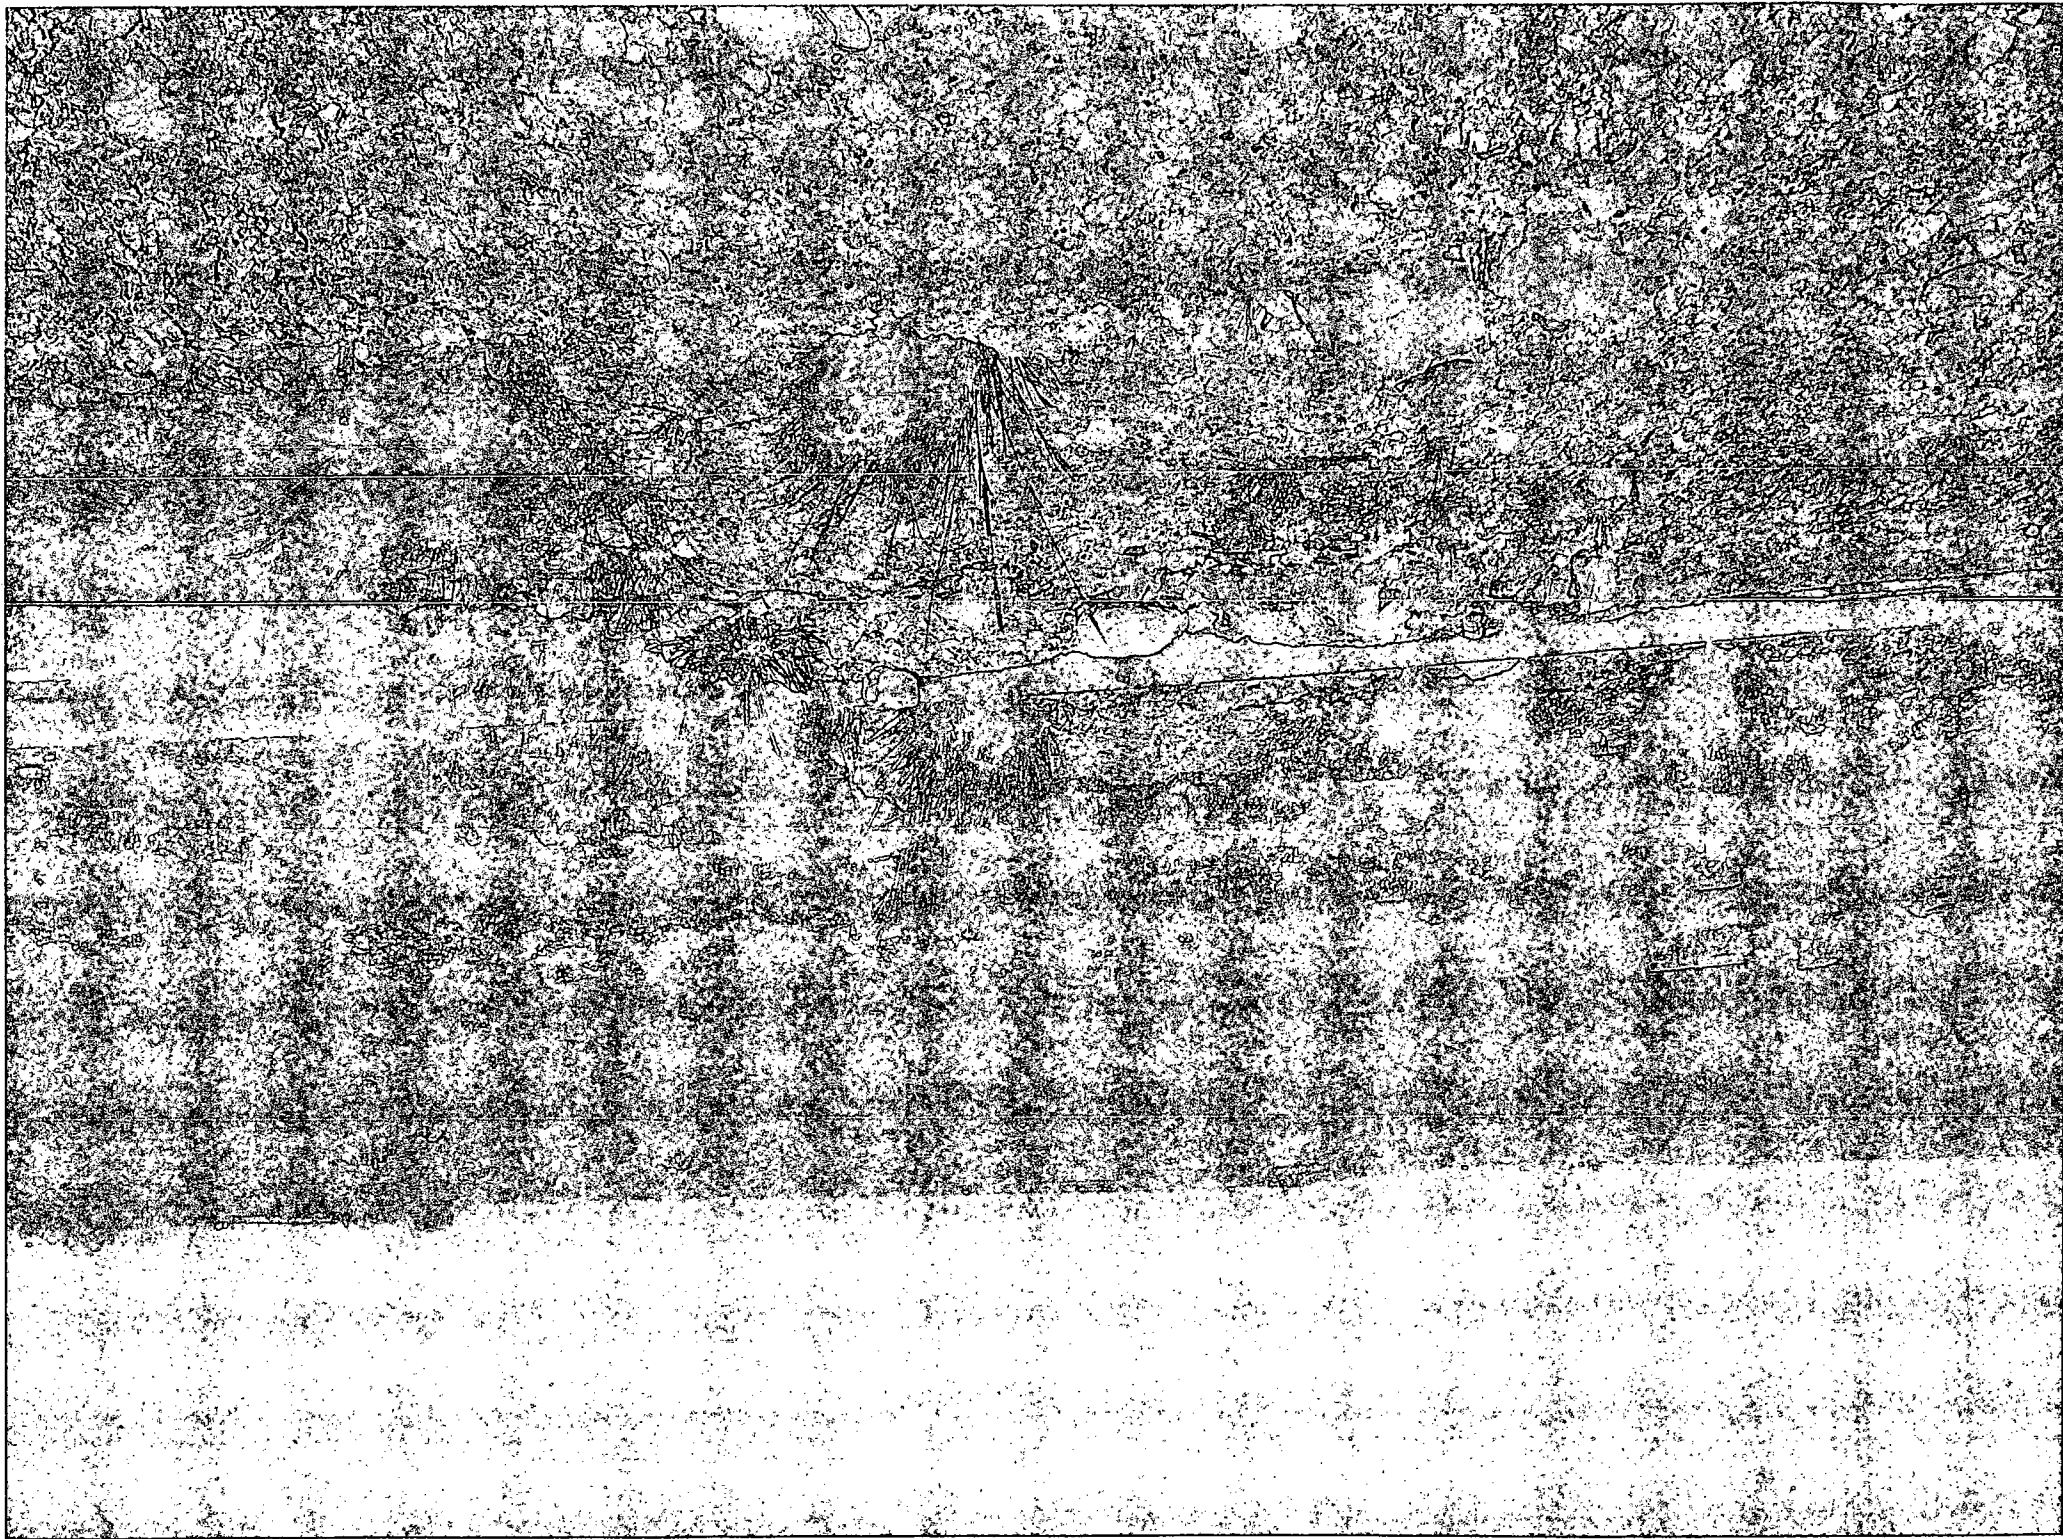
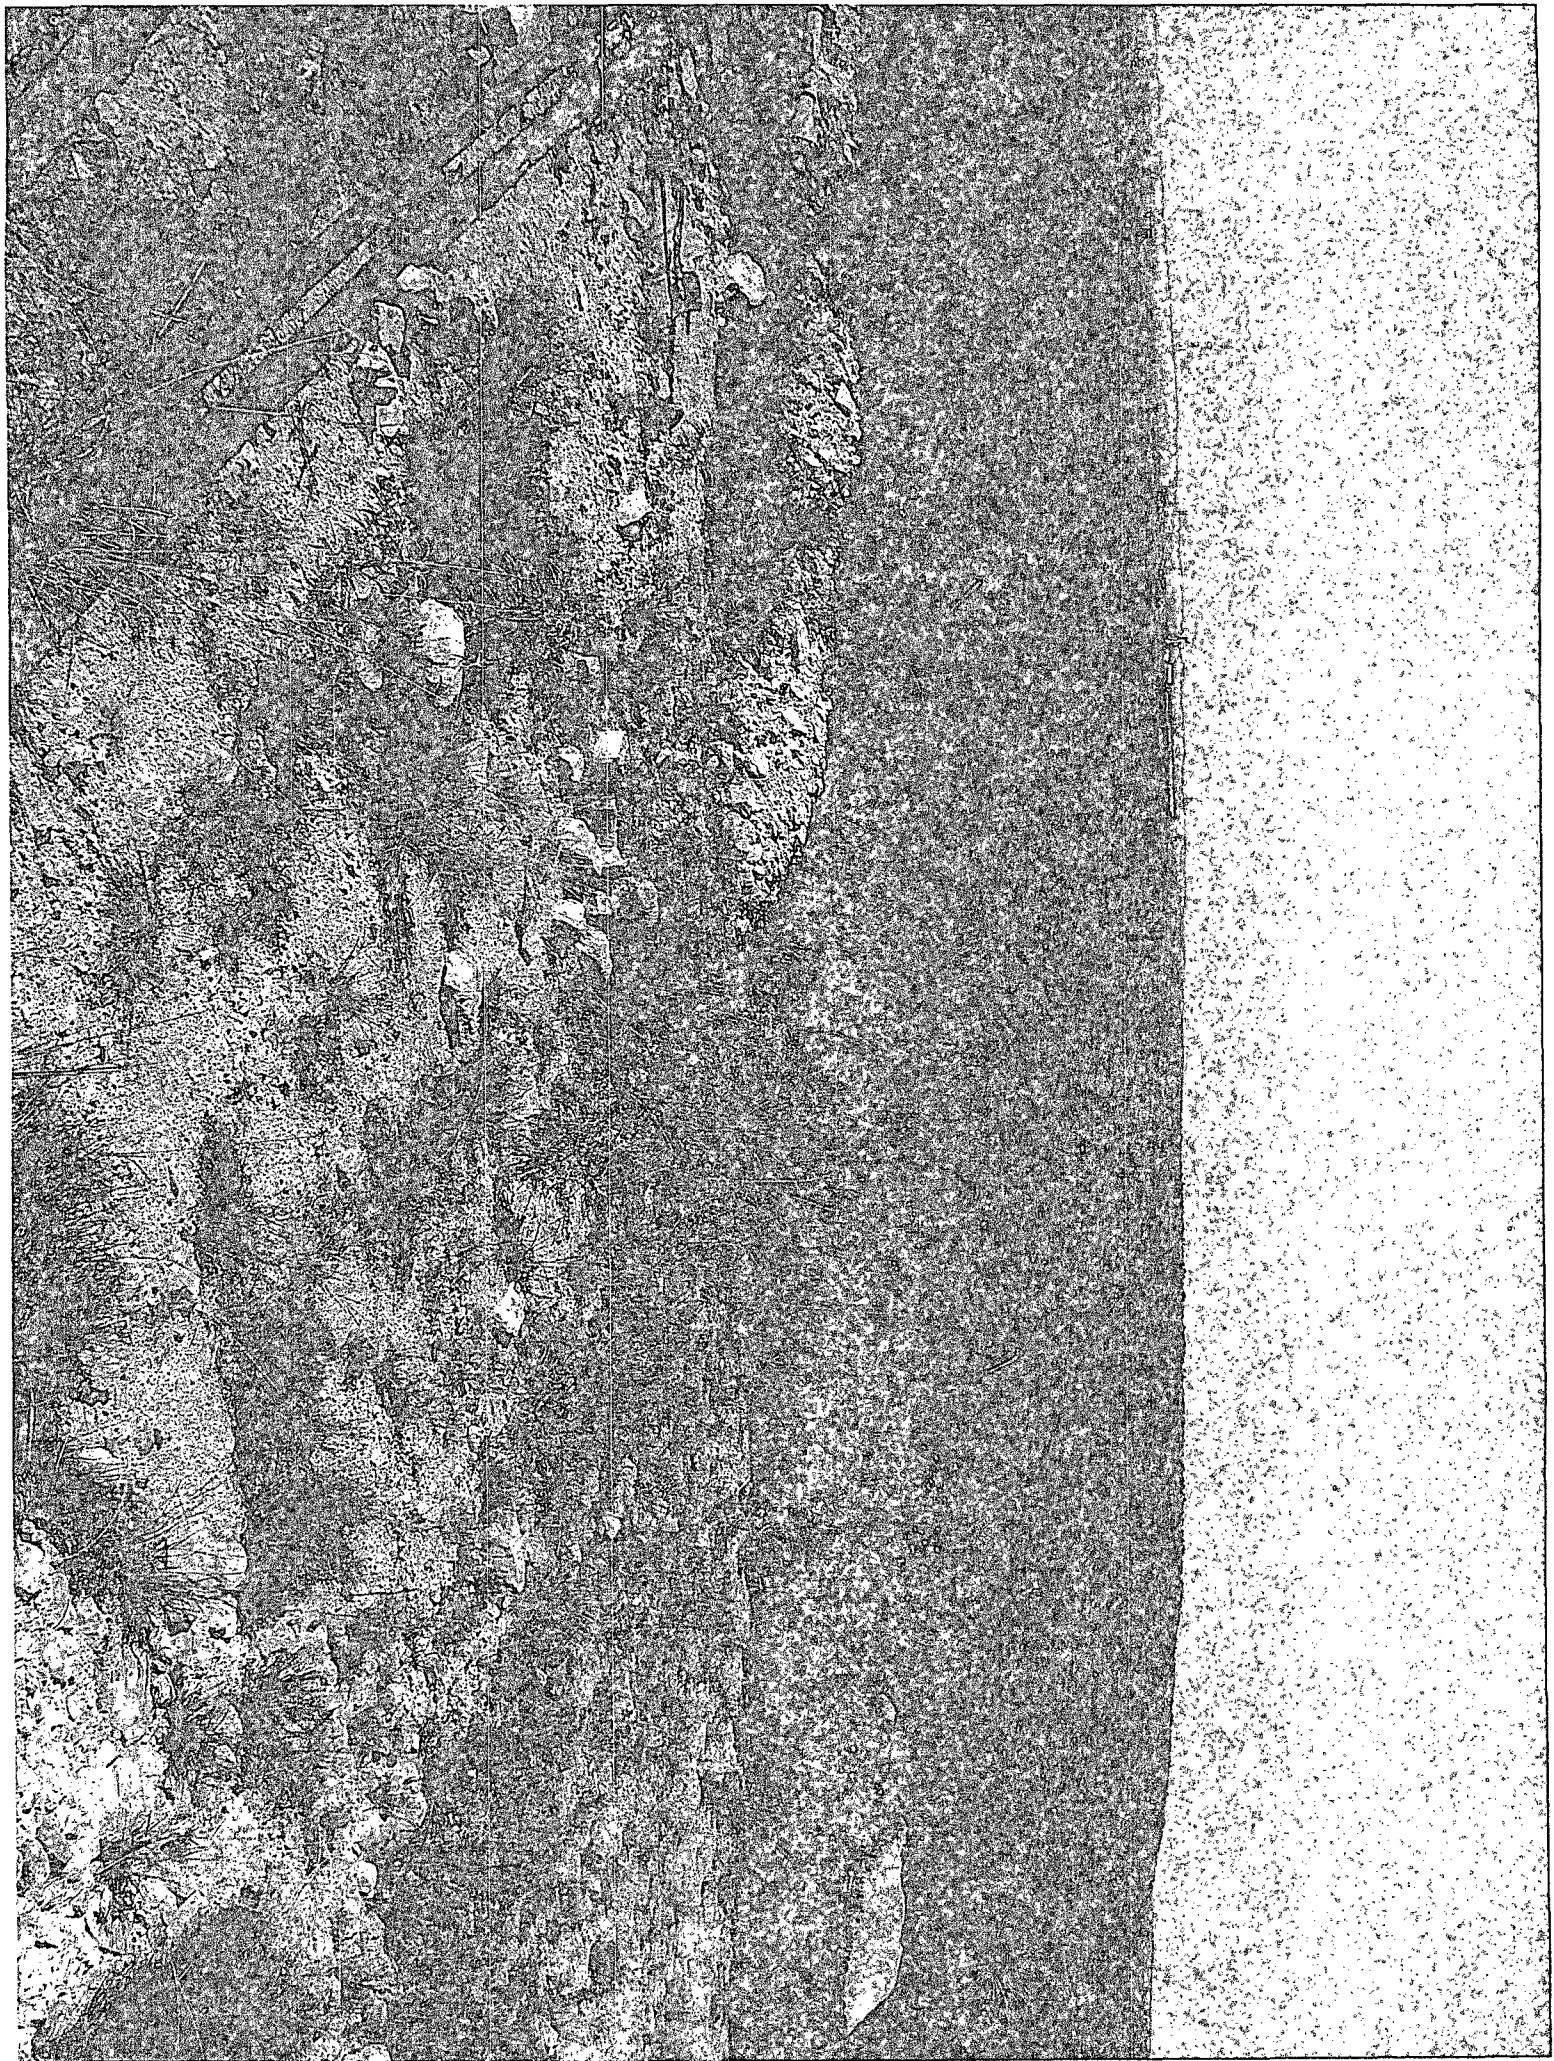
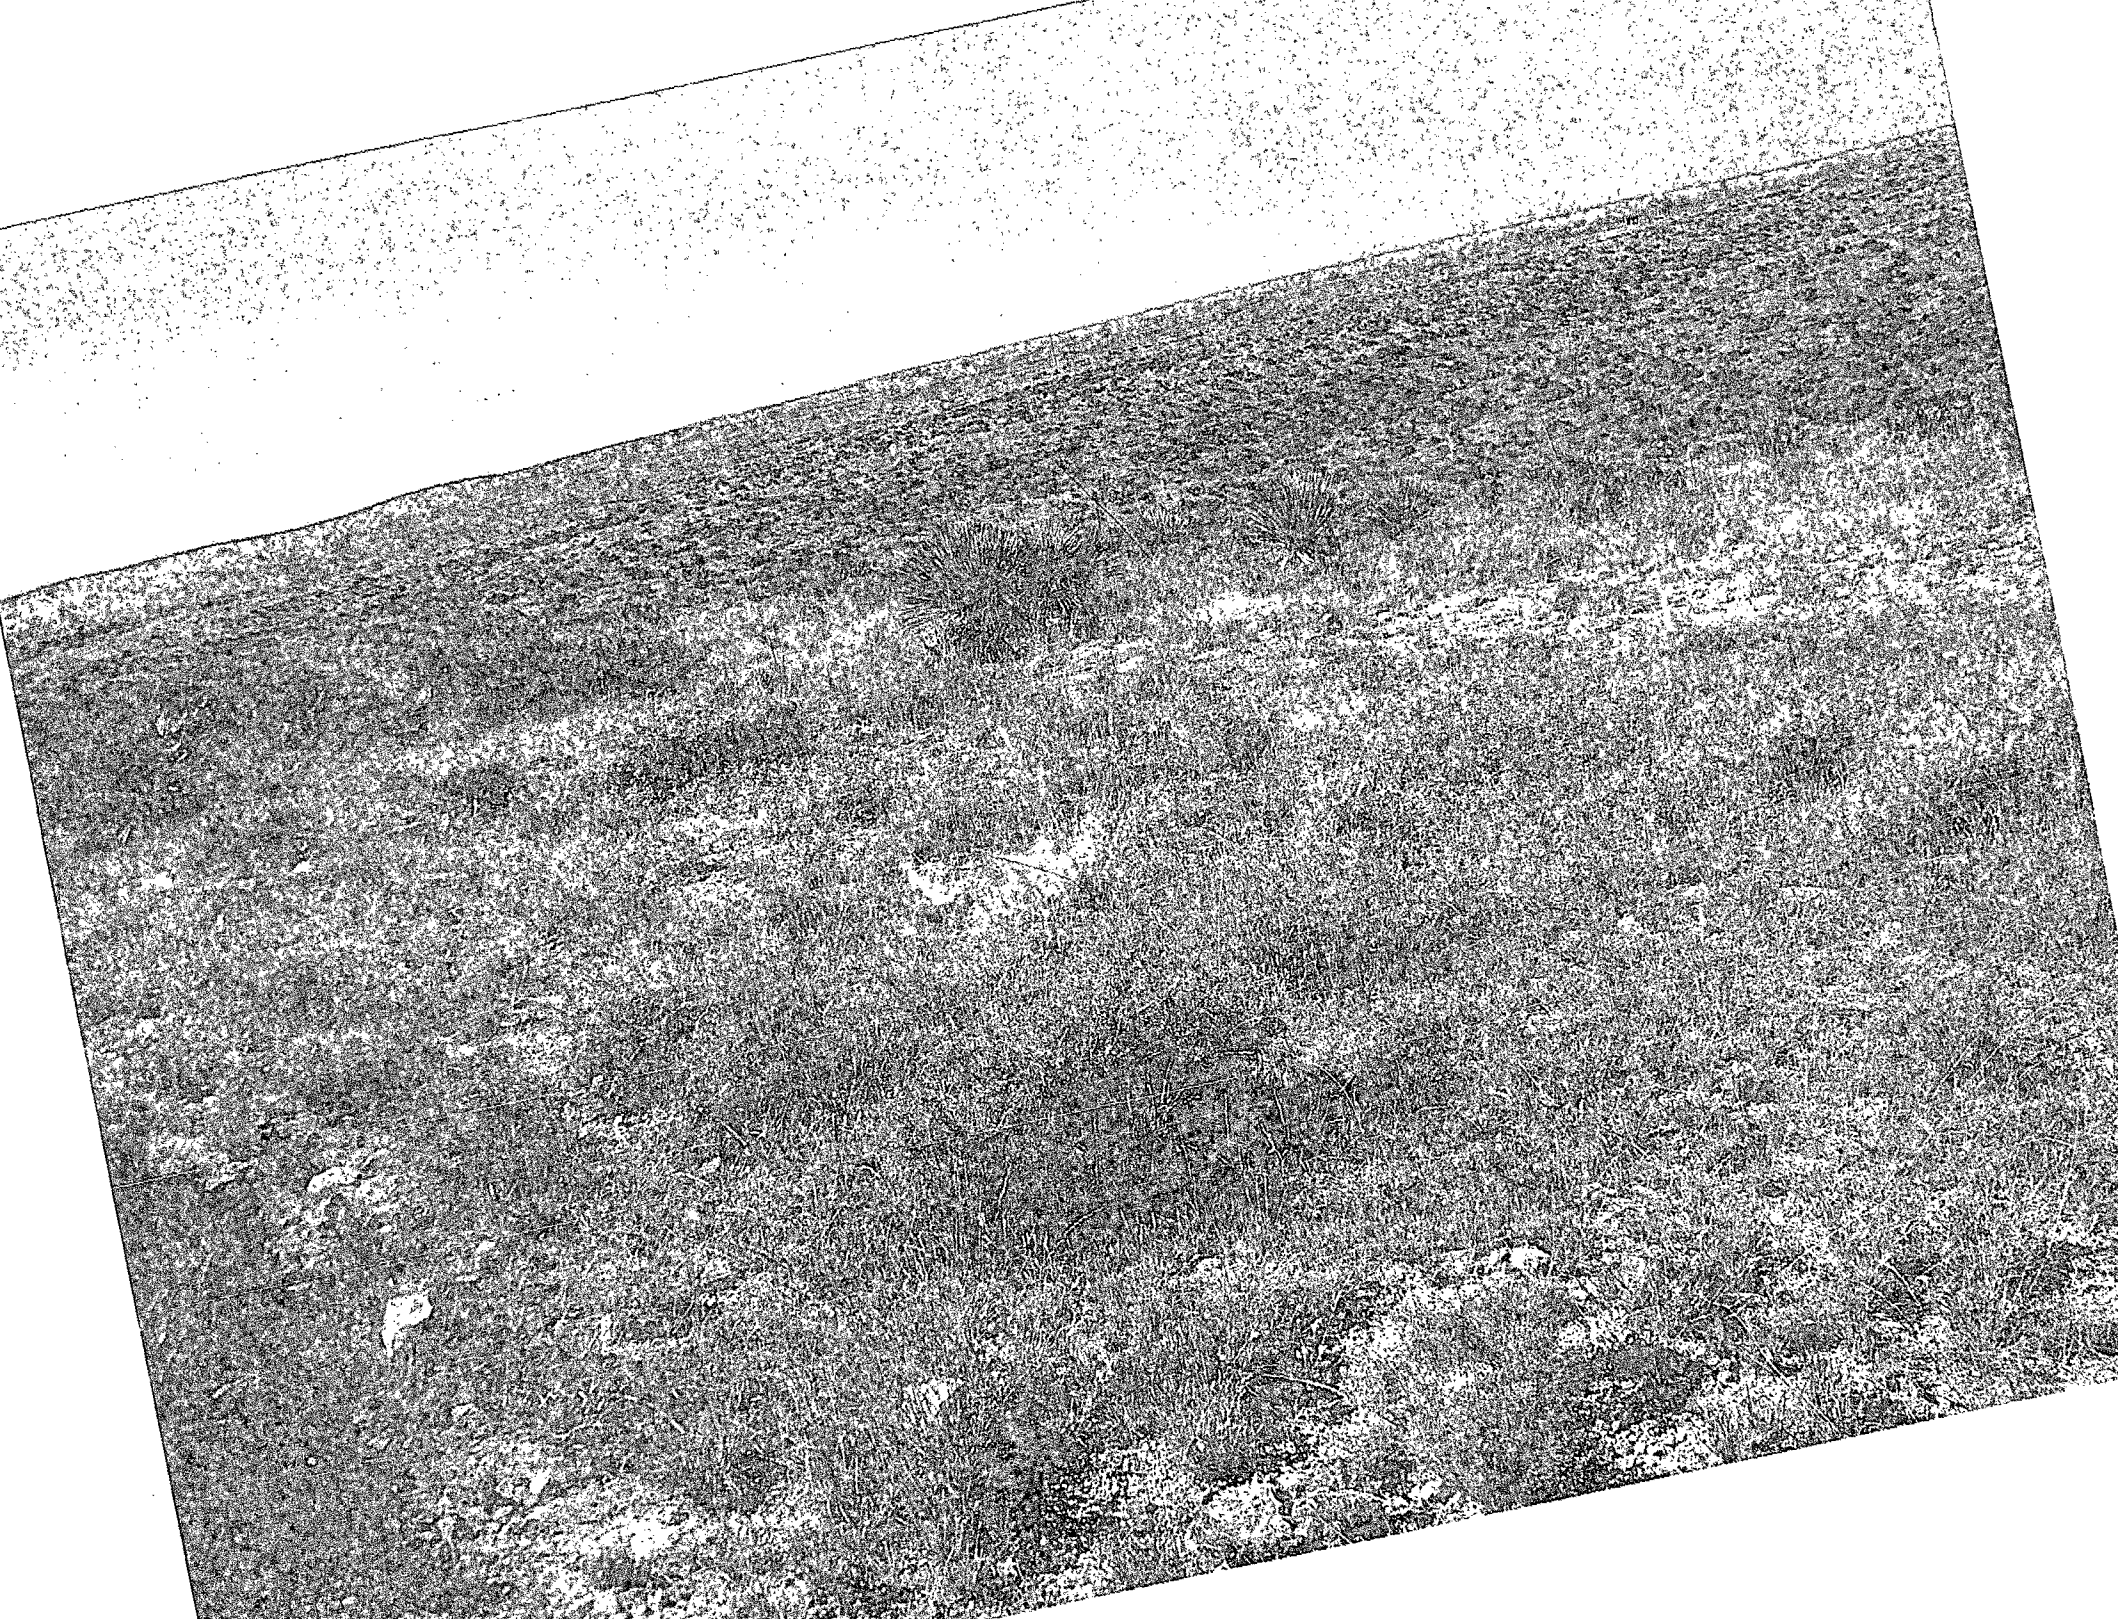
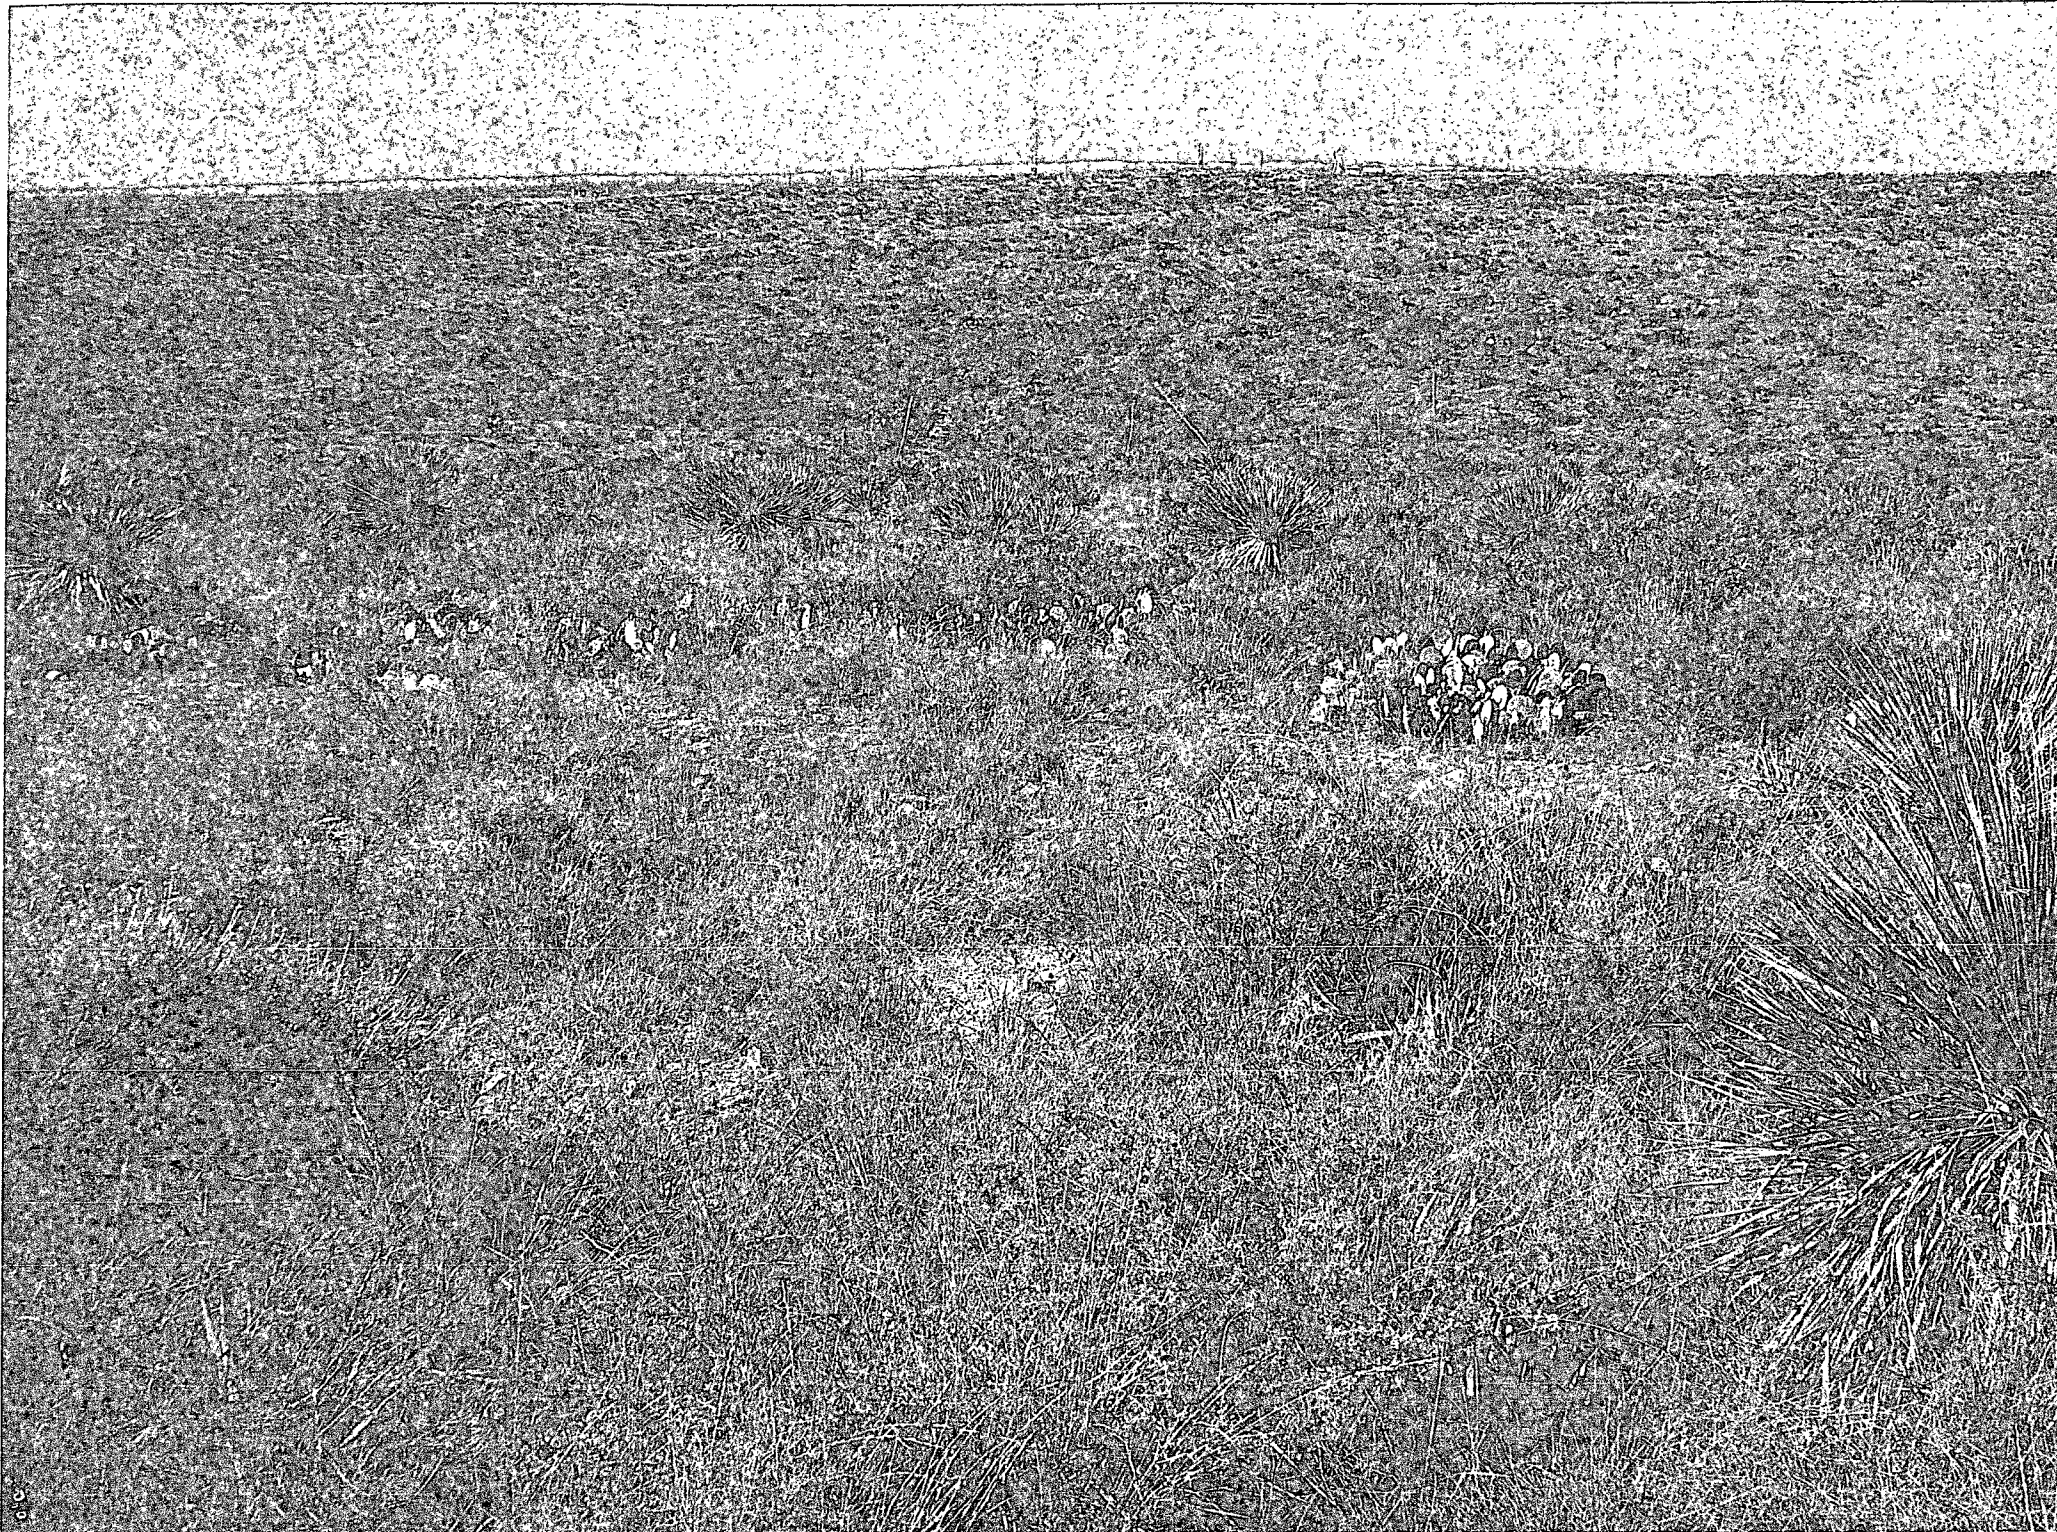
Final Pictures

Area affected was on the backside of the location behind the horizontal vessels and approx. 200 feet in the pasture. The chloride concentration for the water from this well is approx. 500ppm. Samples were taken and all levels were below RQ's. Analytical is attached to closing report. The area has re-established growth, therefore no further action will be taken. Final pictures of re-growth are attached to closing report. BLM was present when sampling occurred.

On 6-18-2010 at approx. 7:00 am, a spill was discovered at the Nagooltee Peak satellite. Notification was made to Mike Bratcher with the NMOCD at approx 8:00 am. The volume of this spill was approx. 60 barrels of produced water in which 0 barrels were recovered. The approx. chloride level of this produced water is 500 ppm. A plat map is attached to this document with approx. measurements of the affected area. Surface Samples were taken and tested for Chloride, TPH, and BTEX levels. All levels were below the required levels set by the State of New Mexico. Terry Gregston with the BLM was present when sampling occurred. Attached to this document is the lab analytical verifying this. Also attached to this document is the final C-141, initial pictures of when the spill occurred, and final pictures after sampling was taken to prove that re-growth has occurred.
