CORRECTIVE ACTION REPORT

**Lateral K-7 (2/18/2015) Pipeline Release
SW 1/4, S27 T26N R7W
Rio Arriba County, New Mexico**

Apex Project No. 7250415005

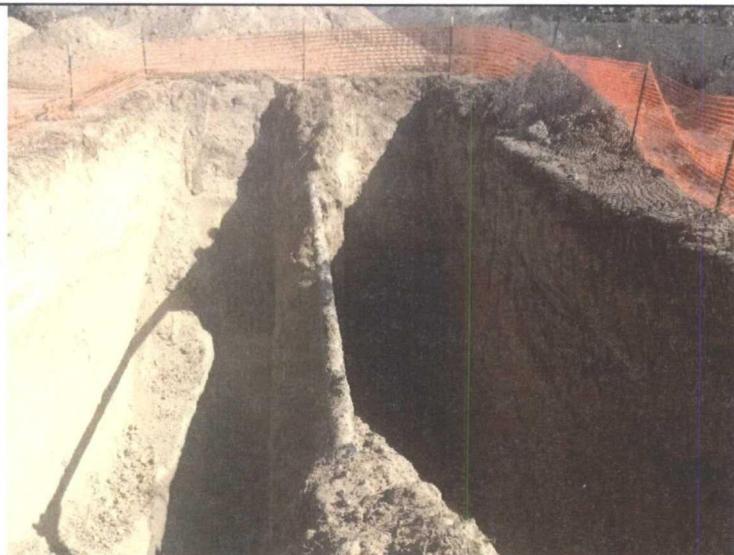
Photograph 1

View of the final excavation, facing north.

The overall surface expression of the final excavation measured approximately 44 feet long by 22 feet wide, with a total depth of approximately 18 feet bgs.

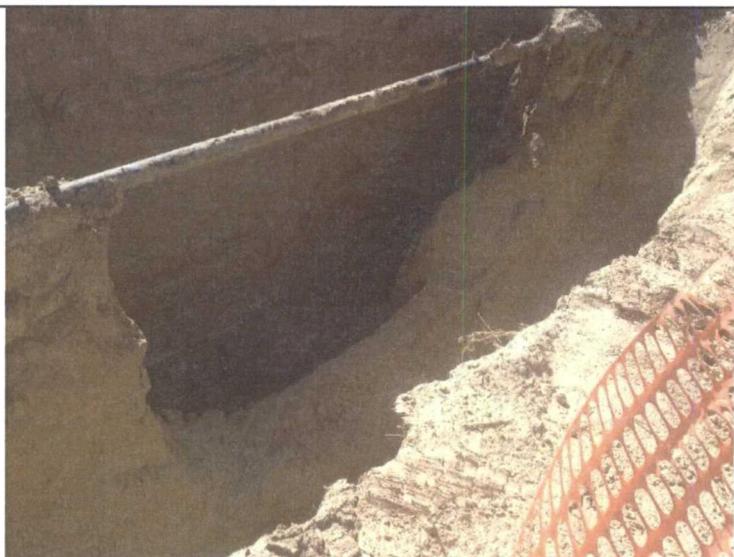
Photograph 2

View of the final excavation, facing southeast.

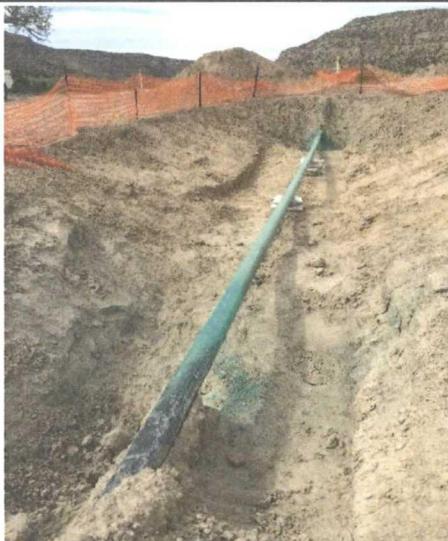
Photograph 3

View of the repaired pipeline, facing north.

On February 24, 2015, Enterprise initiated excavation activities at the Site to locate and repair the subsurface leak and remediate potential hydrocarbon impact. The leak was repaired by replacing approximately 44 feet of pipeline. Natural gas and pipeline liquids were released from the pipeline as a result of internal corrosion. The leak was identified by a release of natural gas at the ground surface. During the corrective action activities, Crossfire, LLC, provided heavy equipment and labor support, and Heather Woods and Rane Deechilly, Apex environmental professionals, provided environmental support.
