BC Operating, Inc.
South Langlie Jal Unit #11
Unit N, Section 8, Township 25S, Range 37E
Lea County, New Mexico

**Work Plan**

**August 10, 2009**

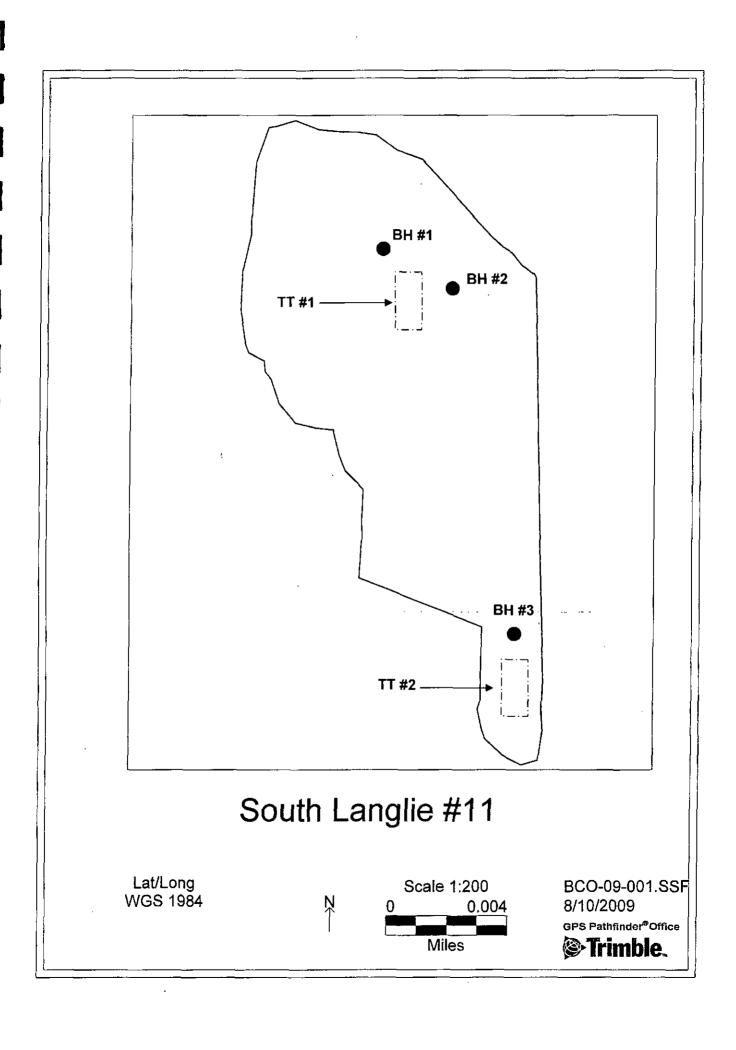
On June 5, 2009, SESI was onsite to map the area. The area was mapped using a Trimble Geo XM GPS. The affected area is 30 feet x 40 feet.
