Release Notification and Corrective Action

REMEDIATION SUMMARY AND SITE CLOSURE REQUEST

**SOUTHERN UNION GAS SERVICES
Line 2B (2010-055)
Lea County, New Mexico
Unit Letter "O" (SW/SE), Section 31, Township 24 South, Range 37 East
Latitude 32° 10.212' North, Longitude 103° 11.978' West
NMOCD Reference # 1RP-2586**

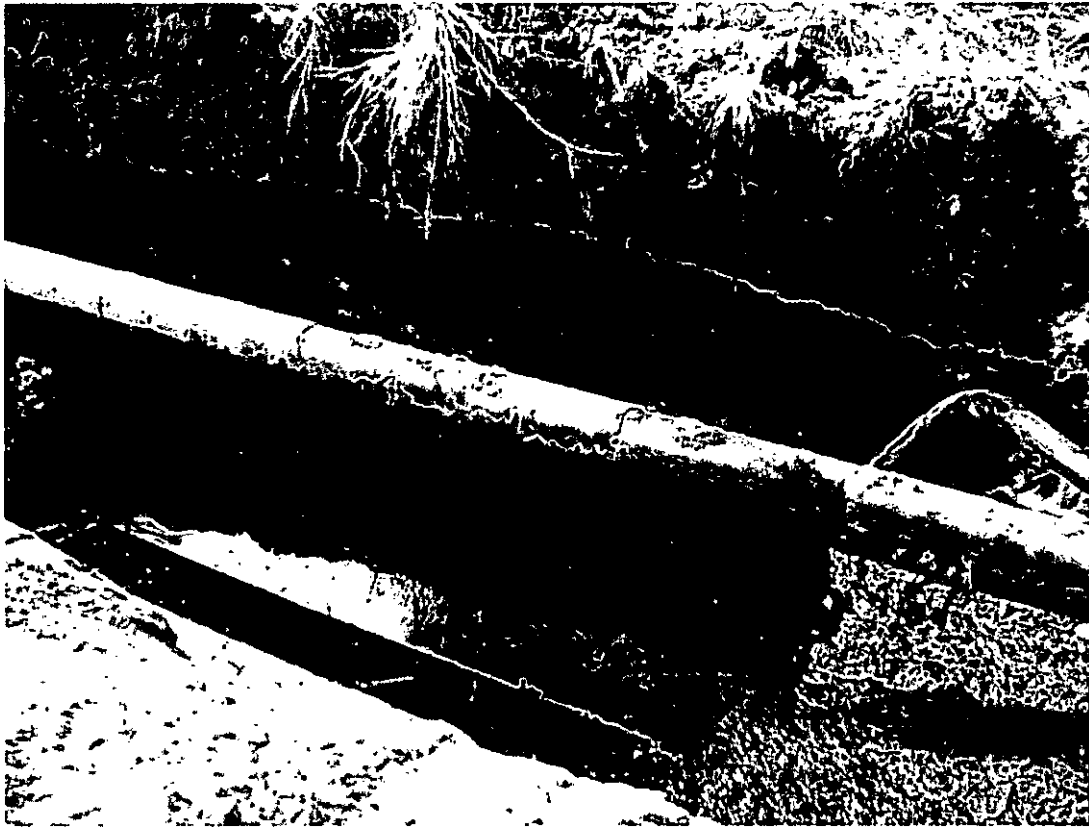
Line 2B Release Site

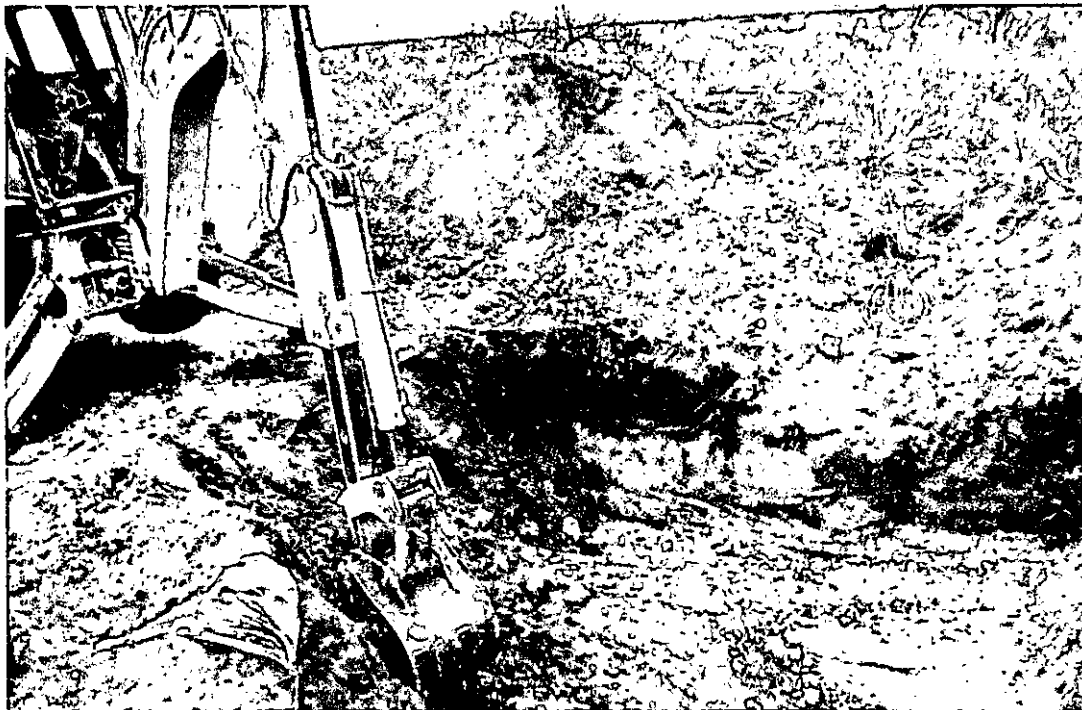
Line 2B - West Excavation

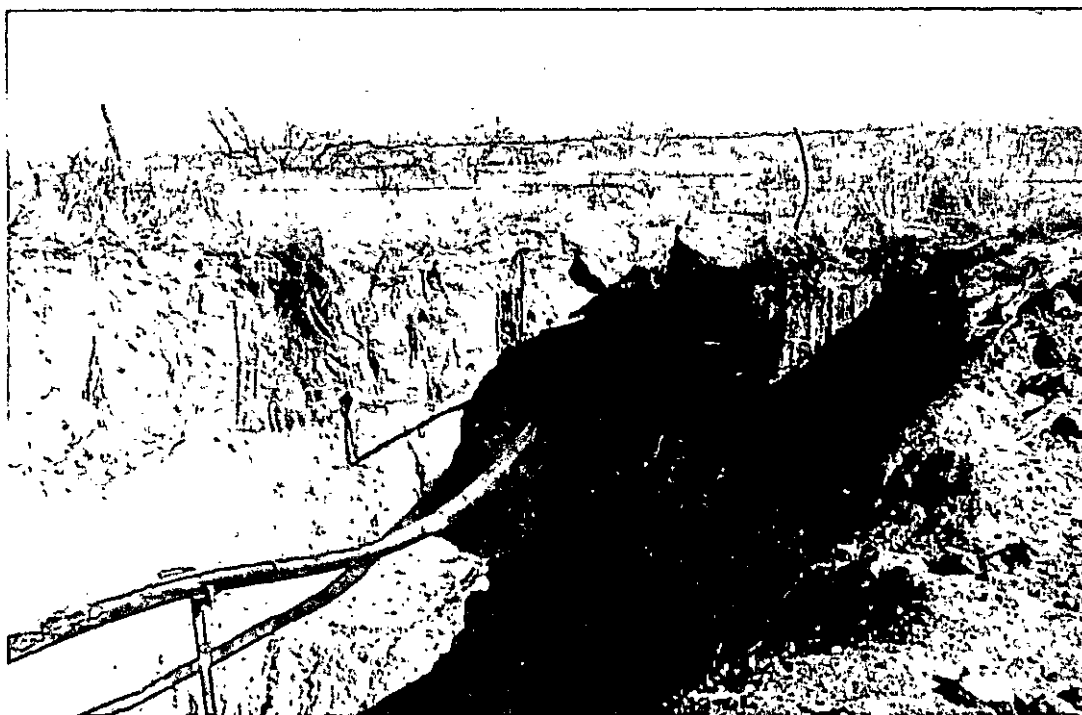
Line 2B - West Excavation (looking North-northeast)

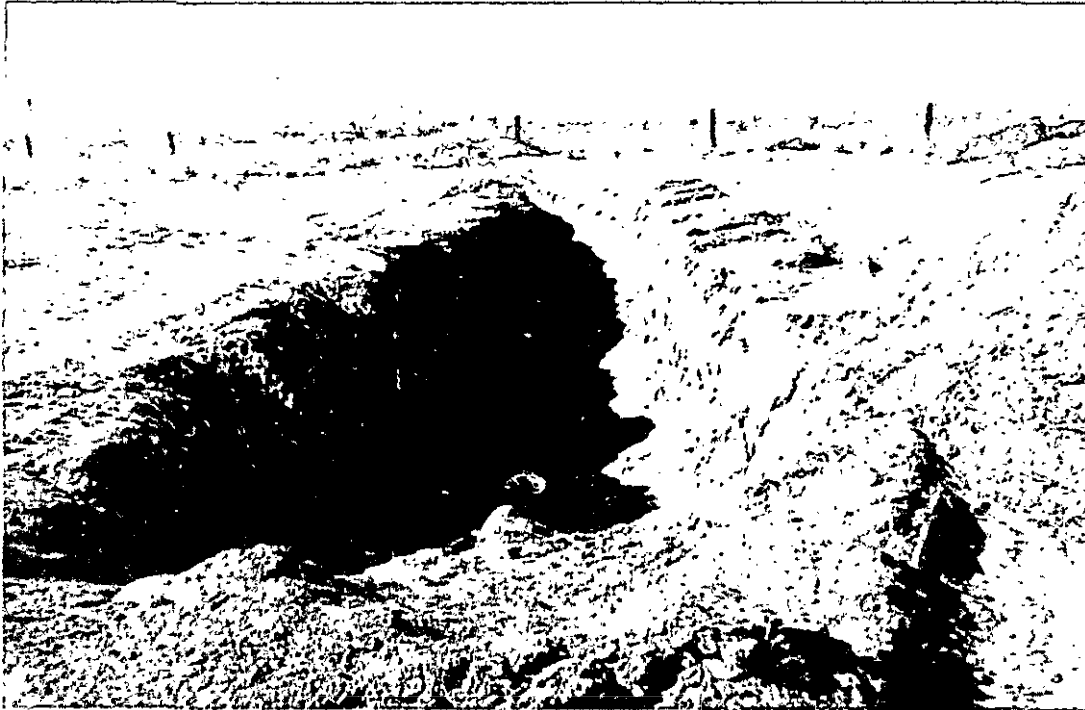
Line 2B Release Site - East Excavation (looking West)
