**Cimarex Energy Company  
Pennzoil 36 State Com. #2  
Unit A Section 36, Township 19S, Range 33E  
Lea County, New Mexico**

**Closure Report**

**January 28, 2011**

Cimarex Pennzoil 36-2 Site Photos 12-10-10

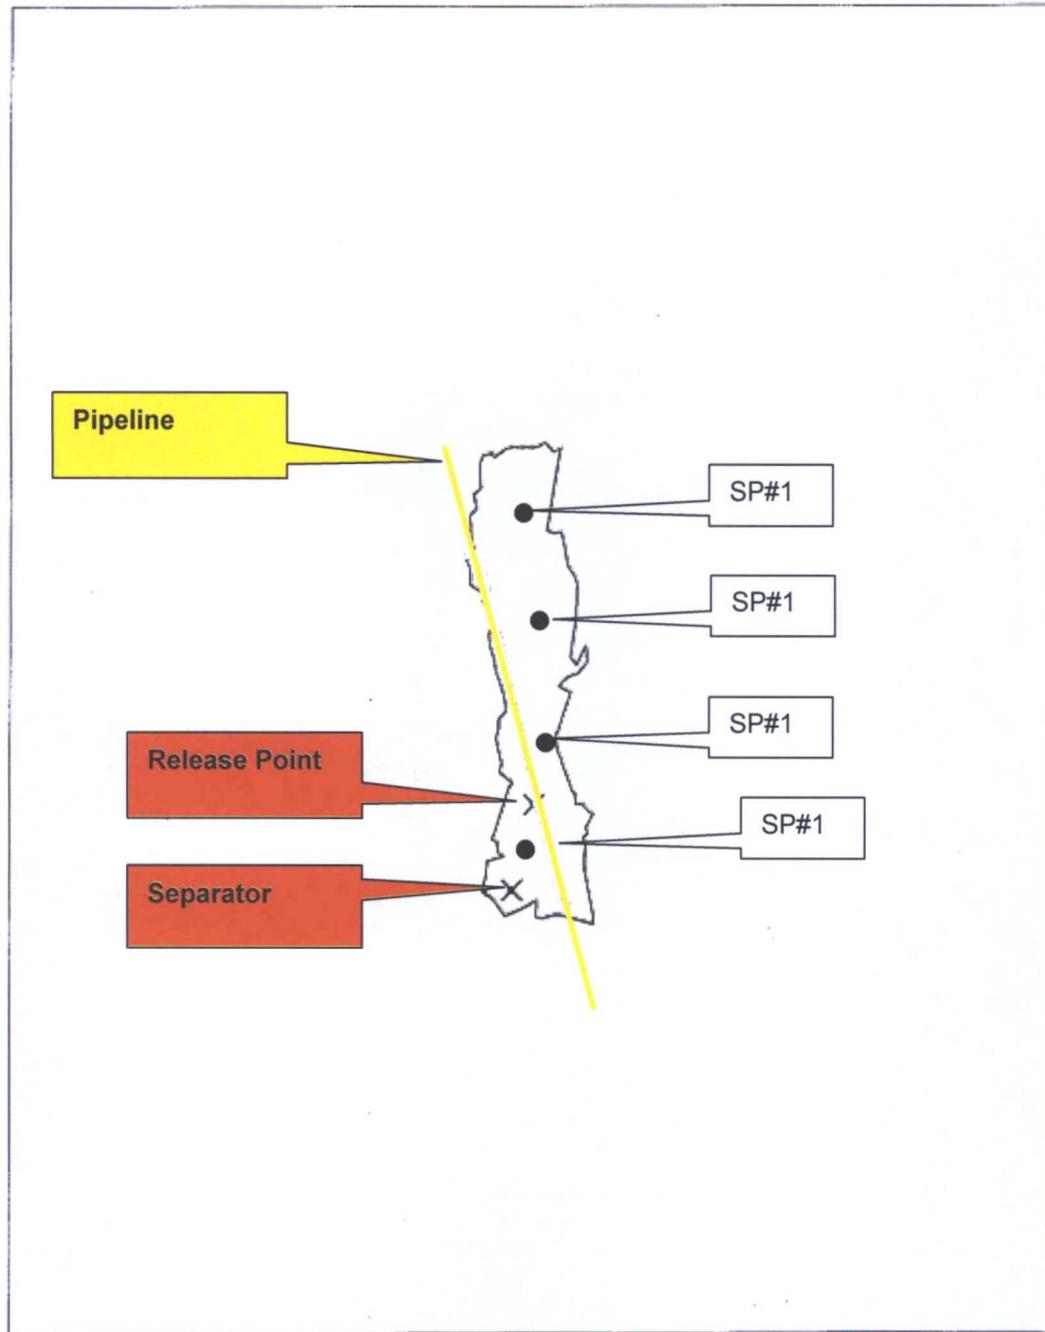
CIM-10-019: 2,520 sq ft

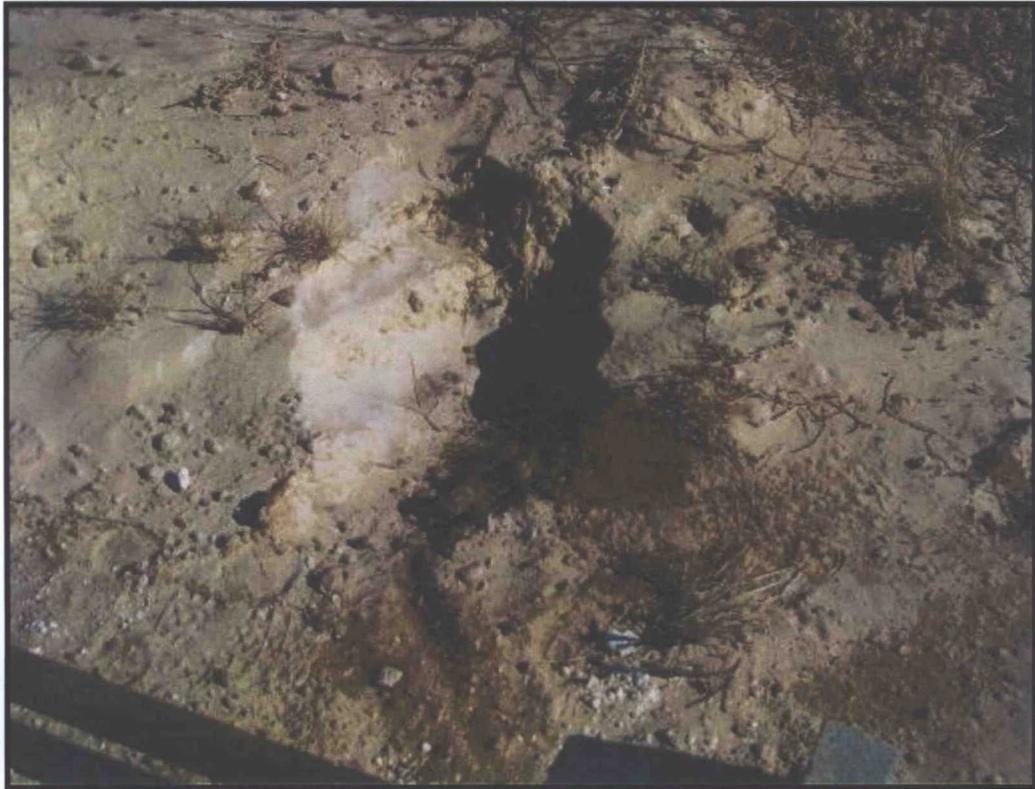
Location area with staining

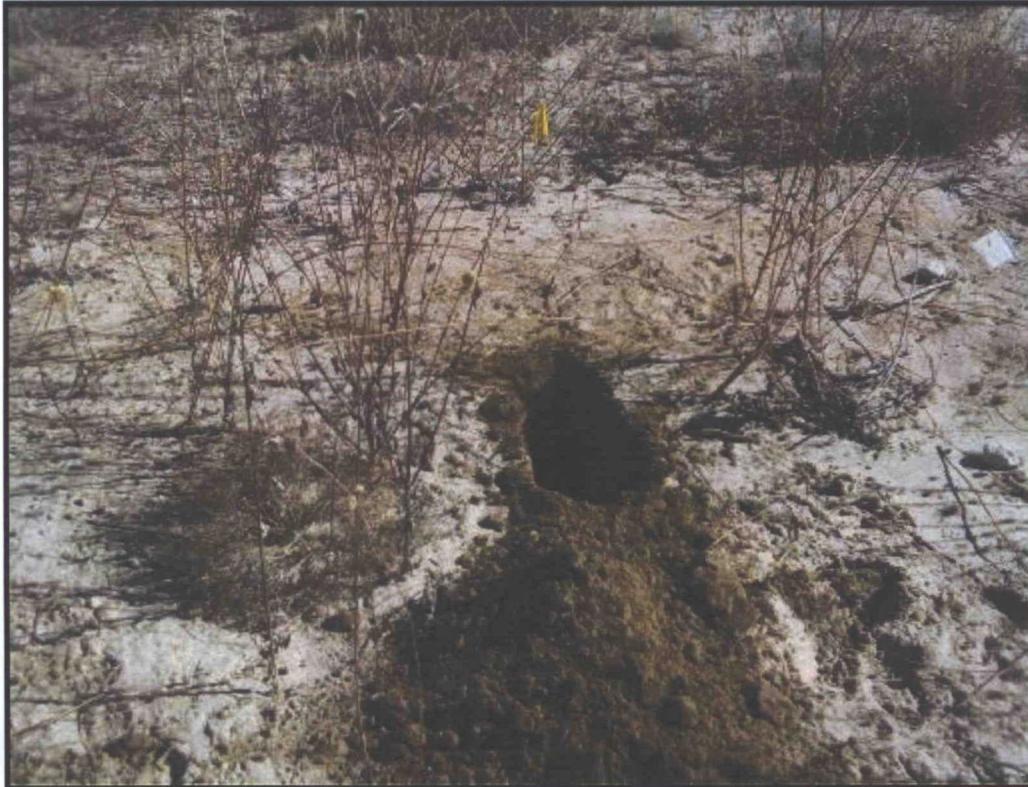
Release area with staining

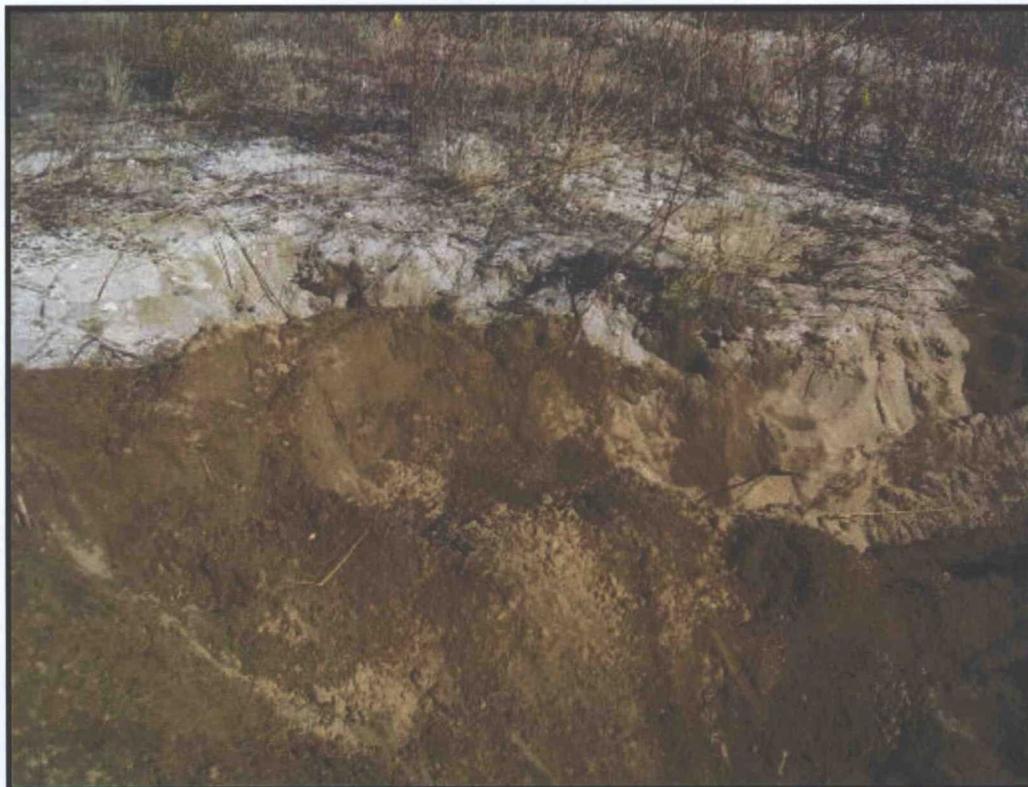
Release area with staining

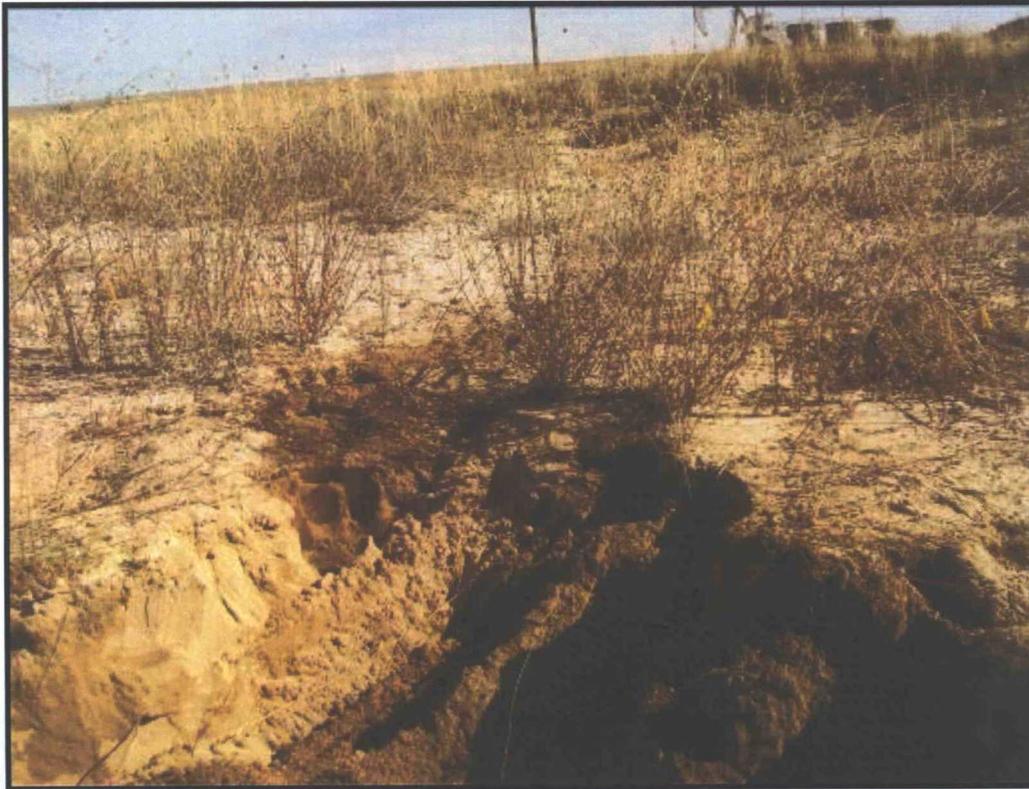
Release area with staining facing east

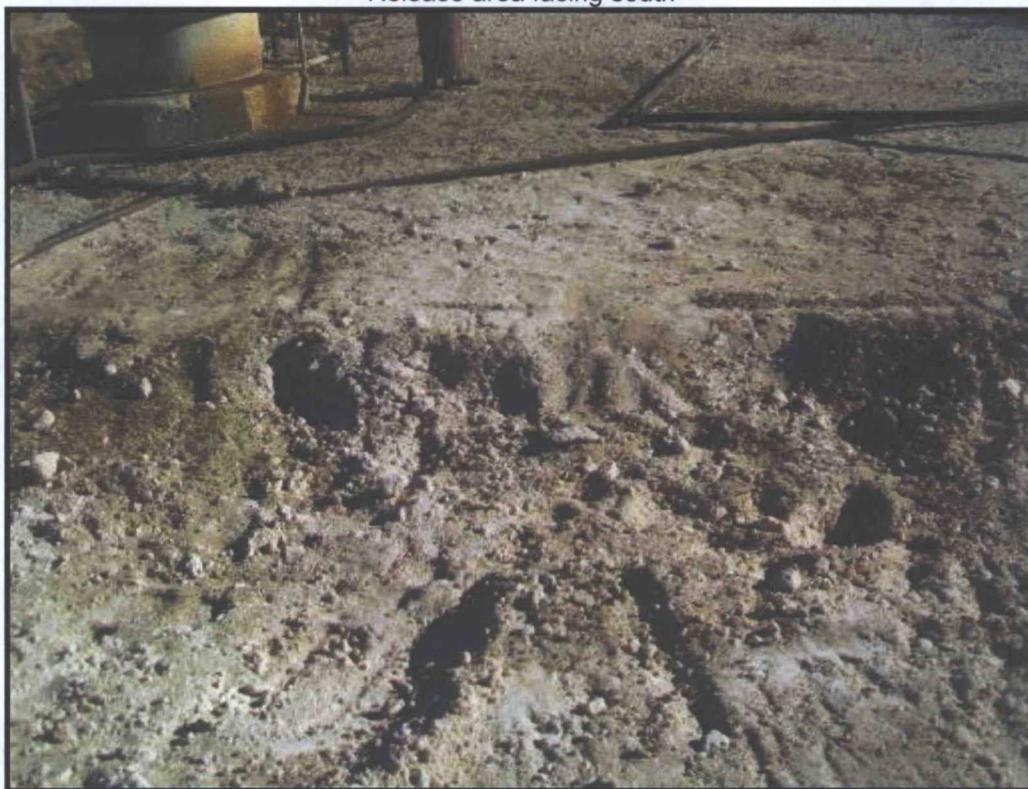
Release area excavated facing south

On December 20, 2010 Safety and Environmental Solutions, Inc. contracted Custom Welding to perform excavation at release area. The release area was excavated between depths of five (5) feet below grade surface (bgs) and six (6) feet below grade surface. Grab samples were retrieved at bottom of excavation and three (3) point composite samples were retrieved from east wall and west wall. Samples were then transported under Chain of Custody to Cardinal Laboratories in Hobbs, NM to be analyzed for Total Petroleum Hydrocarbons (EPA Method 418.1) Chlorides (EPA Method 4500B) and Benzene, Toluene, Ethyl Benzene, and Total Xylenes (BTEX EPA Method 8260B): The results of analysis are as follows:

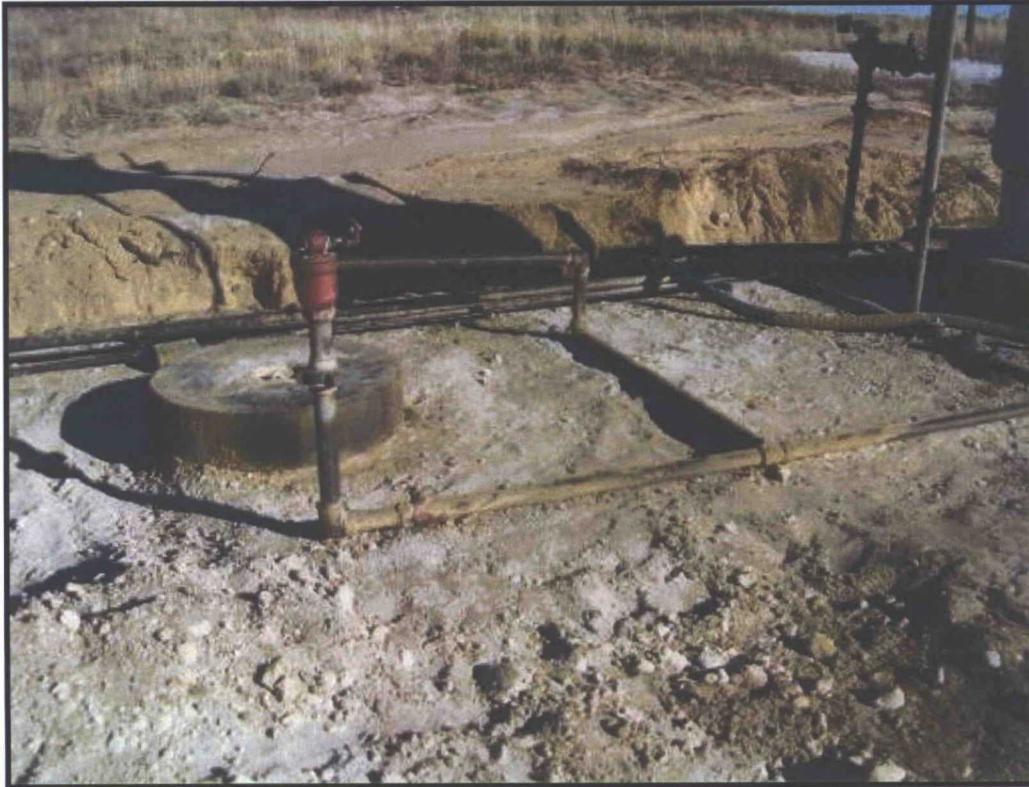
Release area excavated facing east

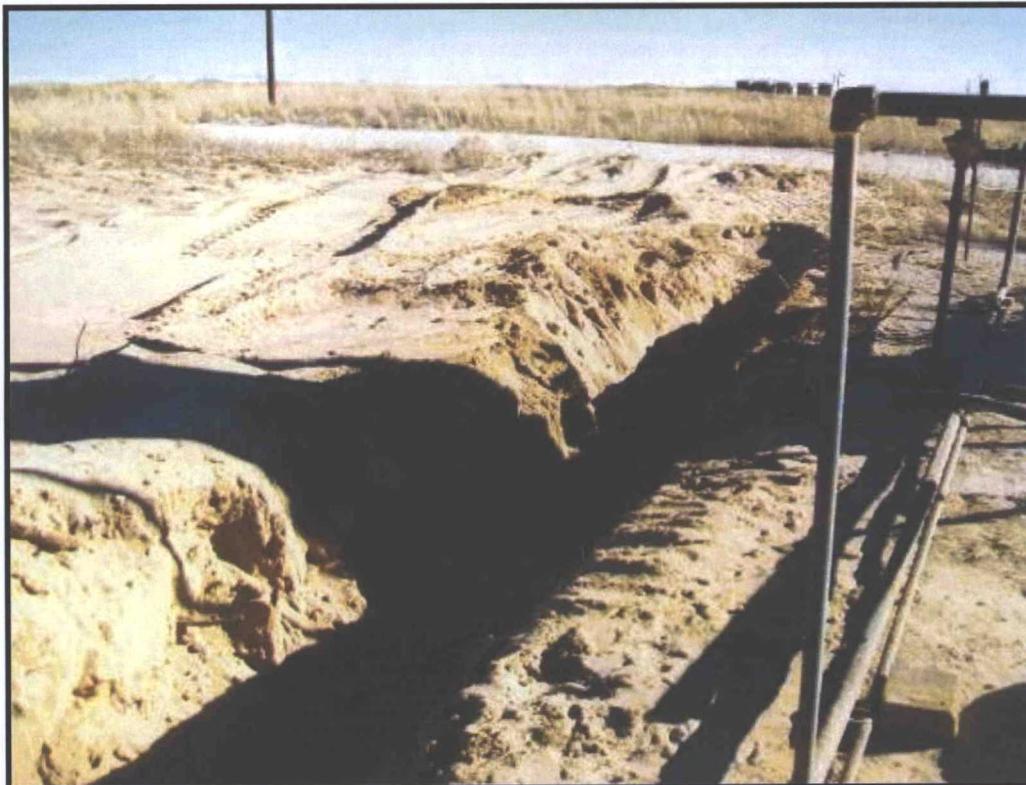
Release area excavated facing southeast

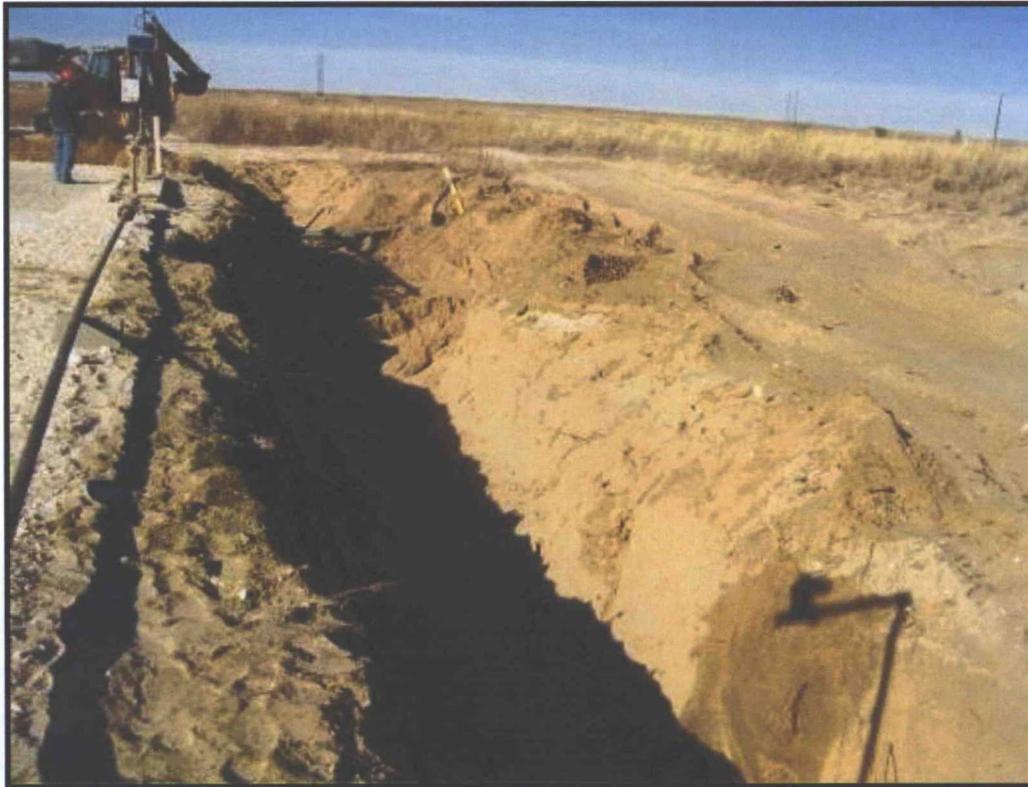
Release area excavated facing northeast

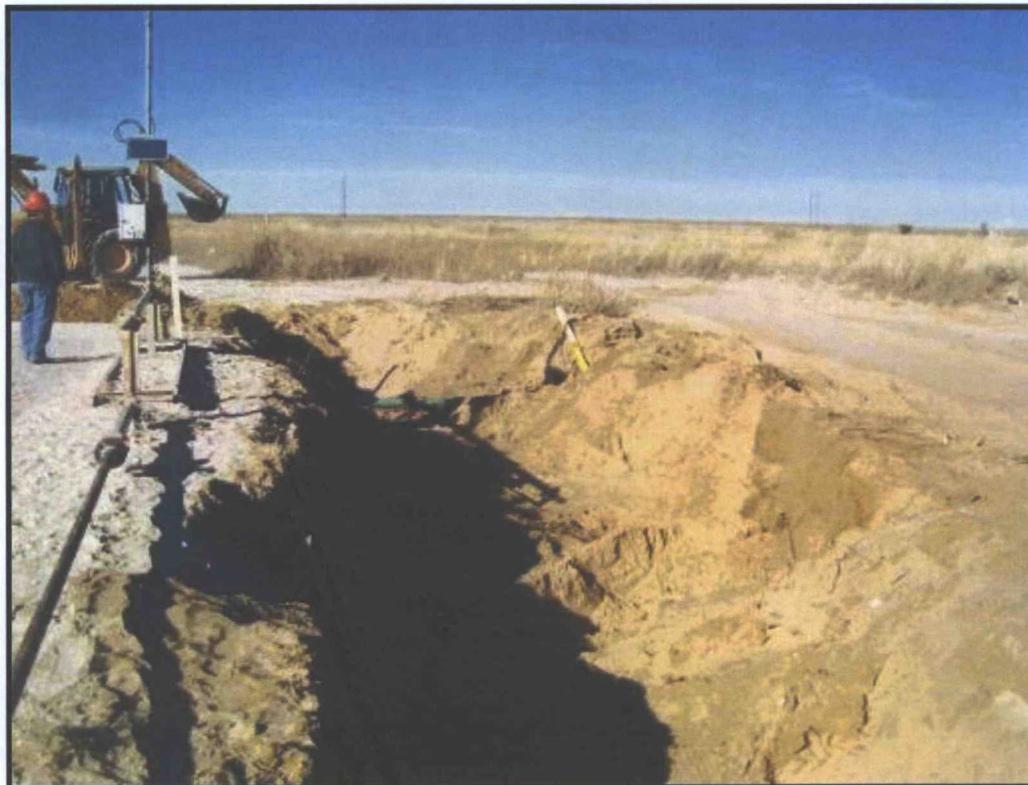
Release area excavated facing north

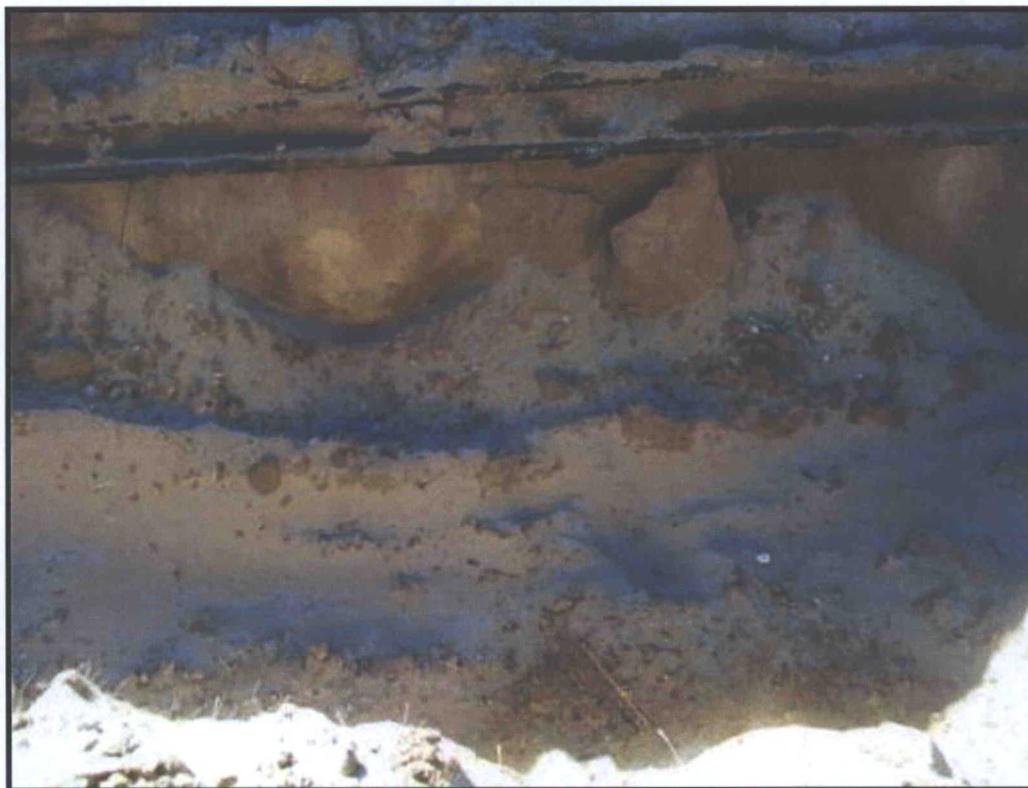
West wall facing west

On January 5, 2011, SESI met with Mr. Geoff Leking with New Mexico Oil Conservation Division (NMOCD). Mr. Leking approved to backfill location area, requiring a 20-mil liner installation on west wall to prevent any further migration into the newly backfilled soils.

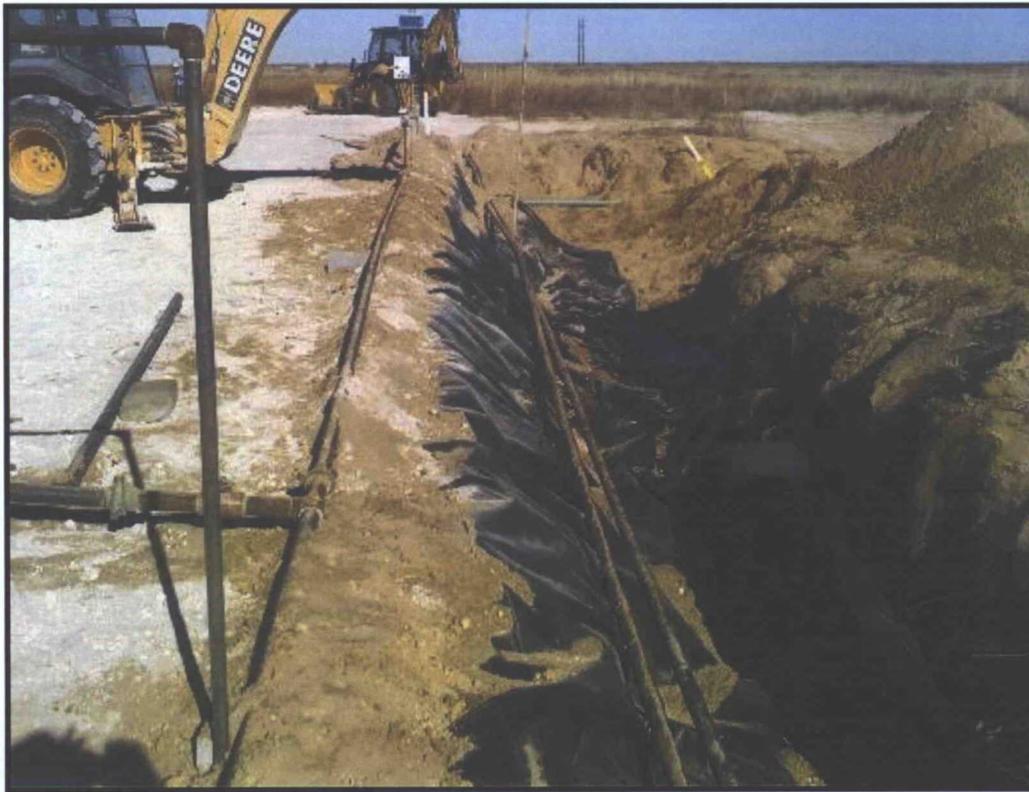
Excavated area west wall lined facing north

On January 27, 2011, SESI was onsite with Gandy Corporation for the installation of a 60' X 12' 20-mil liner on west wall and bottom floor and then backfilled excavated area with 220 yards of likened soils from an offsite facility and contoured location to its natural grade. The area will then be re-seeded in spring for vegetation growth.

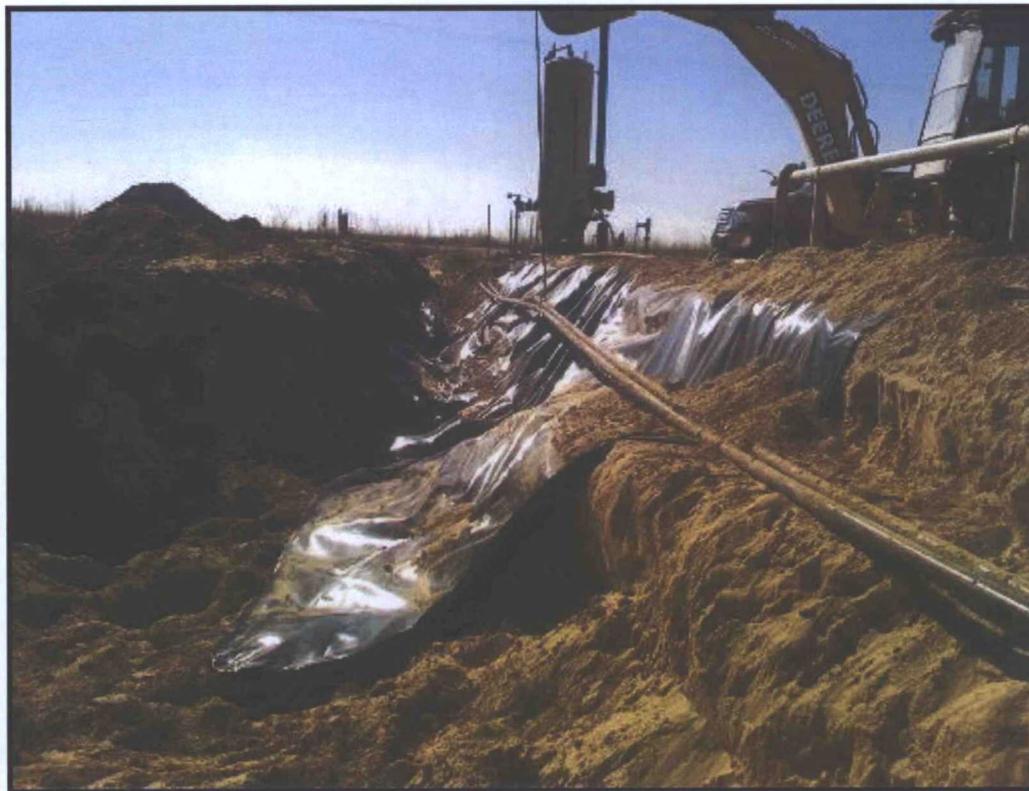
Excavated area west wall lined facing south

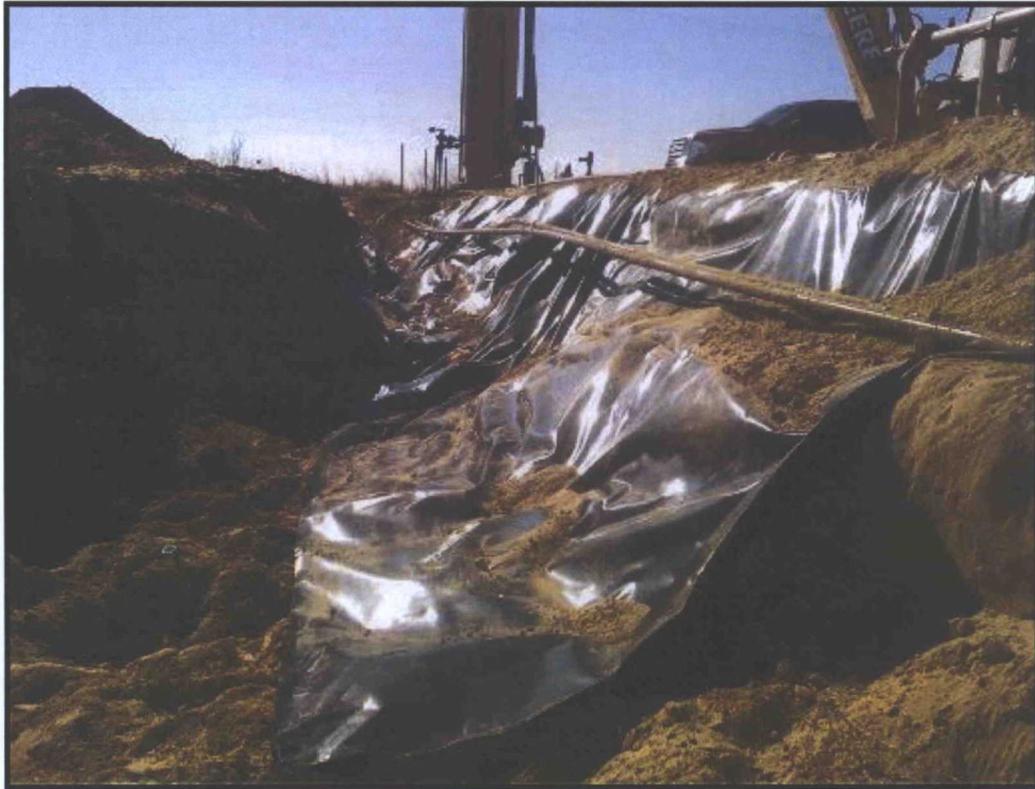
Excavated area west wall lined facing south

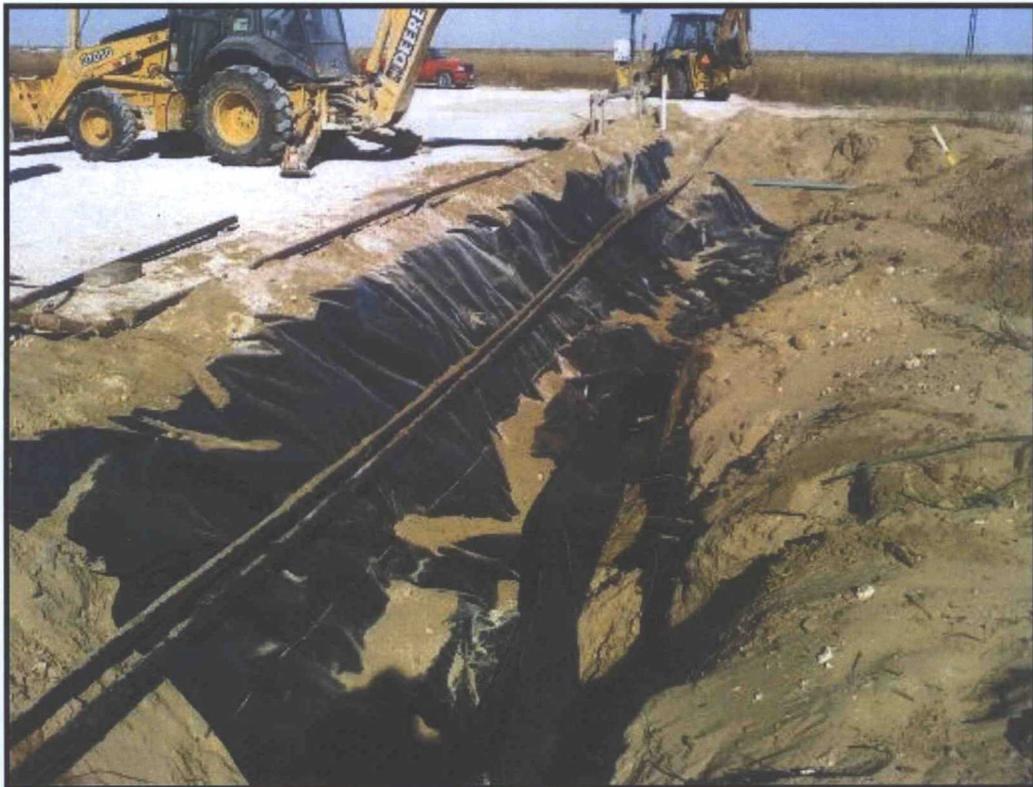
Excavated area west wall lined facing northwest

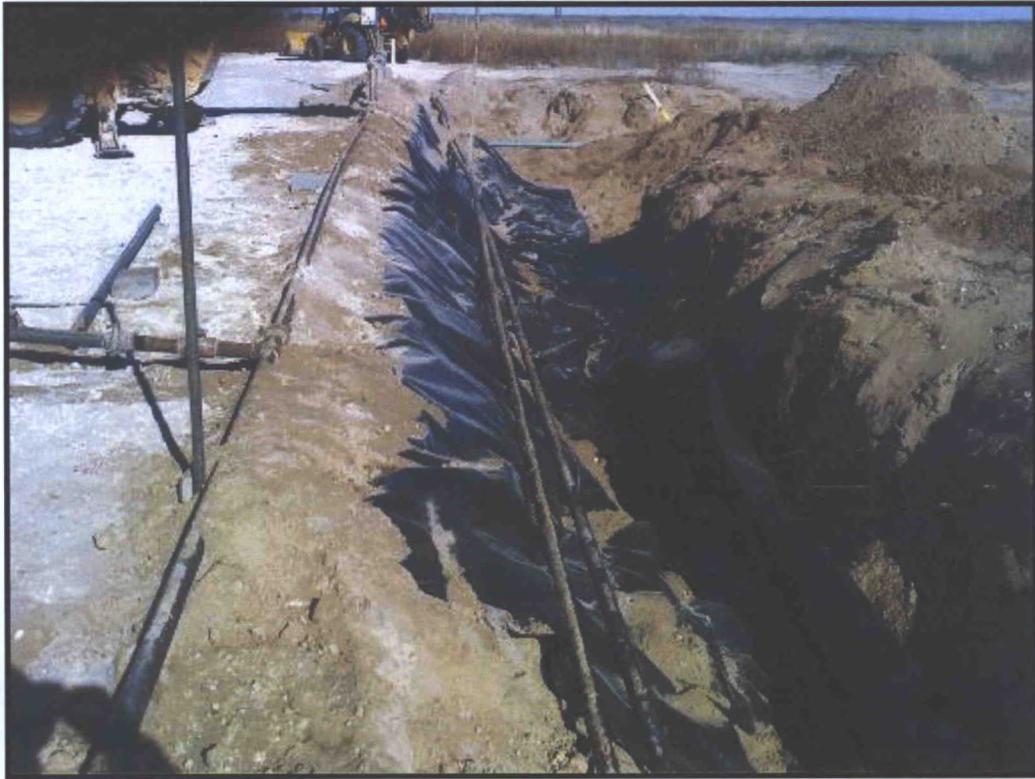
Excavated area west wall lined facing north

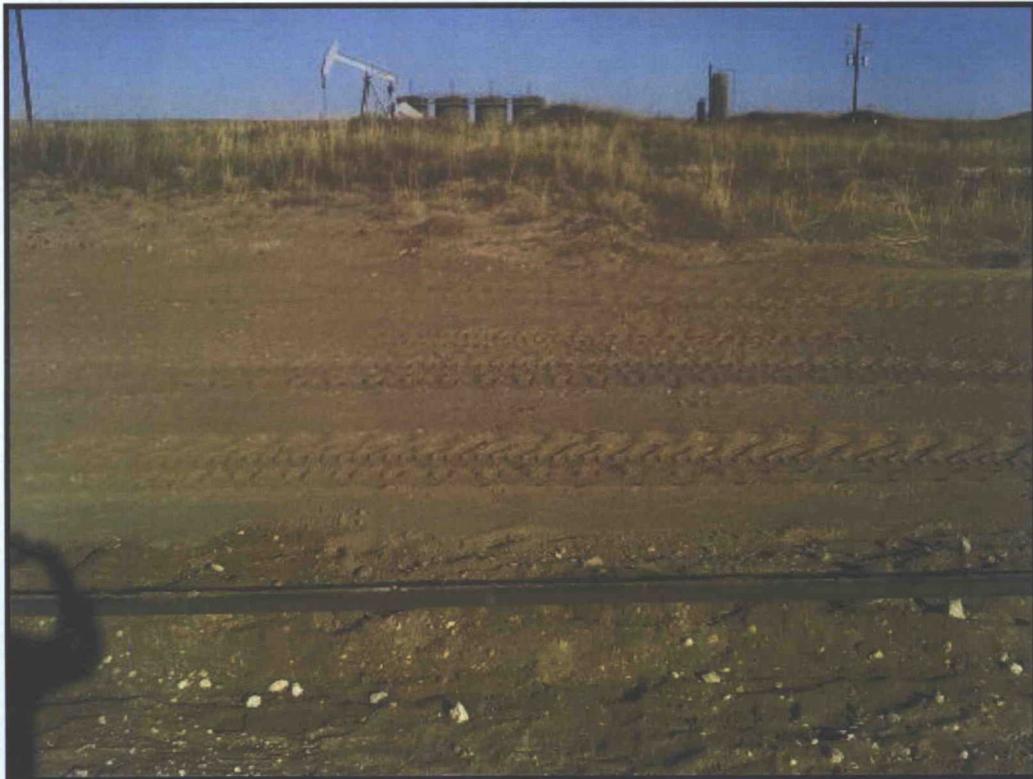
Location backfilled facing east

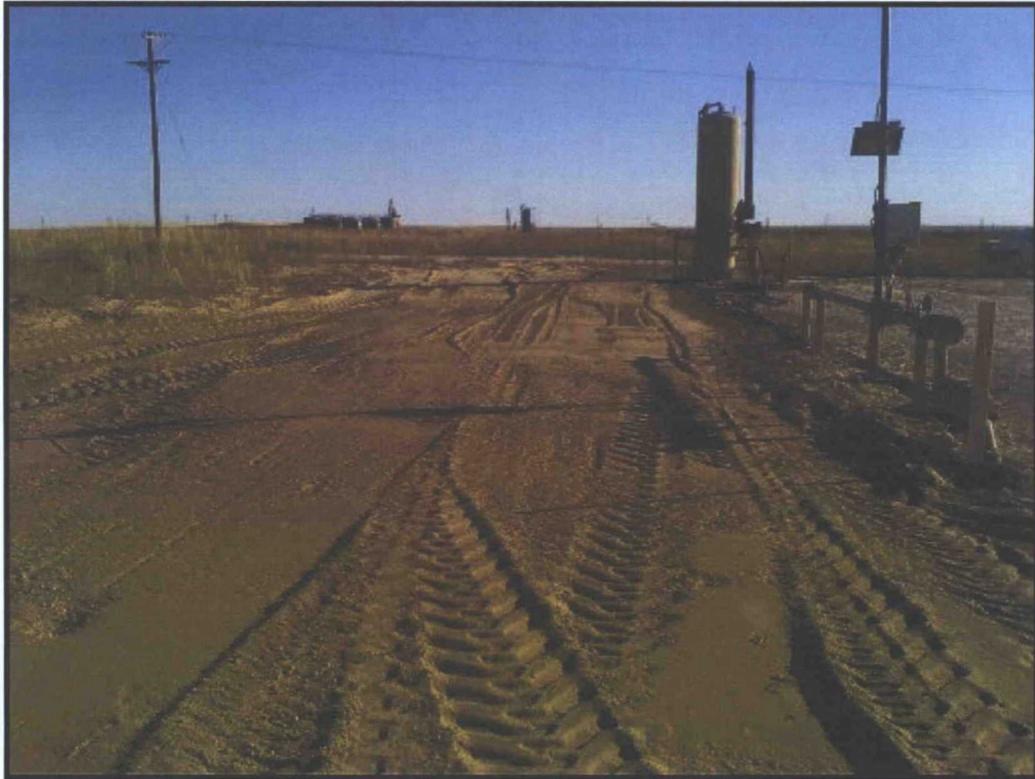
Location area backfilled facing south

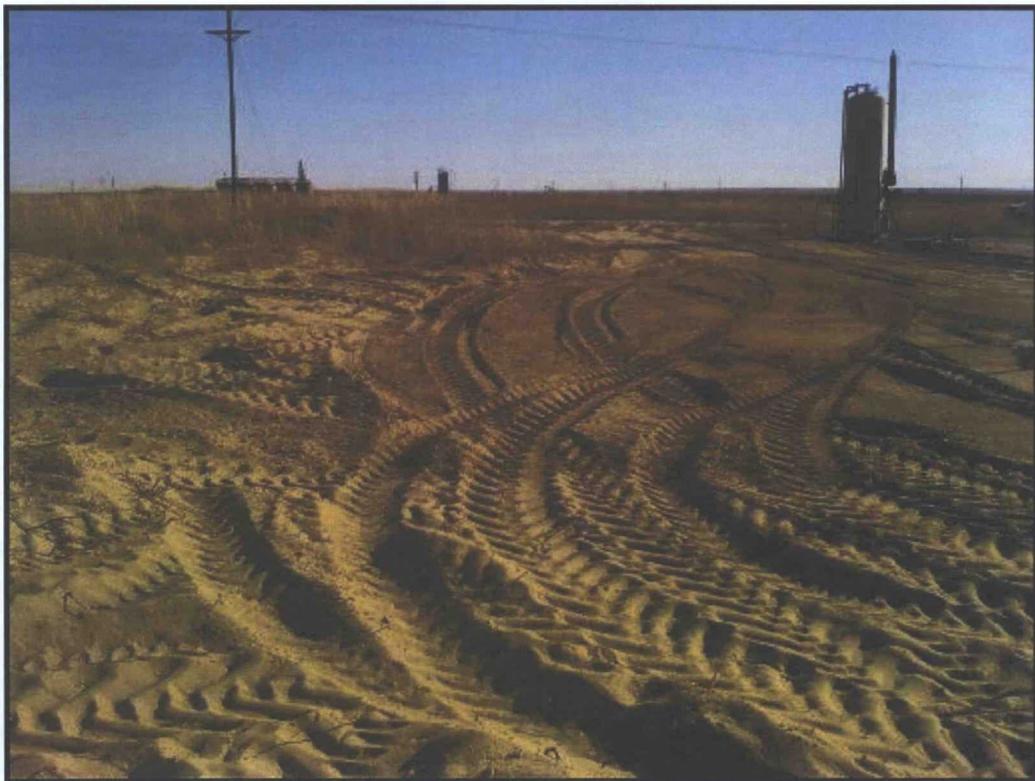
Location area backfilled facing southwest

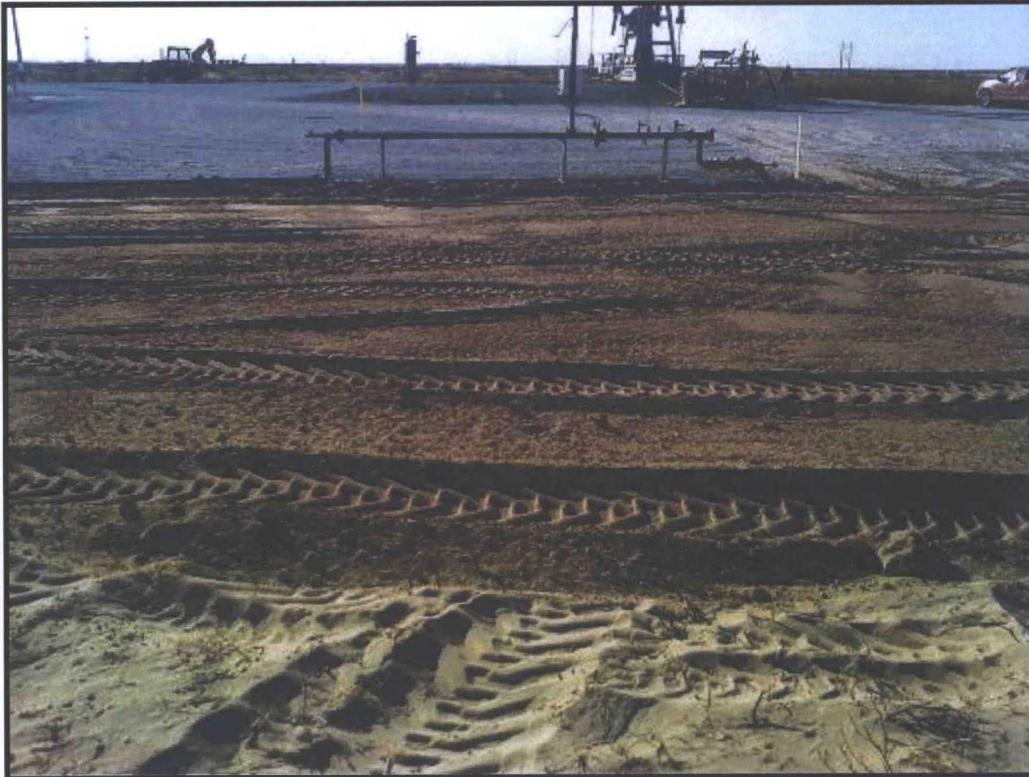
Location area backfilled facing west

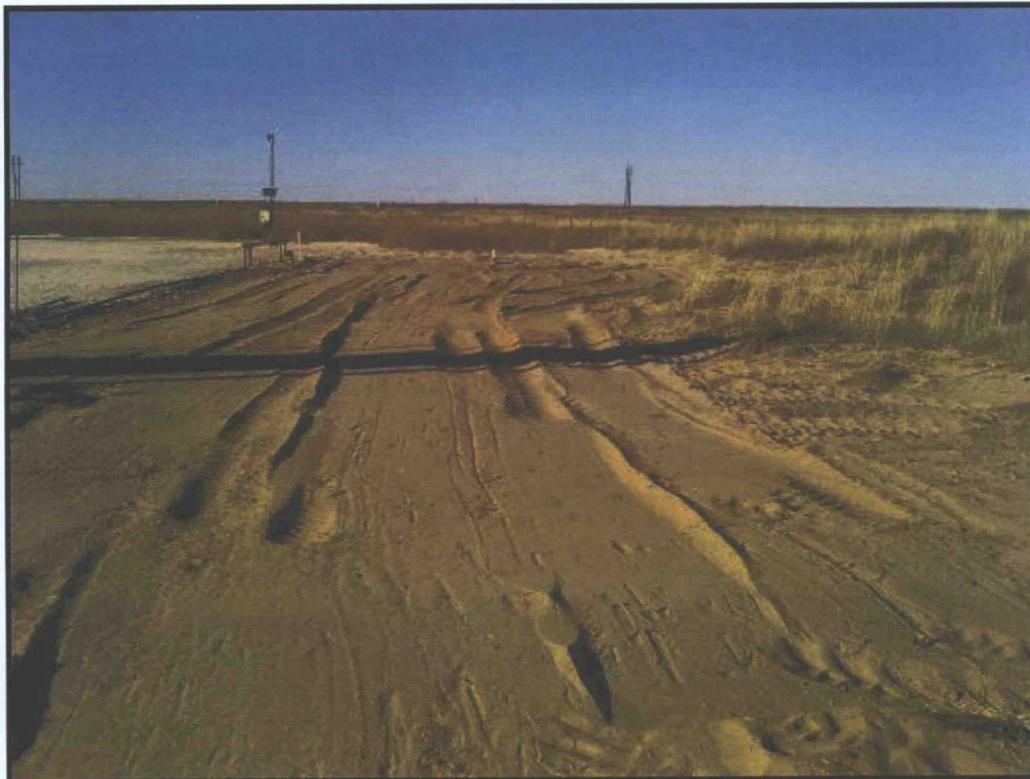
Location area backfilled facing north

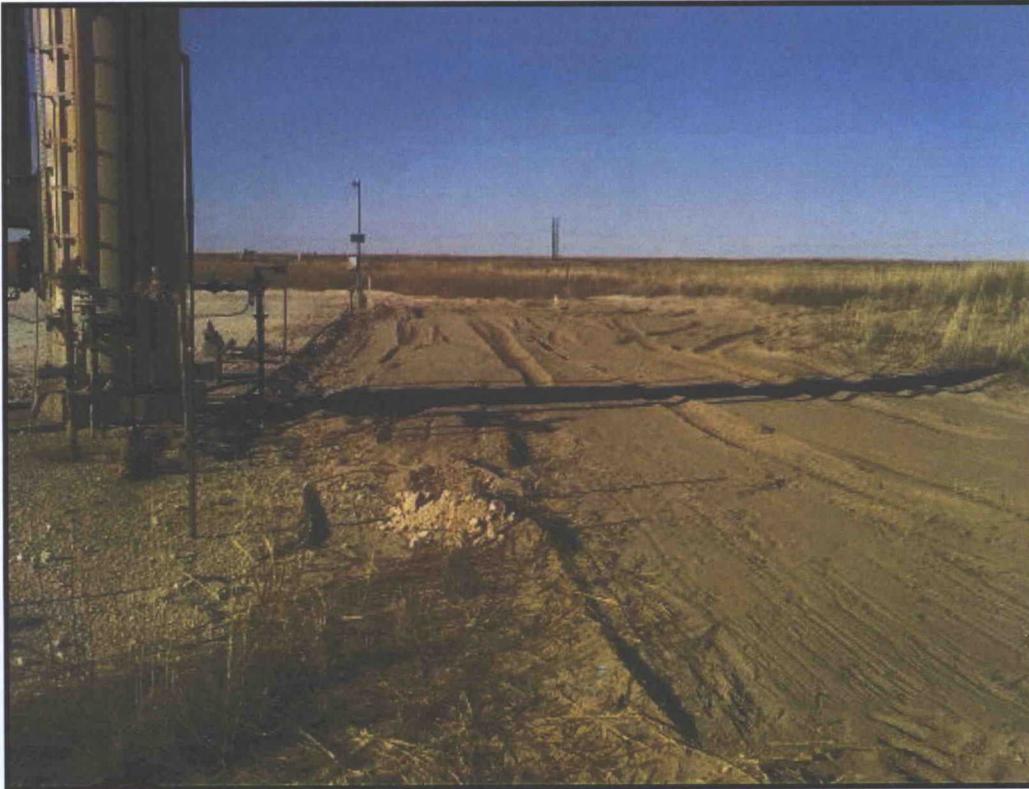
Location area backfilled facing north
