Release Notification and Corrective Action

Name of Company: Samson Resources Company	Contact: Autumn Long, Environmental Specialist
Address: Two West Second Street, Tulsa, OK 74103-3103	Telephone No.: (918) 591-1364
Facility Name: State BD Well #3	Facility Type: Injection (SWD) Well and Tank Battery

Type of Release: Produced Water	Volume of Release: 785 bbl	Volume Recovered: 730 bbl
Source of Release: Flange Gasket Failure at Injection Pump	Date and Hour of Occurrence: 6-19-2010@05:52 hrs	Date and Hour of Discovery: 6-19-2010@05:52 hrs
Was Immediate Notice Given? <input checked="" type="checkbox"/> Yes <input type="checkbox"/> No <input type="checkbox"/> Not Required	If YES, To Whom? E.L. Gonzalez - OCD District 1 - Initial verbal report on 6-19-2010 Geoffrey Leking - OCD District 1 - Follow up report on 6-21-2010	
By Whom? Autumn Long	Date and Hour: 6-19-2010@10:50 hrs	
Was a Watercourse Reached? <input type="checkbox"/> Yes <input checked="" type="checkbox"/> No	If YES, Volume Impacting the Watercourse.

On June 19, 2010, a flange gasket on the injection pump failed releasing approximately 785 barrels (bbl) of produced water that was retained within the earthen firewall. Samson

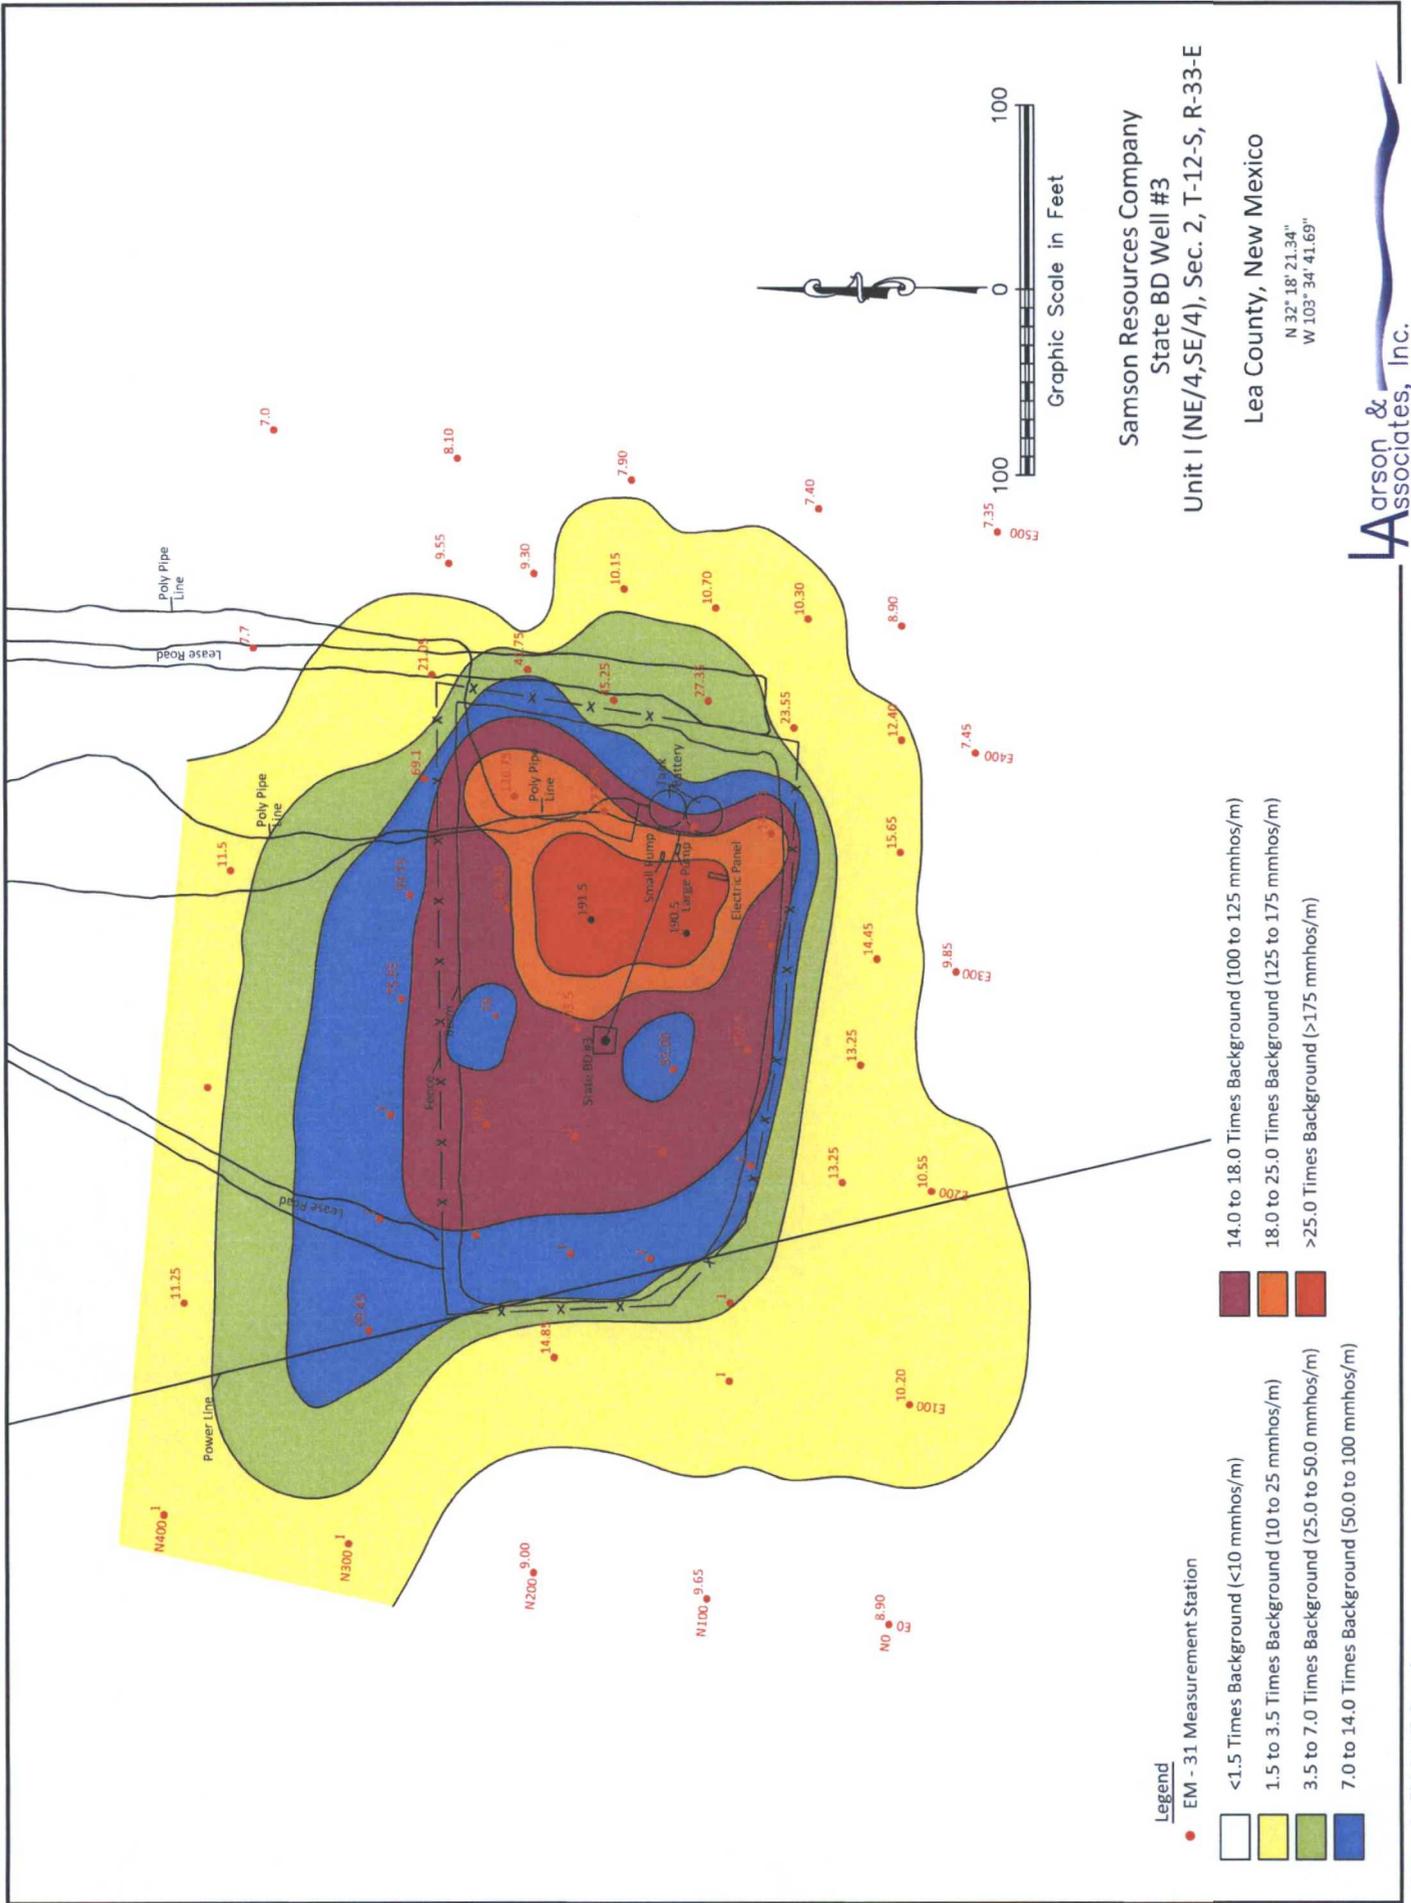
Figure 4 - EM-31 HD Drawing

On July 1, 2010, LAI performed an electromagnetic (EM-31) terrain conductivity survey in horizontal dipole (HD) and vertical dipole (VD) modes to identify areas with elevated conductivity readings relative to background that would correspond with elevated chloride concentrations in soil. An area of EM-31HD and EM-31VD readings greater than 25 times background was observed between the well and tank battery that suggested decreasing chloride concentrations with depth. The EM-31HD and VD readings decreased to near background levels north, south, east and west of the Site.

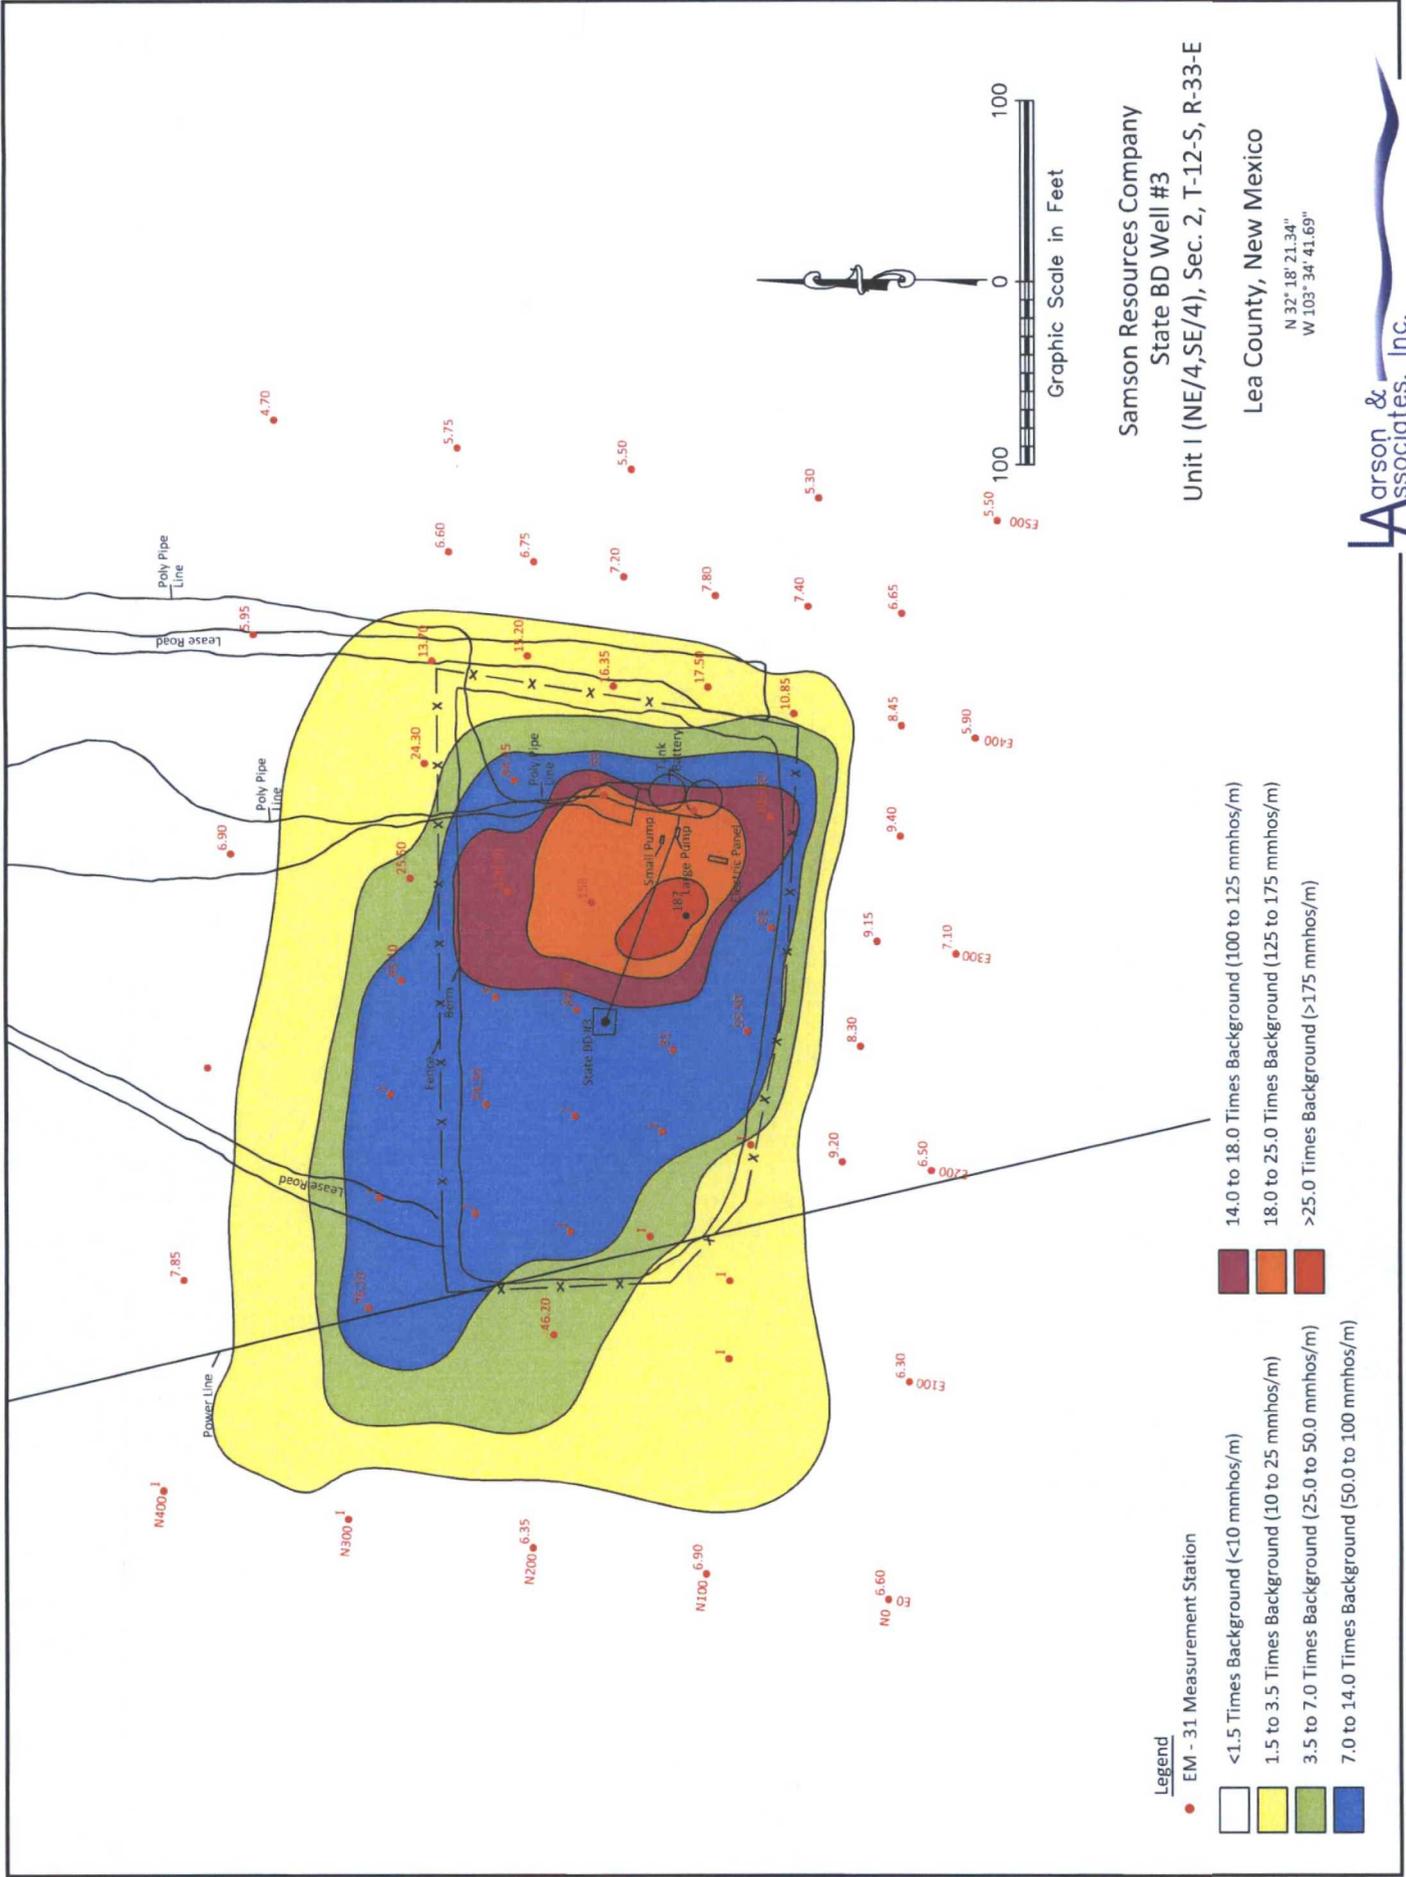
Figure 5 - EM-31 VD Drawing

EM-31VD readings exceeding about 25 times background were also observed in the area between the well and tank battery similar to the EM-31HD readings and suggests that the impact diminishes with depth. The EM-31VD readings decreased to near background north, south, east and west of the Site. Figure 5 presents the EM-31VD survey drawing.

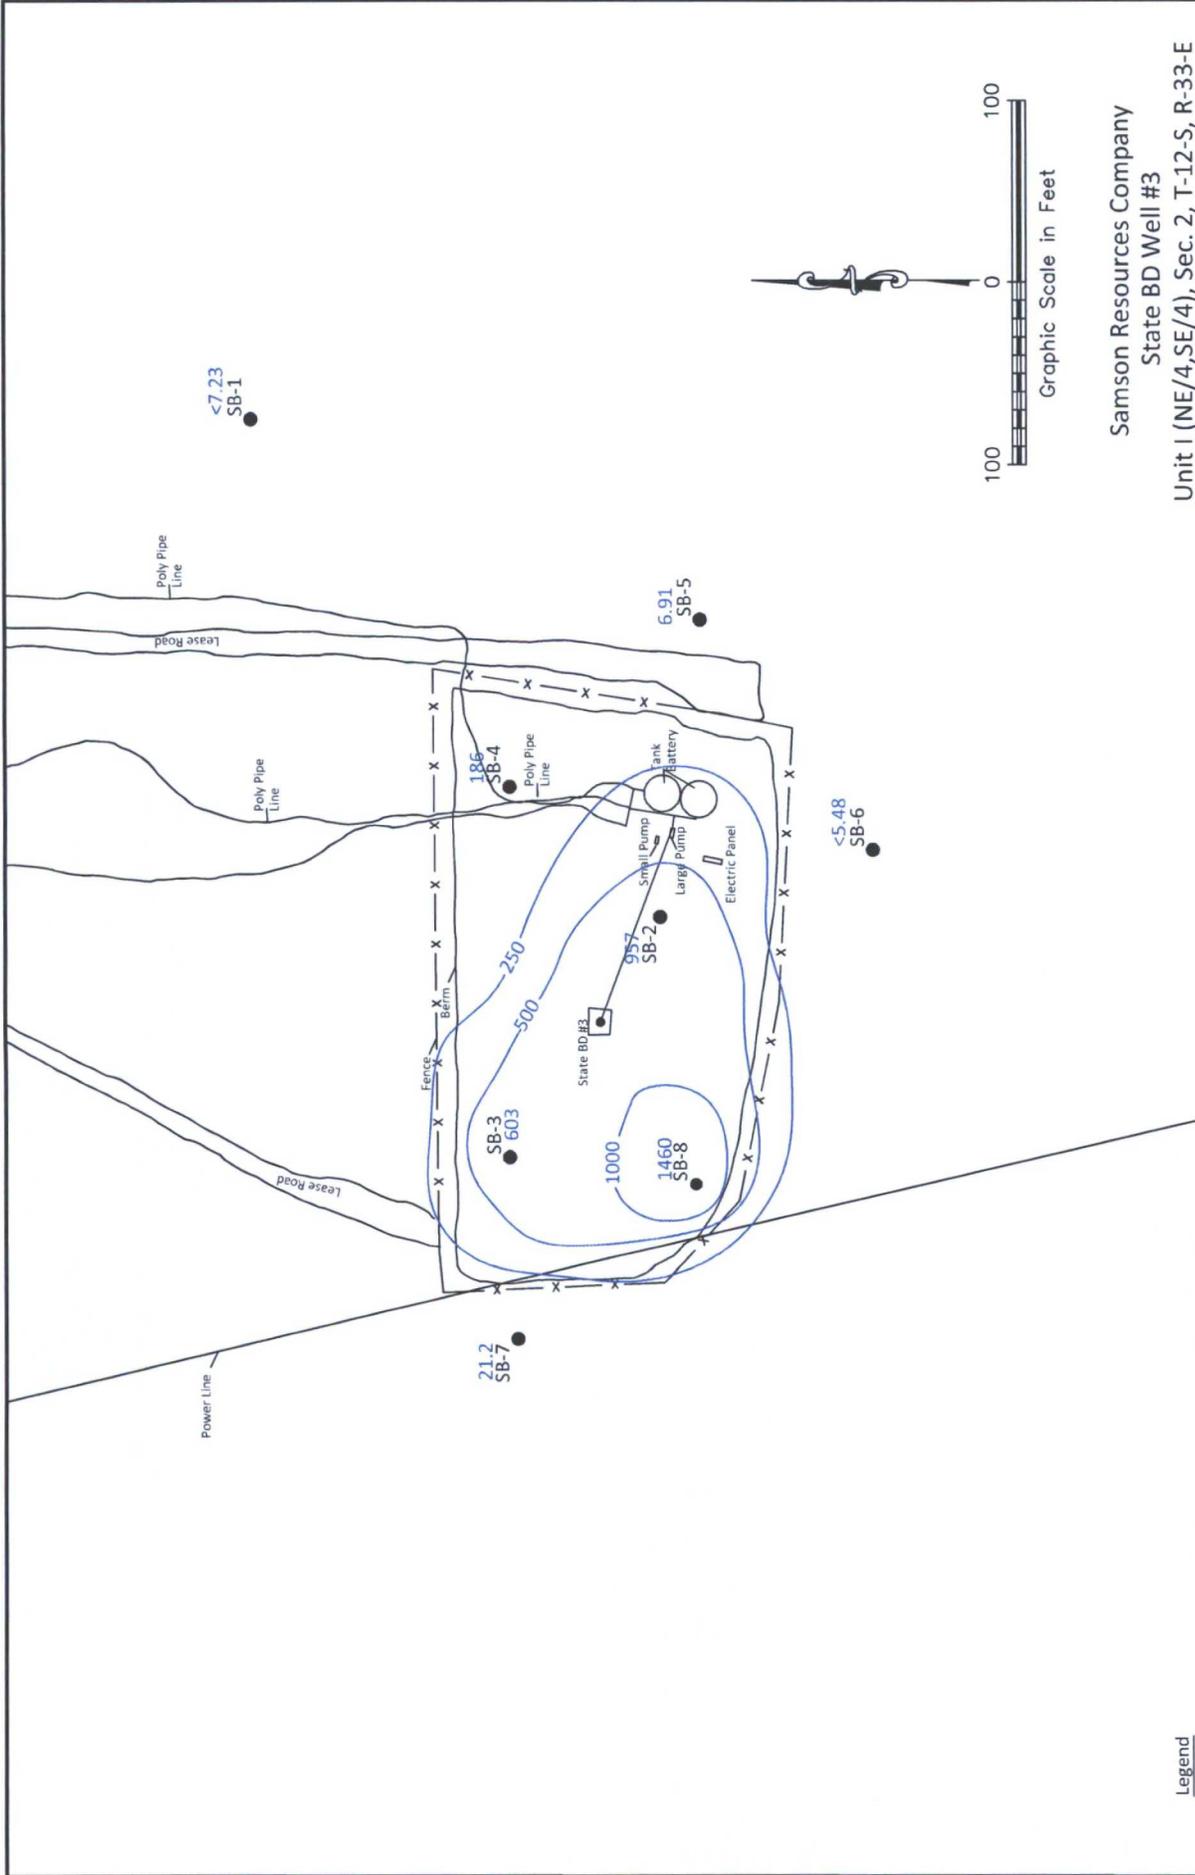
Figure 6 - Chloride Concentration in Soil at 0 Feet

- SB-3 - Soil Boring Location and Chloride Concentration in Soil at 0 feet BGS, mg/Kg, August 3, 4, and 31, 2010
- 250 - Contour of Chloride Concentration in Soil at 0 feet BGS, mg/Kg, August 3, 4, and 31, 2010

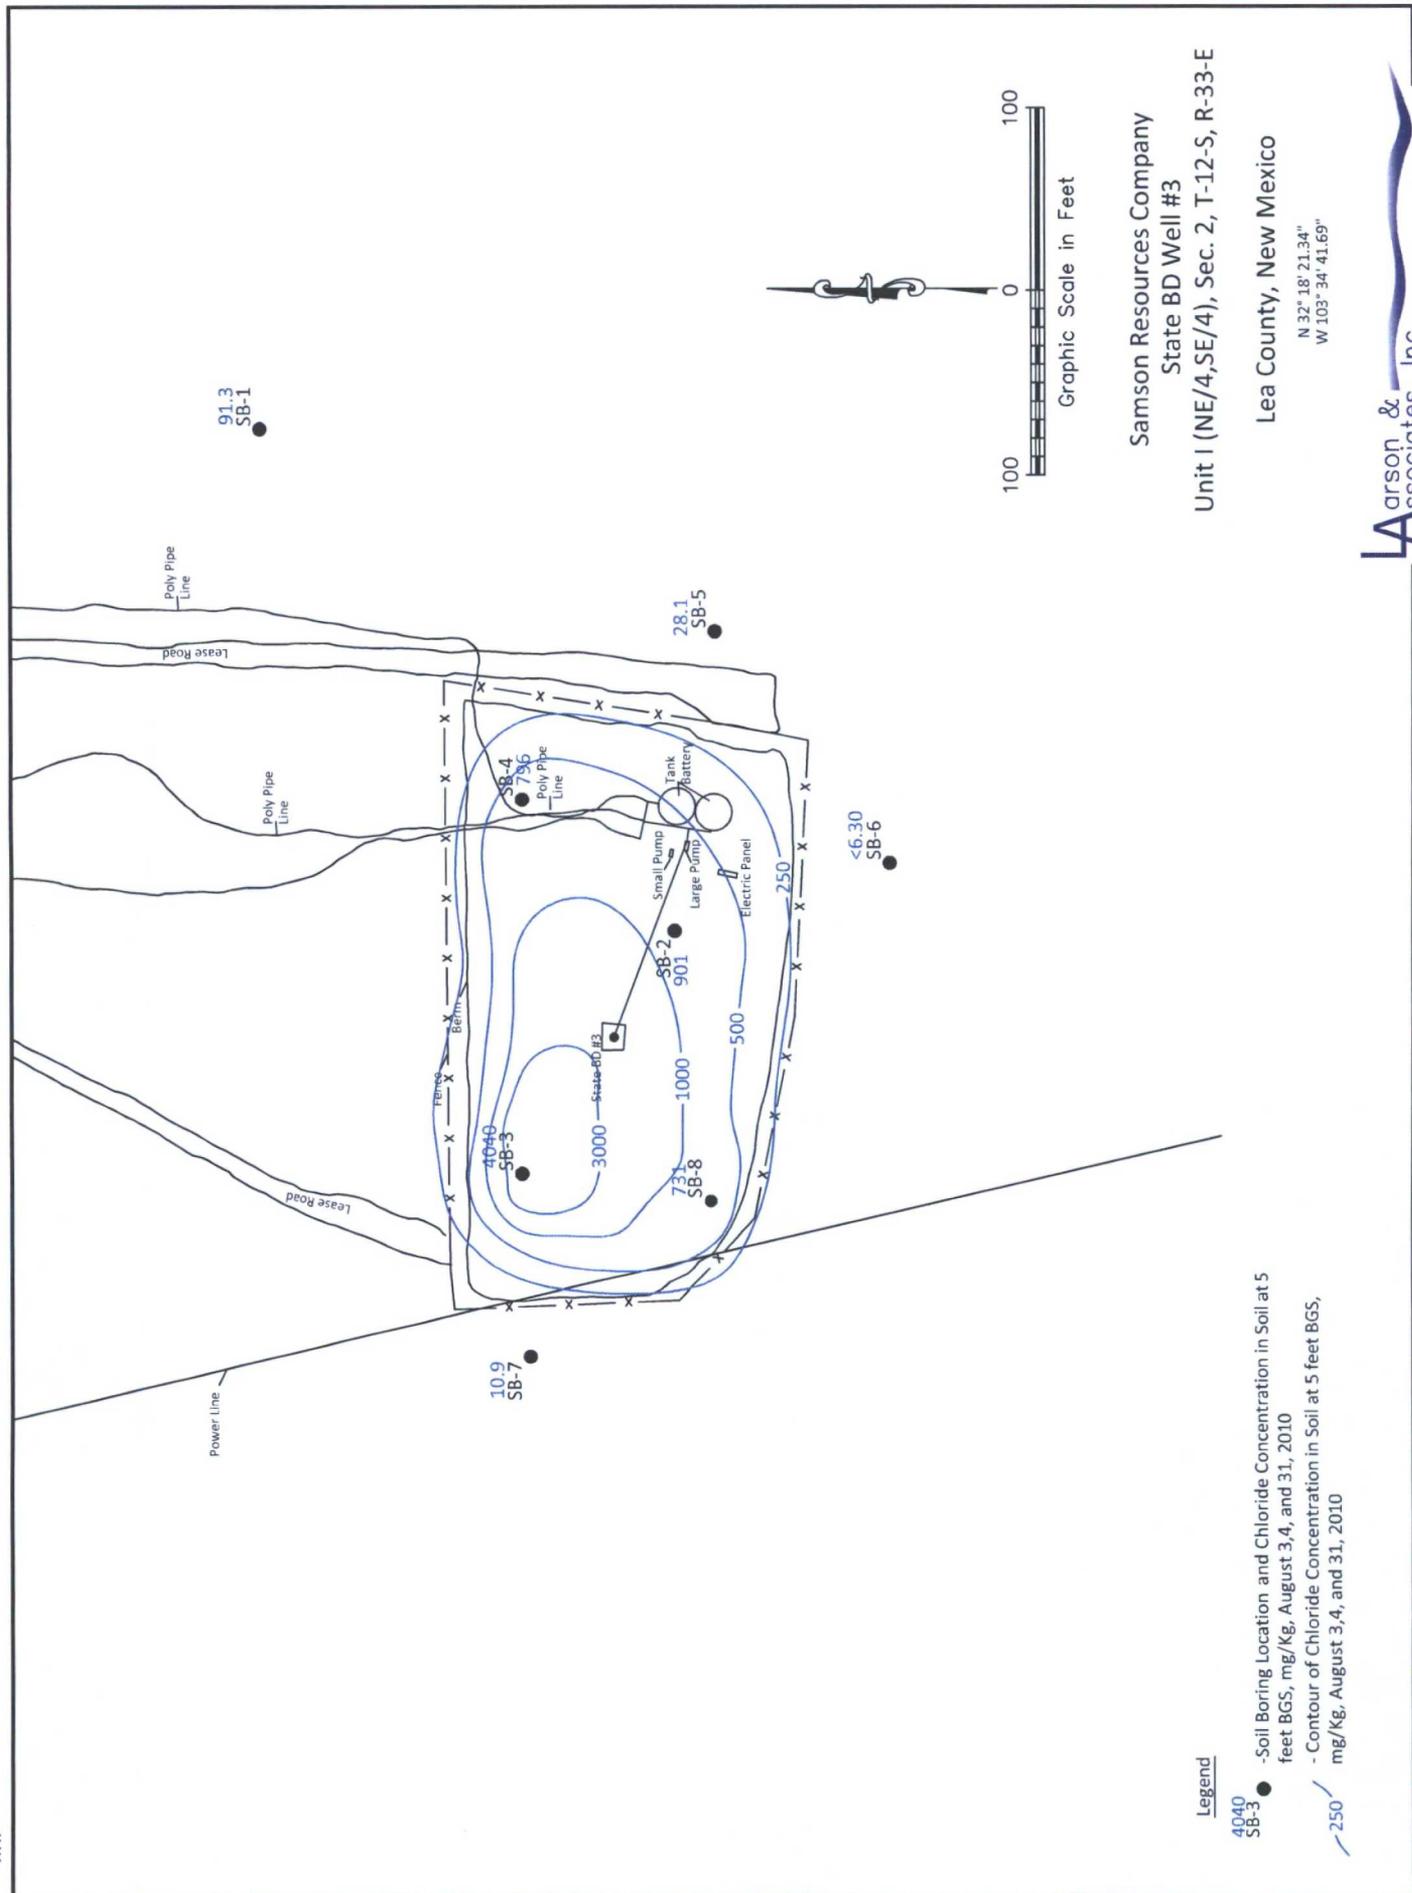
Figure 7 - Chloride Concentration in Soil at 5 Feet

- Legend**
- 4040 SB-3 - Soil Boring Location and Chloride Concentration in Soil at 5 feet BGS, mg/Kg, August 3, 4, and 31, 2010
 - 250 - Contour of Chloride Concentration in Soil at 5 feet BGS, mg/Kg, August 3, 4, and 31, 2010

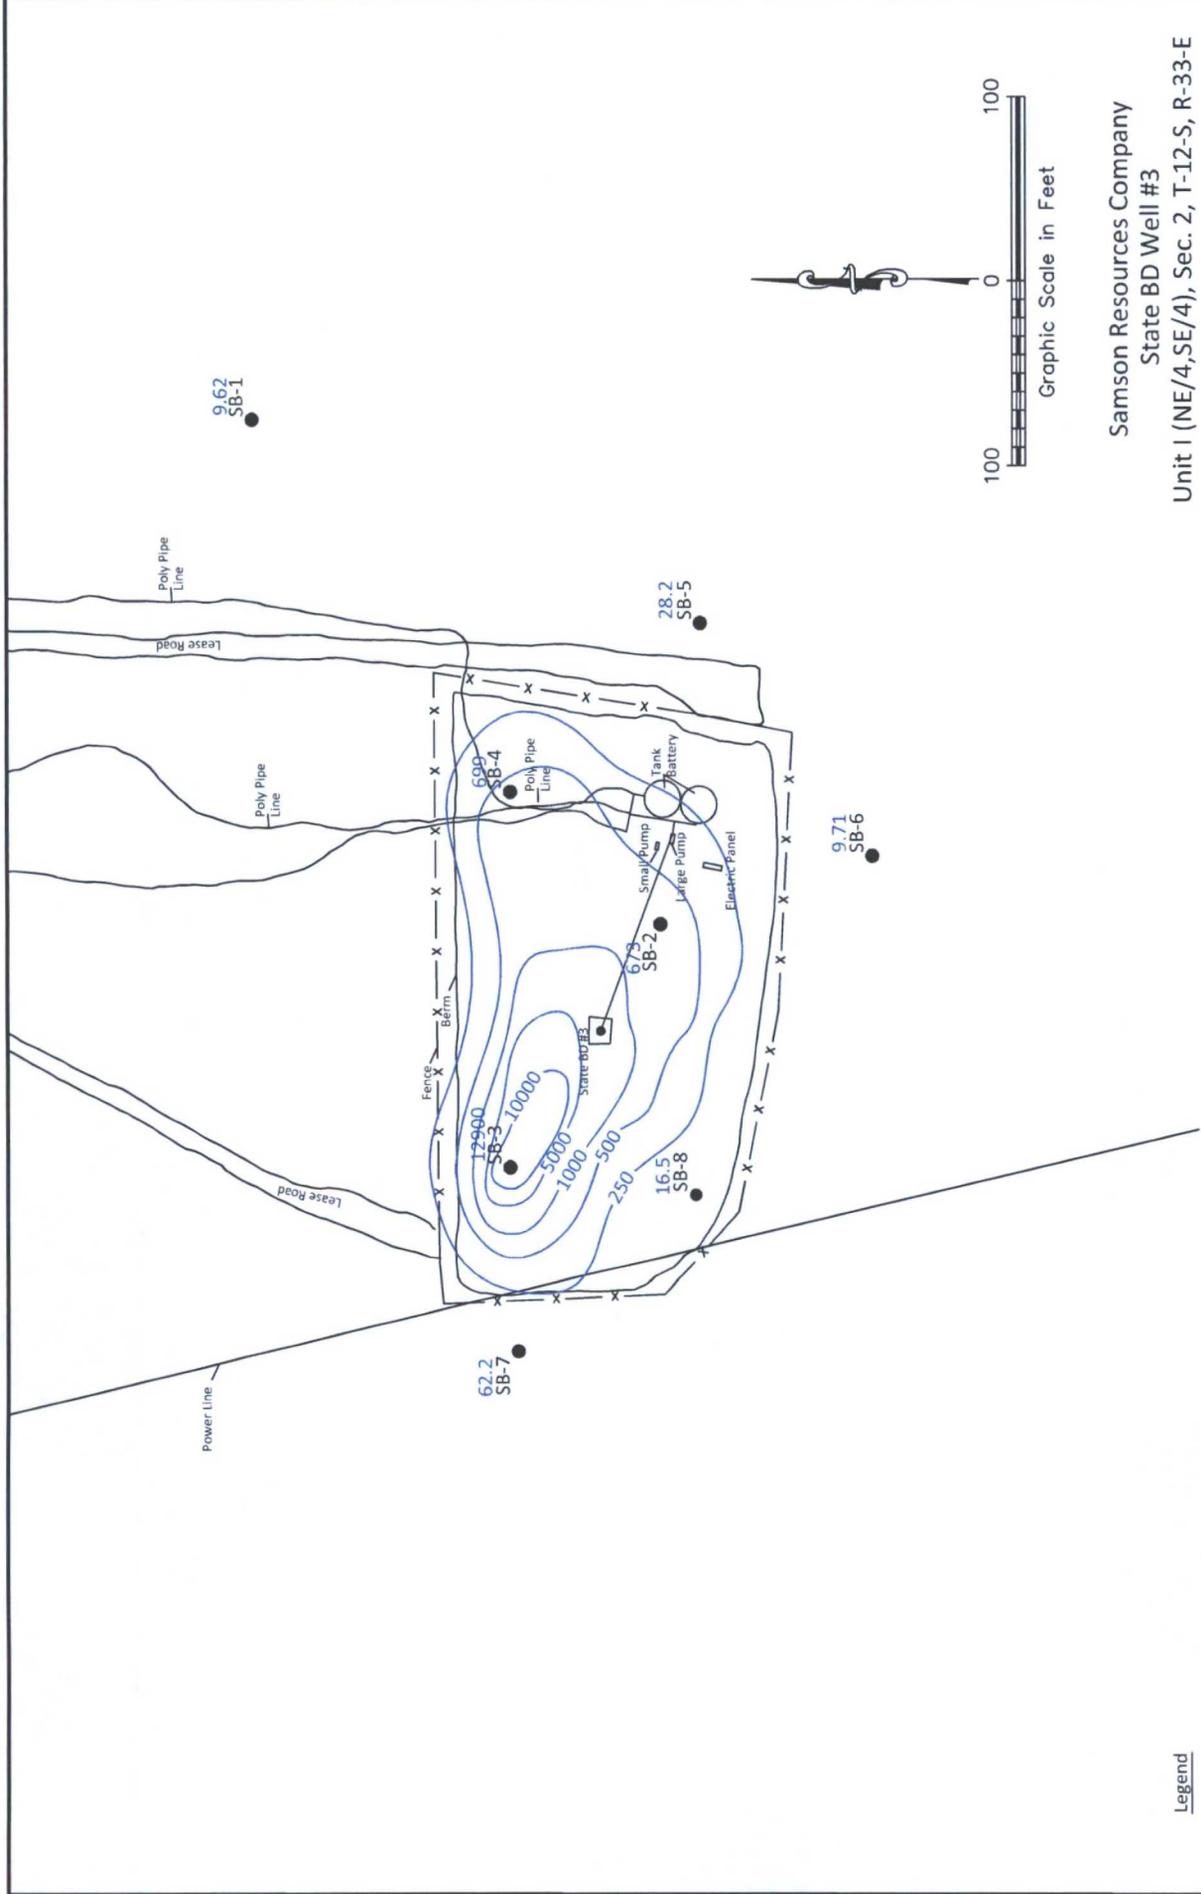
Figure 8 - Chloride Concentration in Soil at 10 Feet

- 12900 mg/Kg, August 3, 4, and 31, 2010
- 5000 mg/Kg, August 3, 4, and 31, 2010
- 1000 mg/Kg, August 3, 4, and 31, 2010
- 500 mg/Kg, August 3, 4, and 31, 2010
- 250 mg/Kg, August 3, 4, and 31, 2010

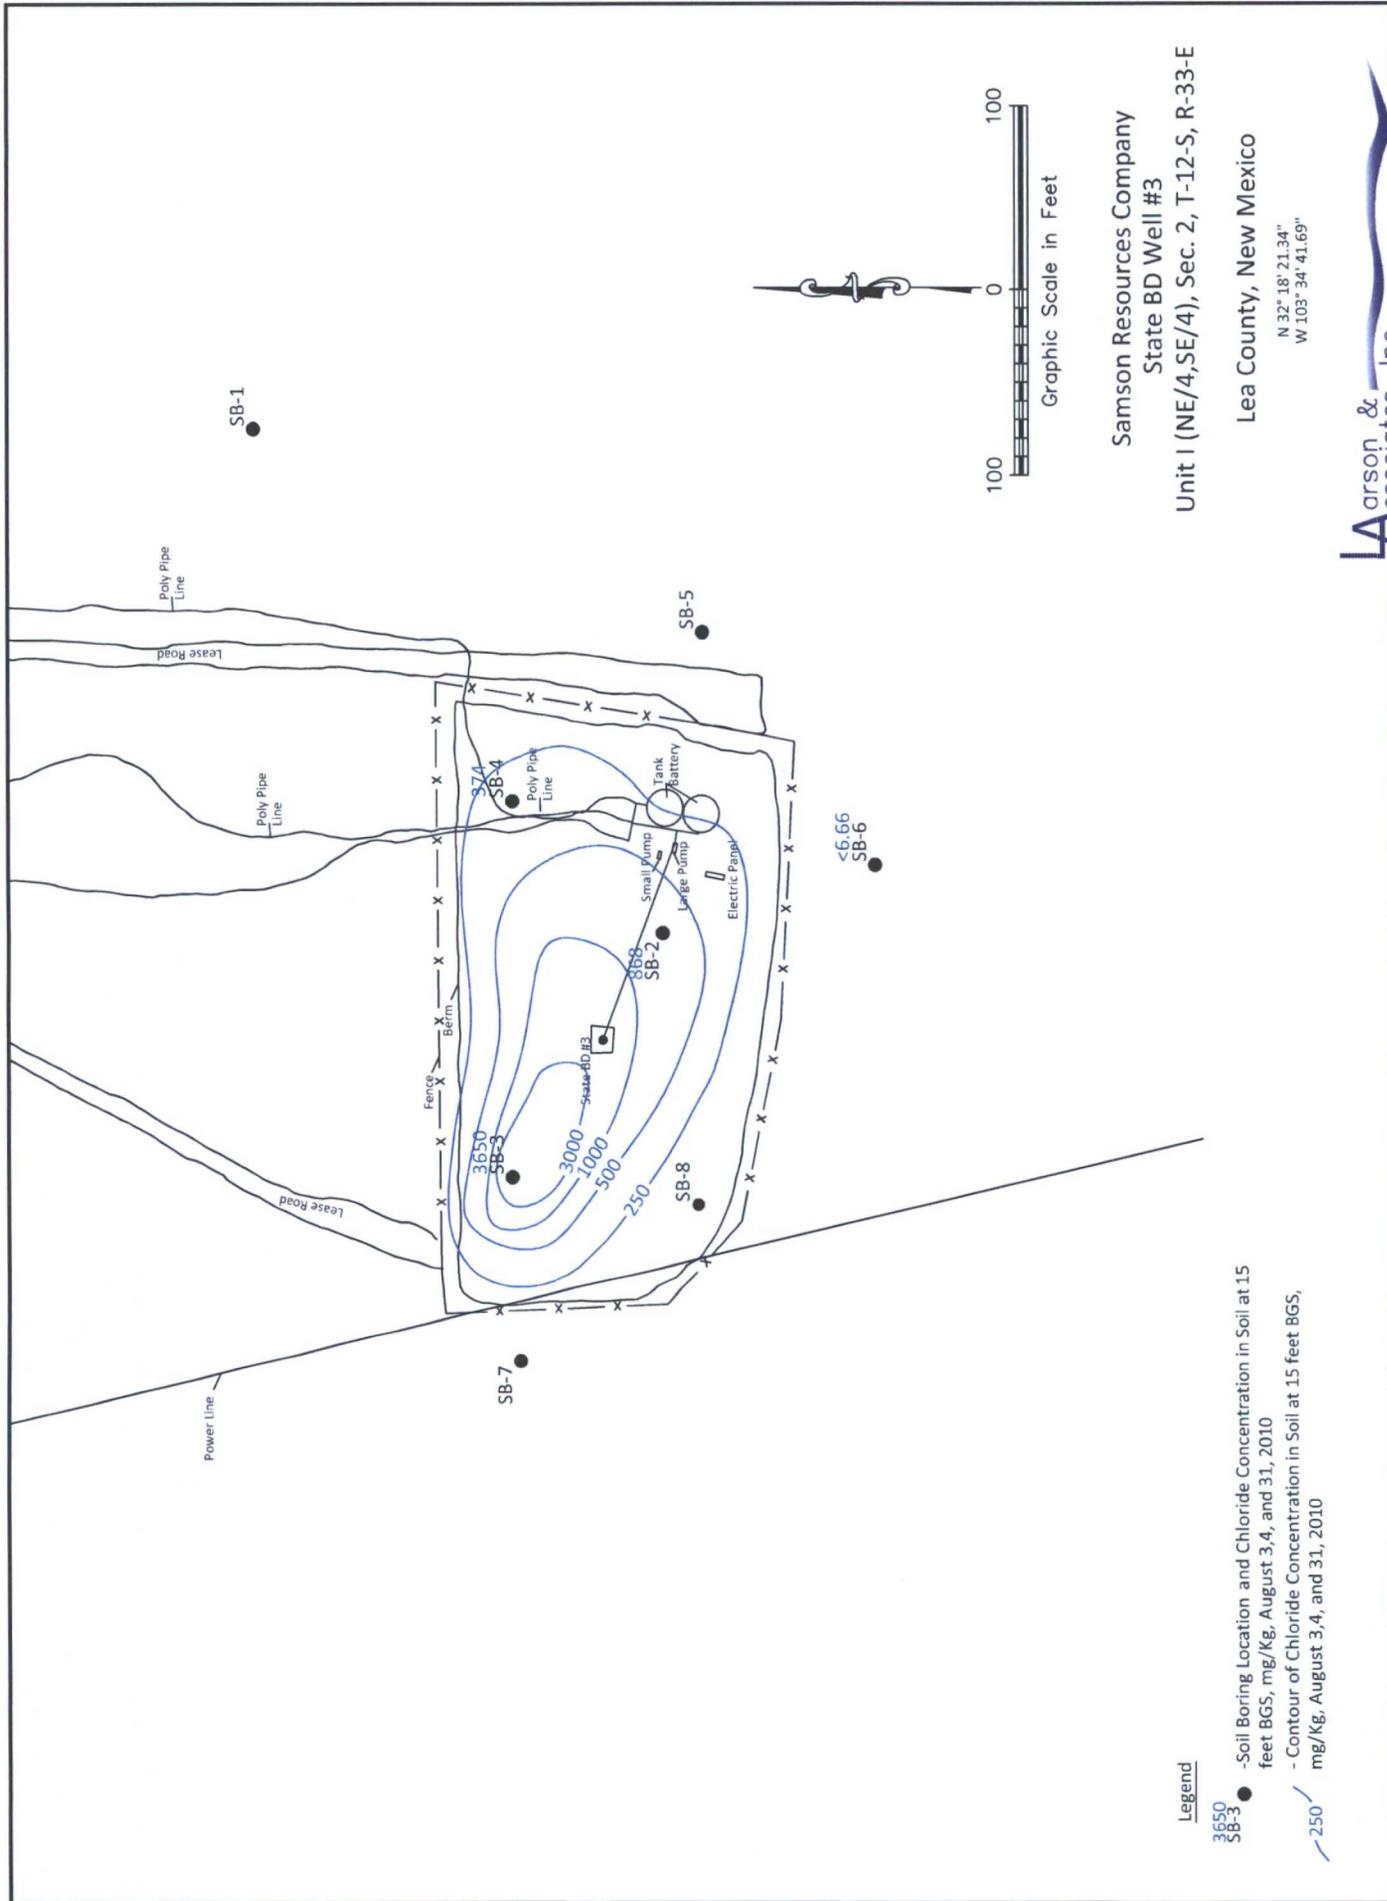
Figure 9 - Chloride Concentration in Soil at 15 Feet

Legend
 ● 3650 mg/Kg - Soil Boring Location and Chloride Concentration in Soil at 15 feet BGS, mg/Kg, August 3, 4, and 31, 2010
 - 250 mg/Kg - Contour of Chloride Concentration in Soil at 15 feet BGS, mg/Kg, August 3, 4, and 31, 2010

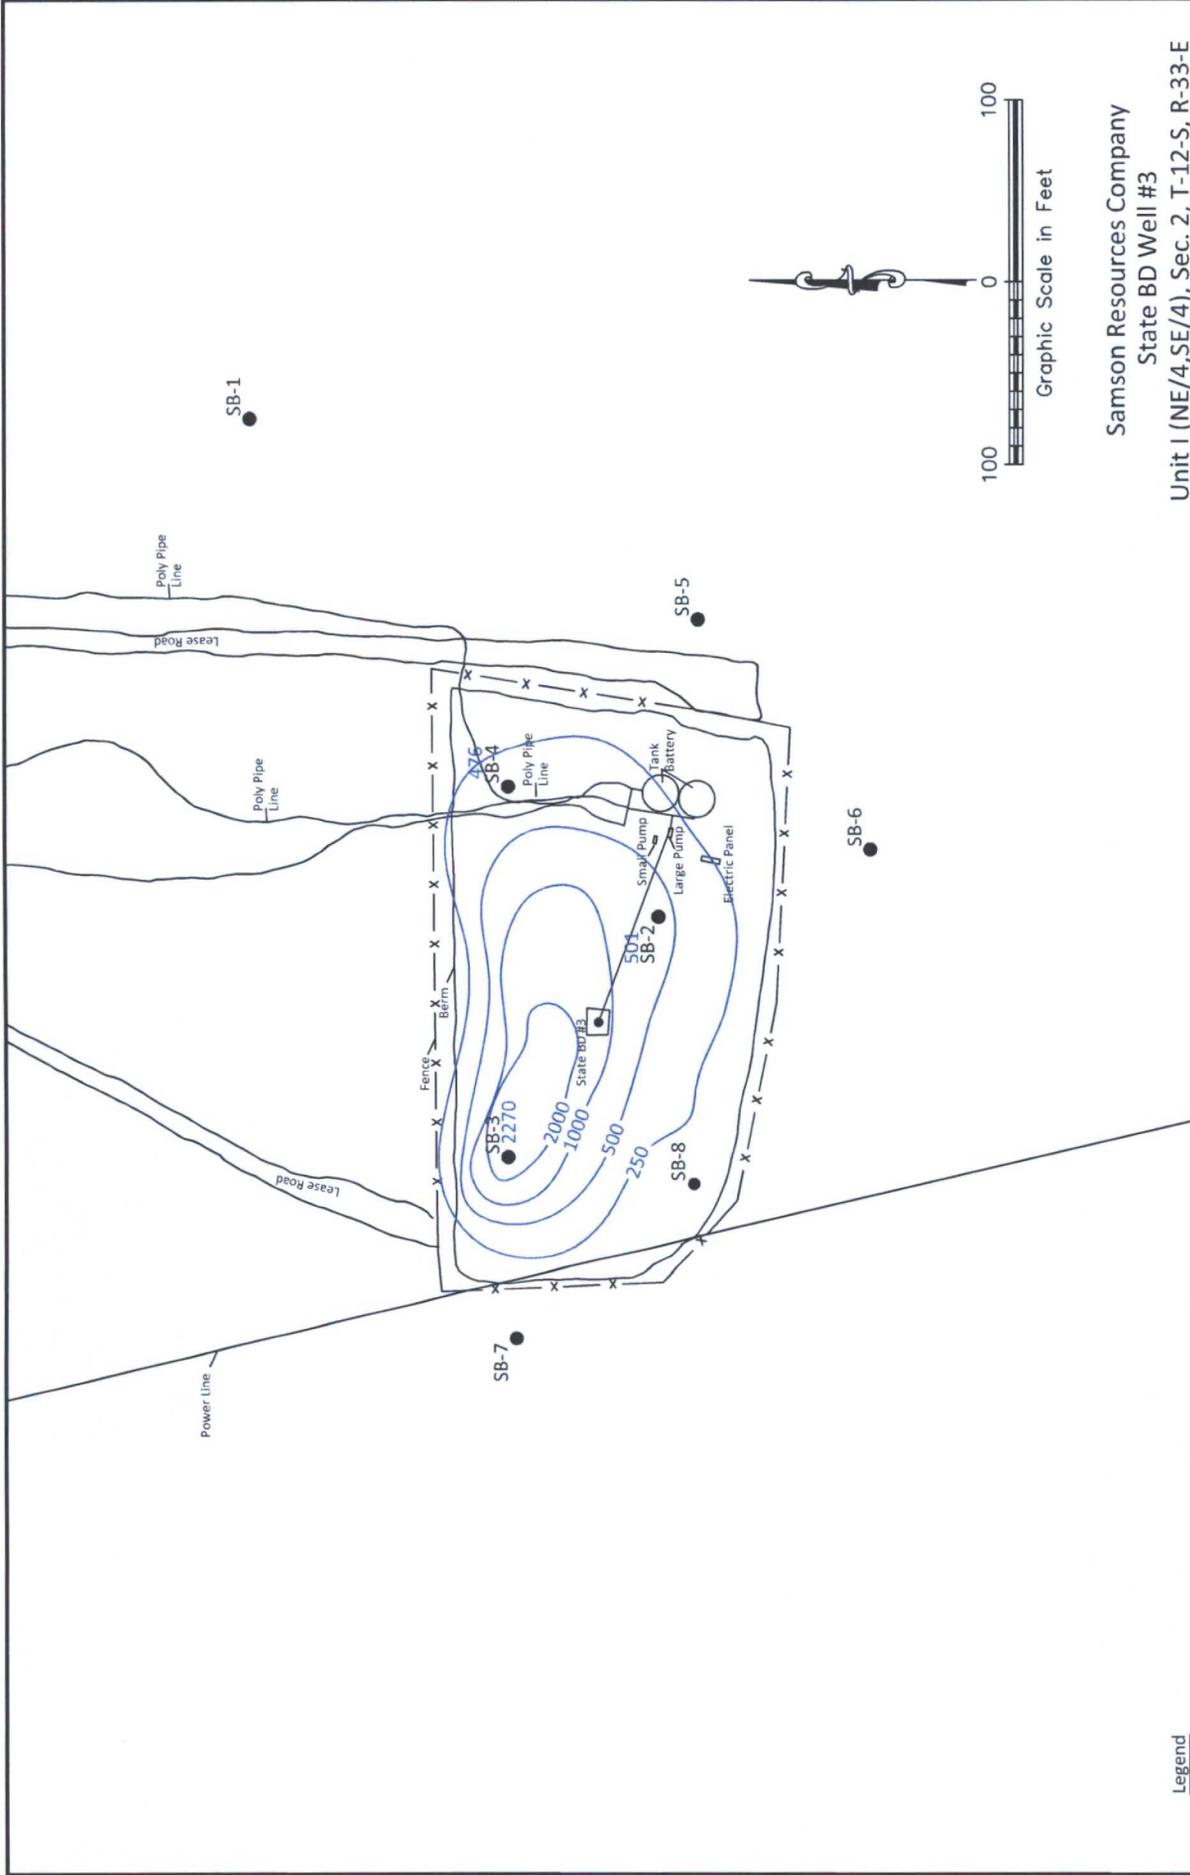
Figure 10 - Chloride Concentration in Soil at 20 Feet

- SB-3 - Soil Boring Location and Chloride Concentration in Soil at 20 feet BGS, mg/Kg, August 3,4, and 31, 2010
- 250 - Contour of Chloride Concentration in Soil at 20 feet BGS, mg/Kg, August 3,4, and 31, 2010

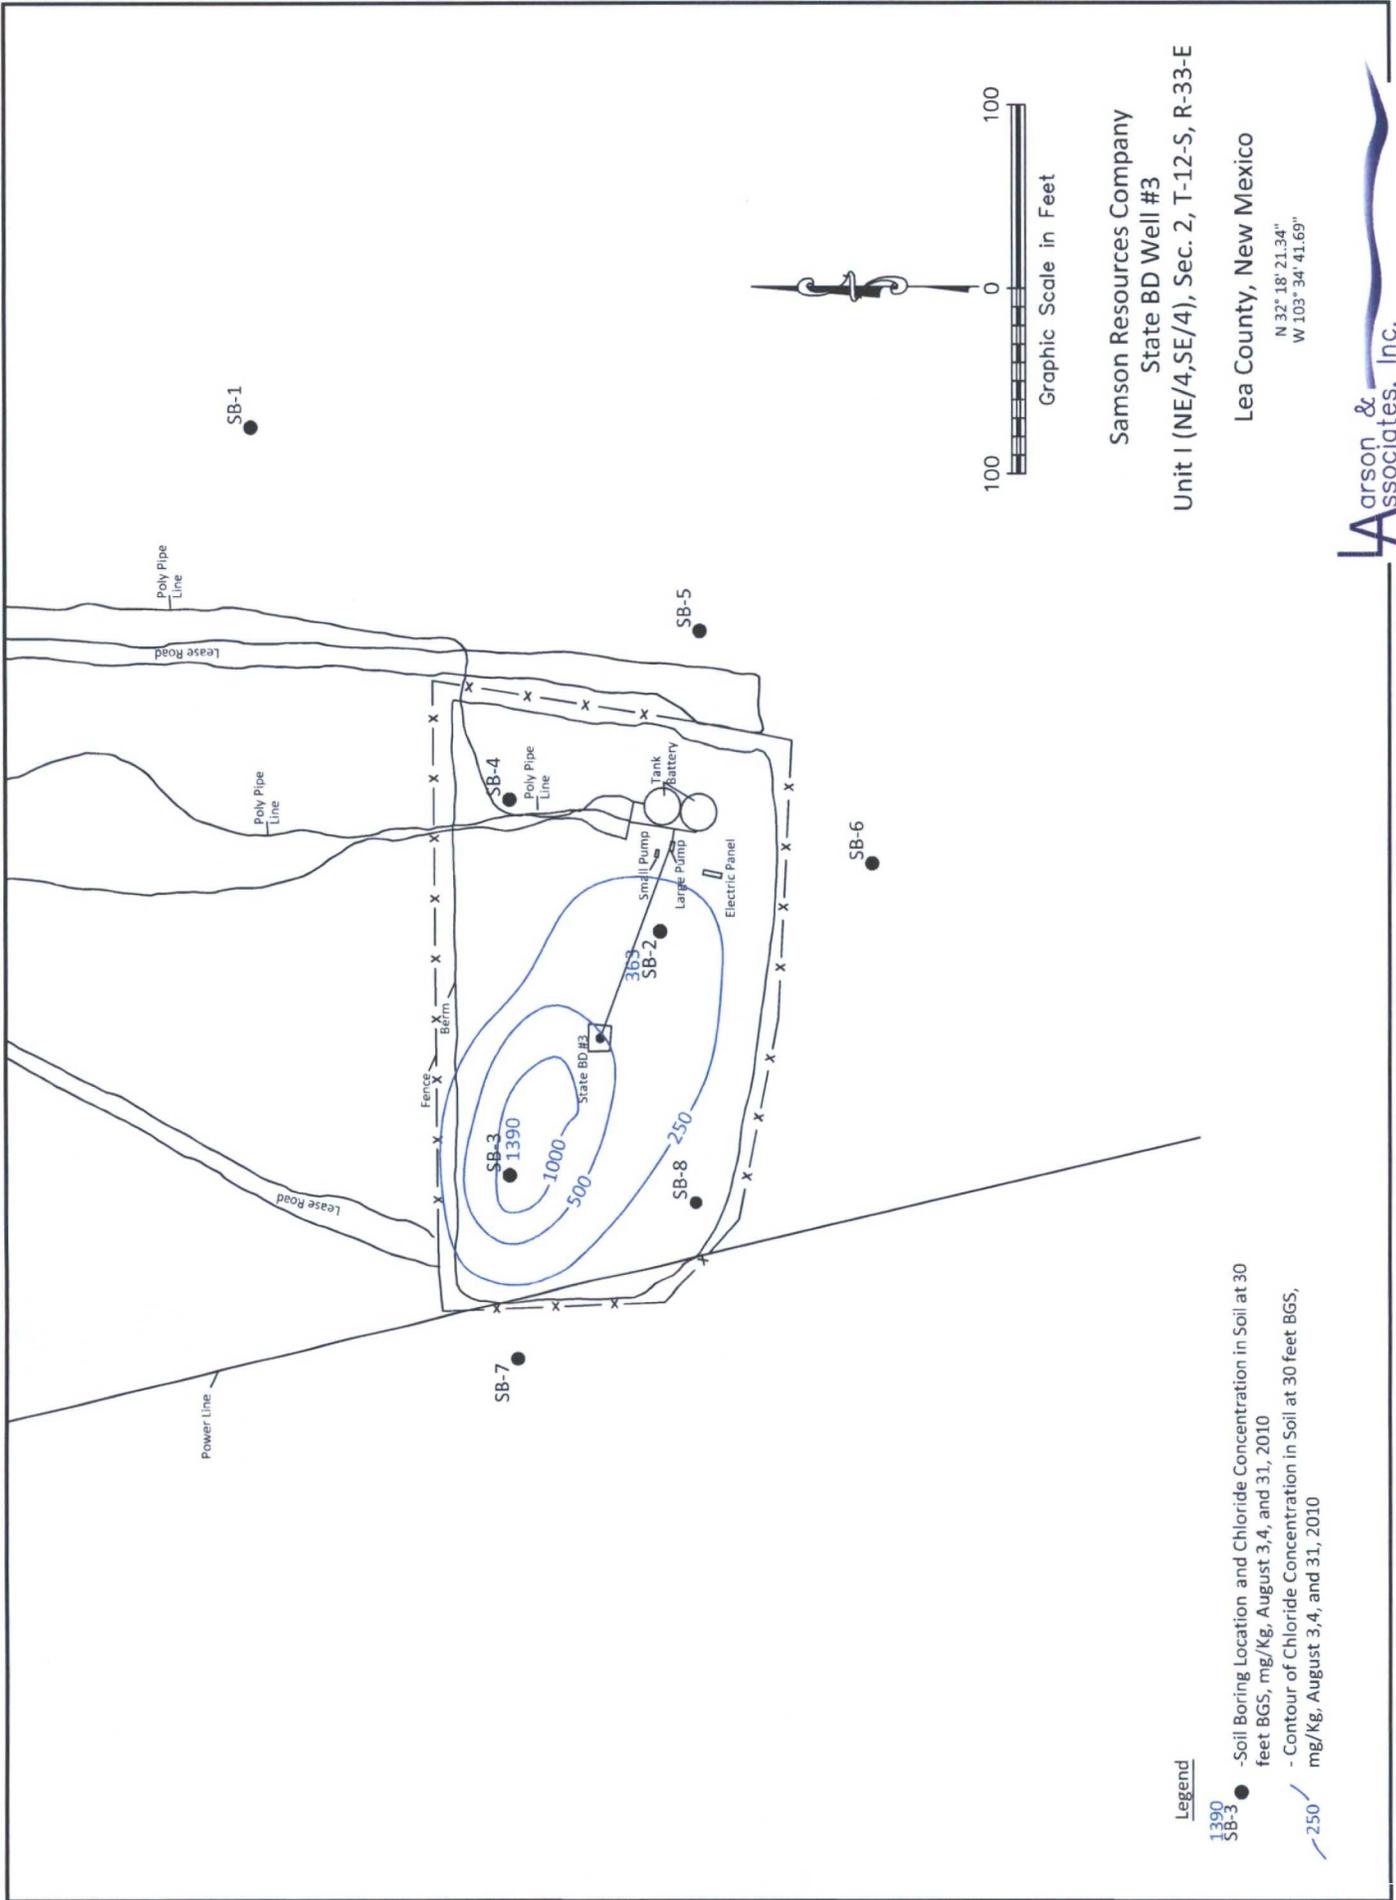
Figure 11 - Chloride Concentration in Soil at 30 Feet

- SB-3 1390 - Soil Boring Location and Chloride Concentration in Soil at 30 feet BGS, mg/Kg, August 3, 4, and 31, 2010
- 250 - Contour of Chloride Concentration in Soil at 30 feet BGS, mg/Kg, August 3, 4, and 31, 2010

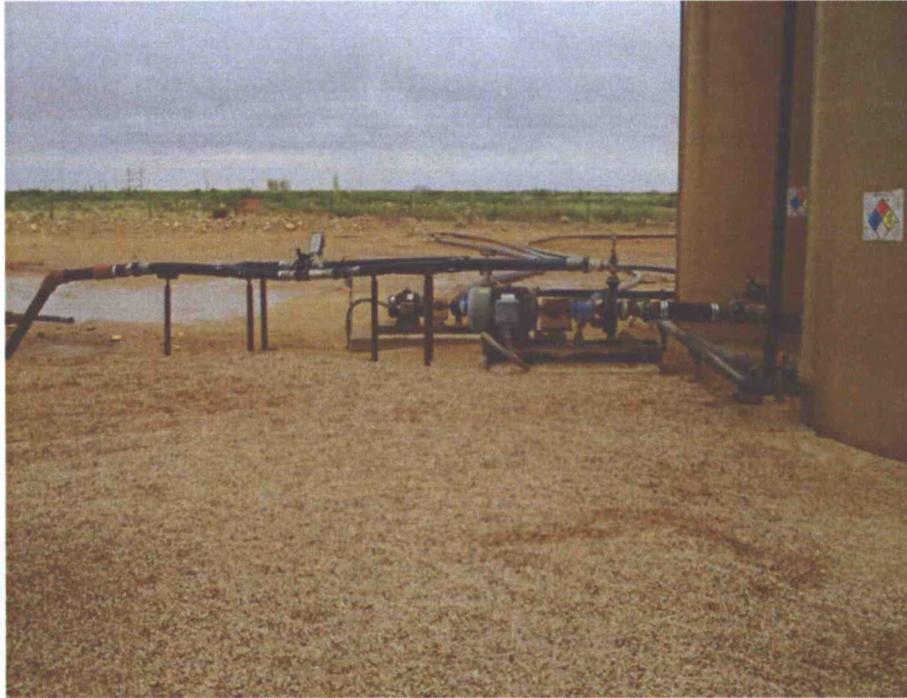
July 1, 2010 – West side of tank battery viewing north.

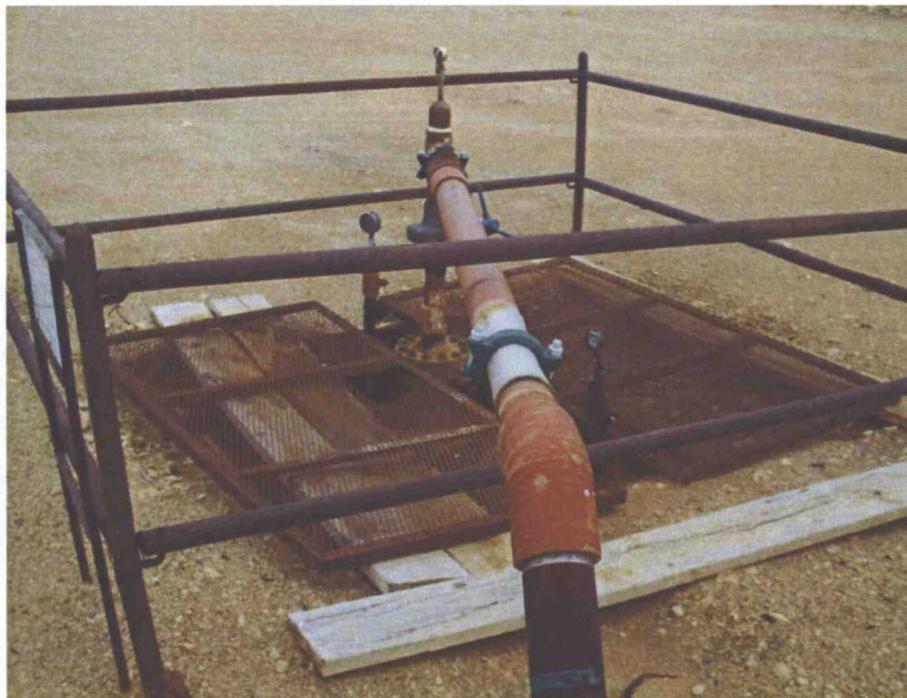
July 1, 2010 – SWD Well viewing northwest.

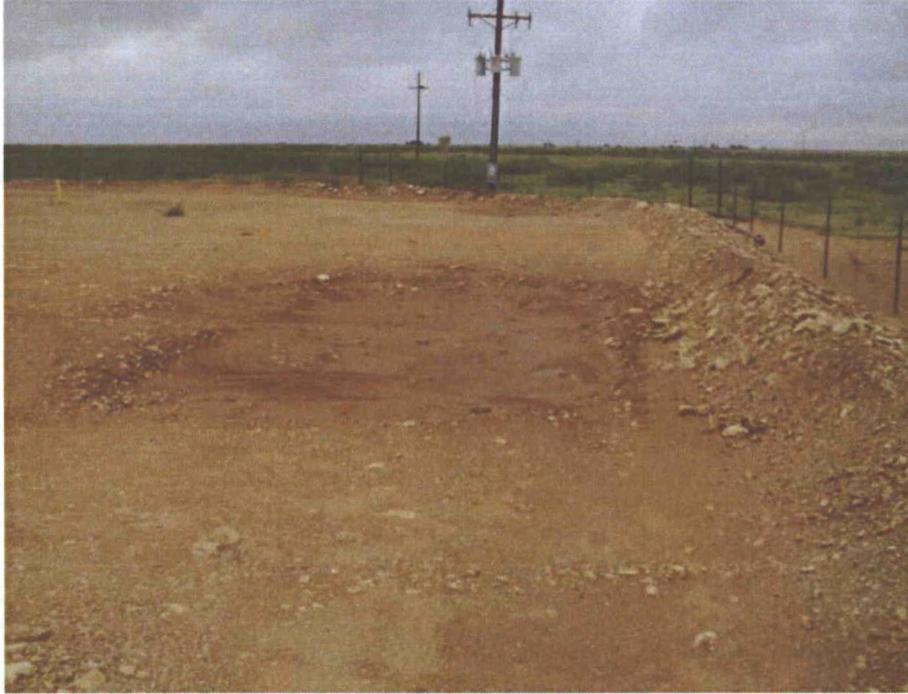
July 1, 2010 – Northeast of tank battery viewing north.
