Release Notification and Corrective Action

Name of Company: Samson Resources Company	Contact: Autumn Long, Environmental Specialist
Address: Two West Second Street, Tulsa, OK 74103-3103	Telephone No.: (918) 591-1364
Facility Name: State BD Well #3	Facility Type: Injection (SWD) Well and Tank Battery

Type of Release: Produced Water	Volume of Release: 785 bbl	Volume Recovered: 730 bbl
Source of Release: Flange Gasket Failure at Injection Pump	Date and Hour of Occurrence: 6-19-2010@05:52 hrs	Date and Hour of Discovery: 6-19-2010@05:52 hrs
Was Immediate Notice Given? <input checked="" type="checkbox"/> Yes <input type="checkbox"/> No <input type="checkbox"/> Not Required	If YES, To Whom? E.L. Gonzalez - OCD District 1 - Initial verbal report on 6-19-2010 Geoffrey Leking - OCD District 1 - Follow up report on 6-21-2010	
By Whom? Autumn Long	Date and Hour: 6-19-2010@10:50 hrs	
Was a Watercourse Reached? <input type="checkbox"/> Yes <input checked="" type="checkbox"/> No	If YES, Volume Impacting the Watercourse.

On June 19, 2010, a flange gasket on the injection pump failed releasing approximately 785 barrels (bbl) of produced water that was retained within the earthen firewall. Samson

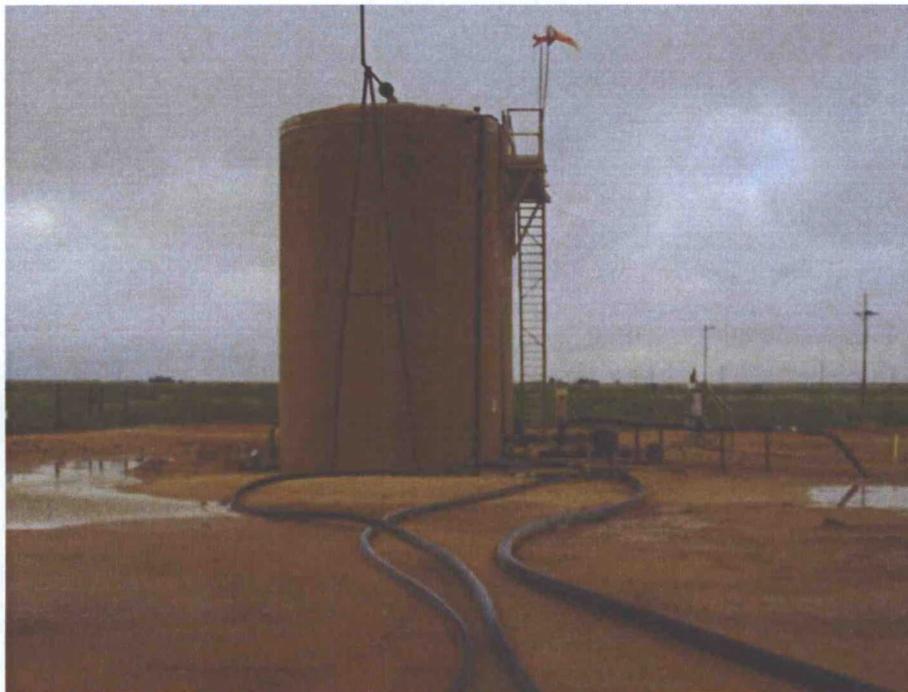
July 1, 2010 – Tank battery viewing south.

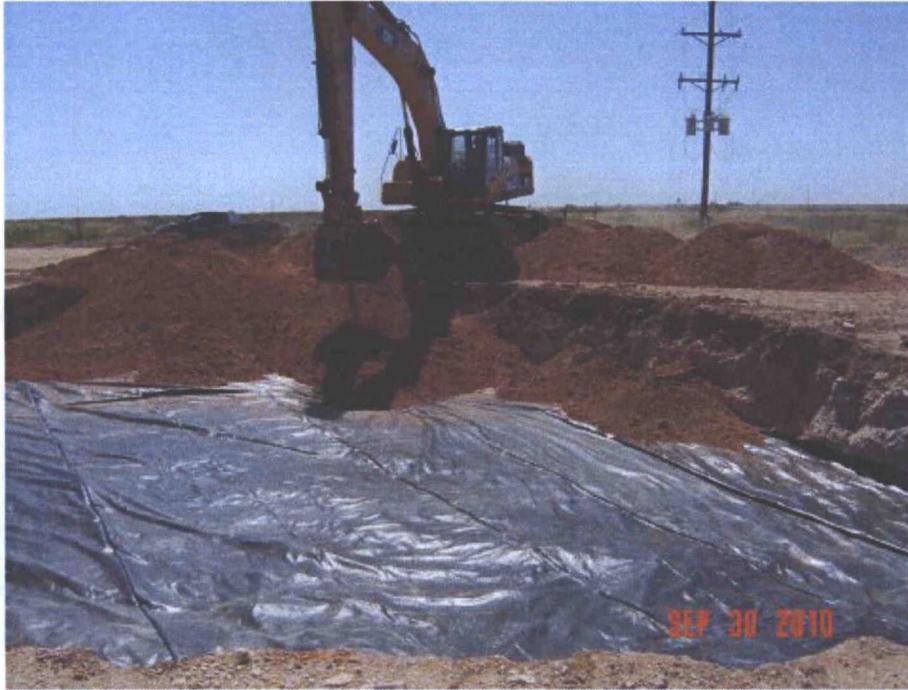
September 30, 2010 – View of Liner and backfill.

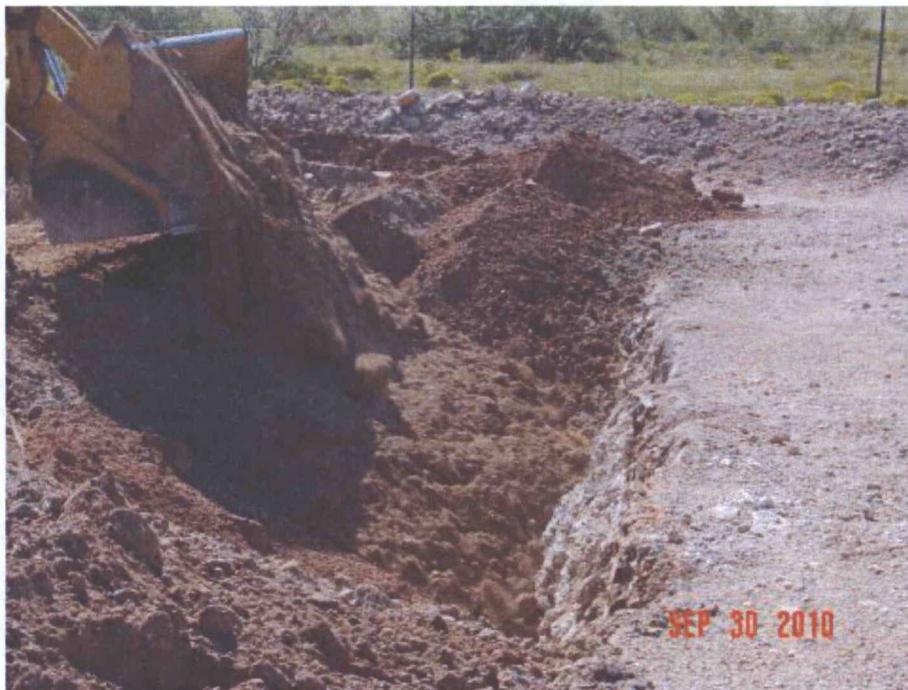
September 30, 2010 – View of excavation backfill.

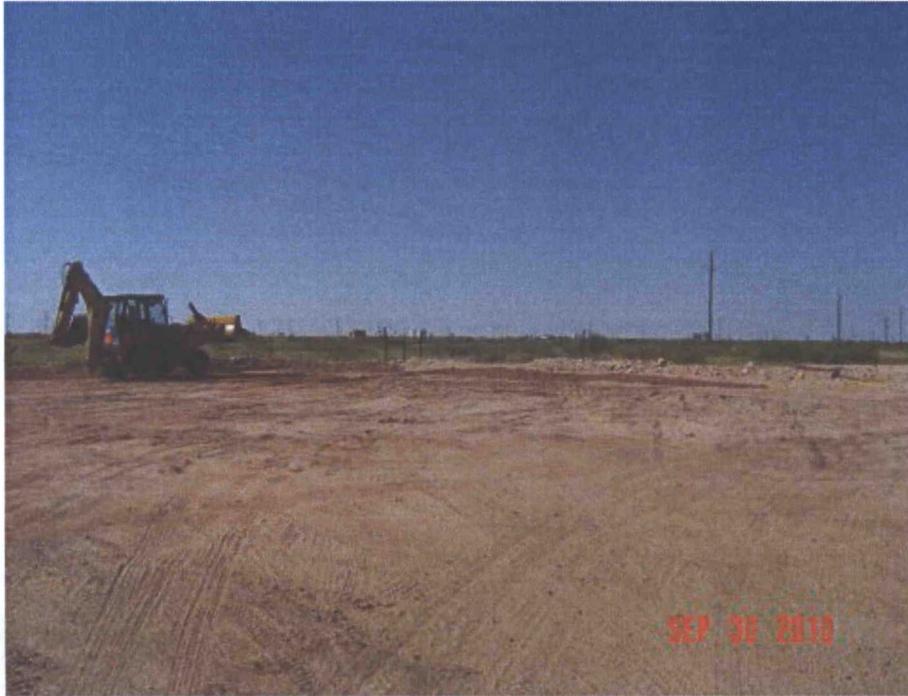
September 30, 2010 – View of backfilled excavation.
