Release Notification and Corrective Action

Status Report - Remediation/Closure Activities

Central Vacuum Unit #342 - RP#2672
Unit A, Section 36, T17S, R34E
Lea County, New Mexico

Re: Status Report - Remediation/Closure Activities
Central Vacuum Unit #342 - RP #2672
Unit A, Section 36, T17S, R34E
Lea County, New Mexico

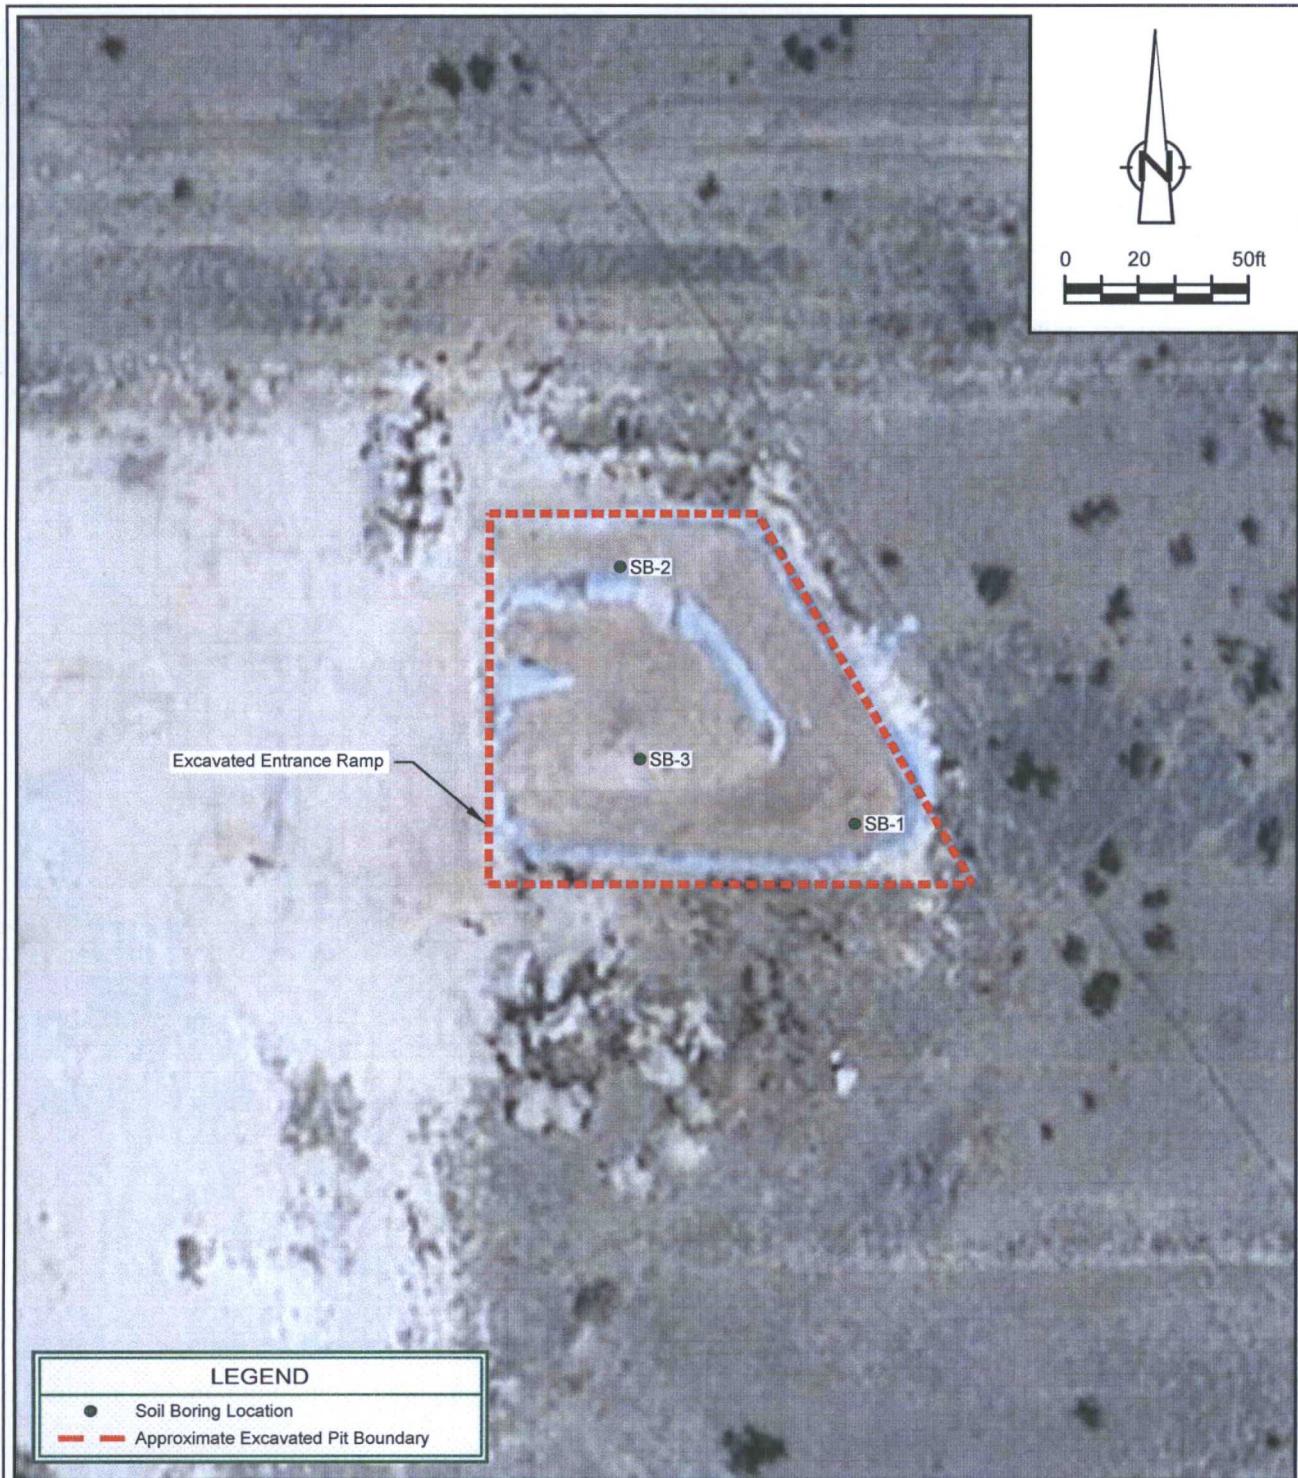
figure 2

**SOIL BORING LOCATION MAP
 CENTRAL VACUUM UNIT 342 RESERVE PIT
 SECTION 36, T 17S, R 34E (RP #2672)**
Chevron Environmental Management Company

In May 2013, three soil borings (SB-1, SB-2, and SB-3) were installed within the existing remedial excavation to a depth of 100 feet bgs. Soil boring locations are presented in Figure 2. Soil boring logs are detailed in Appendix B. Soil samples were collected at 5 to 10 foot intervals in an effort to horizontally and vertically evaluate the extent of chloride impacts. Soil samples were collected and sent to Xenco Laboratories of Midland, Texas for chloride analyses using EPA Method 300. Copies of the certified laboratory reports and chain-of-custody documentation are attached in Appendix C. The soil borings were properly plugged with bentonite. May 2013 soil analytical results are summarized in Table I. Soil cross-section and chloride results are presented in Figure 3.

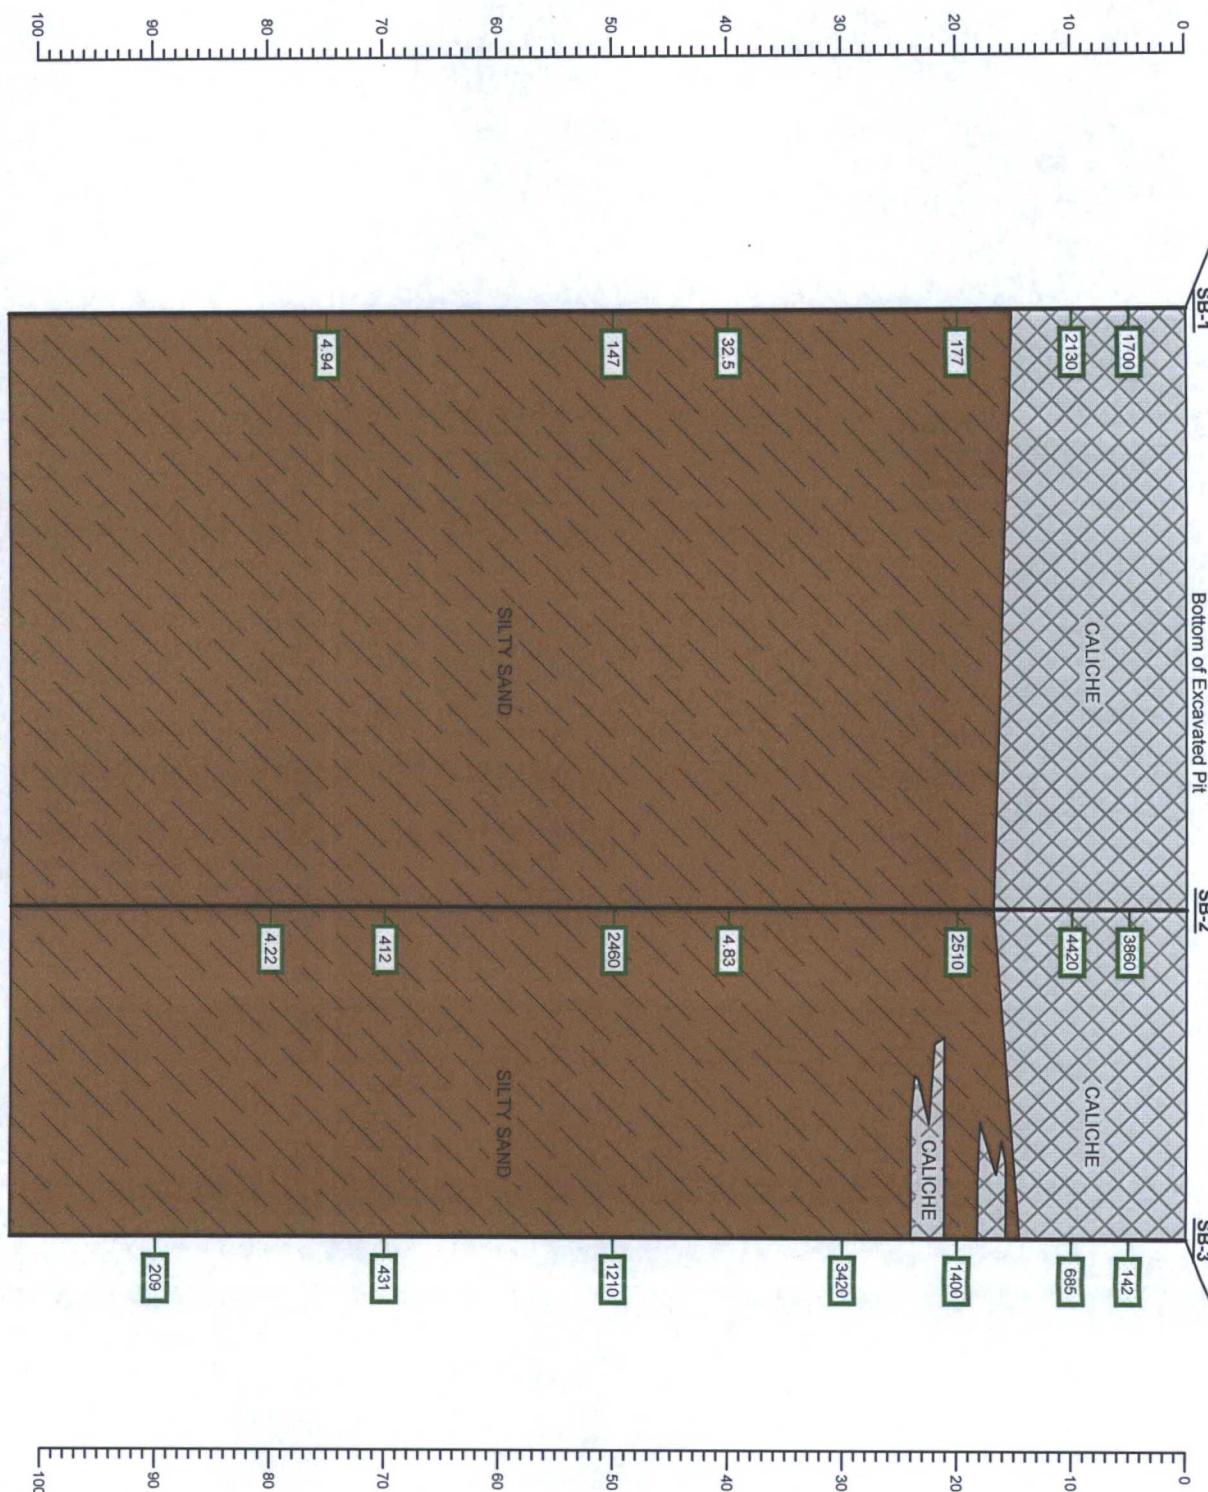
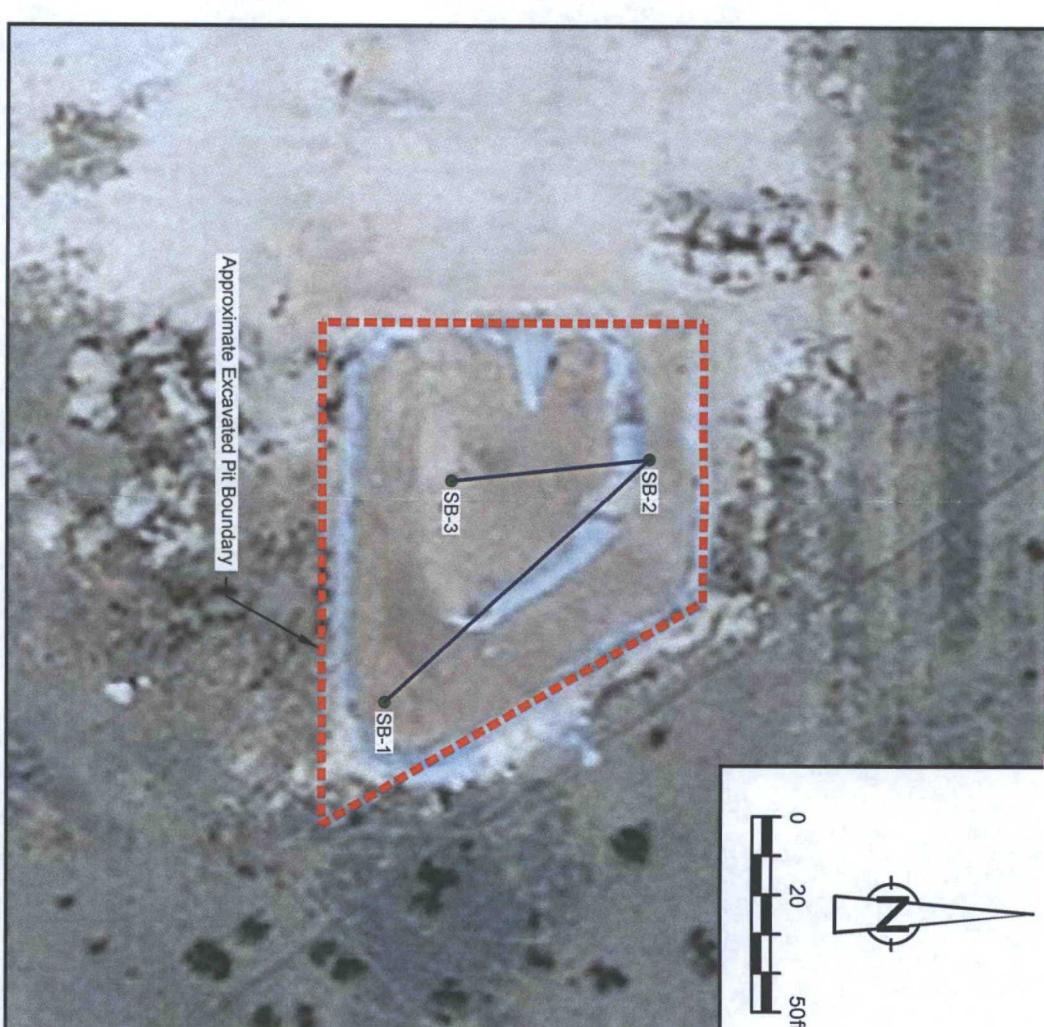
figure 3

SOIL CROSS-SECTION
CENTRAL VACUUM UNIT 342 RESERVE PIT
SECTION 36, T 17S, R 34E (RP #2672)
Chevron Environmental Management Company

- All three soil borings (SB-1, SB-2 and SB-3) demonstrate decreasing chloride levels with depth to well below recommended remediation and delineation levels.
- SB-1 demonstrated chloride levels below recommended delineation levels at 20 feet bgs (177 mg/kg), and decreasing to 75 feet bgs (4.94 mg/kg).
- SB-2 demonstrated chloride levels below recommended delineation levels at 40 feet bgs (4.83 mg/kg), and decreasing to 80 feet bgs (4.22 mg/kg).
- SB-3 demonstrated chloride levels below recommended delineation levels at 90 feet bgs (209 mg/kg).
