**Release Notification and Corrective Action**

# **CrownQuest Operating, LLC**

## **Battery Reclamation Summary**

**State 31 Battery**

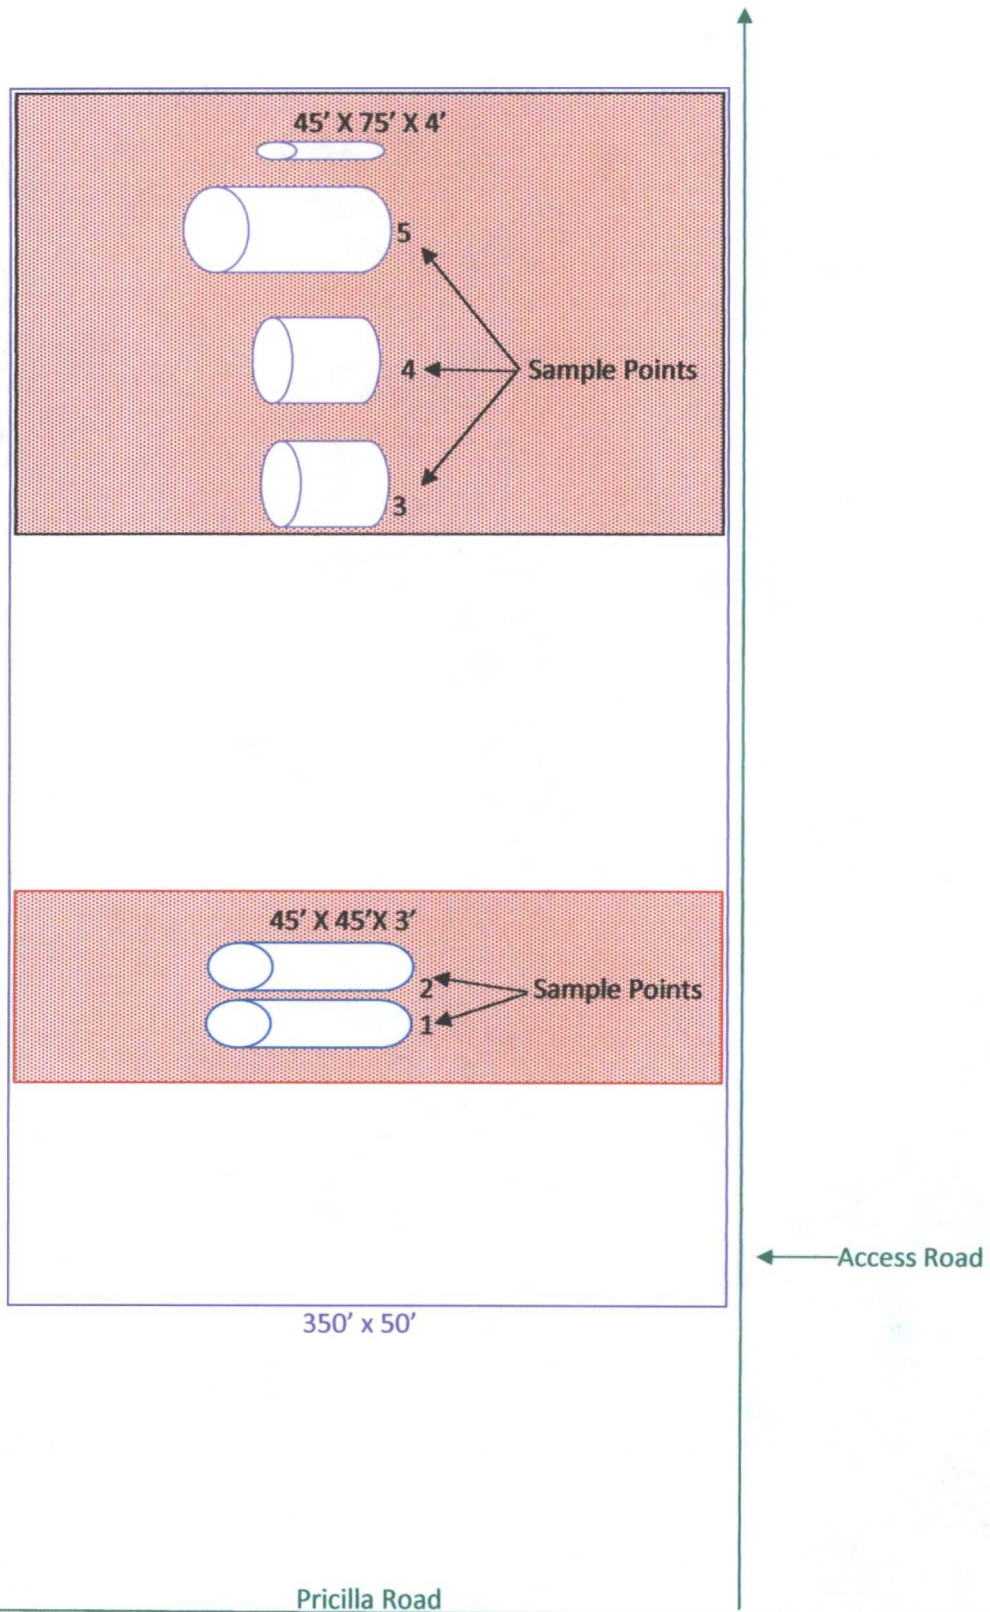
Note: Drawing is not to scale

Reclamation efforts began with the excavation of 3'-4' of soil from the areas where the heater treaters and tanks were previously located. The excavated areas were 45'W X 45'L X 3'D and 45'W X 75'L X 4'D respectively. Soil samples were obtained at each excavated location. Sample Points 1&2 were obtained at the heater treater site and Sample Points 3-5 were obtained at the tank locations. An additional composite sample of the stockpile was also obtained. All samples were transported under chain of custody to Cardinal Laboratories in Hobbs, NM for analysis. Lab analysis was conducted to determine the levels, if any, of Chlorides, TPH, and BTEX. Lab results indicate all sample points had levels below the limits set forth by NM OCD for an area with a site ranking score of 0. Mr. Larry Johnson, NM OCD Dist 1, gave approval for closure. A total of 940 yards of contaminated material was excavated from the two areas and transported to a division approved land farm for disposal.

The excavated areas were backfilled using clean material from a nearby source. The areas were contoured to match the surrounding terrain, ripped, and seeded.

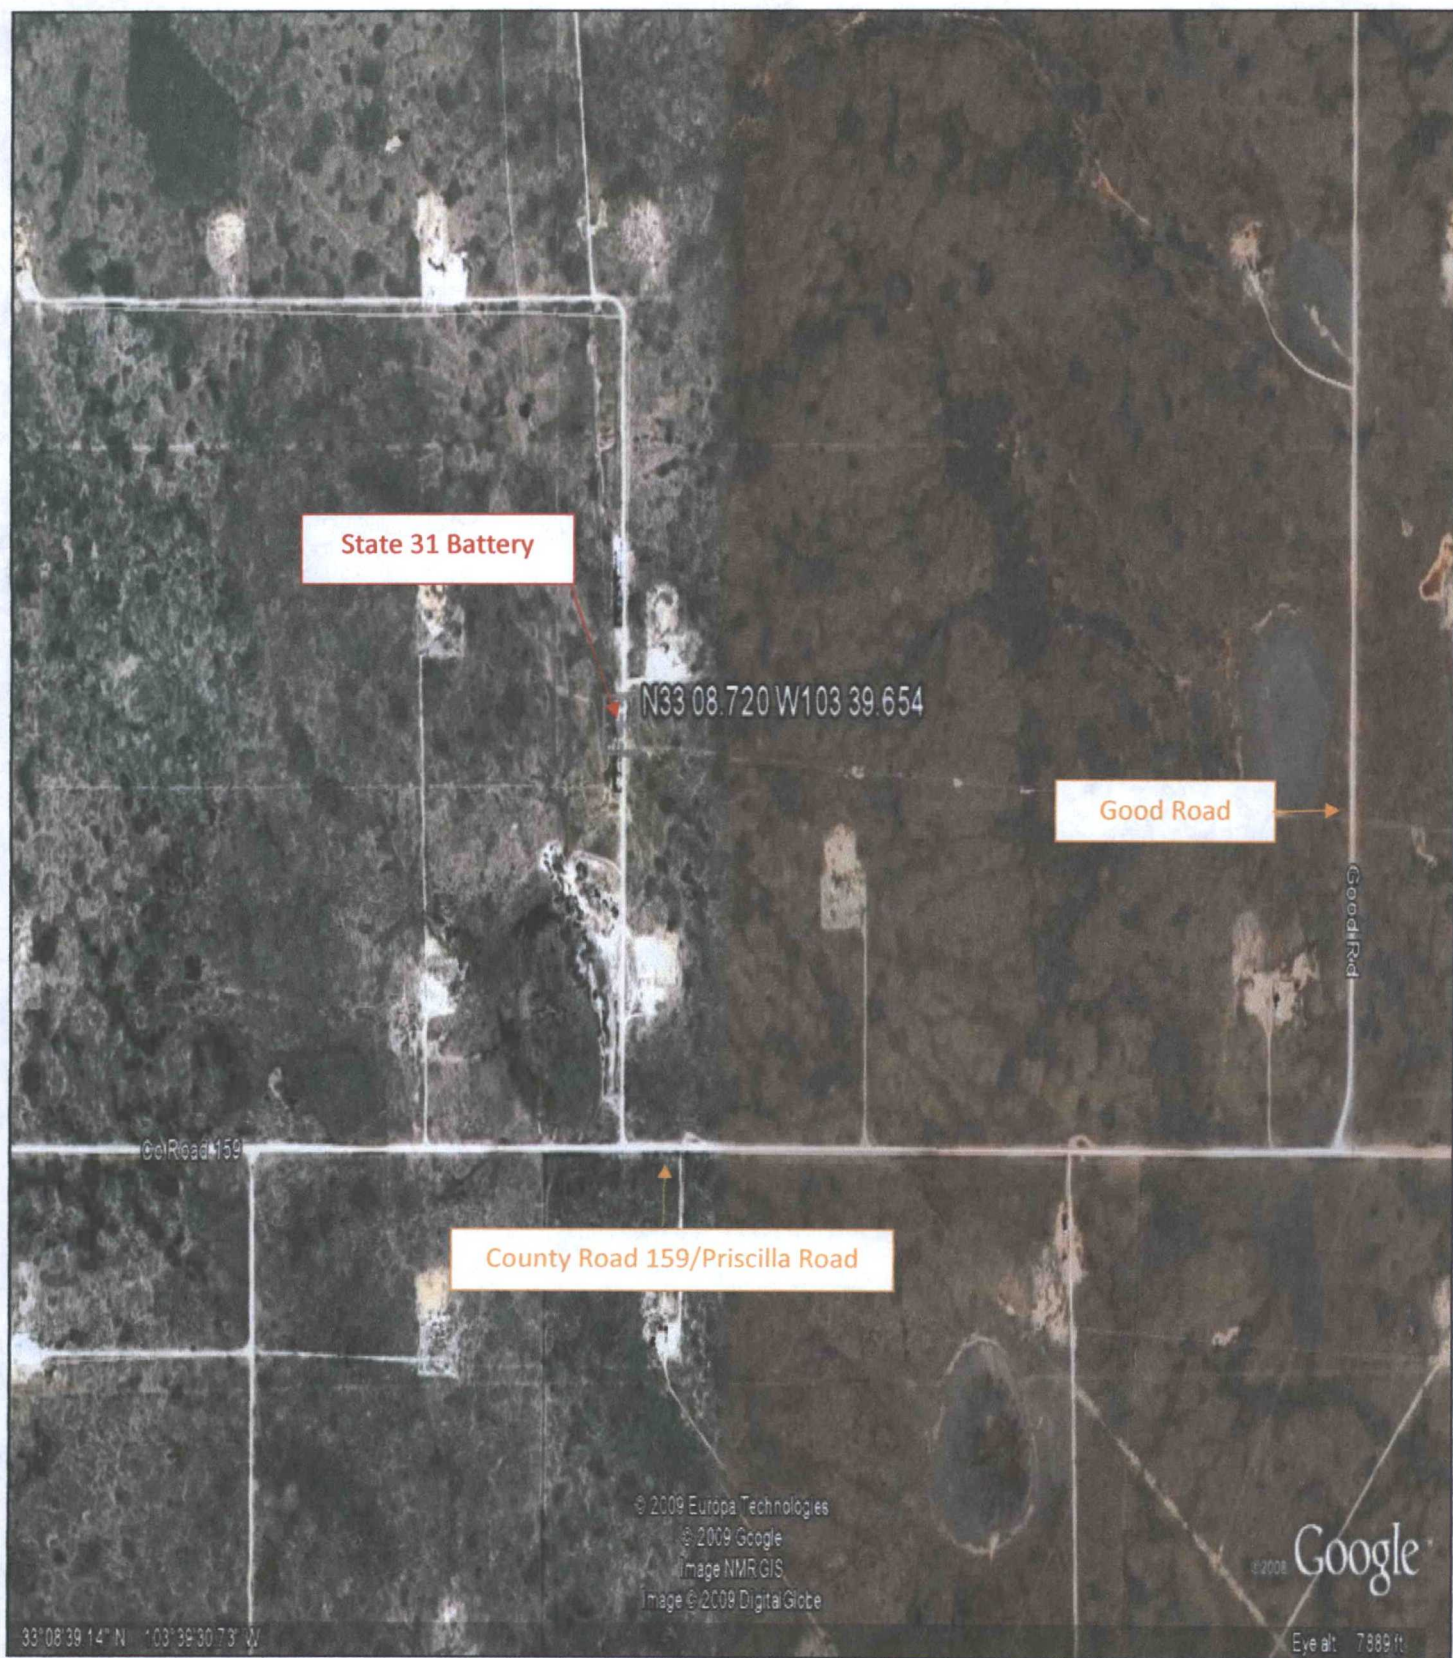
State 31 Battery

N33 08.720 W103 39.654
