Release Notification and Corrective Action

| Facility Name | Maljamar SWD 29 #1 | Facility Type | SWD |

Re: Work Plan for the COG Operating LLC., Maljamar 29 #1 SWD, Unit O, Section 29, Township 17 South, Range 32 East, Lea County, New Mexico.

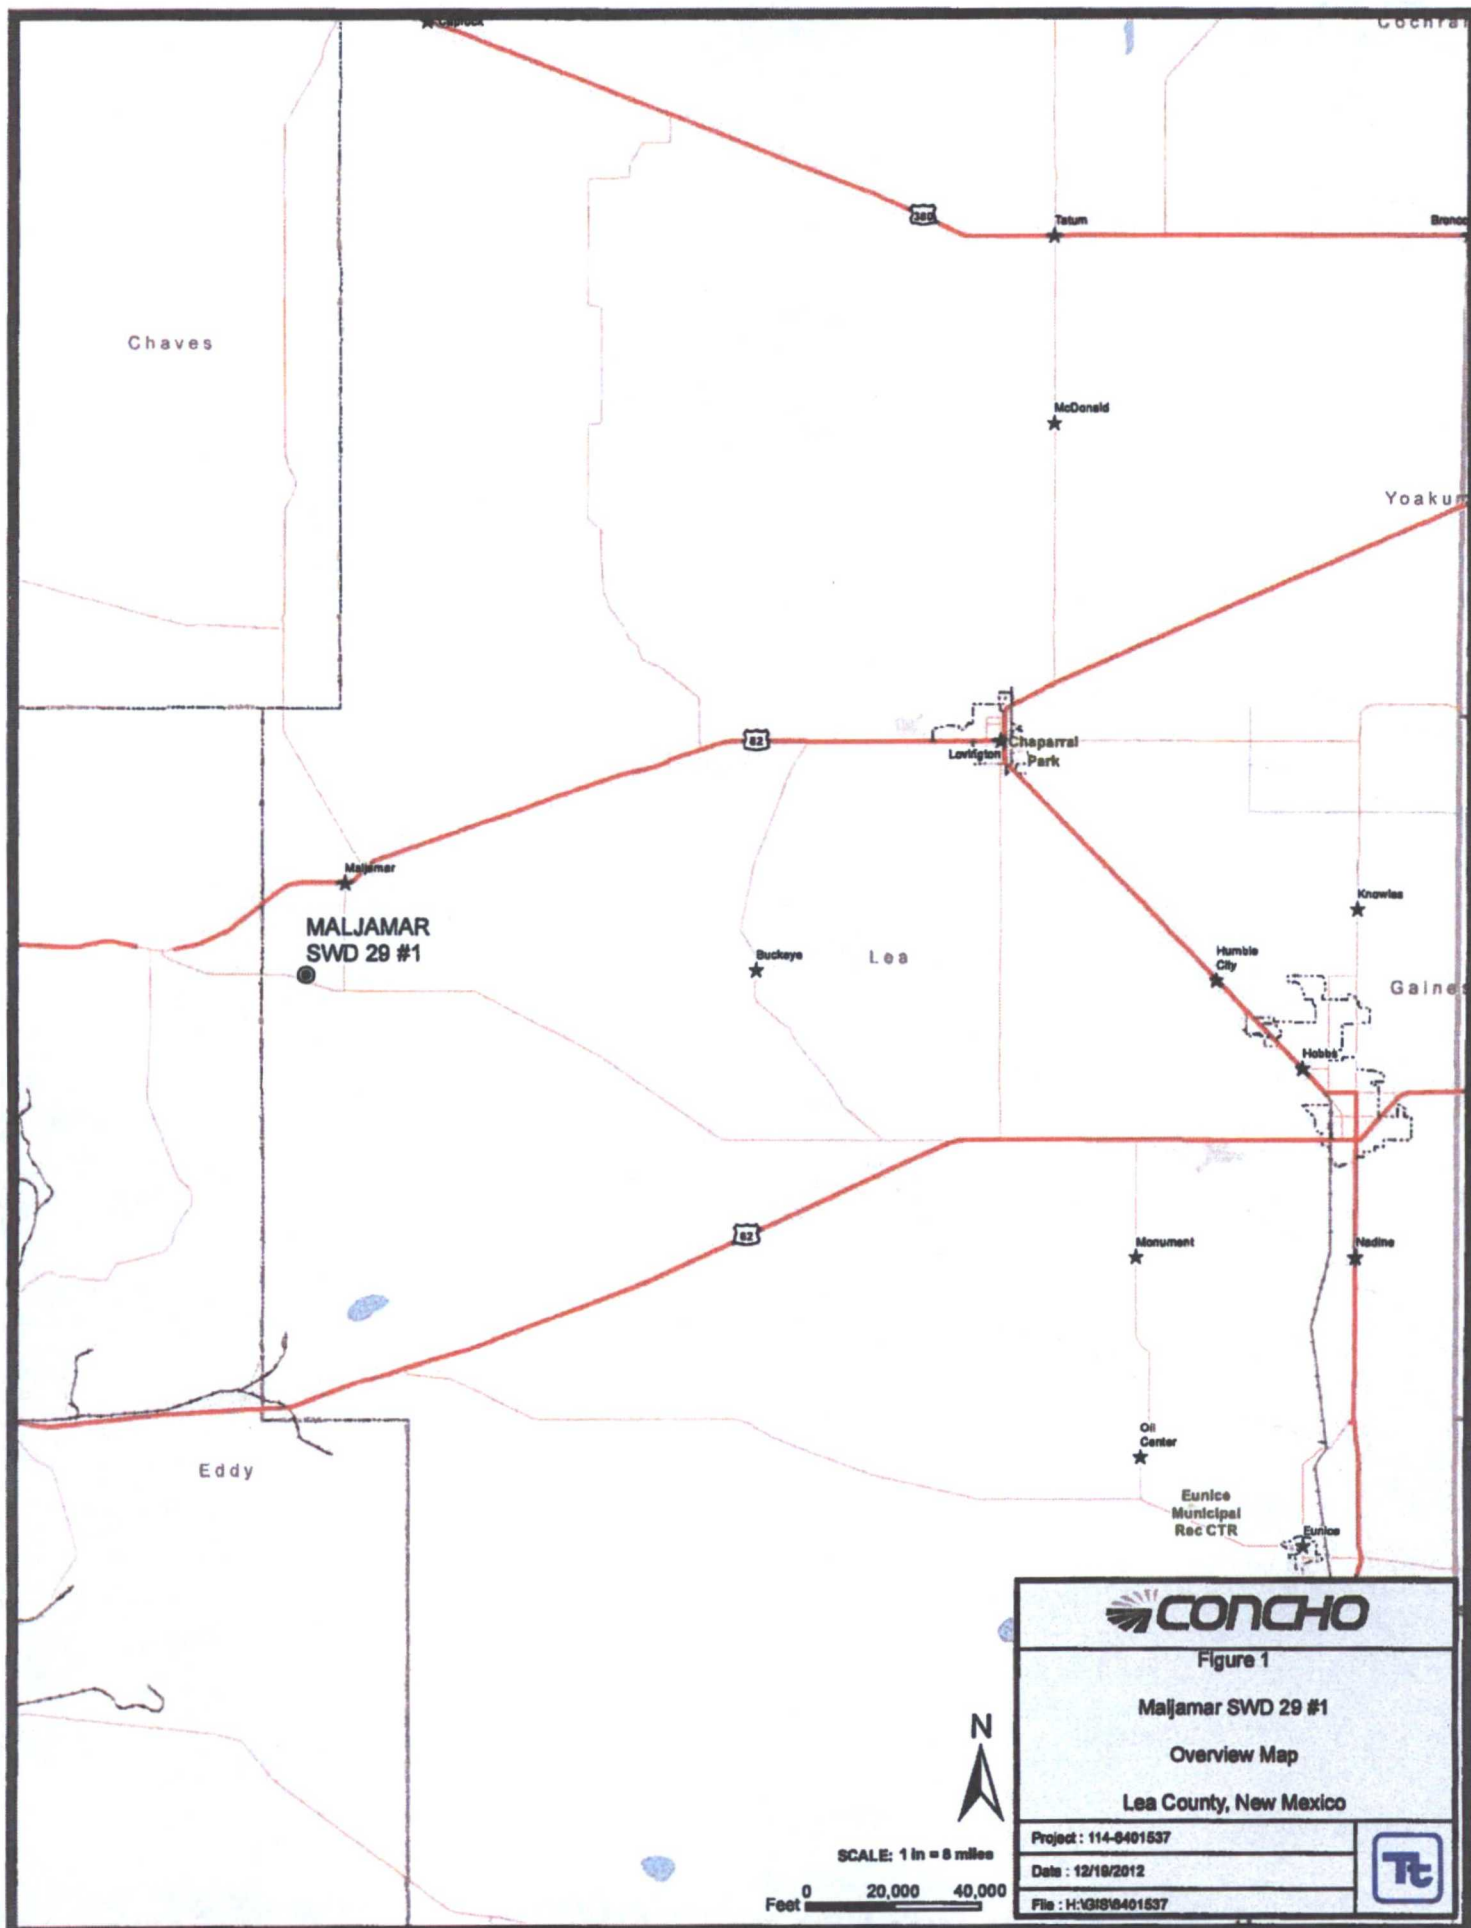
Figure 1

Tetra Tech, Inc. (Tetra Tech) was contacted by COG Operating LLC. (COG) to assess a spill that occurred at the Maljamar 29 #1 SWD located in Unit O, Section 29, Township 17 South, Range 32 East, Lea County, New Mexico (Site). The spill site coordinates are N 32.79974°, W 103.78716°. The site location is shown on Figures 1 and 2.

Overview Map

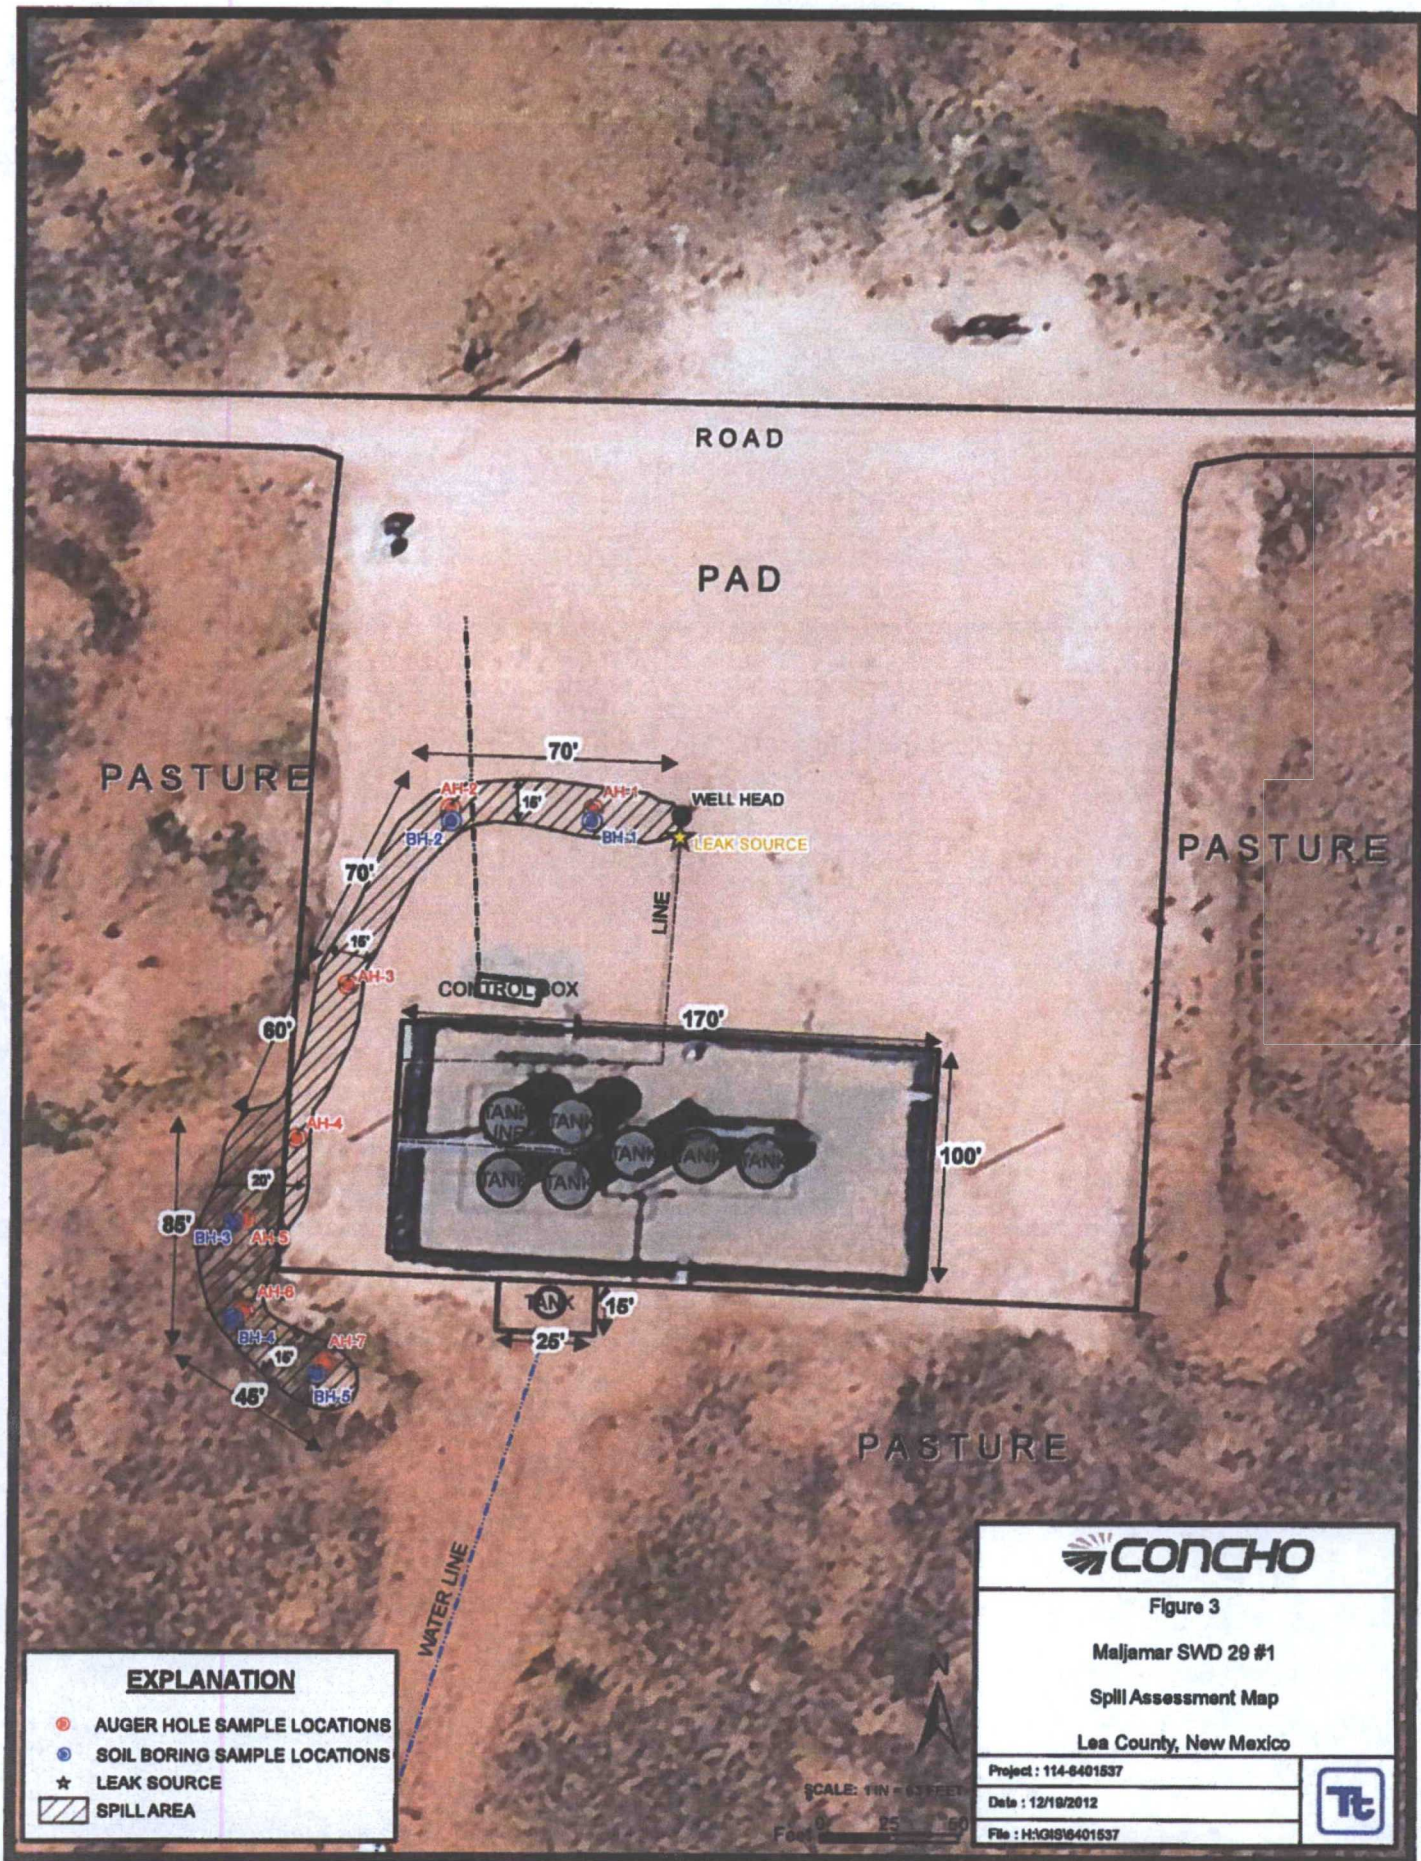
On October 30, 2012, Tetra Tech personnel inspected and sampled the spill area. The spill area on the pad measured approximately 20' x 200' and 20' x 130' in the pasture area. A total of seven (7) auger holes (AH-1 through AH-7) were installed using a stainless steel hand auger to assess the impacted soils. Selected samples were analyzed for TPH analysis by EPA method 8015 modified, BTEX by EPA Method 8021B and chloride by EPA method 300.0. Copies of laboratory analysis and chain-of-custody documentation are included in Appendix C. The sampling results are summarized in Table 1. The auger hole locations are shown on Figure 3.

On November 30, 2012, Tetra Tech supervised the installation of soil borings to assess the areas not vertically defined. A total of five (5) soil borings were installed to a depth of approximately 20.0' below surface. Copies of laboratory analysis and chain-of-custody documentation are included in Appendix C. The sampling results are summarized in Table 1. The soil boring locations are shown on Figure 3.

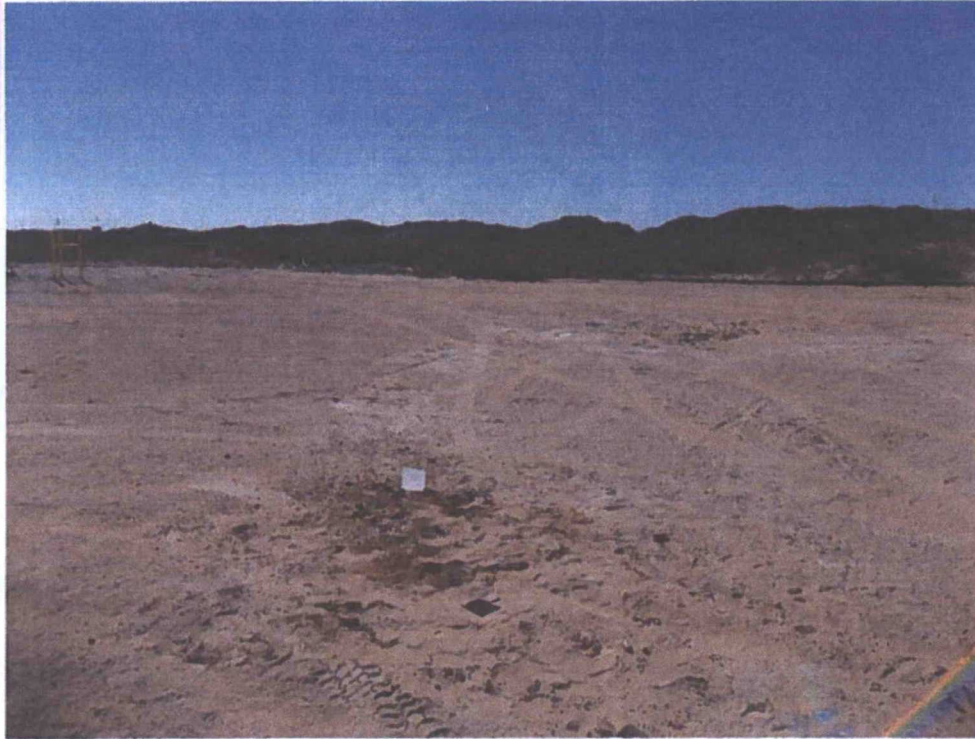
Referring to Table 1, all of the auger hole samples were below the RRAL for TPH and BTEX. The areas of AH-1 and AH-2 showed a shallow chloride impact and were vertically defined with chloride concentrations of 24.6 mg/kg (1-1.5') and 134 mg/kg (2-2.5'), respectively. The remaining auger holes were not vertically defined. Auger holes (AH-1, AH-5, AH-6 and AH-7) did show the chlorides concentrations declining, but spiked with depth towards the auger hole bottoms.

Areas of AH-1 and AH-2 on pad

COG proposes to remove impacted material as highlighted (green) in Table 1 and shown on Figure 4. In the areas of AH-1 (SB-1) and AH-3, the proposed excavation depths will range from 1.0' to 3.0' below surface and approximately 4.0' in the area of AH-2 (SB-3). The areas of AH-5 (SB-3), AH-6 (SB-4) and AH-7 (SB-7) will be excavated to a depth of approximately 9.0' to 10.0' below surface.

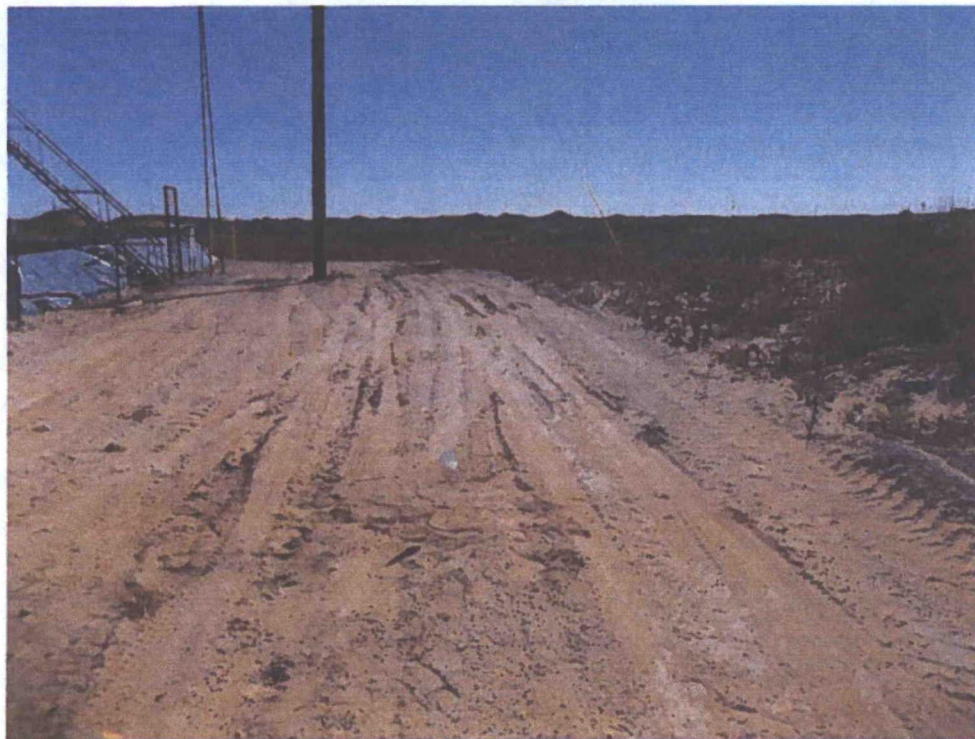
Areas of AH-3 and AH-4 on the pad.

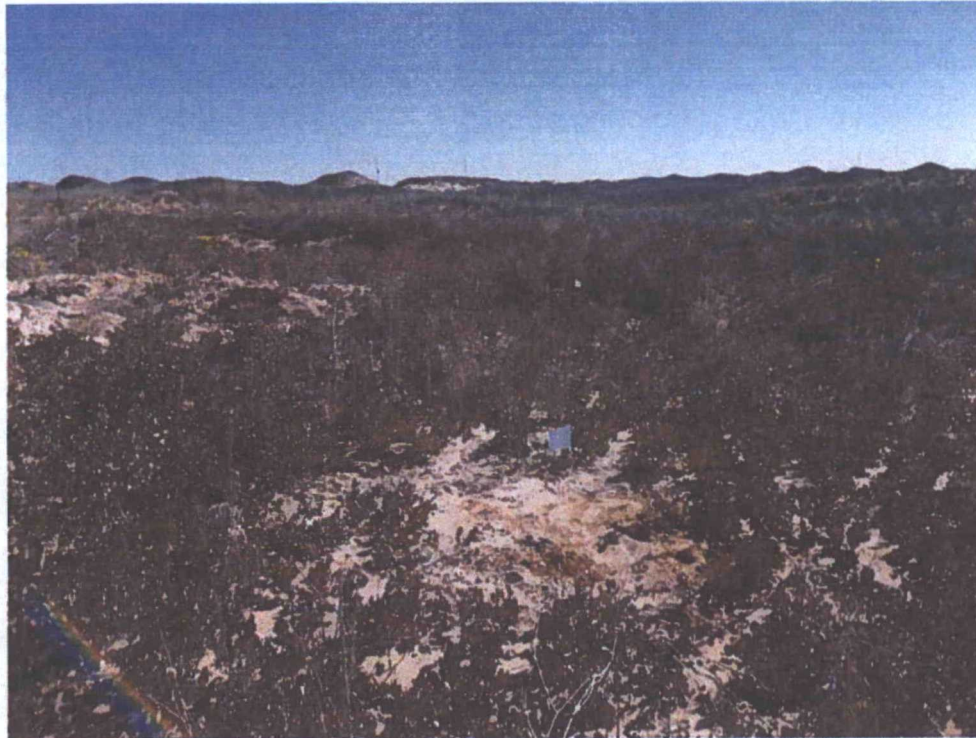
Areas of AH-5 and AH-6 in the pasture

As shown in Table 1, the shallow soils (0 to 3.0') in the areas of AH-6 and AH-7 did not show a significant chloride impact the soils. Prior to excavating the soils to approximately 9.0' to 10.0', Tetra Tech proposes to excavate these areas to an approximate depth of 3.0' below surface and field screen the excavated soils for chlorides. Based on the results, either the soil will be transported to disposal or used to backfill these areas. Tetra Tech will contact the NMOCD and BLM to review the sampling results for proper approval.

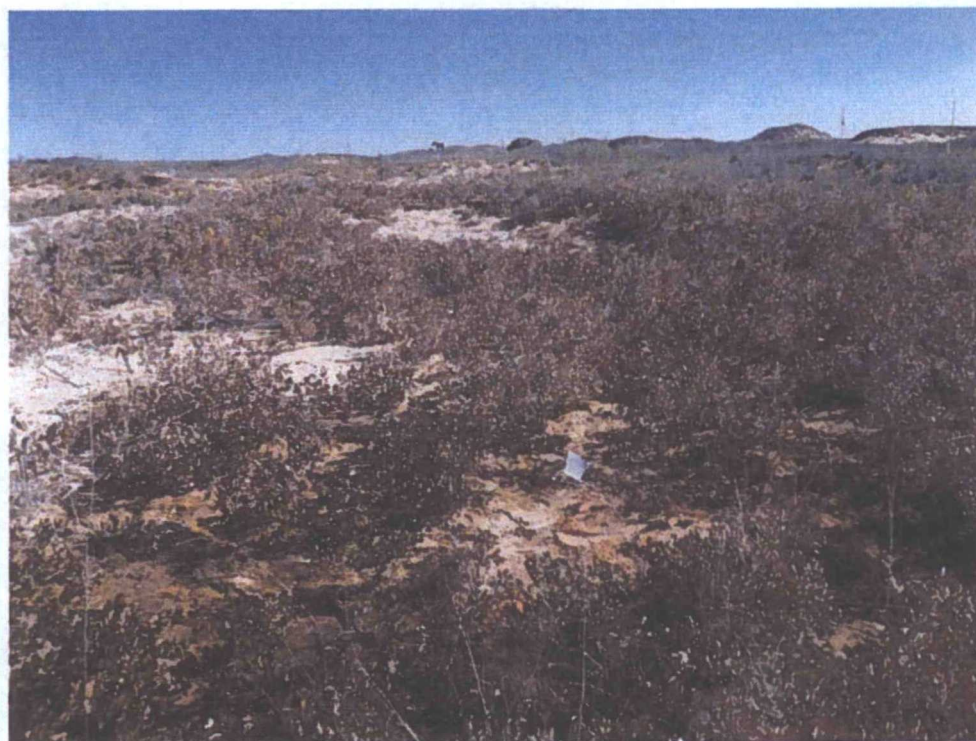
Area of AH-7 in the pasture
