Release Notification and Corrective Action

NEDU #519

Termination Report

Apache Corporation – NEDU #519

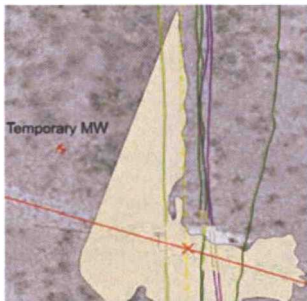
Driller:	Harrison & Cooper, Inc.		
Drilling Method:	Air rotary		Apache NEDU #519 Well ID: <div style="text-align: right;">SB-1</div>
Start Date:	4/8/2013		
End Date:	4/8/2013

Comments:	Location: UL/I sec. 15 T-21-S R-37-E Lat: 32°29'7.996"N County: Lea Long: 103°8'40.724"W State: NM
<p style="text-align: center;">DRAFTED BY: L. Weinheimer</p> <p style="text-align: center;">TD = 50 ft GW = 39 ft</p>

Depth (feet)	Chloride field tests	LAB	PID	Description	Lithology	Well Construction
				6 " Brown Sand Top Soil		
				Caliche/Sandstone		<div></div> <div>bentonite seal</div>
SS	149		5			
5 ft	106		4.7			
10 ft	120		4.7			
20 ft	119		2.5	Red Bed Clay		
30 ft	139		4.3			
				Red Bed Clay		
40 ft	152		2.5			
				Red Bed Clay		
50 ft

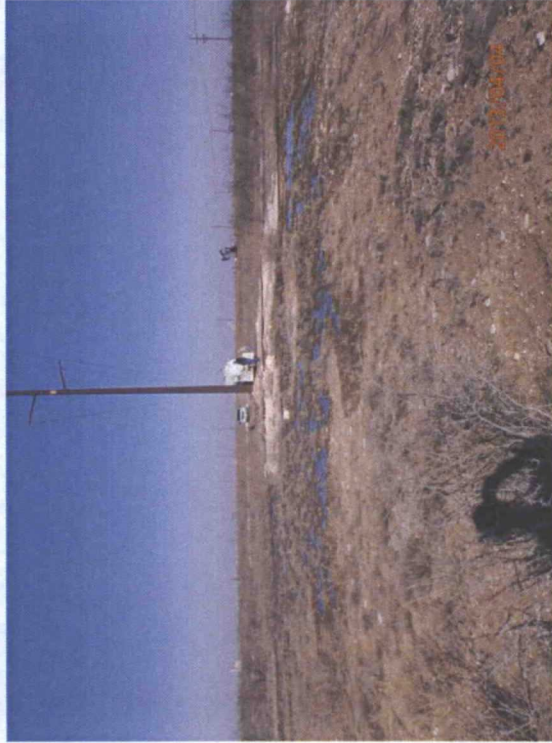
4/4/13

Initial release area, facing west

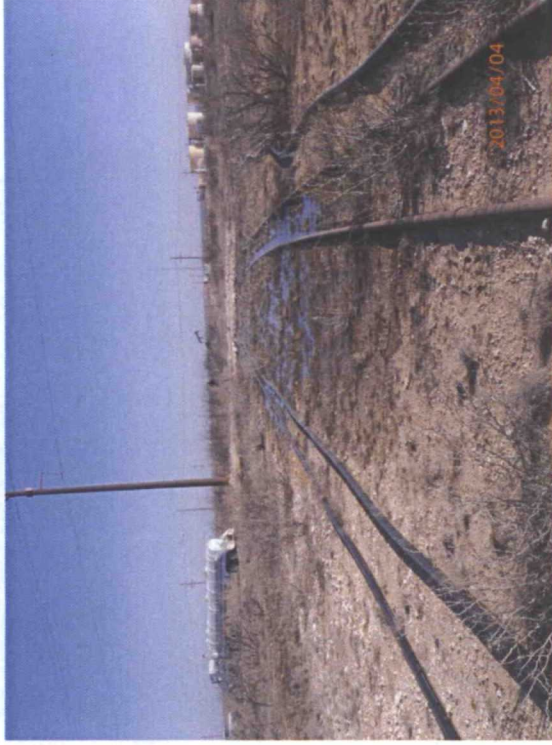
4/4/13

Initial release area, facing north

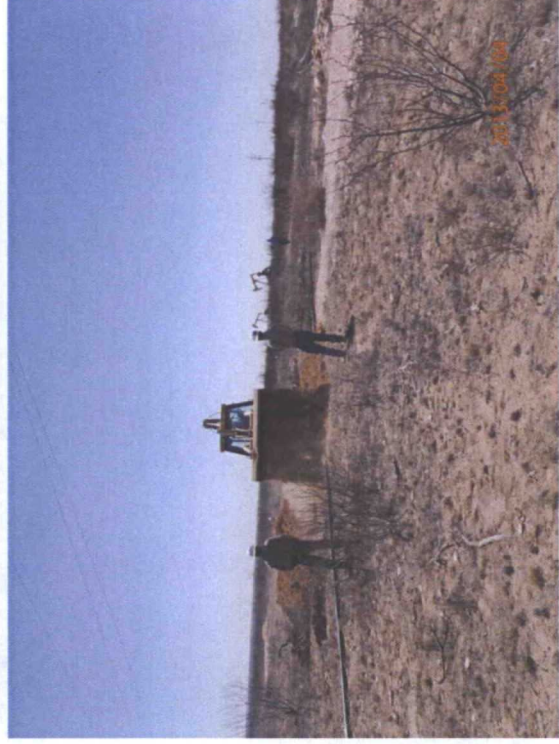
4/4/13

Covering exposed lines, facing south

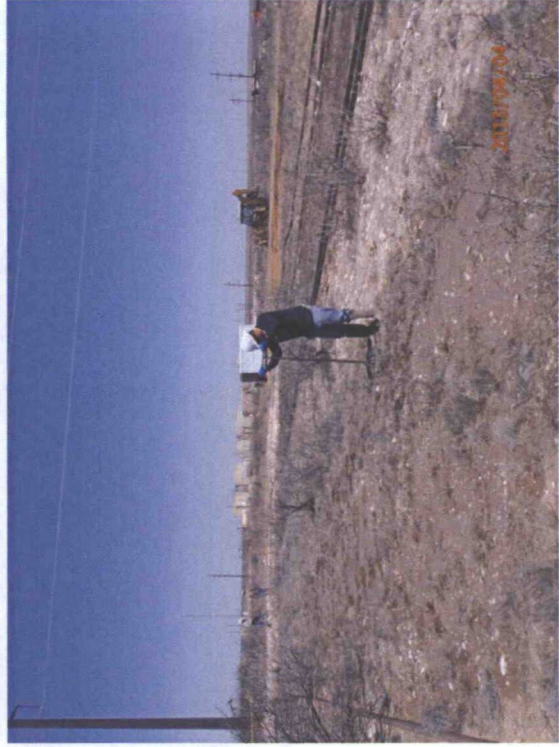
Hand auguring for samples, facing northeast 4/4/13

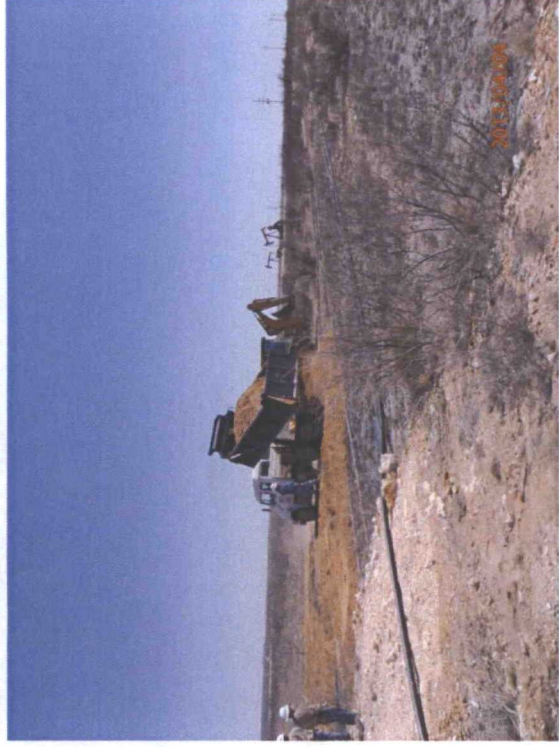
Importing soil, facing northeast 4/4/13

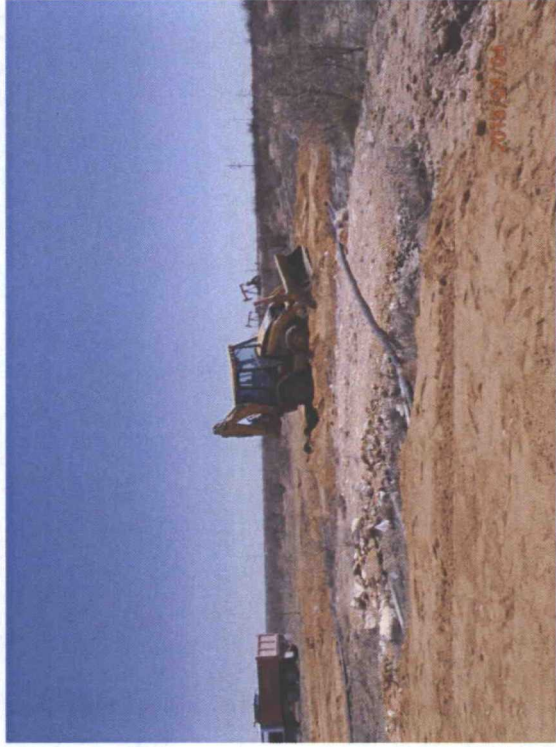
Covering exposed lines, facing northeast 4/4/13

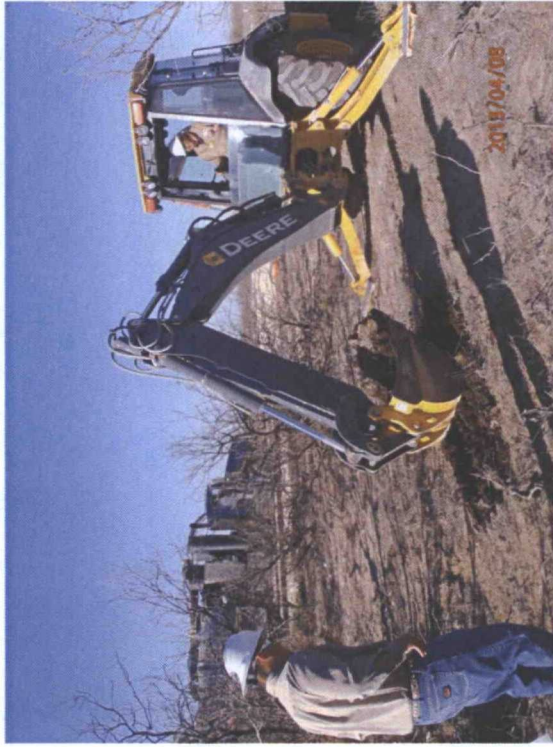
4/8/13

Digging vertical, facing southwest

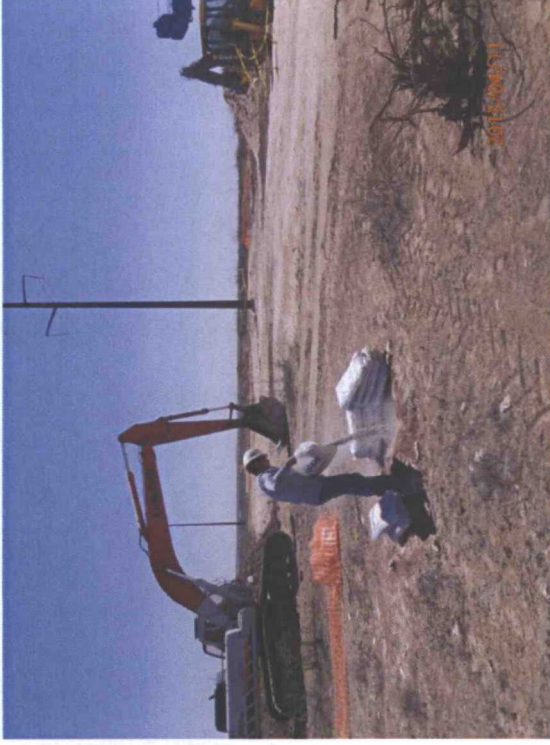
Plugging temporary MW in total with bentonite, facing southeast 4/11/13

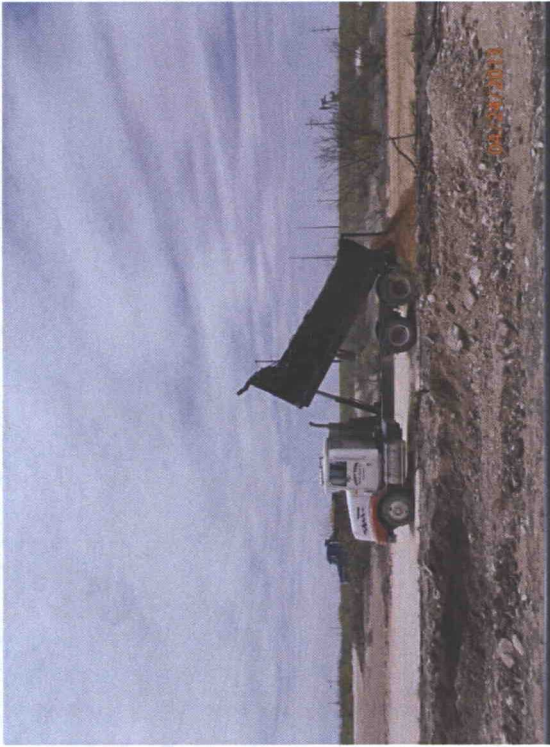
4/24/13

Importing soil, facing west

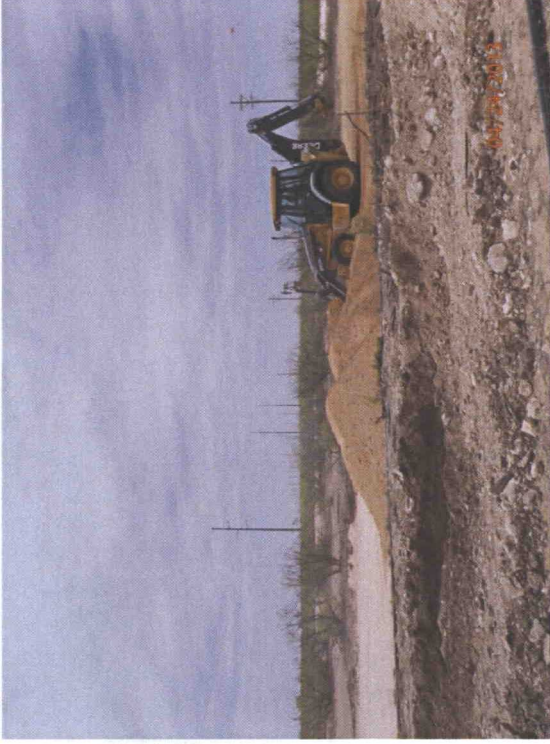
4/24/13

Backfilling site, facing west
