Release Notification and Corrective Action

Name of Company ConocoPhillips Company	Contact John W. Gates
Address 3300 North A St. Bldg 6, Midland, TX 79705-5406	Telephone No. 505.391.3158
Facility Name MCA 2A Header	Facility Type Oil and Gas

FIGURE 2	MCA 2A HEADER PRODUCED WATER EXCAVATION BOUNDARY, SOIL BORING (SB) SAMPLING LOCATIONS, AND EXCAVATION DEPTHS (FEET = ')	
	ConocoPhillips	TETRA TECH, INC.
Lea County, Texas Unit G, Sec 29, T17S, R32E		PROJECT NO. 6400314 DRAWING BY: CWD DRAWING DATE: 9/16/2010 COP PROJECT FILE

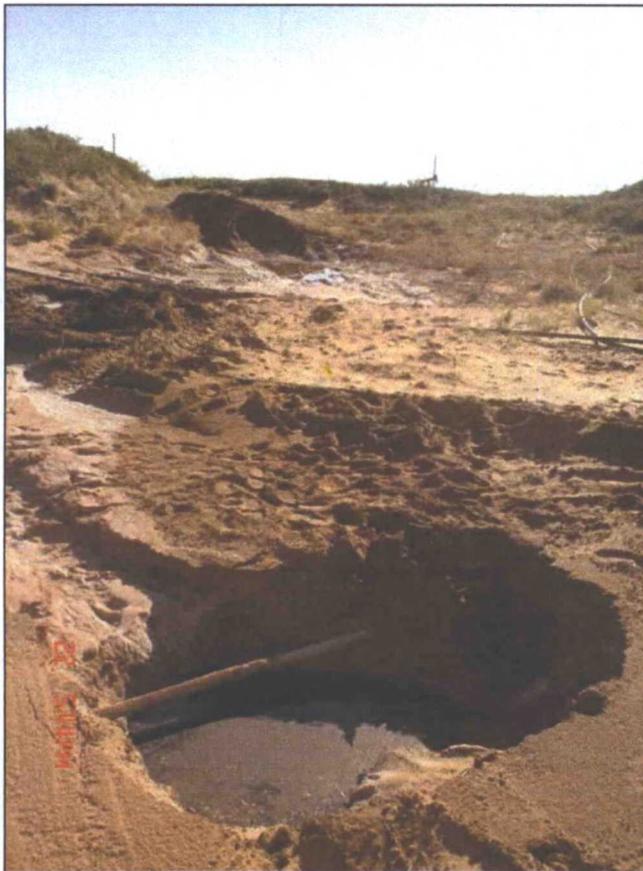
VIEW: South
Produced water
release site

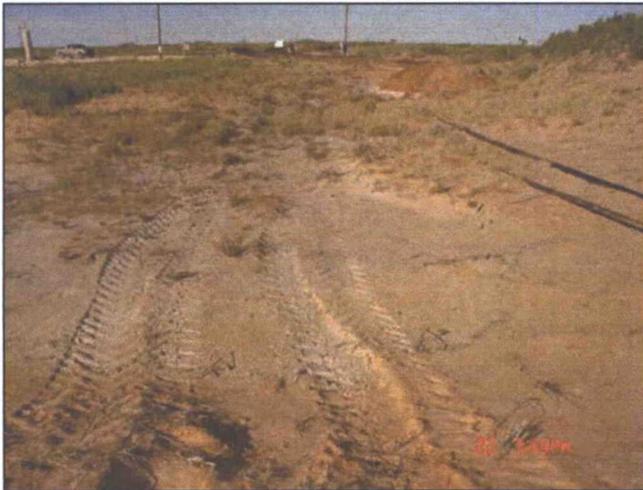
VIEW: North
Produced water release
site at south end of
affected area

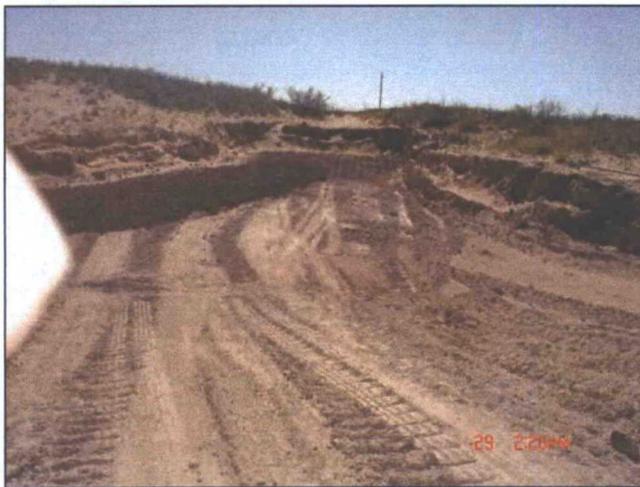
VIEW: South
Placing clay over
backfill

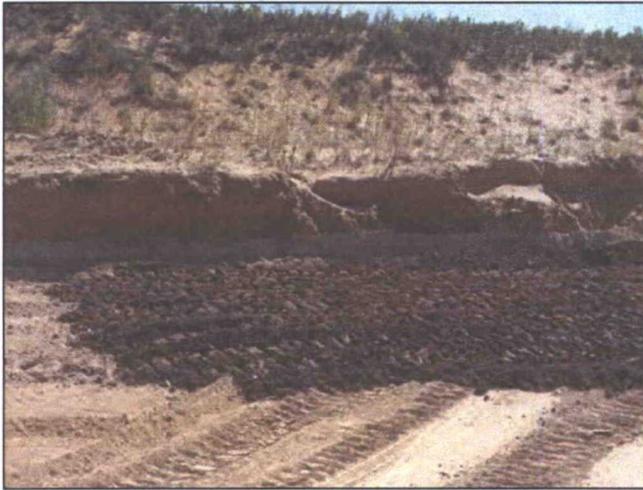
VIEW: East
Placing clay over
backfill

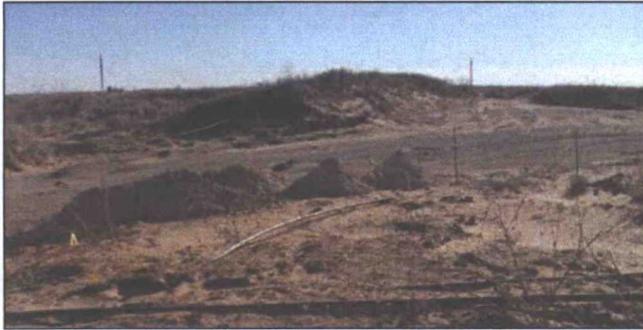
VIEW: South
Remediated location

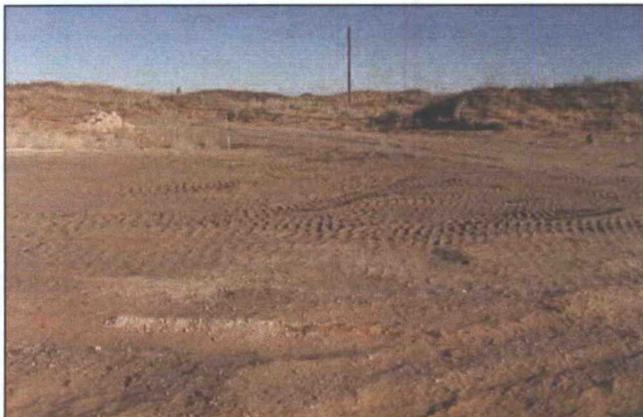
VIEW: Northeast
Remediated location
