Lou Wortham Central Battery AD

Update Report

NMOCD Case #: 1R0811-2733

Unit Letter C, D, E & F, Section 11, Township 22S, Range 37E

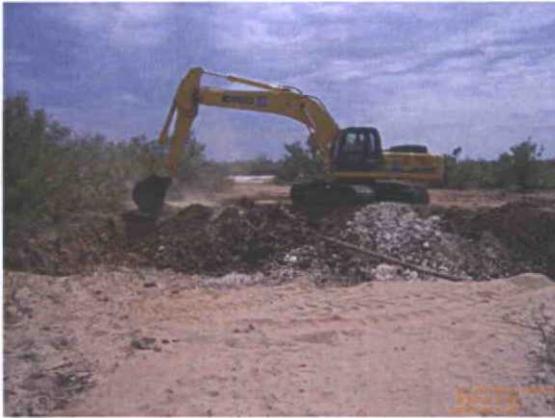
Beginning west excavation, facing south
8/29/11

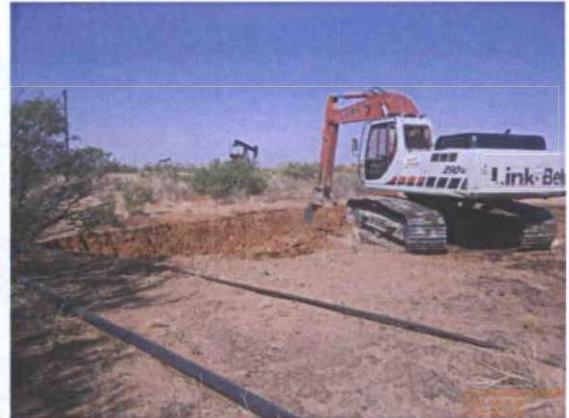
Beginning east excavation, facing northeast
8/31/11

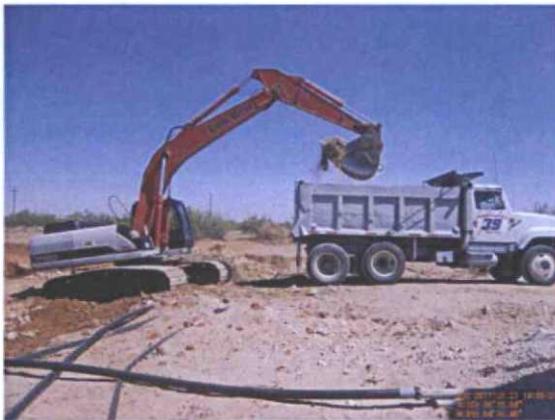
Exporting soil, facing east
9/23/11

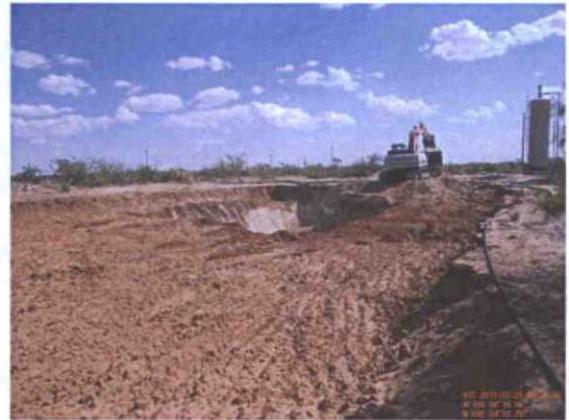
East side, 21 ft excavation complete, facing south
9/26/11

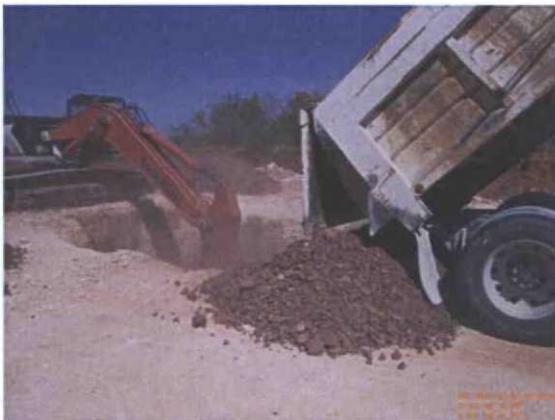
Importing clay, facing northwest
10/6/11

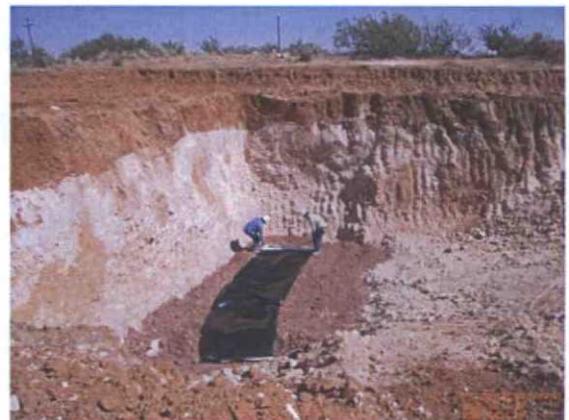
East side, clay layer completed in 21 ft excavation, facing northeast
10/6/11

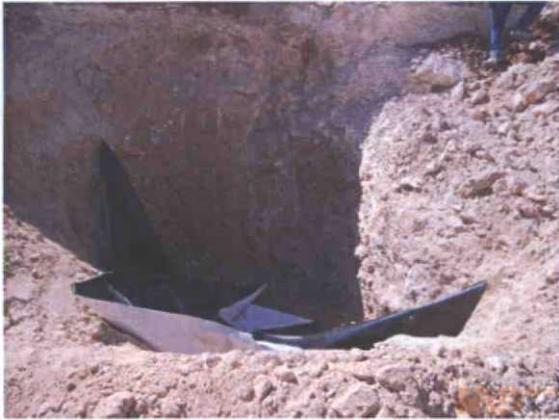
West side, installing liner over clay layer, facing west
10/6/11

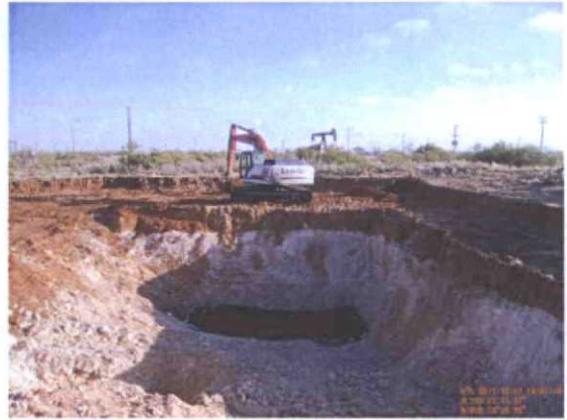
Padding the liner, facing north
10/7/11

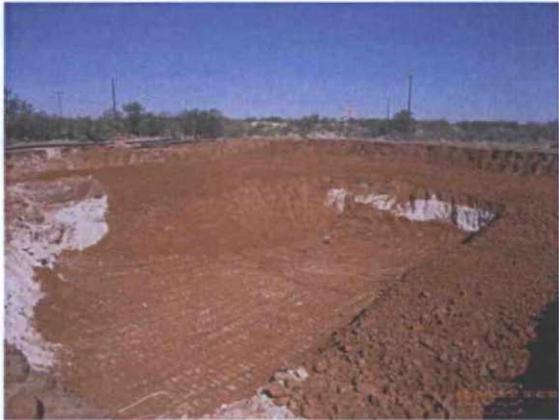
East side, deeping main excavation to 5 ft, facing northwest
10/7/11

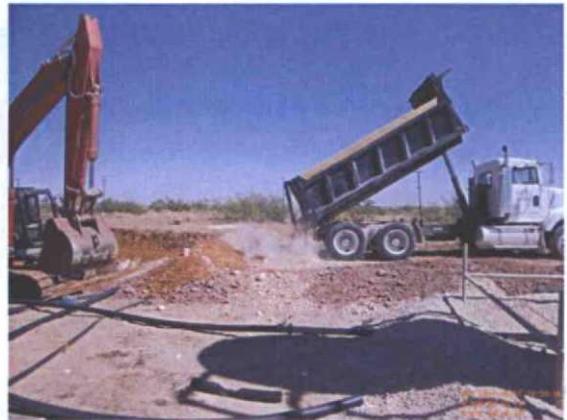
Importing caliche, facing east
10/7/11

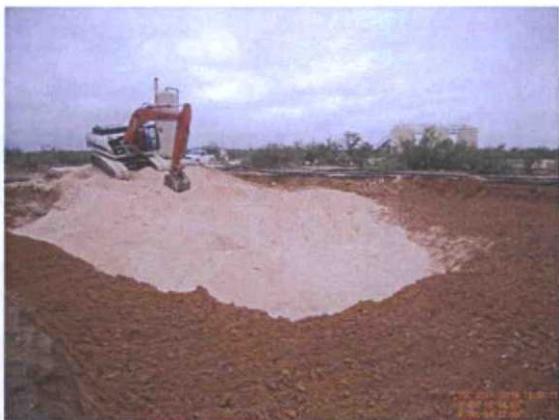
East side, backfilling pit, facing southwest
10/10/11

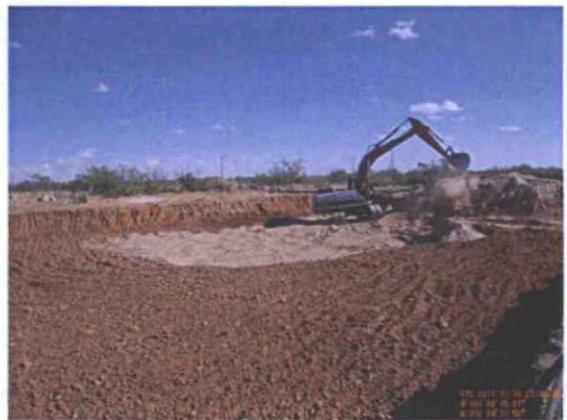
East side, placing sand pad over caliche, facing Southeast
10/10/11

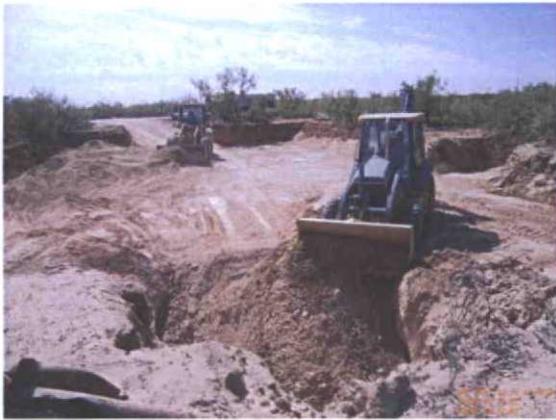
West side, backfilling 21 ft excavations, facing south 10/11/11

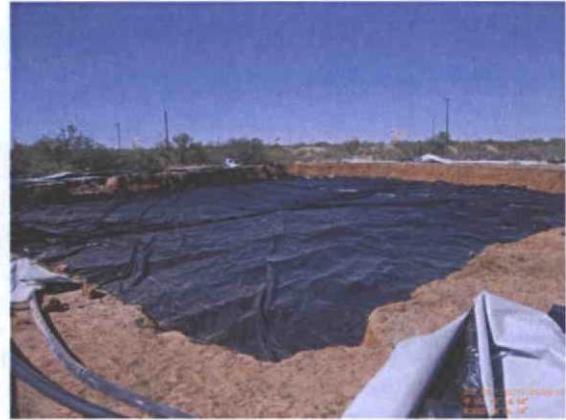
East side, liner installed at 5 ft, facing northwest 10/11/11

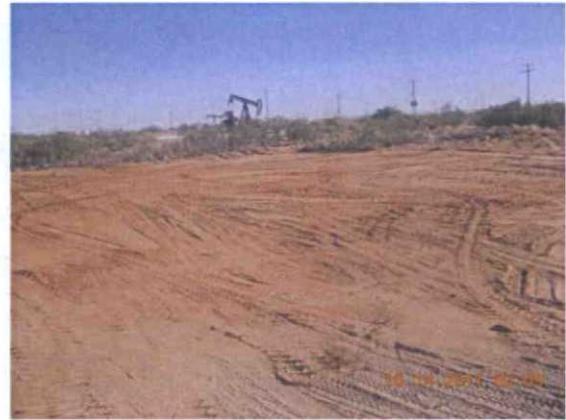
East side, excavation backfilled, facing northeast 10/14/11

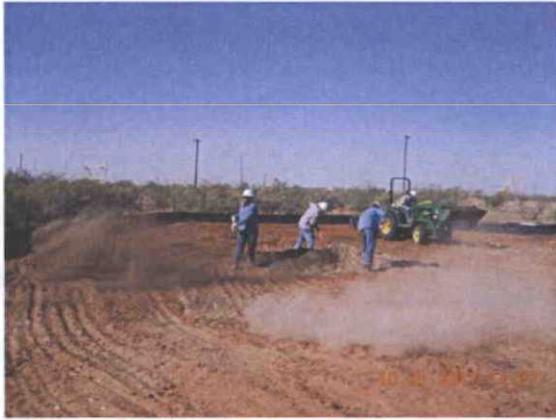
West side, adding soil amendments, facing north 10/21/11

Soil amendments were added to the site and the site was seeded with a native vegetative mix on October 21st, 2011 (Appendix F). Photos of these activities can be found in Appendix G.

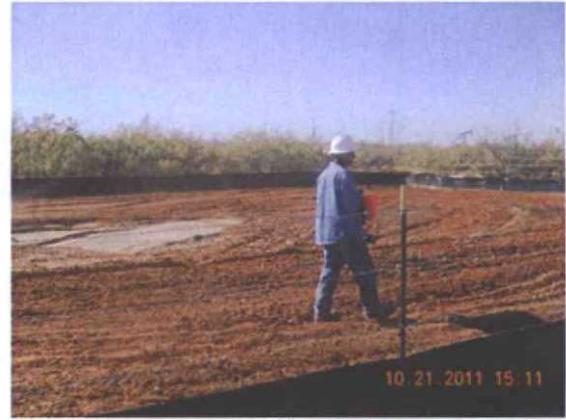
West side, seeding site, facing north 10/21/11

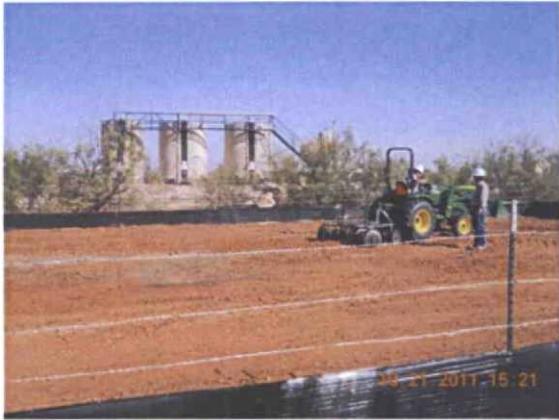
West excavation, disking the seed in, facing east
10/21/11

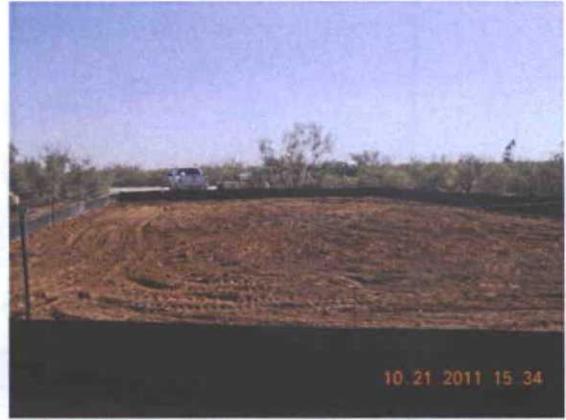
West side, excavation complete, facing west
10/21/11

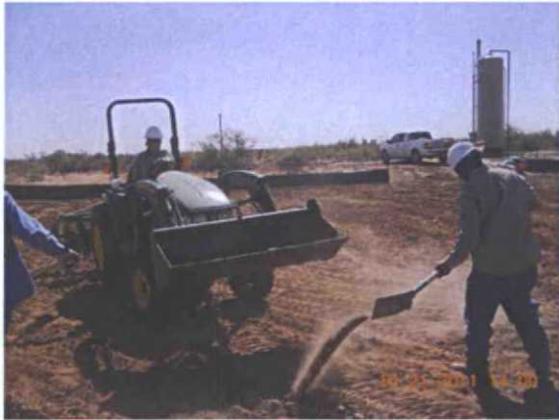
East excavation, adding soil amendments, facing north
10/21/11

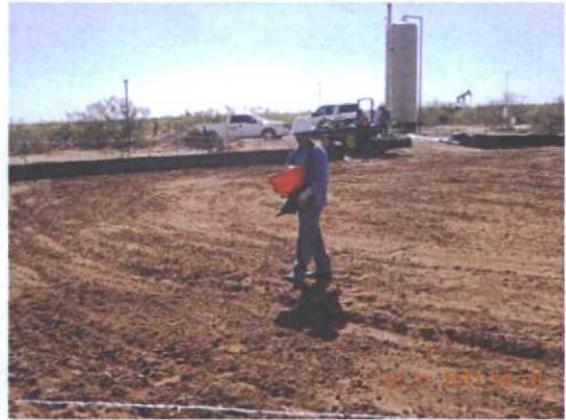
East side, seeding site, facing southwest
10/21/11

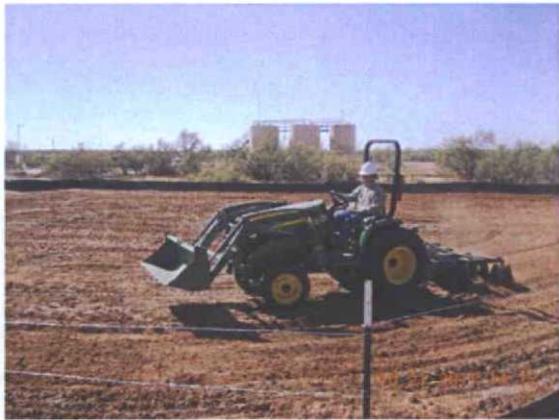
East side, disking the seed in, facing west
10/21/11

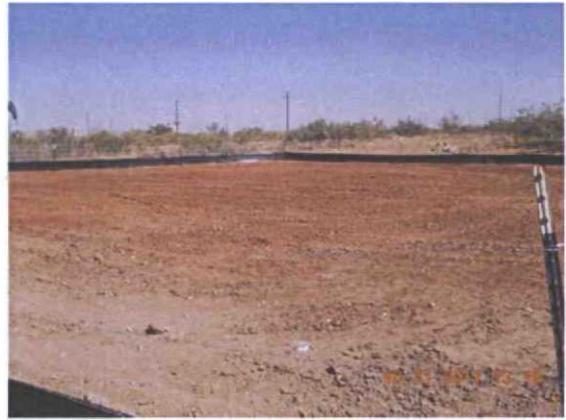
East side, excavation complete, facing northeast
10/21/11
