CML EXPLORATION, LLC

Revised Investigation & Characterization Plan

**Paddy 19 State #3
API # 30-025-38591**

R.T. Hicks Consultants, Ltd.

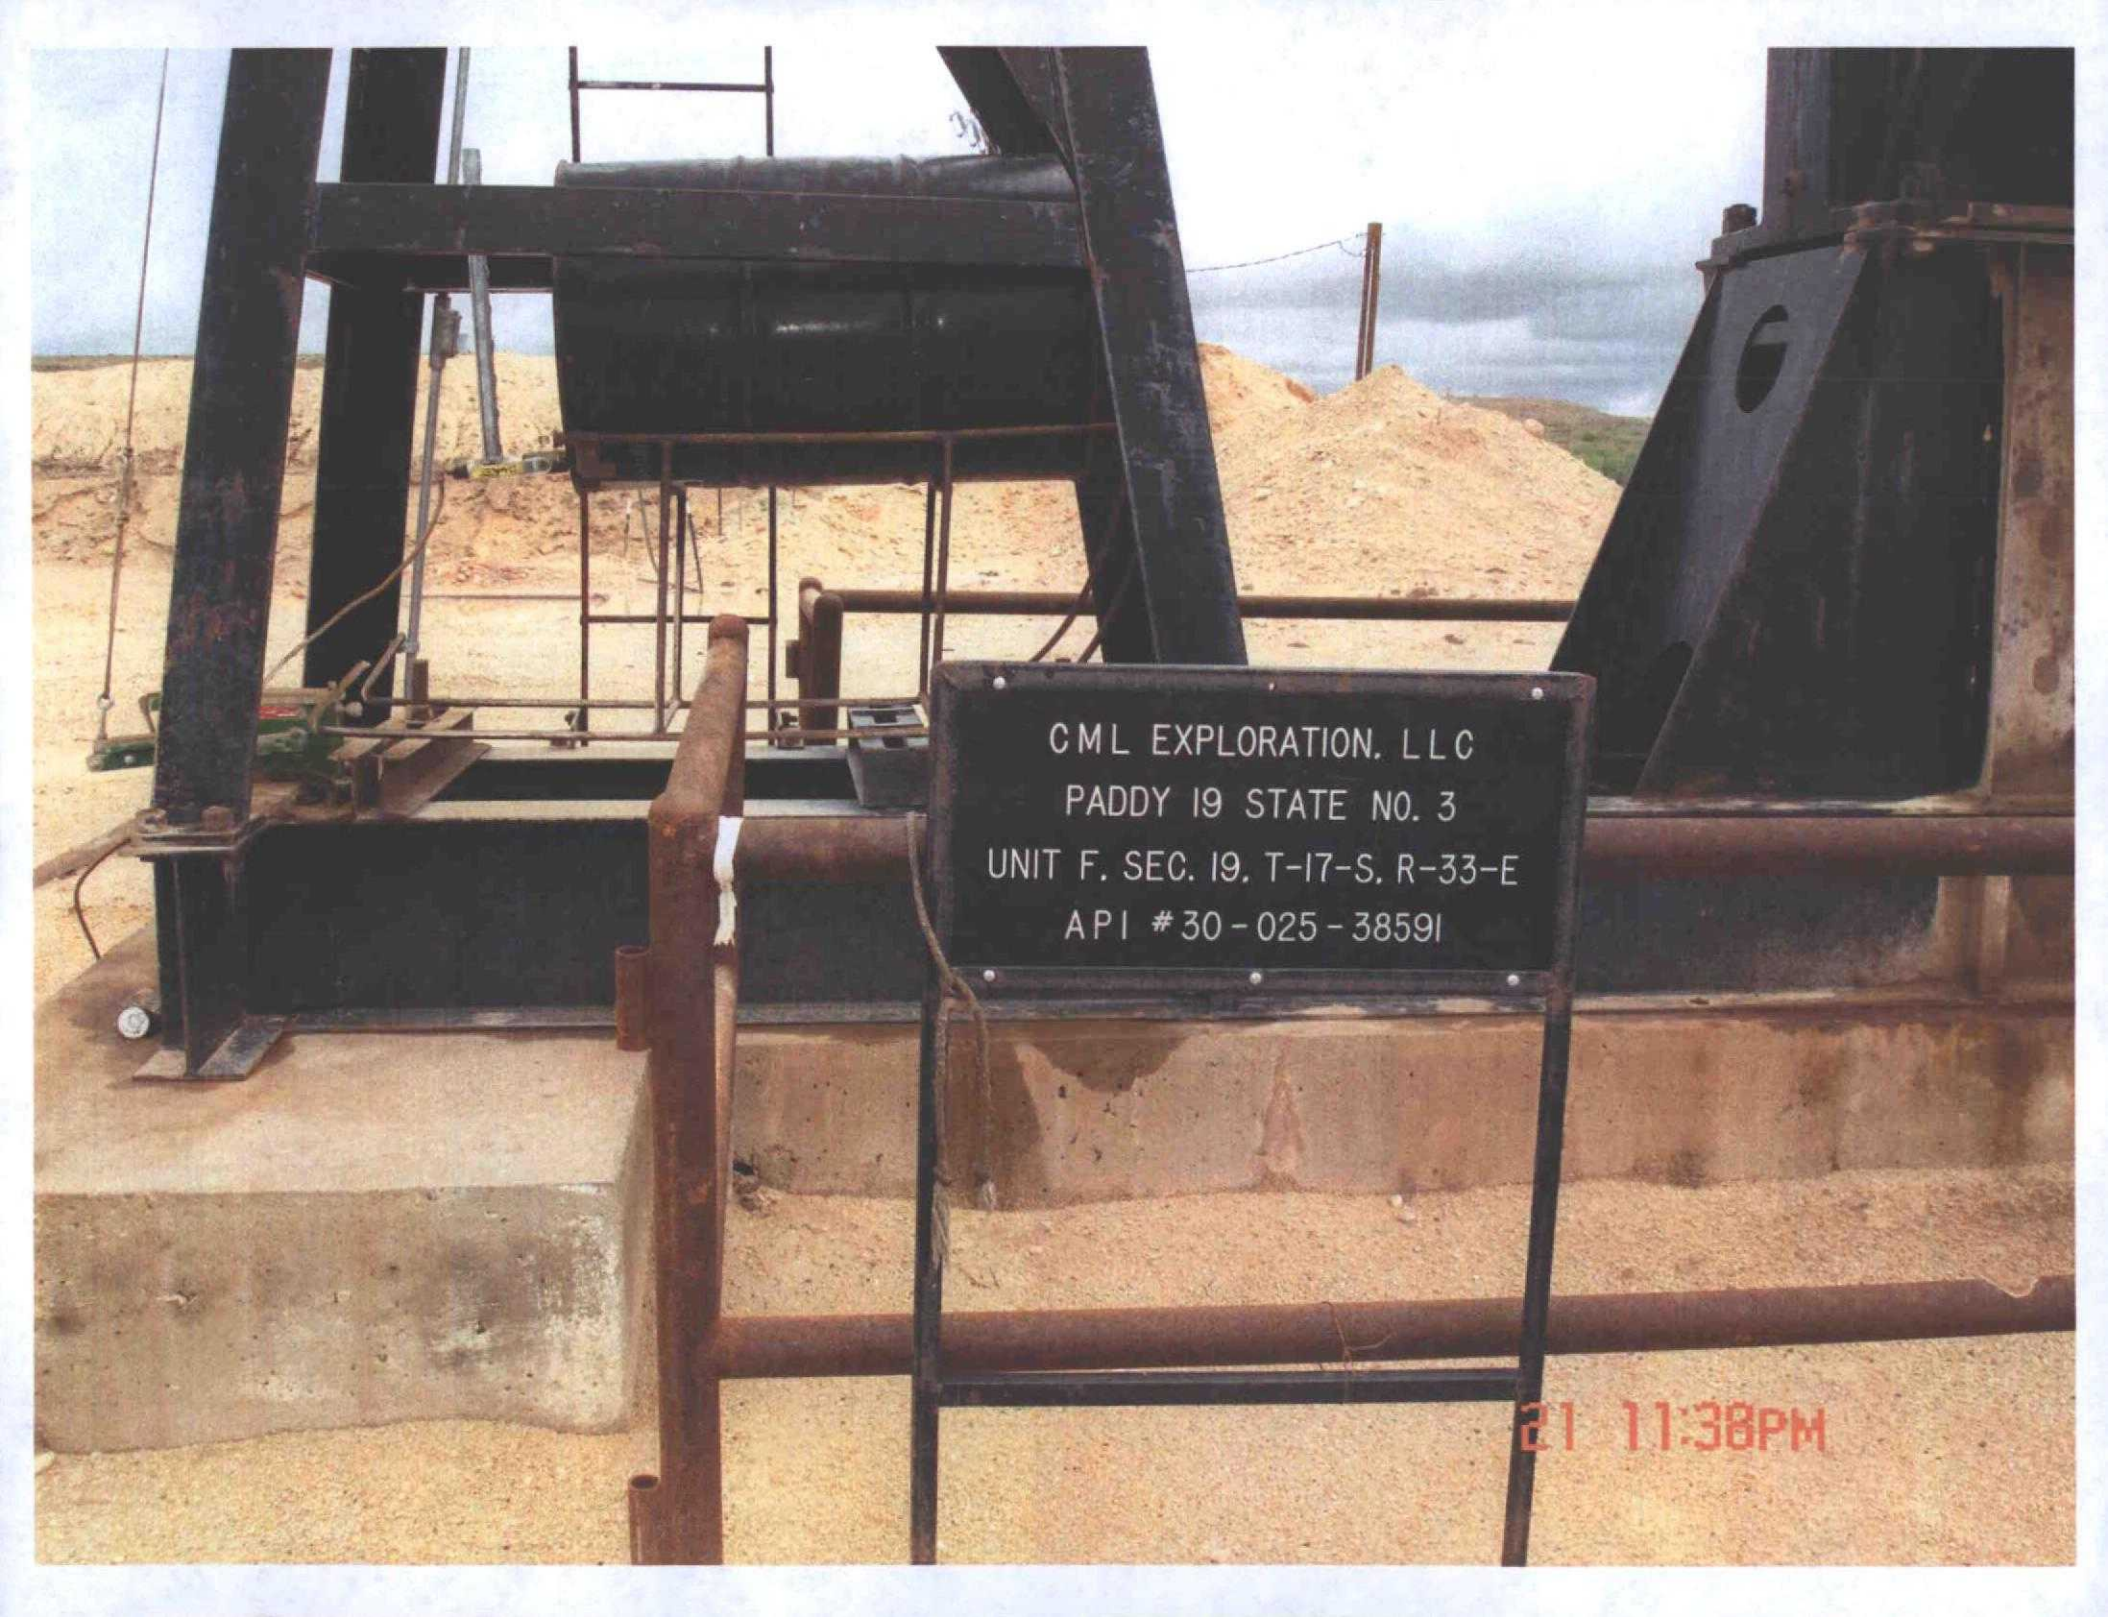
A photograph of an oil well pumpjack structure in a desert environment. The pumpjack is made of dark metal and is partially buried in sand. In the foreground, a black metal sign with white text is attached to the structure. The background shows a large pile of sand and a cloudy sky. A red timestamp is visible in the bottom right corner.

CML EXPLORATION, LLC
PADDY 19 STATE NO. 3
UNIT F, SEC. 19, T-17-S, R-33-E
API # 30 - 025 - 38591
