CONOCOPHILLIPS COMPANY

Proposed Alternative Method Permit or Closure Plan Application

Burlington Resources Oil & Gas Company
San Juan Basin: New Mexico Assets
Below Grade Tank Closure Report

Lease Name: San Juan 30-6 CTB 3
API No.: N/A

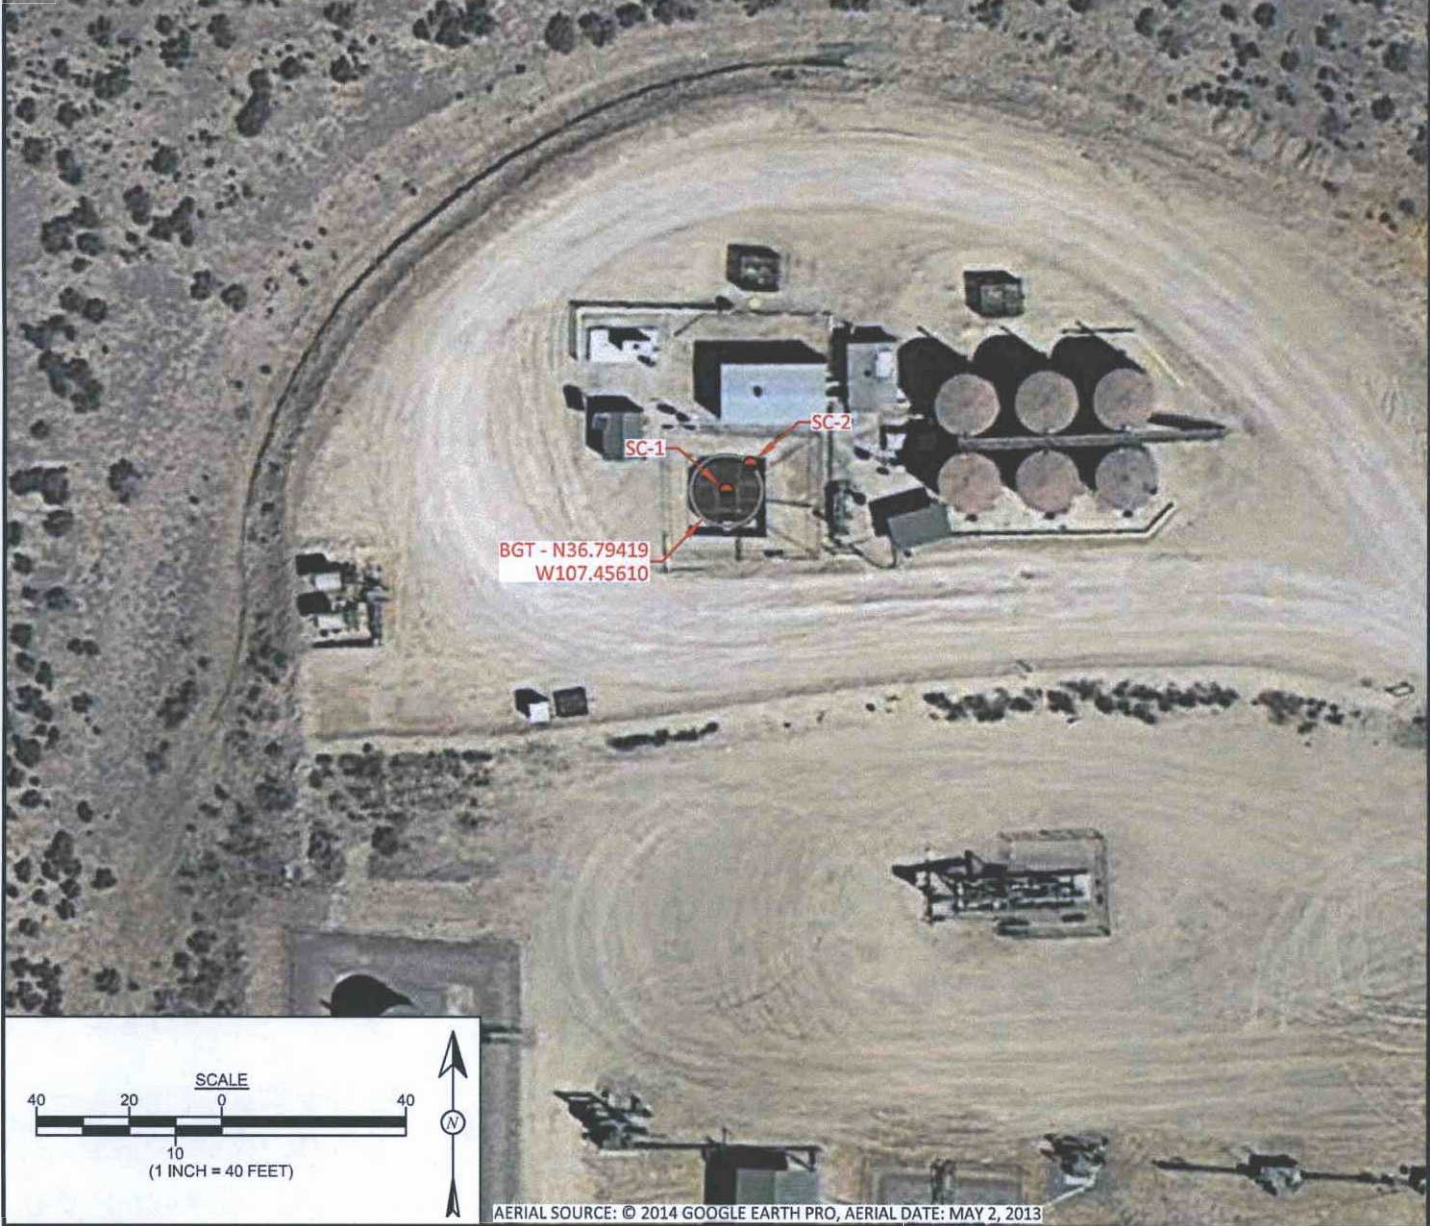
Field Sampling Results					
Sample ID	Date	Depth (ft)	OVM-PID (ppm)	TPH (mg/kg)	Chlorides (mg/kg)
NMOCD ACTION LEVEL			--	100	600
SC-1	8/17/15	0.5	7.6	96.8	120
SC-2	8/17/15	0.5	0.4	1,990	NA
SC-1 WAS A 7-POINT COMPOSITE SAMPLE AND SC-2 WAS A 5-POINT COMPOSITE SAMPLE. NA - NOT ANALYZED

Laboratory Analytical Results						
Sample ID	Date	Depth (ft)	Benzene (mg/kg)	Total BTEX (mg/kg)	TPH (mg/kg)	Chlorides (mg/kg)
NMOCD ACTION LEVEL			10	50	100	600
SC-1	8/17/15	0.5	<0.046	<0.230	24	<30
SC-2	8/17/15	0.5	<0.050	<0.249	84	<30
SAMPLE WERE ANALYZED PER USEPA METHOD 8021B, 418.1 AND 300.0.
