3RP - 1012

ENTERPRISE PRODUCTS OPERATING, LLC

**Release Report/ General
Correspondence**

Release Notification and Corrective Action

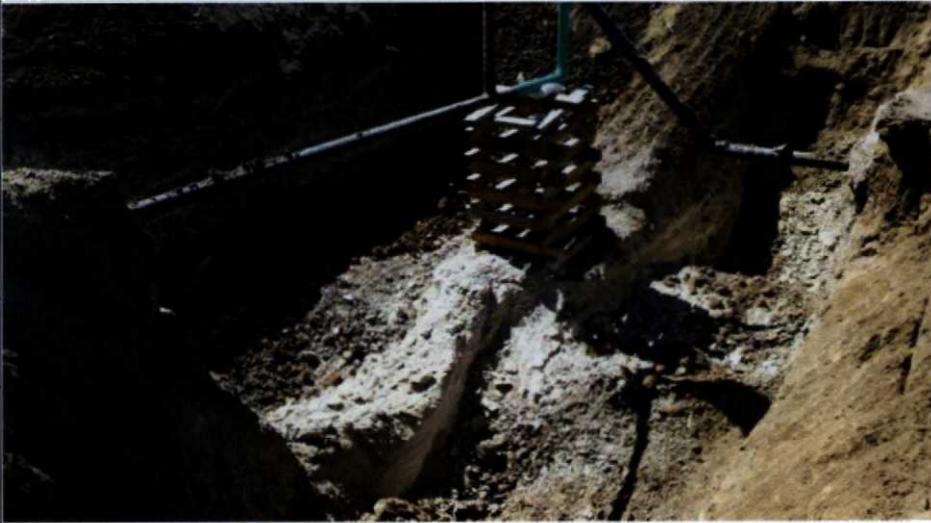
Photograph #3

Client: Enterprise	
Site Name: Reams LS #4 Well Tie Pipeline Release	
Date Photo Taken: May 12, 2016	
Release Location: N36.47020, W107.44220 L-23-26N-6W Rio Arriba County, NM	
Photo Taken by: Justin Valdez	Description: Facing southeast, view of the final excavation.

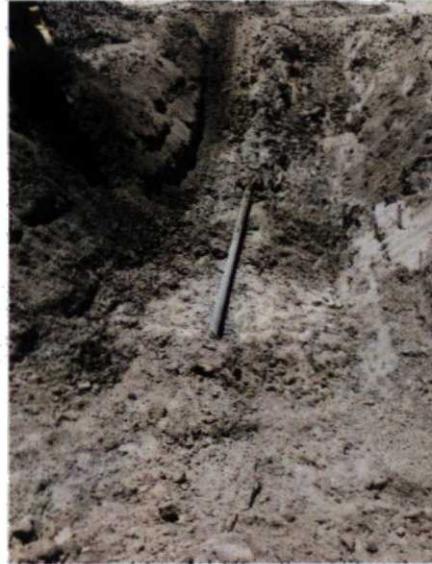
Photograph 1

View of the release area, facing southwest.

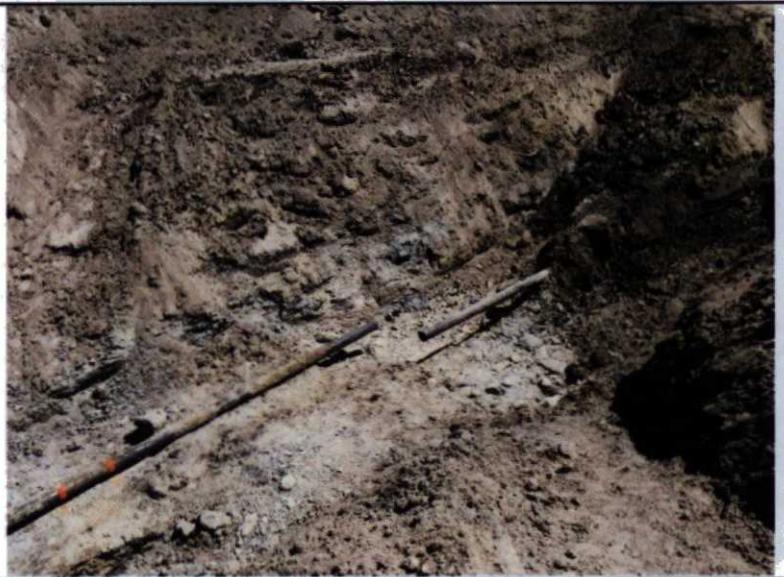
**Photograph 2**

View of in-process corrective action activities, facing north.

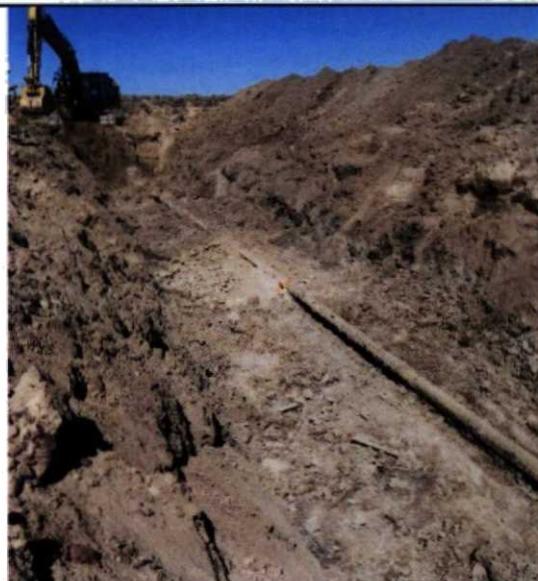
**Photograph 3**

View of in-process corrective action activities, facing southwest.

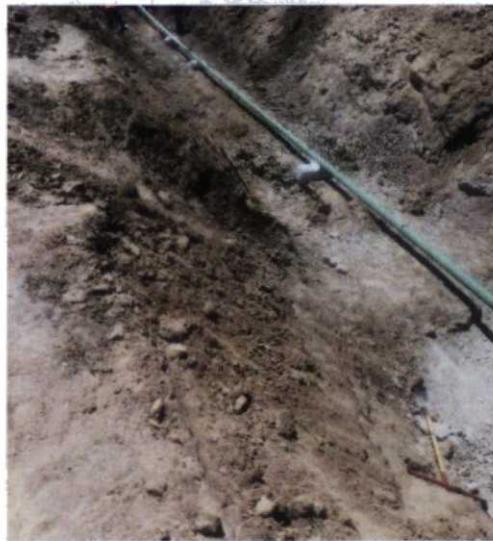
Photograph 4

View of the final excavation, facing west.

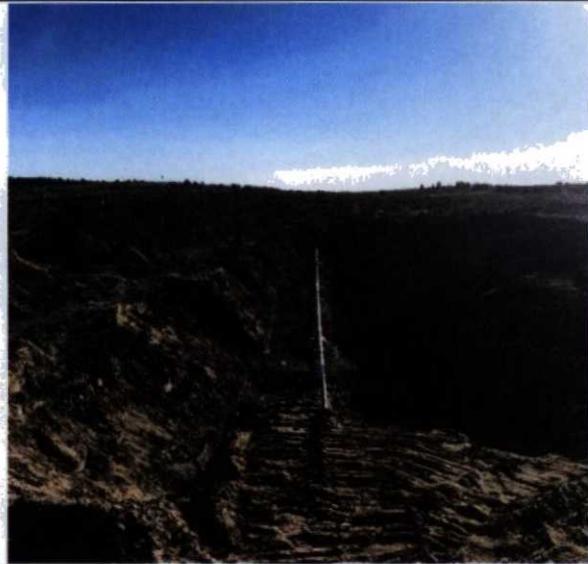
**Photograph 5**

View of the final excavation, facing southwest.

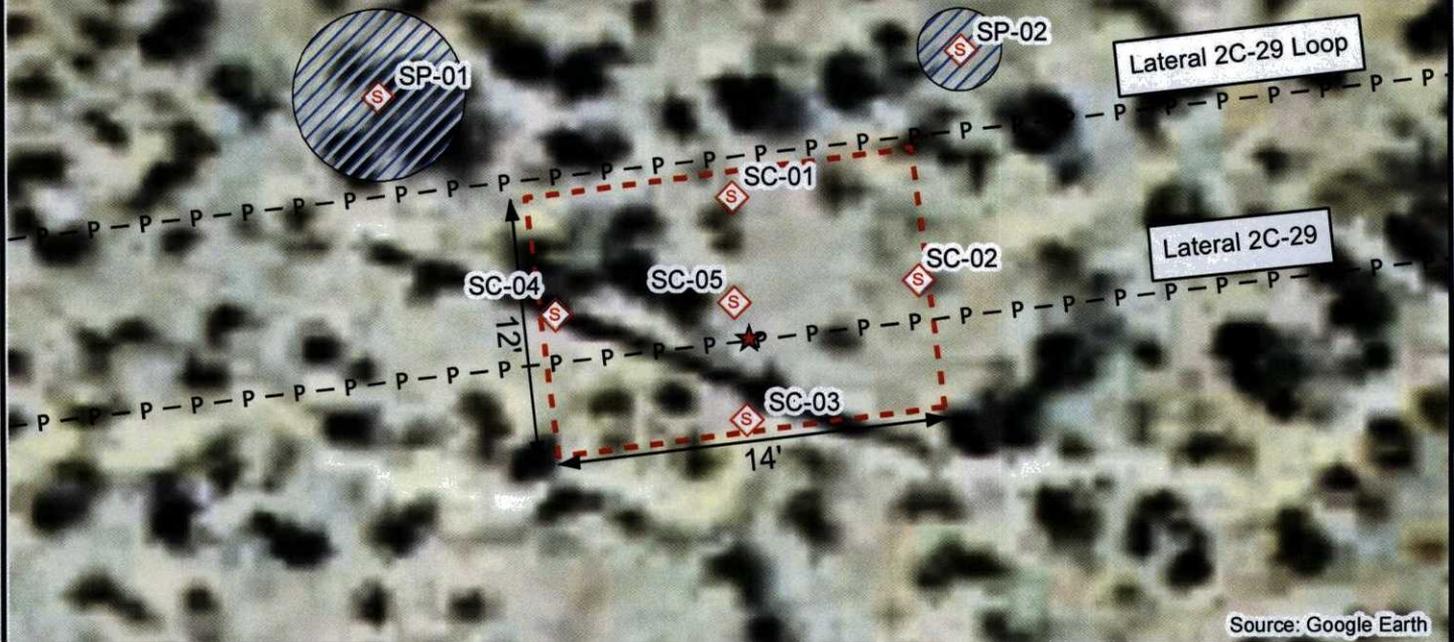
- ★ Lateral 2C-29 Release Location
- ◇ Soil Sample Locations
- ▨ Soil Stockpiles
- ⋯ Estimated Excavation Extent
- P - Pipeline

Figure 3 and Figure 4 are site maps that indicate the approximate location of the excavated area and stockpiles in relation to the Enterprise pipeline (Appendix A). Photographic documentation of the field activities is included in Appendix B.

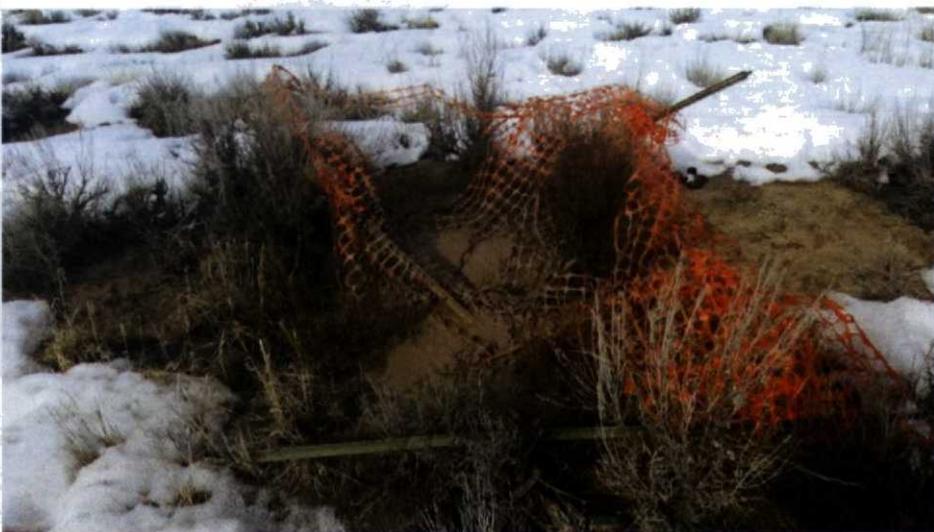
Photograph #1

Client: Enterprise	
Site Name: Lateral 2C-29 Pipeline Release	
Date Photo Taken: January 30, 2016	
Release Location: N36.37997, W107.337953 M-23-25N-5W Rio Arriba County, NM	
Photo Taken by: Heather Woods

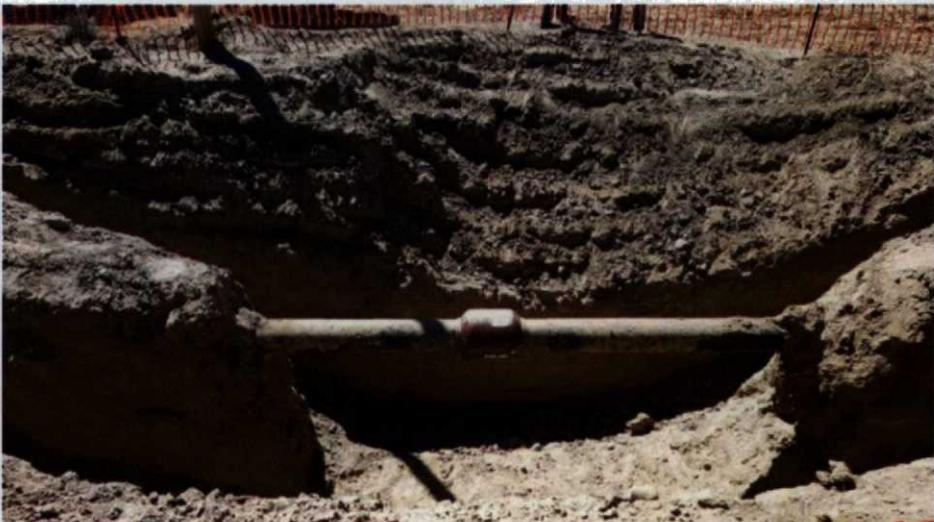
Photograph #2

Client: Enterprise	
Site Name: Lateral 2C-29 Pipeline Release	
Date Photo Taken: March 31, 2016	
Release Location: N36.37800, W107.33790 M-23-25N-5W Rio Arriba County, NM	
Photo Taken by: Heather Woods

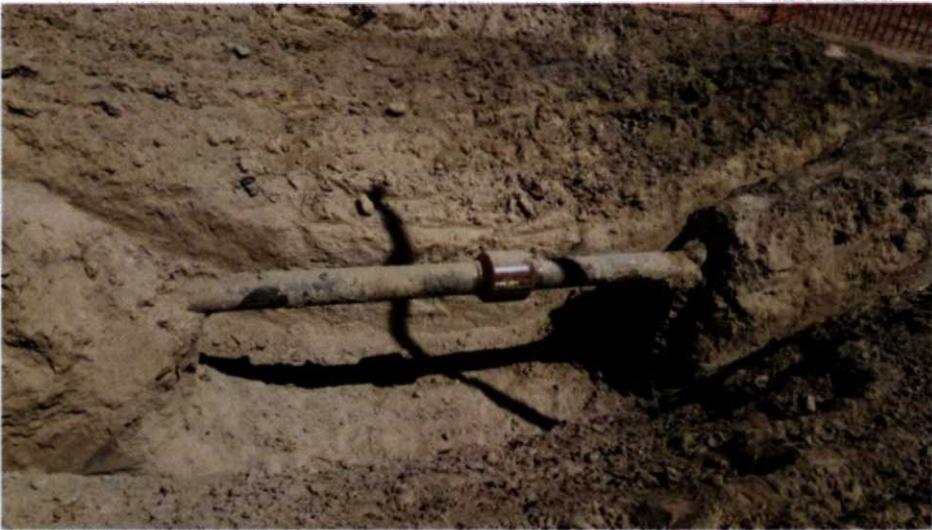
Client: Enterprise	
Site Name: Lateral 2C-29 Pipeline Release	
Date Photo Taken: March 31, 2016	
Release Location: N36.37800, W107.33790 M-23-25N-5W Rio Arriba County, NM	
Photo Taken by: Heather Woods	Description: Facing north, view of the repaired pipeline and final excavation.

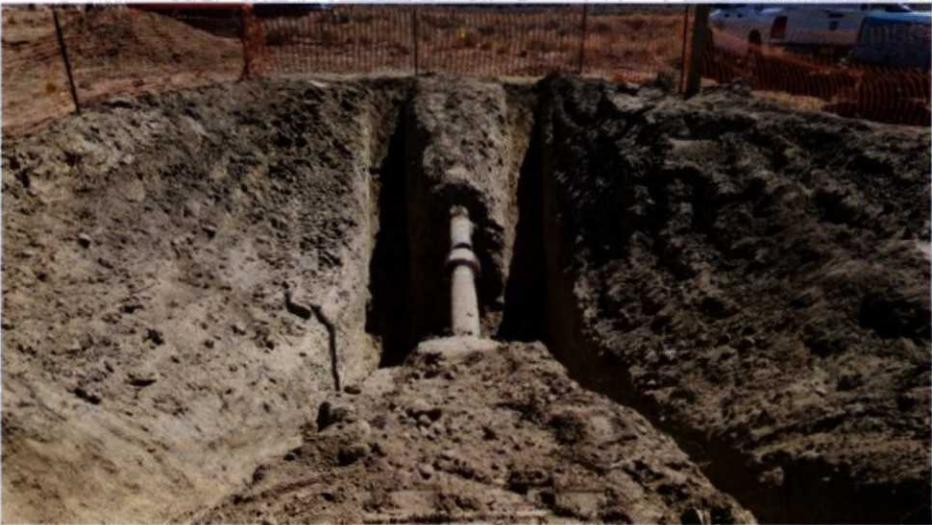
Photograph #4

Client: Enterprise	
Site Name: Lateral 2C-29 Pipeline Release	
Date Photo Taken: March 31, 2016	
Release Location: N36.37800, W107.33790 M-23-25N-5W Rio Arriba County, NM	
Photo Taken by: Heather Woods	Description: Facing east, view of the repaired pipeline and final excavation.

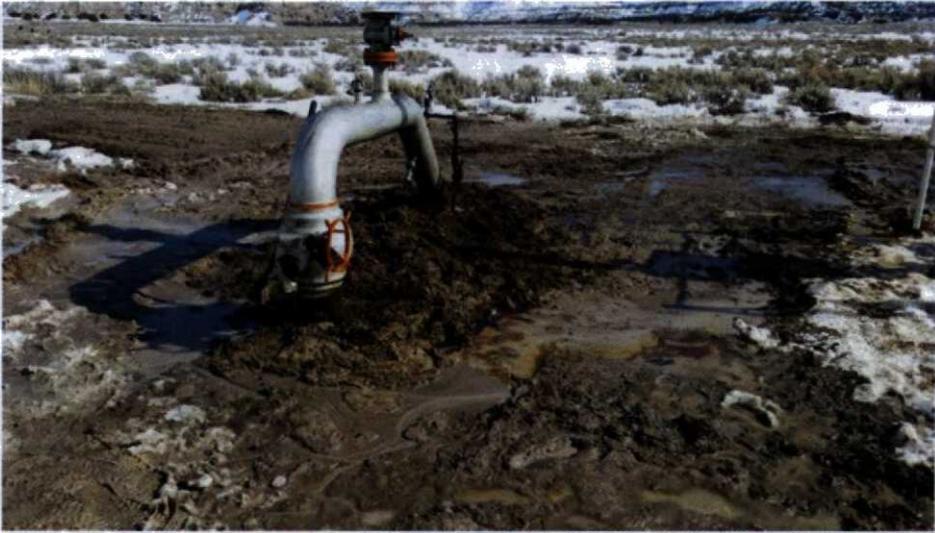
Photograph #1

Client: Enterprise	
Site Name: Lateral 2C-29 Pipeline Valve Release	
Date Photo Taken: January 30, 2016	
Release Location: N36.38057, W107.34384 O-22-25N-5W Rio Arriba County, NM	
Photo Taken by: Heather Woods	
Description: Facing east, general view of release source.

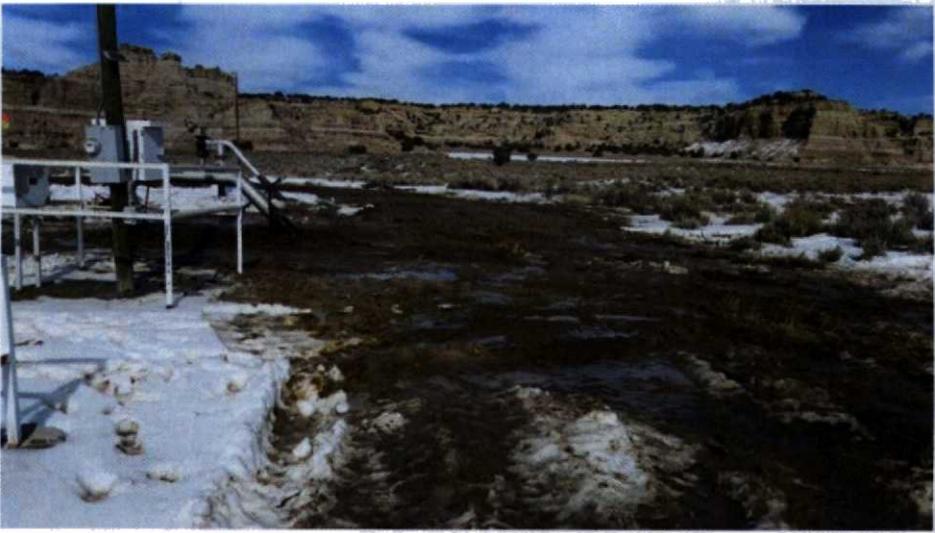
Photograph #2

Client: Enterprise	
Site Name: Lateral 2C-29 Valve Pipeline Release	
Date Photo Taken: January 30, 2016	
Release Location: N36.38057, W107.34384 O-22-25N-5W Rio Arriba County, NM	
Photo Taken by: Heather Woods	
Description: Facing northeast, general view of release area.

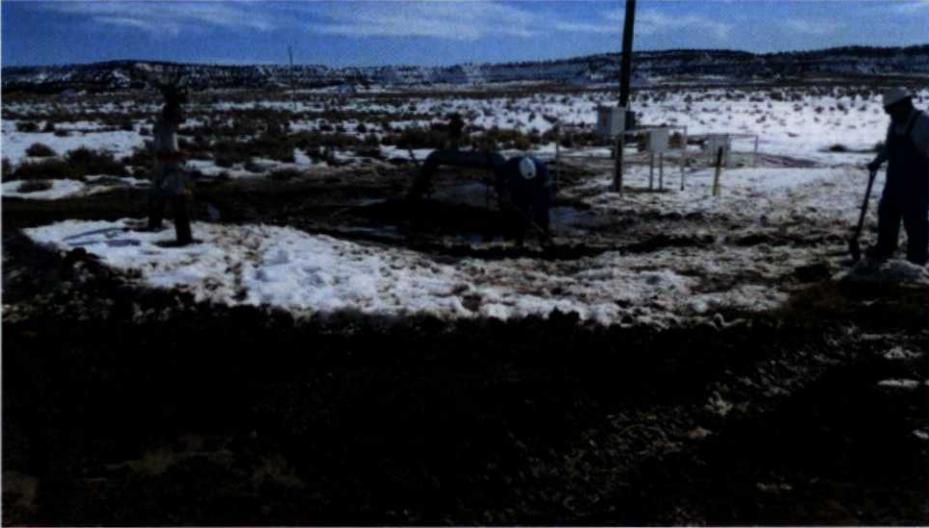
Photograph #3

Client: Enterprise	
Site Name: Lateral 2C-29 Pipeline Valve Release	
Date Photo Taken: January 30, 2016	
Release Location: N36.38057, W107.34384 O-22-25N-5W Rio Arriba County, NM	
Photo Taken by: Heather Woods	Description: Facing southeast, berming and trenching to divert snow melt from release area.

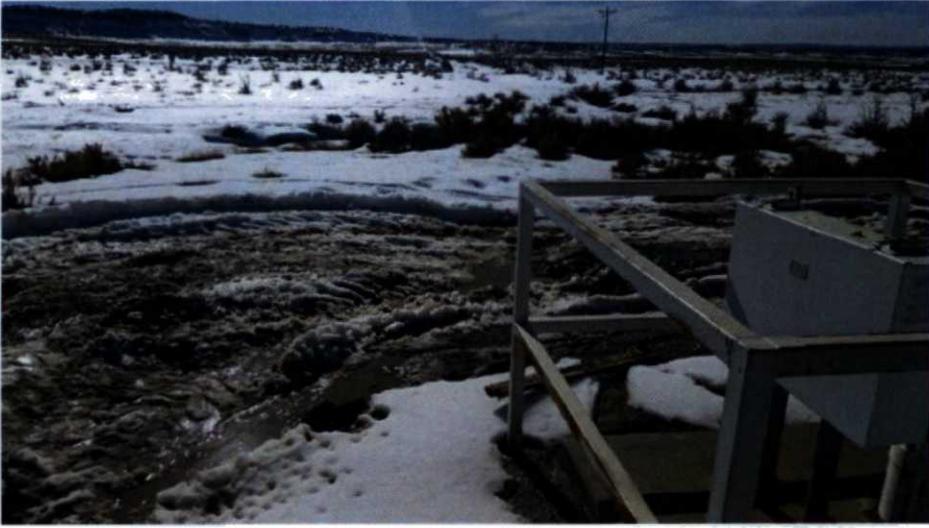
Photograph #4

Client: Enterprise	
Site Name: Lateral 2C-29 Pipeline Valve Release	
Date Photo Taken: January 30, 2016	
Release Location: N36.38057, W107.34384 O-22-25N-5W Rio Arriba County, NM	
Photo Taken by: Heather Woods	Description: Facing southwest, site drainage path to southeast.
