**Release Report/ General
Correspondence**

Lateral 2C-24 Pipeline Release Report

Unit Letter M, Section 2, Township 24 North, Range 5 West
Rio Arriba County, New Mexico

November 15, 2016

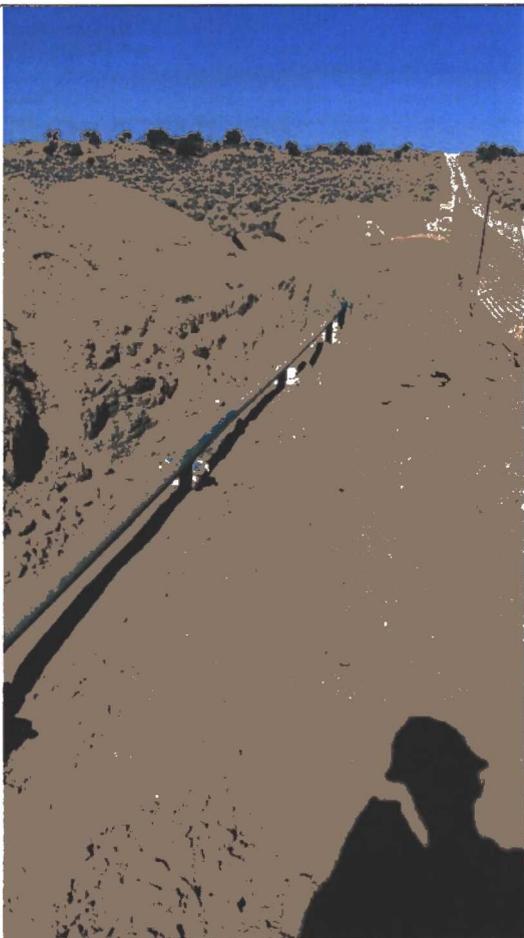
Photograph #1

Client: Enterprise	
Site Name: Lateral 2C-24 Pipeline Release	
Date Photo Taken: September 9, 2016	
Release Location: N36.33443, W107.33692 M-2-24N-5W Rio Arriba County, NM	
Photo Taken by: Justin Valdez	Description: Facing southeast, view of east half of the final excavation.

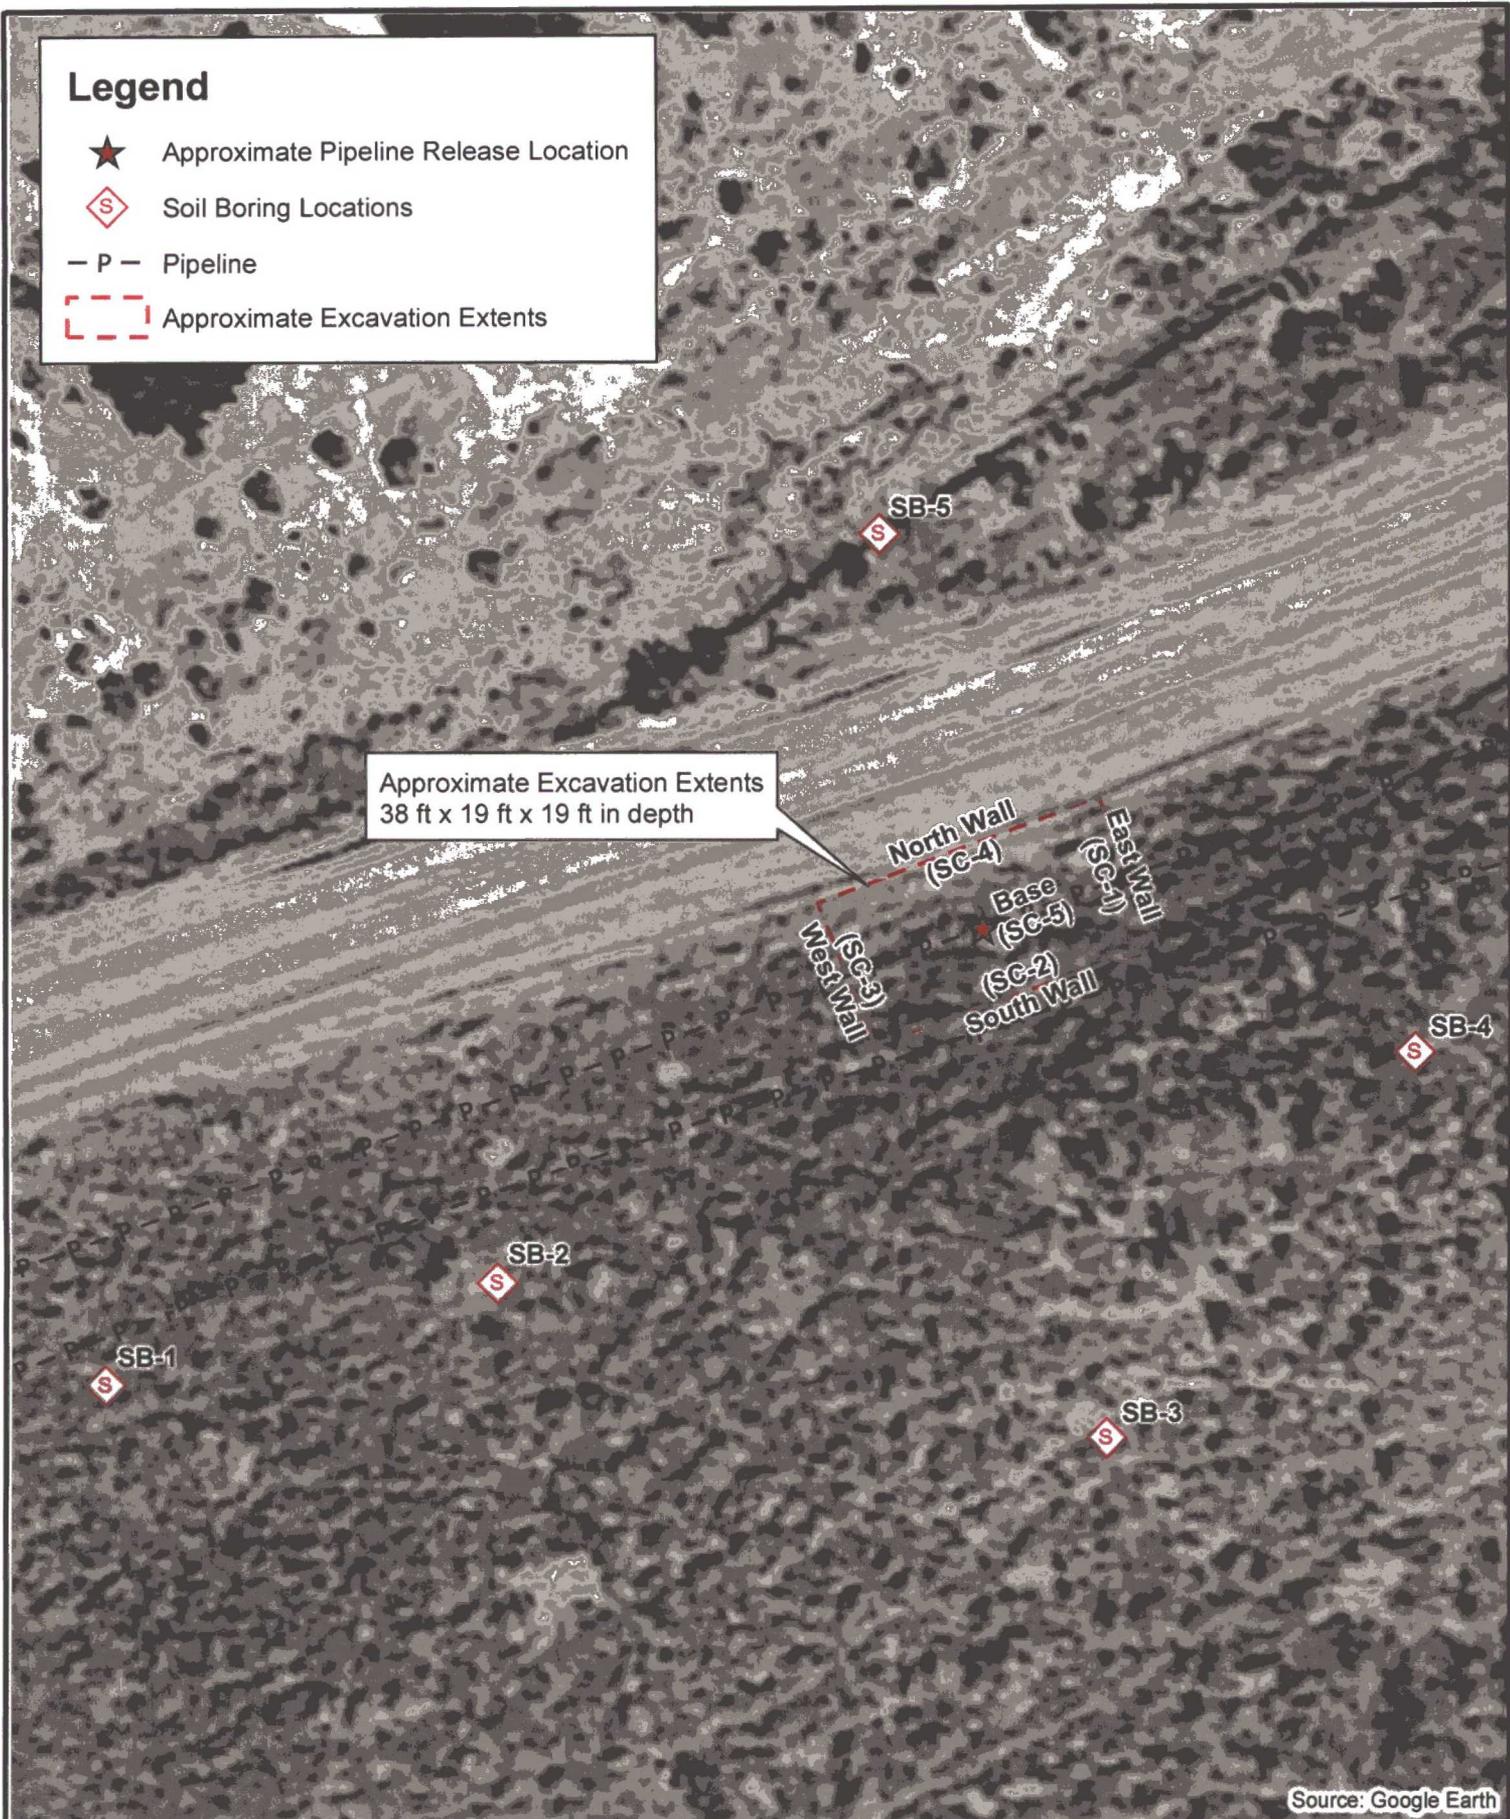
- ★ Approximate Pipeline Release Location
- ◊ Soil Boring Locations
- P - Pipeline
- - - Approximate Excavation Extents
