3R-1011

**Release Report/ General
Correspondence**

Enterprise SJ

Release Notification and Corrective Action

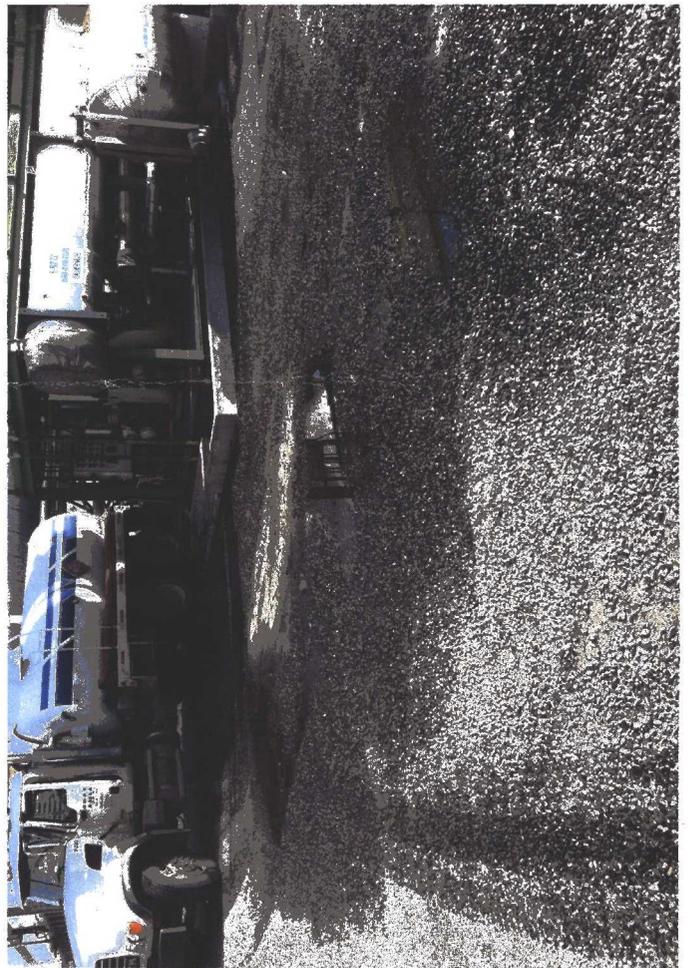
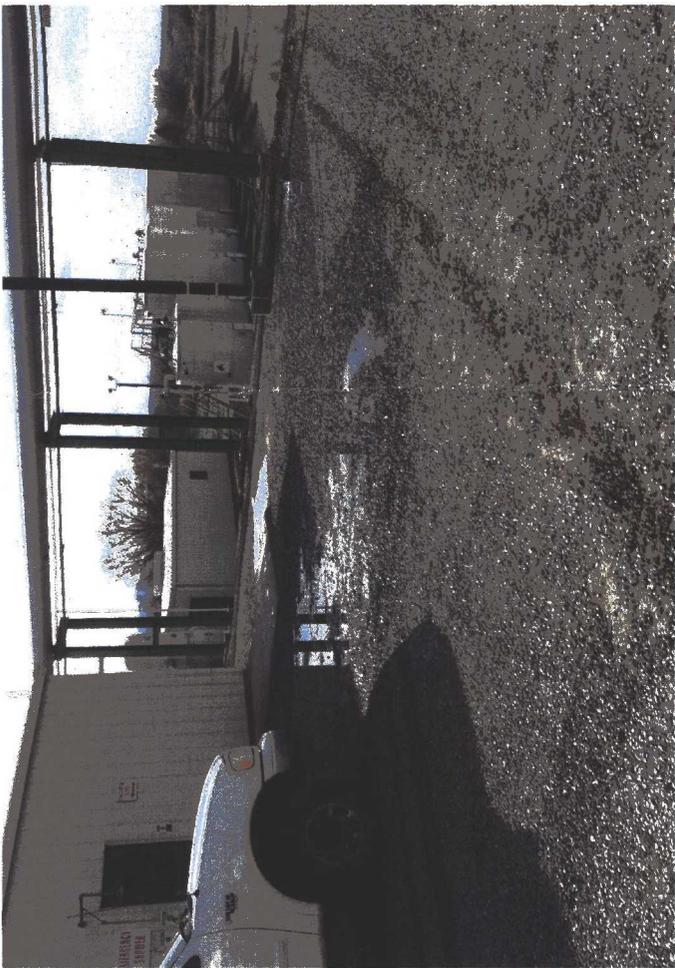
Train 8 Still Feed Pump expansion joint failed, thus causing amine to over fill concrete containment. Once containment was full, amine escaped to the surrounding gravel area and proceeded to flow in a southern direction. Approx amount of amine is estimated at 10 to 12 barrels of amine. Outside operator discovered this problem and worked quickly to create dikes to contain the amine spill from spreading further. At the same time, this pump was shut down and rendered out of service until the problem can be effectively resolved.

Before cleanup - 3.25.2012

Operations group dispatched a contractor with a vacuum truck and shovel crew to remove the liquid and amine stained soil from the area. The excavation continued until all visual staining and odor of amine was removed from the release location. Amine contaminated soil, a volume of approximately 40 yards, was hauled to an OCD permitted landfarm facility. Please see the attached photo documentation and MSDS information.

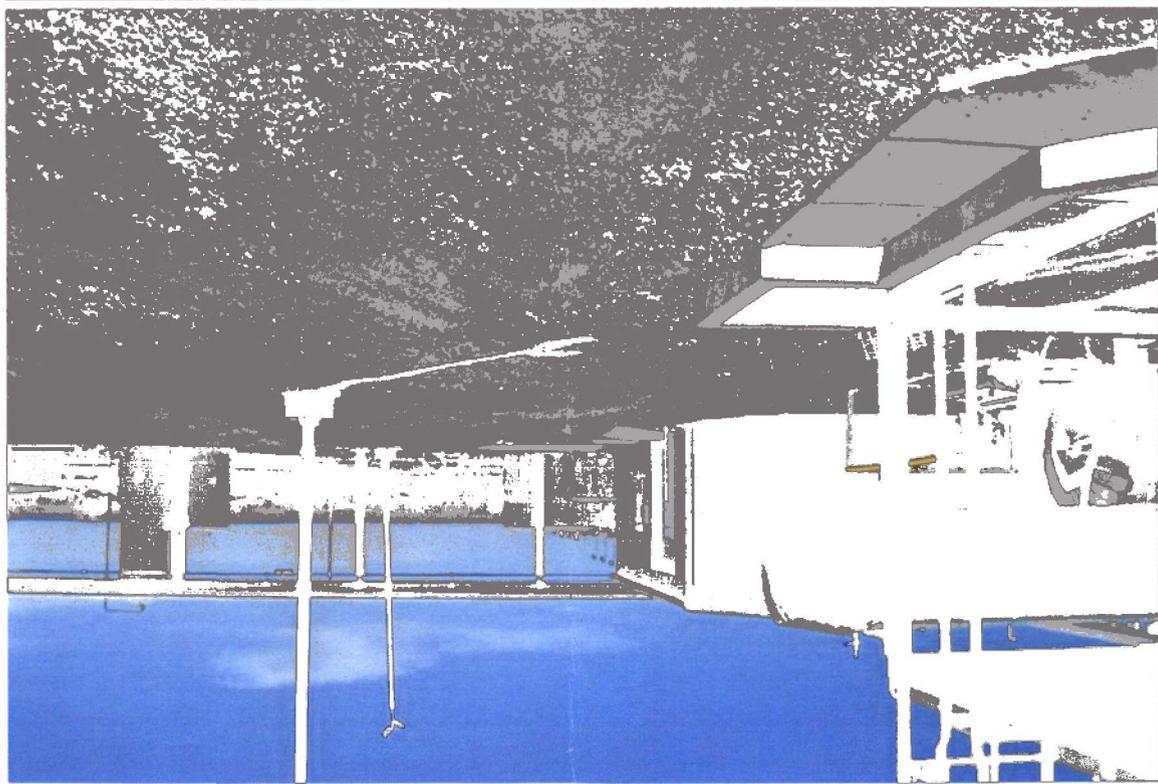
After clean up - completed 3/30/2012
Soils were excavated @ depths of 6" to 18"

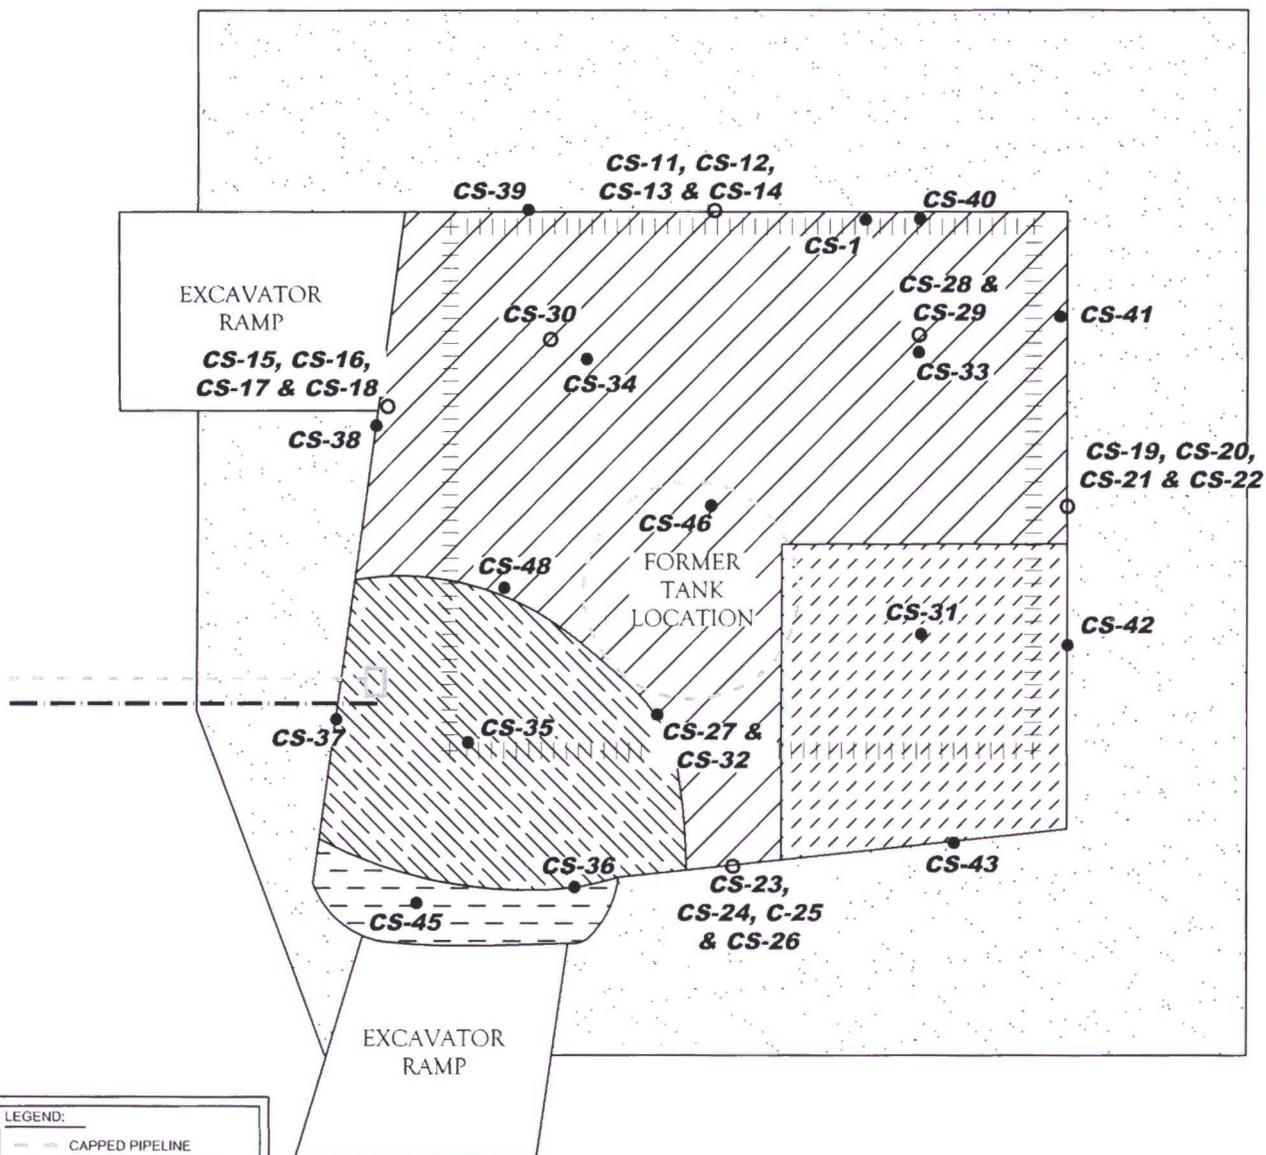
Figure 3
Site Map

CAPPED PIPELINE
	ABANDONED PIPELINE
	FORMER BERM
	CONFIRMATION SAMPLE
	TRENCH CONFIRMATION SAMPLE
	AREA EXCAVATED TO 8-14 FT BGS
	AREA EXCAVATED TO 11-12 FT BGS
	AREA EXCAVATED TO 14-17 FT BGS
	AREA EXCAVATED TO 16-20 FT BGS
	SLOPED AREA (0-6 FT BGS)

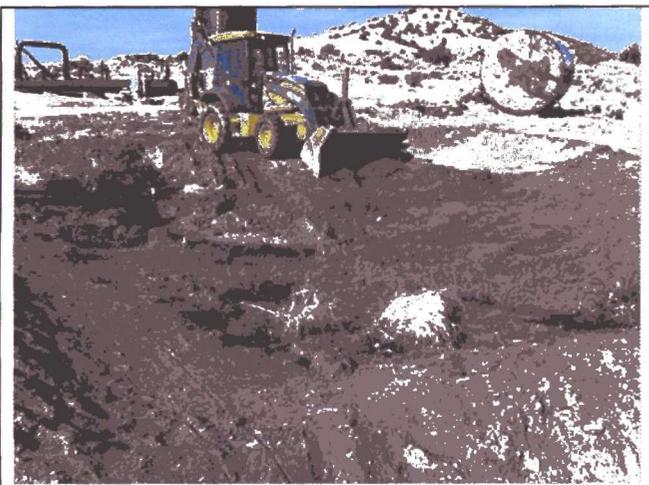
1.) View of initial activities.

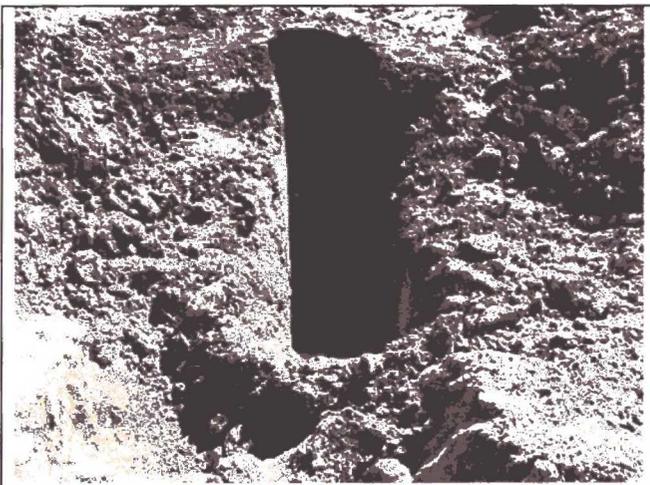
2.) View of trench sampling location.

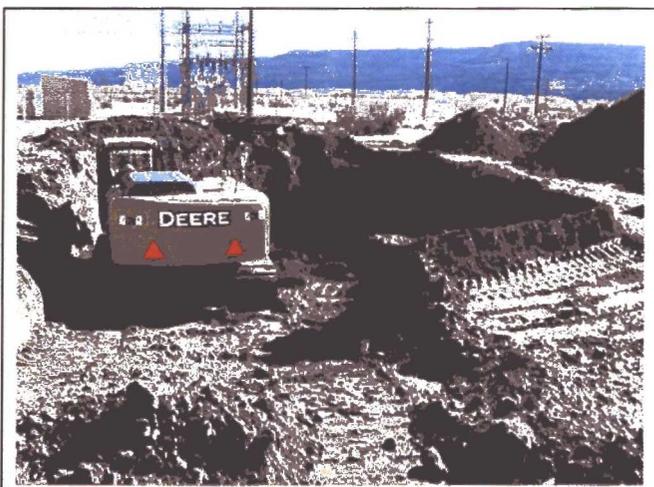
5.) Excavator ramp to provide safer access.

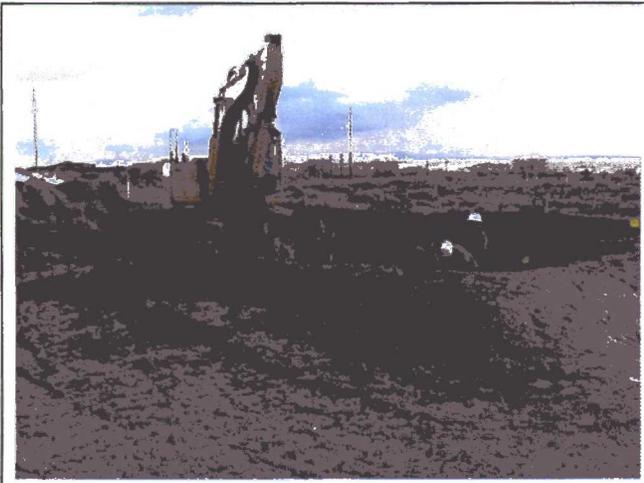
1.) View of initial activities.

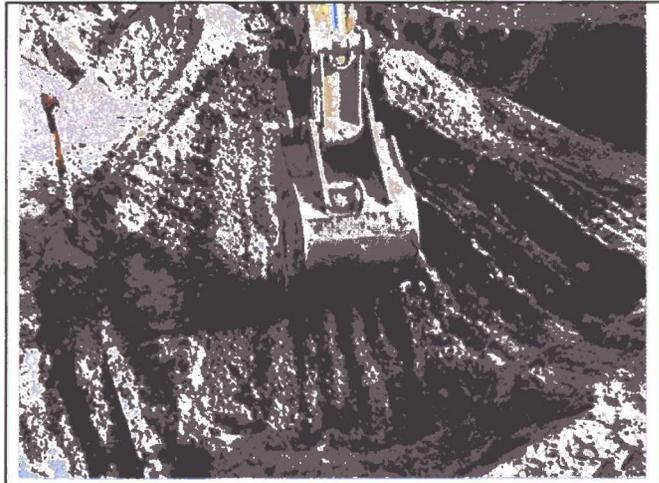
2.) View of historic impact.

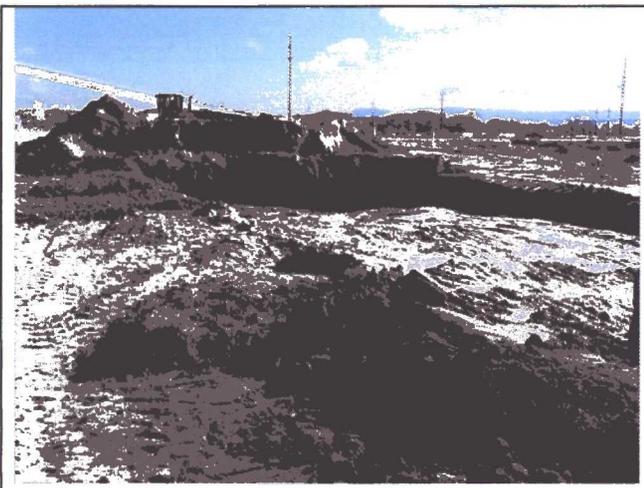
3.) General view excavation facing east.

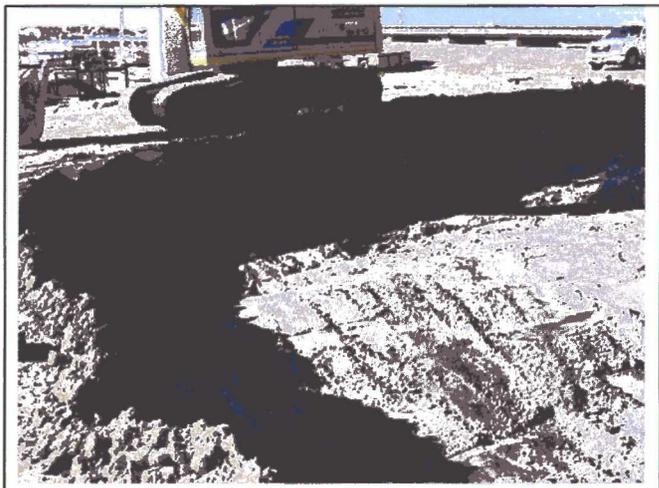
4.) View of final excavation, southwest corner.

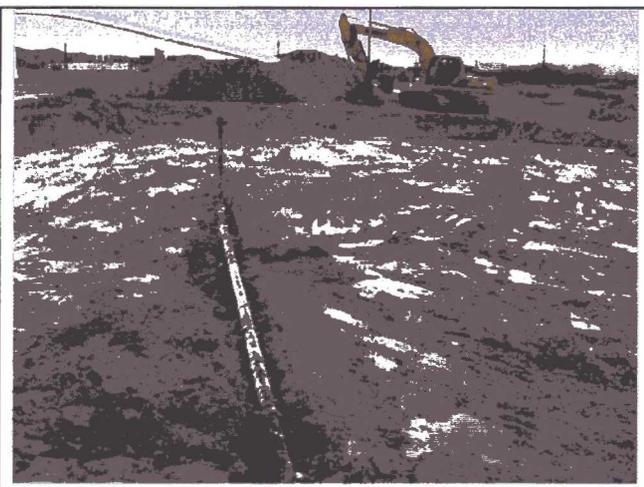
5.) View of final excavation facing east.
