**3R-1011**

**Release Report/ General  
Correspondence**

**Enterprise SJ**

## **CORRECTIVE ACTION REPORT**

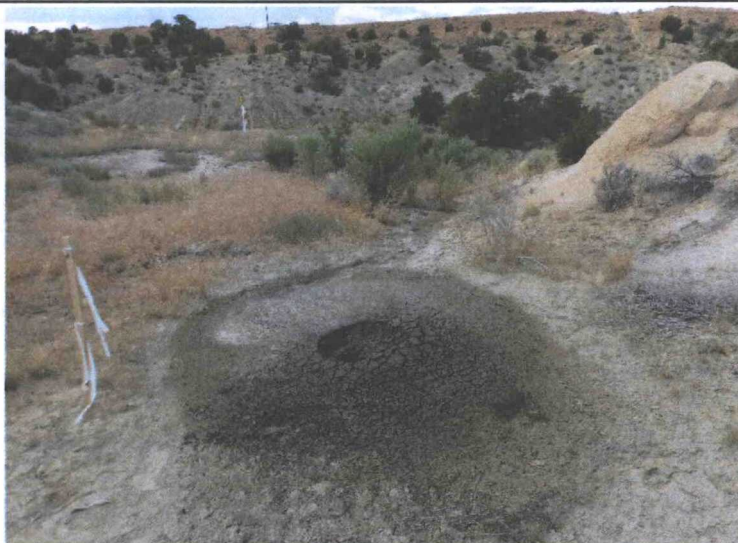
**Photograph 1**

Point of release.

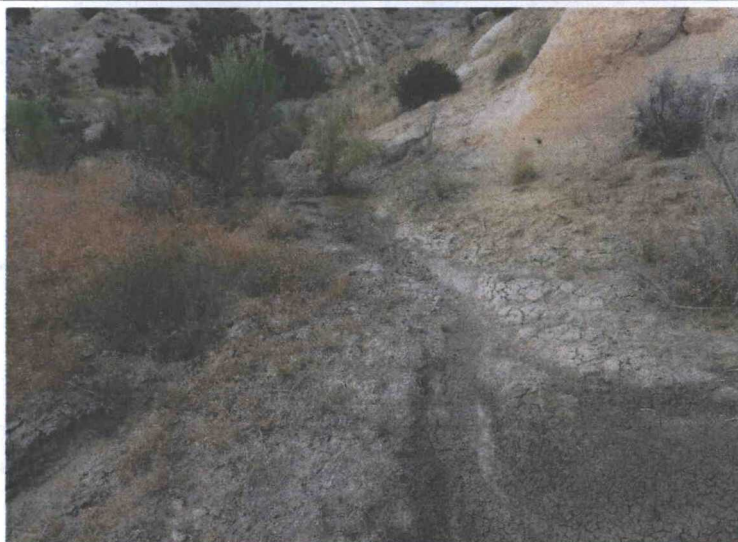
**Photograph 2**

View of the flow path.

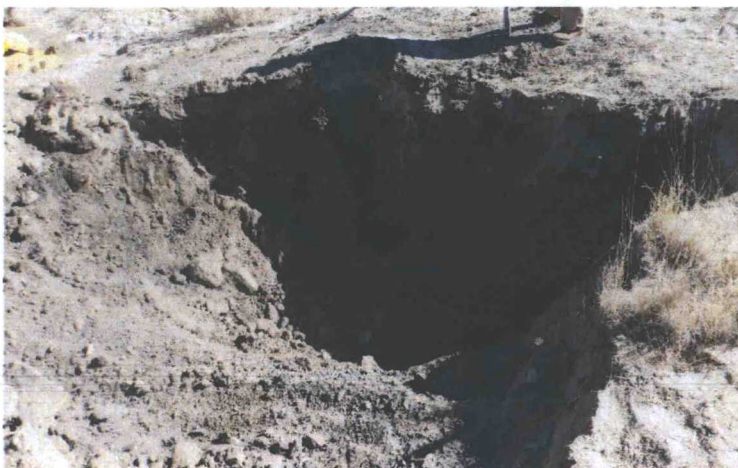
**Photograph 3**

Beginning of excavation activities.

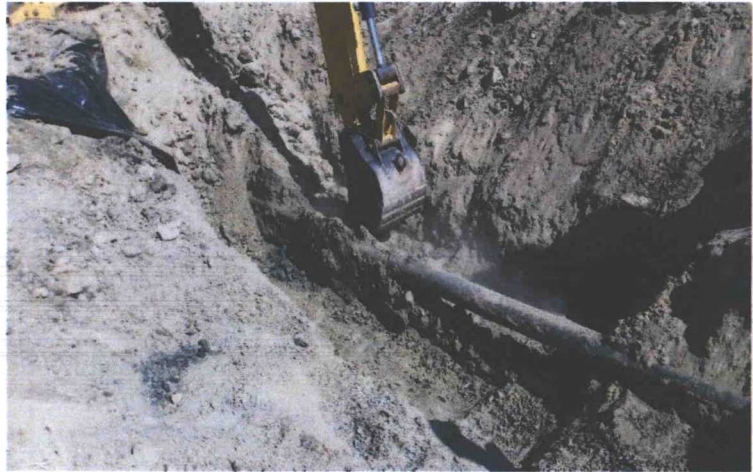
## Photograph 4

View of in-process excavation activities.

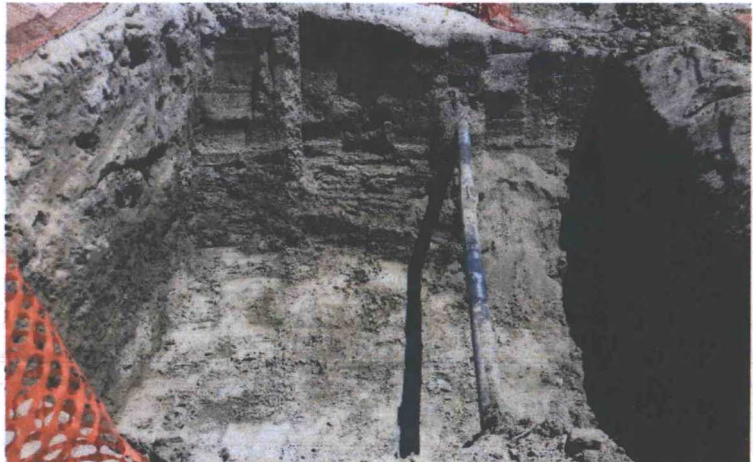
## Photograph 5

View of the excavation, facing southeast.

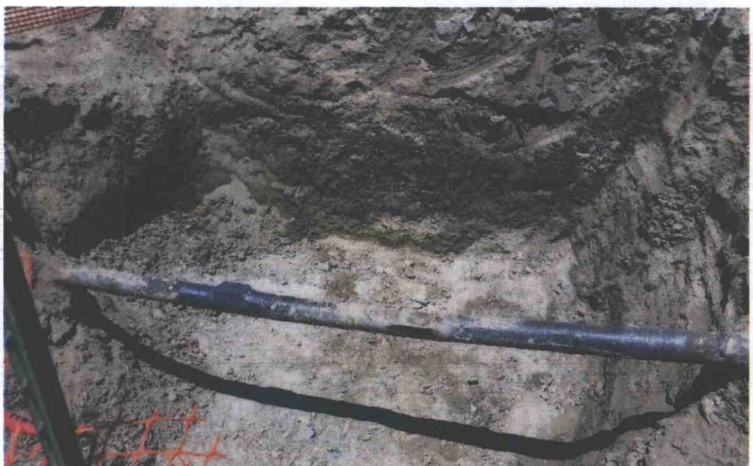
## Photograph 6

View of the final excavation, facing north.

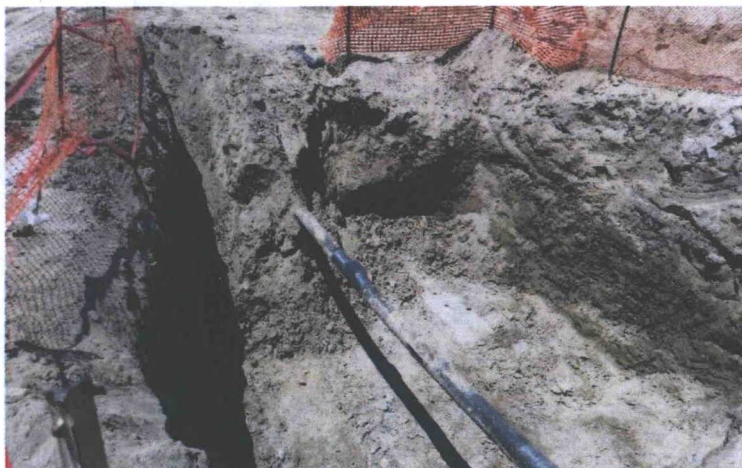
**Photograph 7**

View of the final excavation.

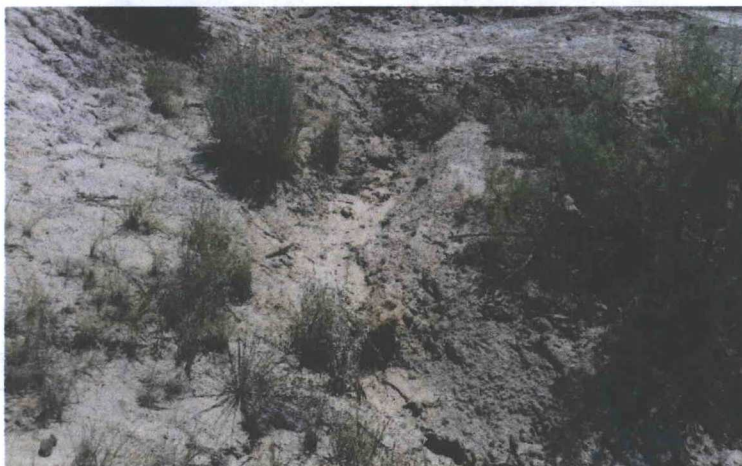
**Photograph 8**

View of the hand-excavated flow path, facing east.

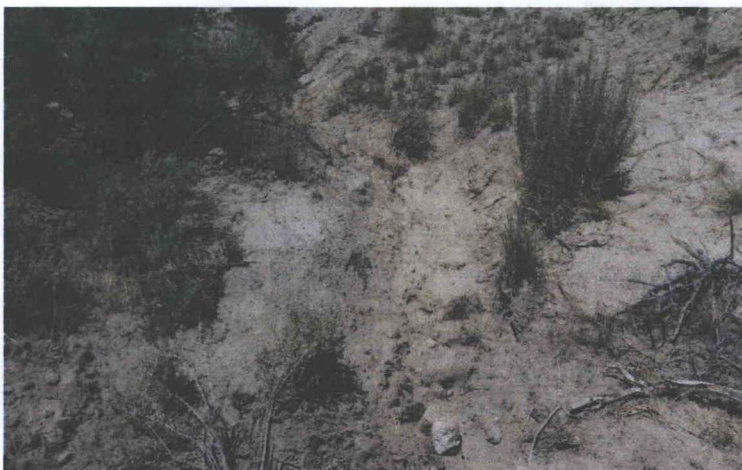
**Photograph 9**

View of the hand-excavated flow path.

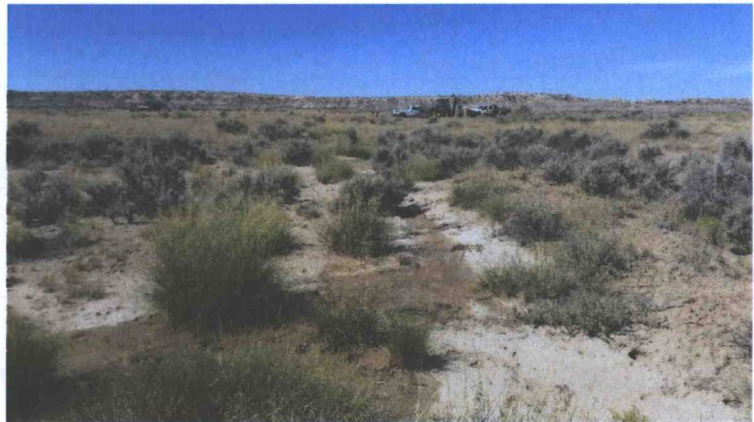
**Photograph 1**

View of the flow path, facing south-west.

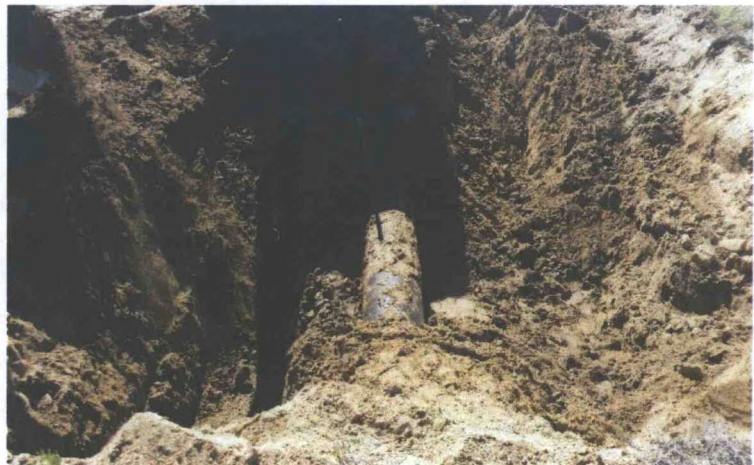
**Photograph 2**

Initiation of excavation activities.

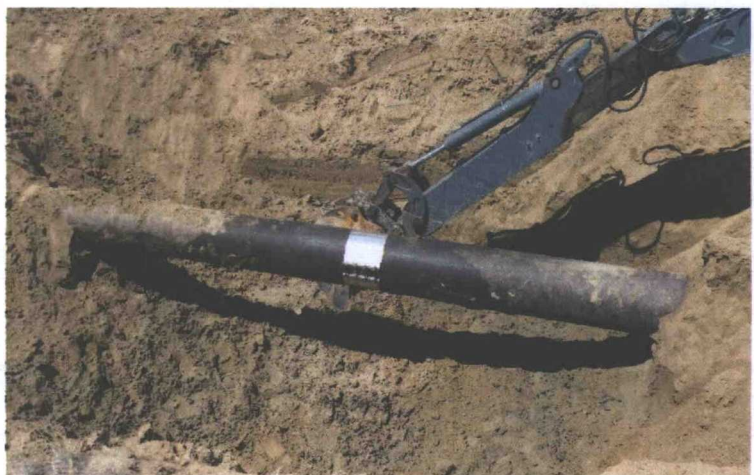
**Photograph 3**

View of in-process excavation activities.

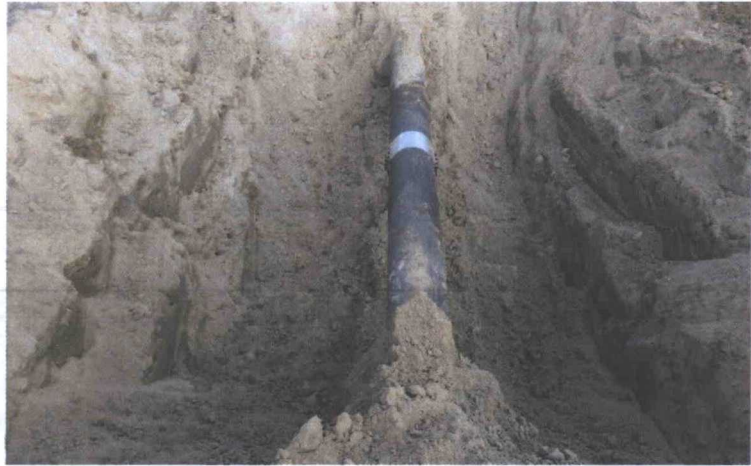
**Photograph 4**

View of the final excavation.

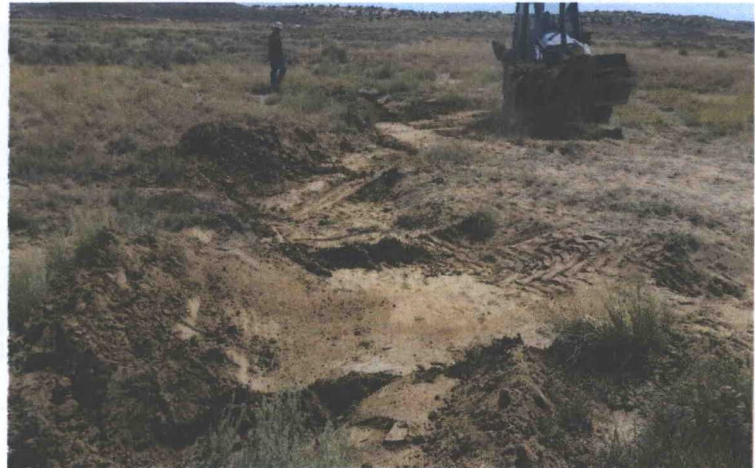
**Photograph 5**

View of the flow path excavation.

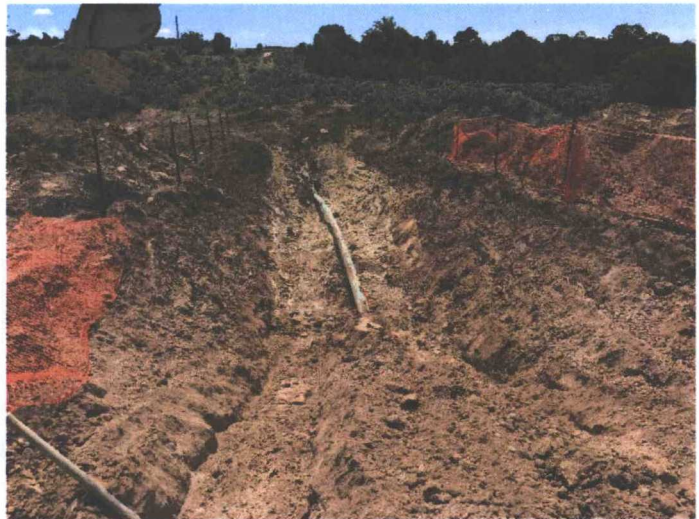
**Photograph 1**

View of the initial excavation, facing south.

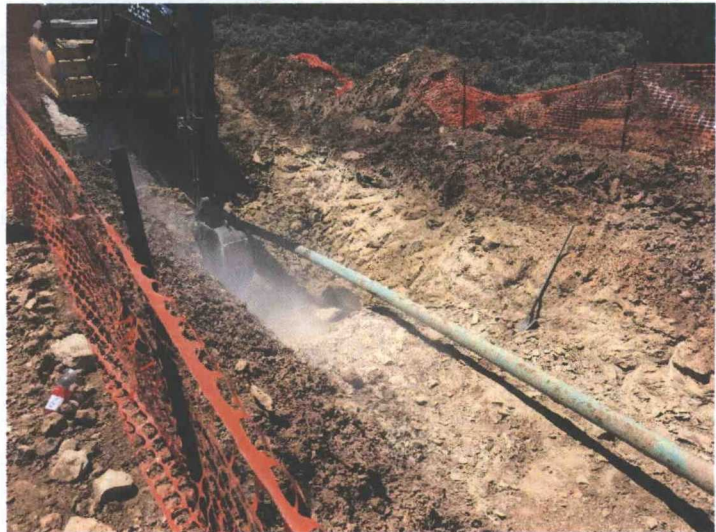
**Photograph 2**

View of the in-process over-excavation activities, facing southwest.

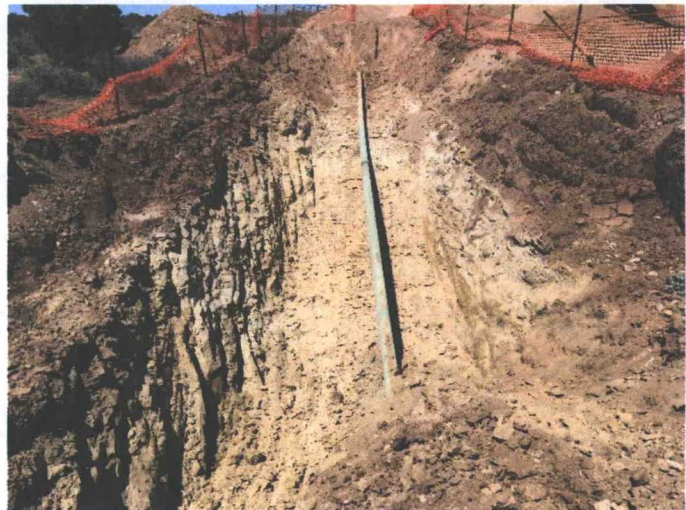
**Photograph 3**

View of the final excavation, facing north.

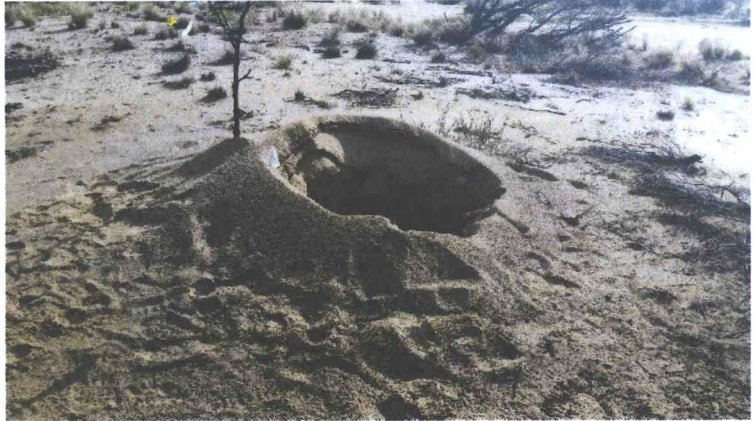
**Photograph 1**

Surface expression of the release.

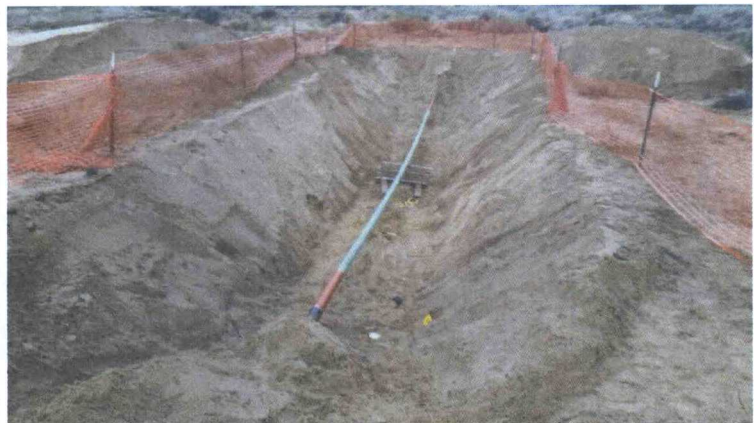
**Photograph 2**

Pipeline after repairs.

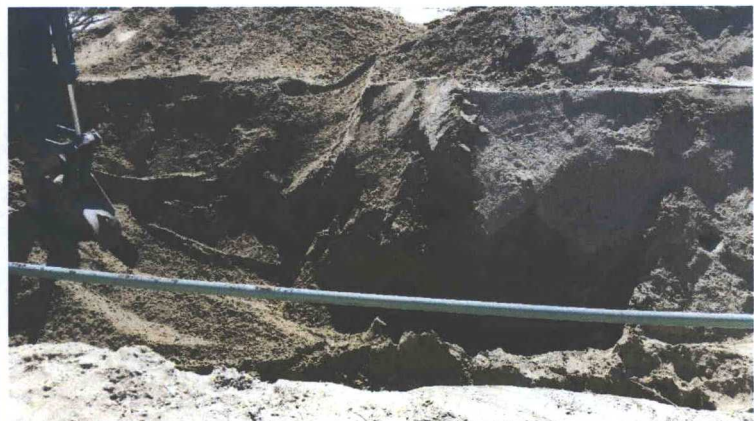
**Photograph 3**

Pipeline excavation, facing northeast.

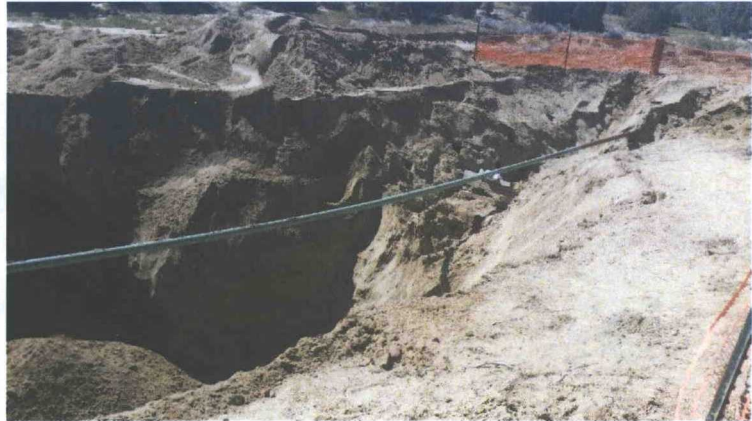
**Photograph 4**

View of the excavation, facing southeast

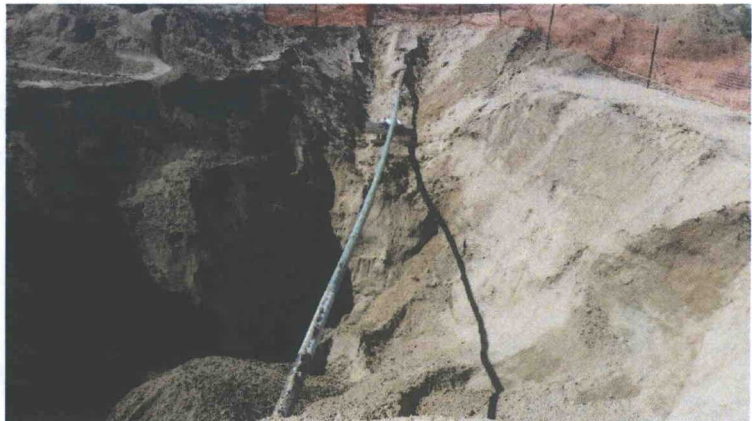
**Photograph 5**

Excavation at the point of release, facing northeast.

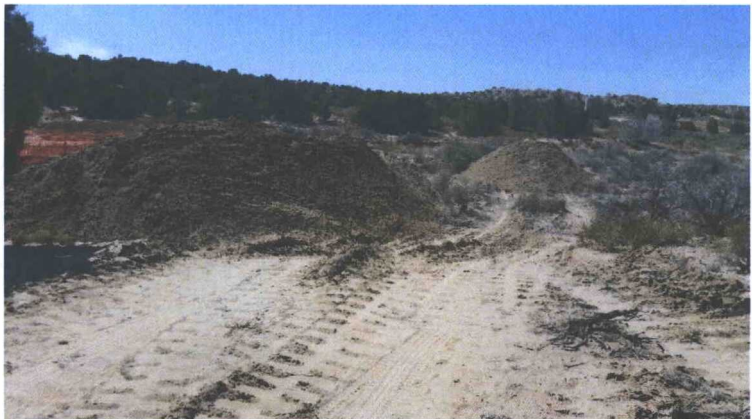
**Photograph 6**

View of the stockpiles.

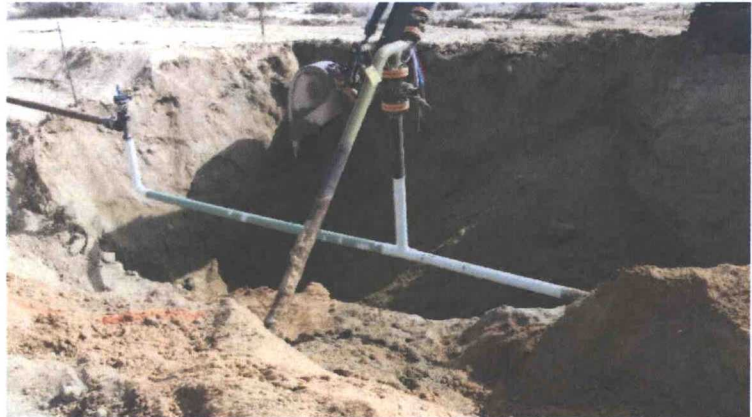
**Photograph 1**

View of the in-process excavation activities, facing north.

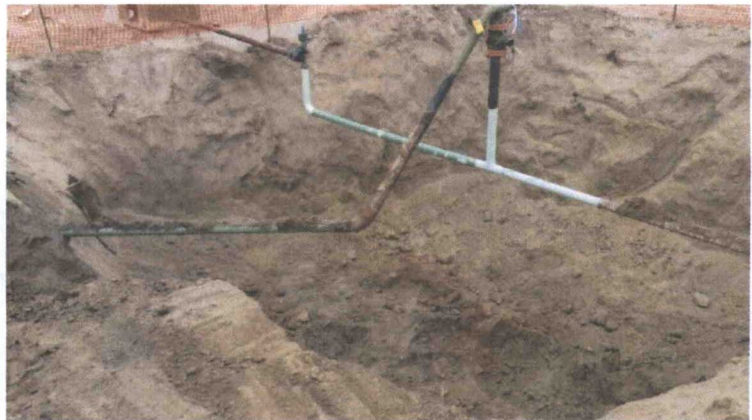
**Photograph 2**

View of the excavation, facing north.

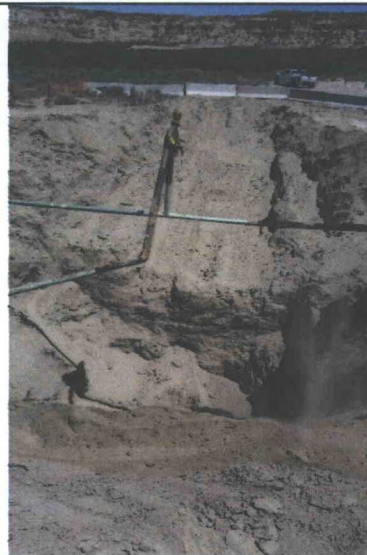
**Photograph 3**

View of the excavation, facing east.

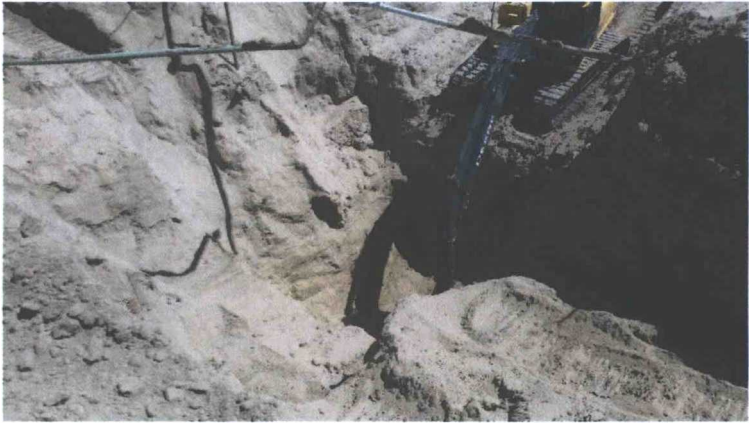
<p><b>Photograph 4</b></p> <p>View of the in-process excavation activities.</p>

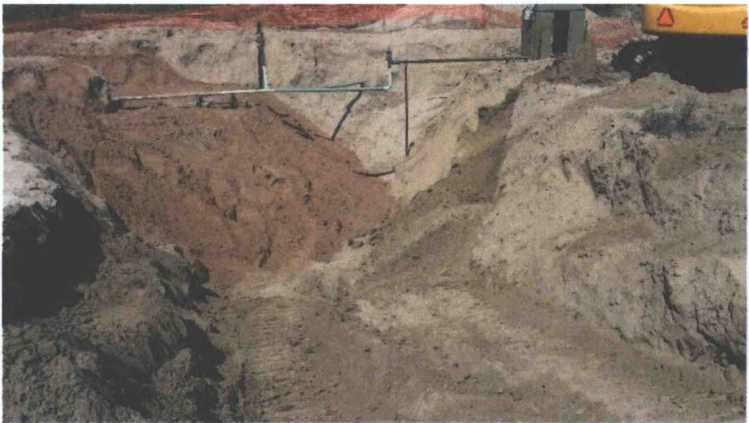
<p><b>Photograph 5</b></p> <p>View of the excavation with southern portion backfilled to allow additional excavation of the north wall (facing west).</p>

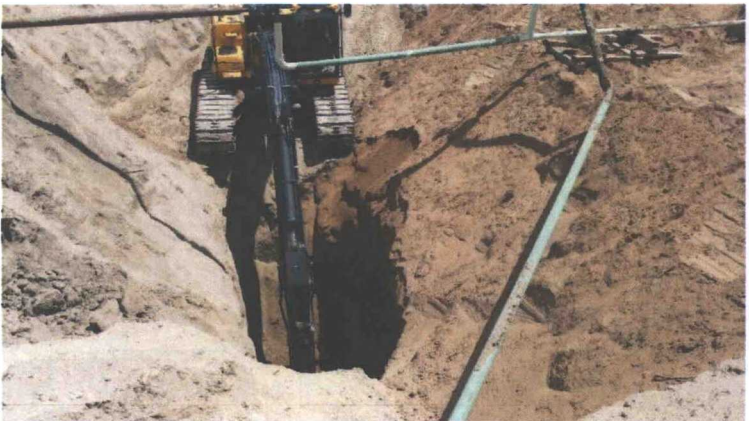
<p><b>Photograph 6</b></p> <p>View of the in-process excavation of north wall after southern portion backfilled for pipeline support.</p>

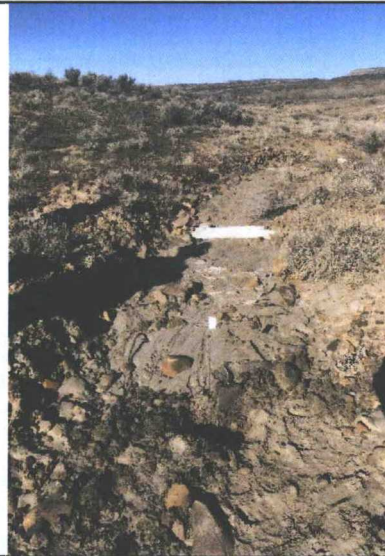
## Photograph 1

Flow path near the release point, facing southwest.

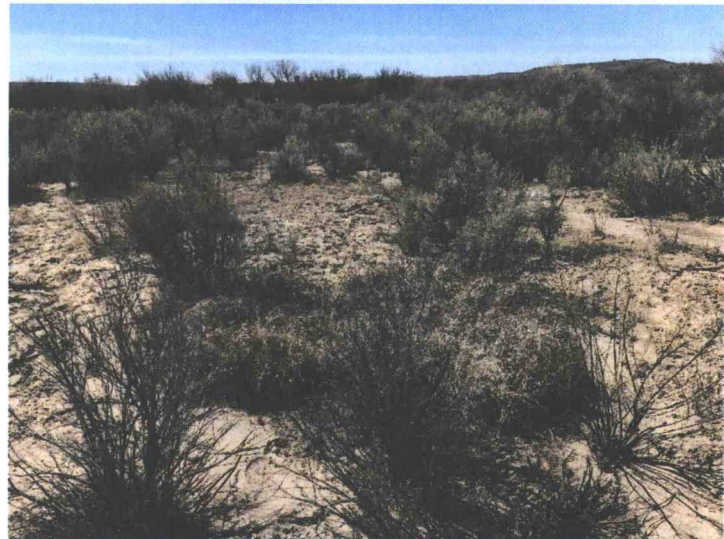
## Photograph 2

Flow path and potential sheet flow area, facing south.

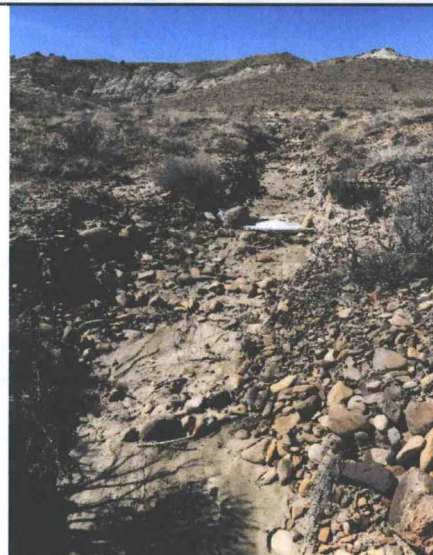
## Photograph 3

Central flow path, facing northeast.

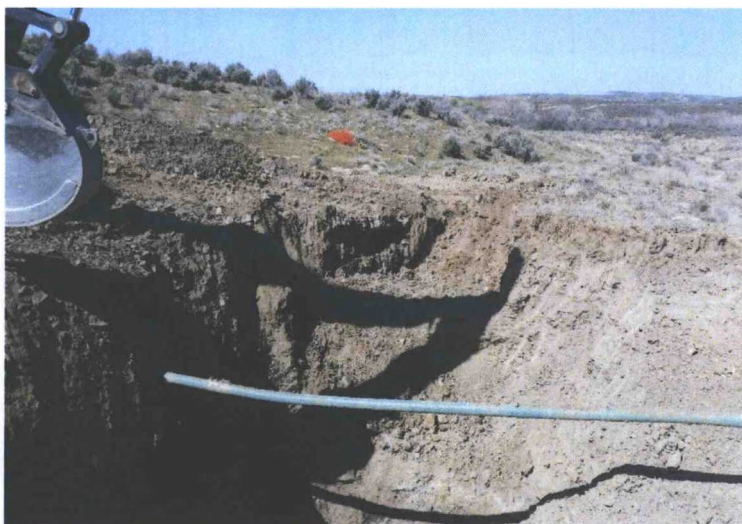
**Photograph 4**

View of excavation activities, facing west.

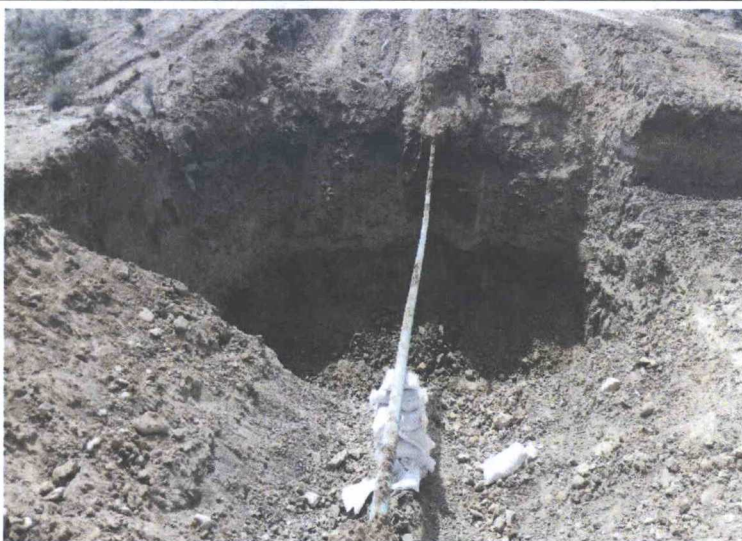
**Photograph 5**

View of the pipeline ROW excavation, facing south.

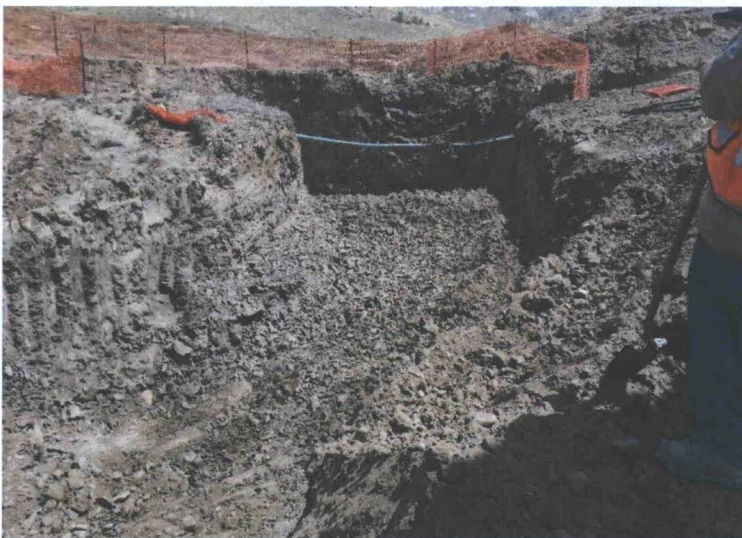
**Photograph 6**

View of the upper flow path excavation, facing east.

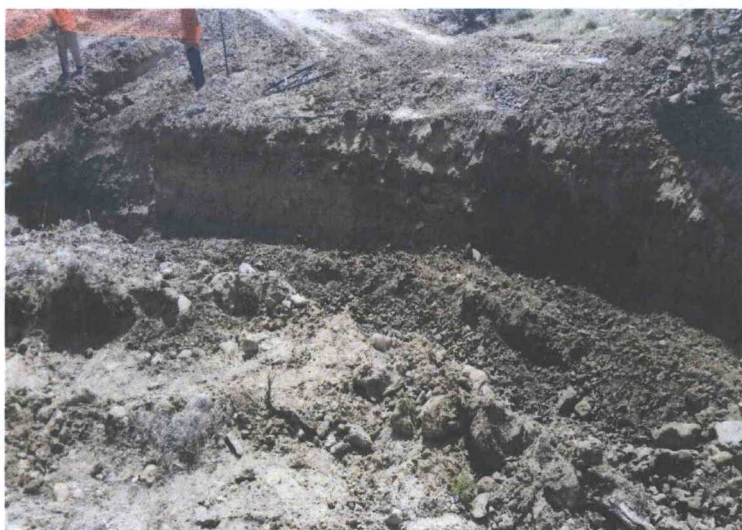
**Photograph 7**

View of the flow path excavation.

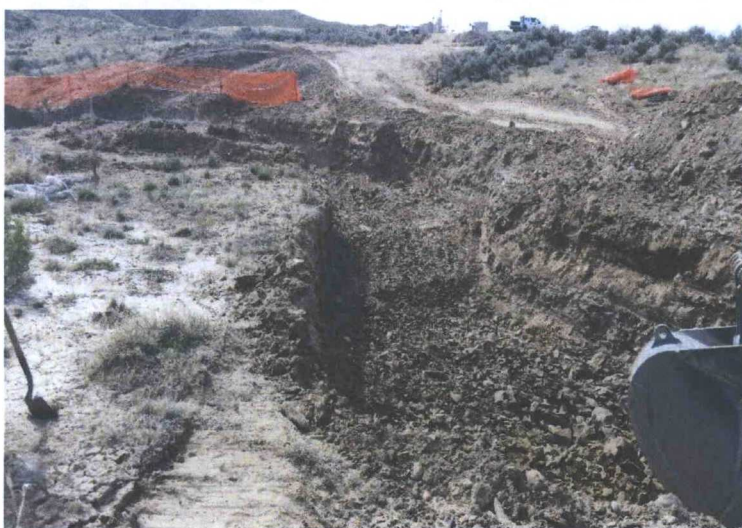
**Photograph 8**

View of the flow path excavation, facing southeast.

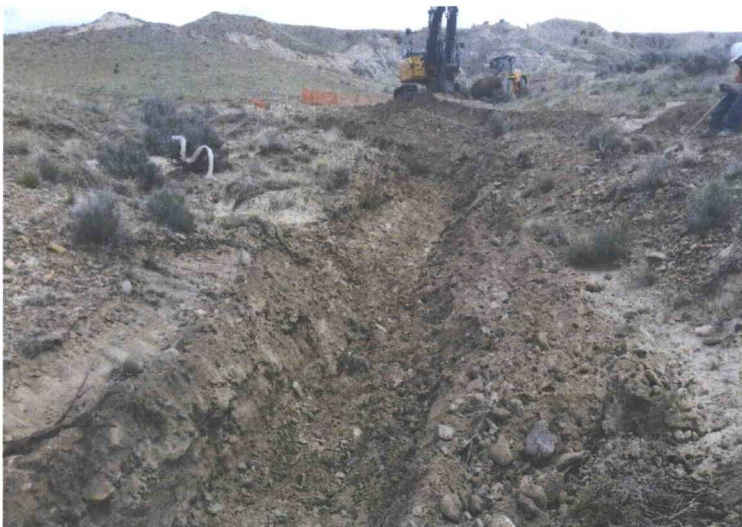
**Photograph 9**

View of the flow path excavation, facing east.
