# CLOSURE REPORT

**MEYER B-4 #24**

**LEA COUNTY, NEW MEXICO**

**APRIL 2006**

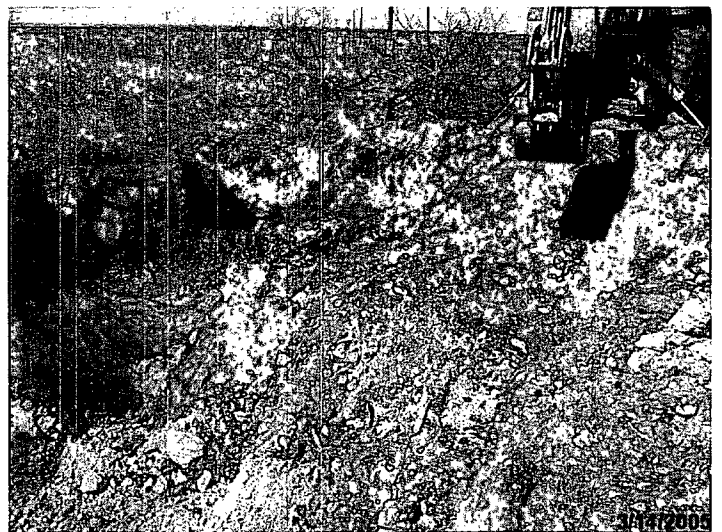
**Photo #4:** Looking southerly at southeast side of excavation.

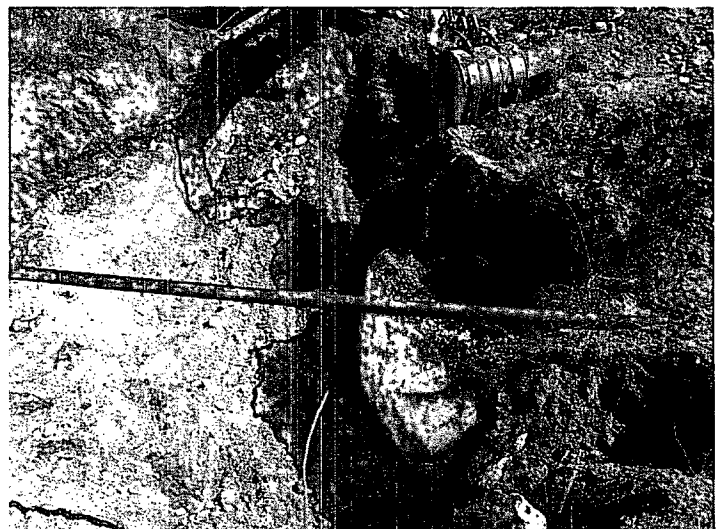
**Photo #6:** Looking southerly at south end of excavation.
