CLOSURE REPORT

MCNEILL 12-INCH LOOPLINE

TARGA REF: 210011

JULY 2006

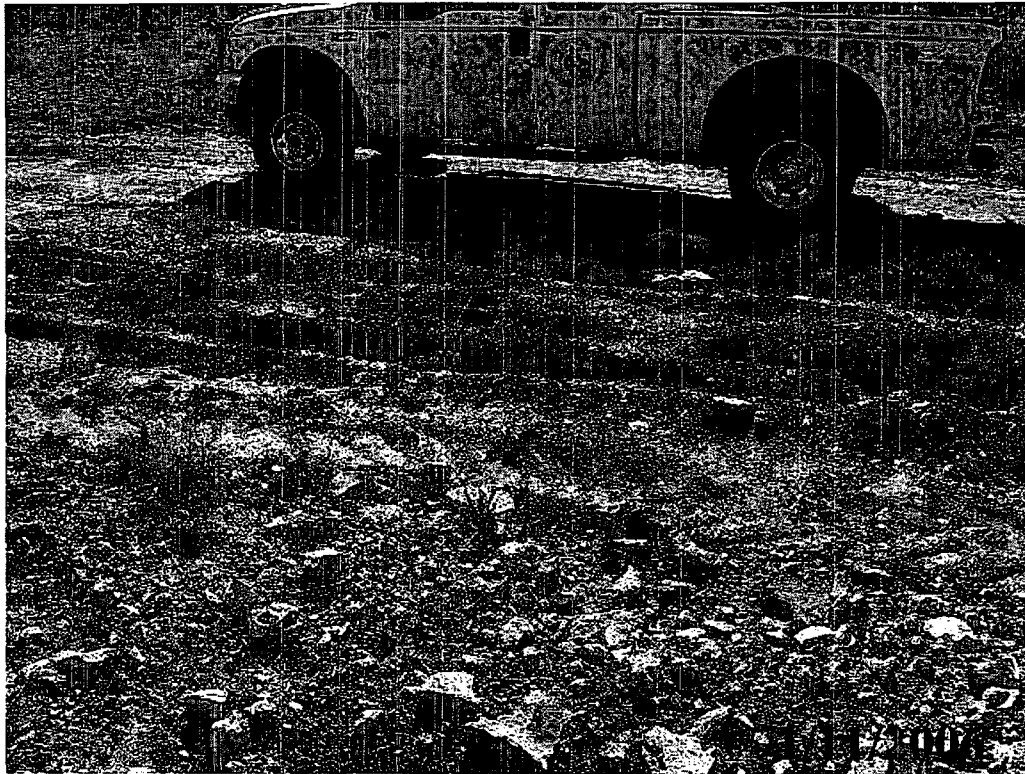
Photograph #1 – Looking southerly across western release area.

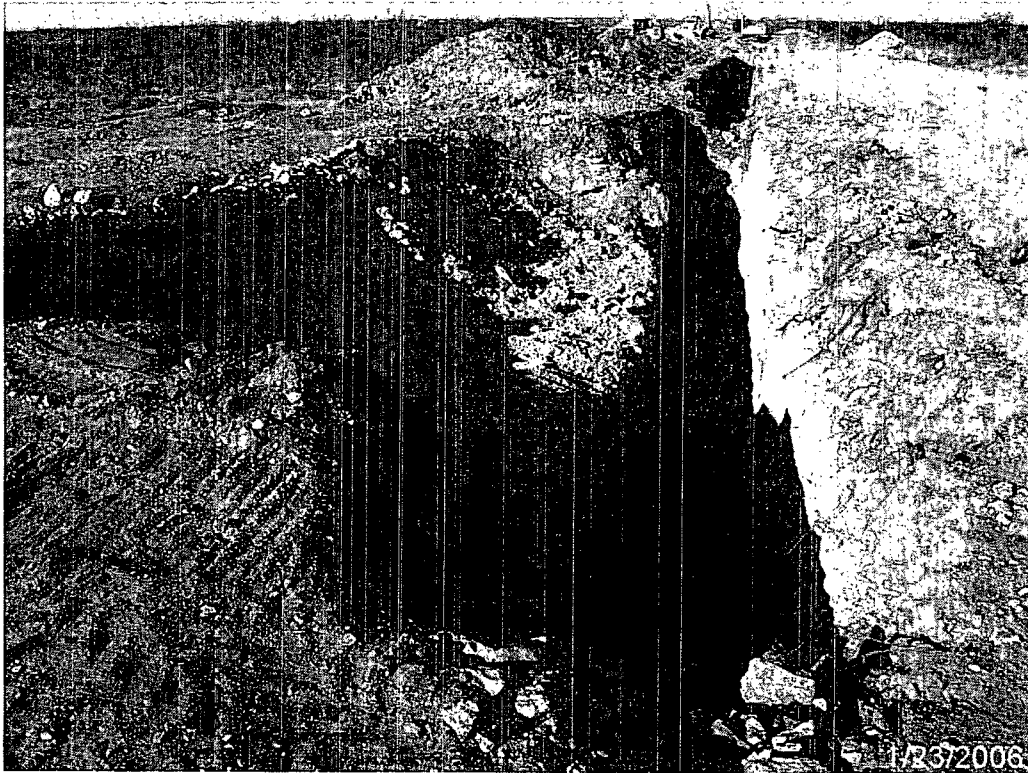
Photograph #5 – Eastern excavation (Excavation C) looking westerly.

Laboratory analyses of soil samples collected on January 18, 2006 from the eastern excavation (Excavation C) floor and sidewalls indicated TPH and BTEX constituent concentrations were ND at or above laboratory MDL. Chloride concentrations were reported to range from 16 to 48 mg/Kg. Sulfate concentrations were reported to range from 63 to 1,324 mg/Kg (reference *Table 2, Figure 6 and Appendix I*).

Laboratory analyses of soil samples collected from eastern excavation on March 1, 2006 from the south sidewall (C-WSW-5' A) and west sidewall (C-SSW-5' A) indicated TPH and BTEX constituent concentrations were ND at or above laboratory MDL. Chloride concentrations were reported to range from 16 to 384 mg/Kg. Sulfate concentrations were reported to range from 488 to 566 mg/Kg (reference *Table 2, Figure 6 and Appendix I*).

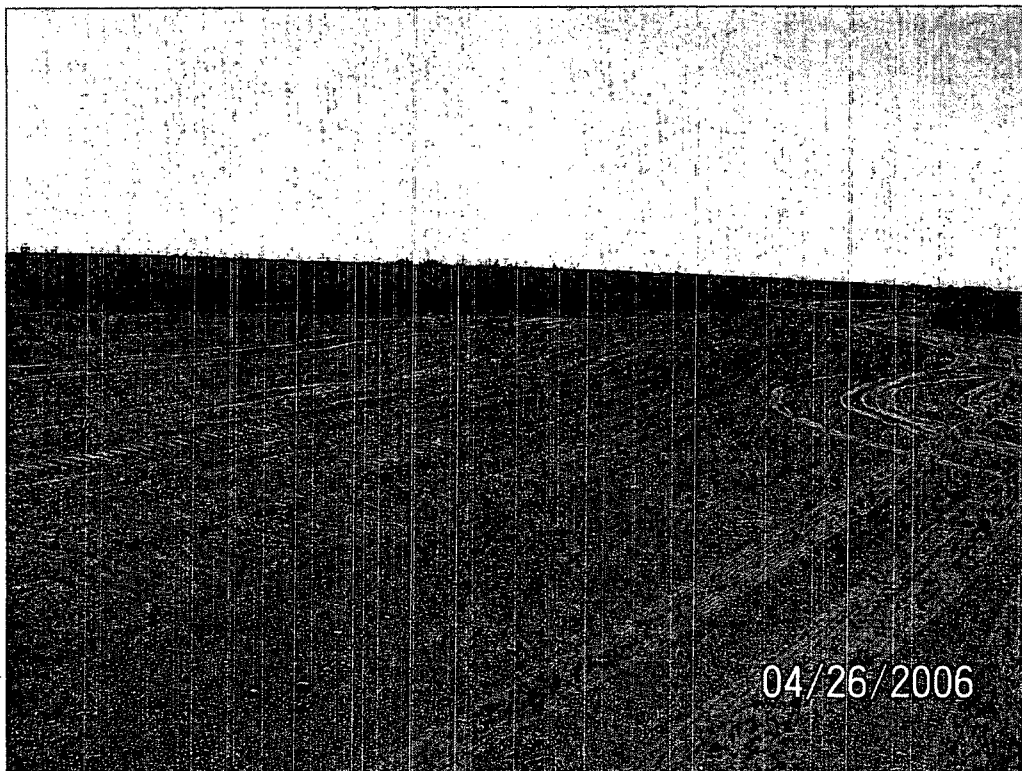
Photograph #7 – Site graded and contoured, looking west-southwesterly.
