Re: Delineation Report and Remediation Proposal  
Apache Corporation NEDU 809, (Ref. #240011)  
UL- H of Section 22, T21S, R37E  
Latitude 32° 28' 0.9"N and Longitude 103° 08' 40.1"W  
Landowner: C.A. Bettis

**Figure 2**  
**Apache Corporation**  
**Northeast Drinkard Unit (NEDU) #809**  
**Chloride Delineation**

Figure 1  
 Apache Corporation  
 NEDU #809 Site Map  
 November 1, 2005

**Figure 2**  
 Apache Corporation NEDU #809  
 Proposed Soil Boring Location Map

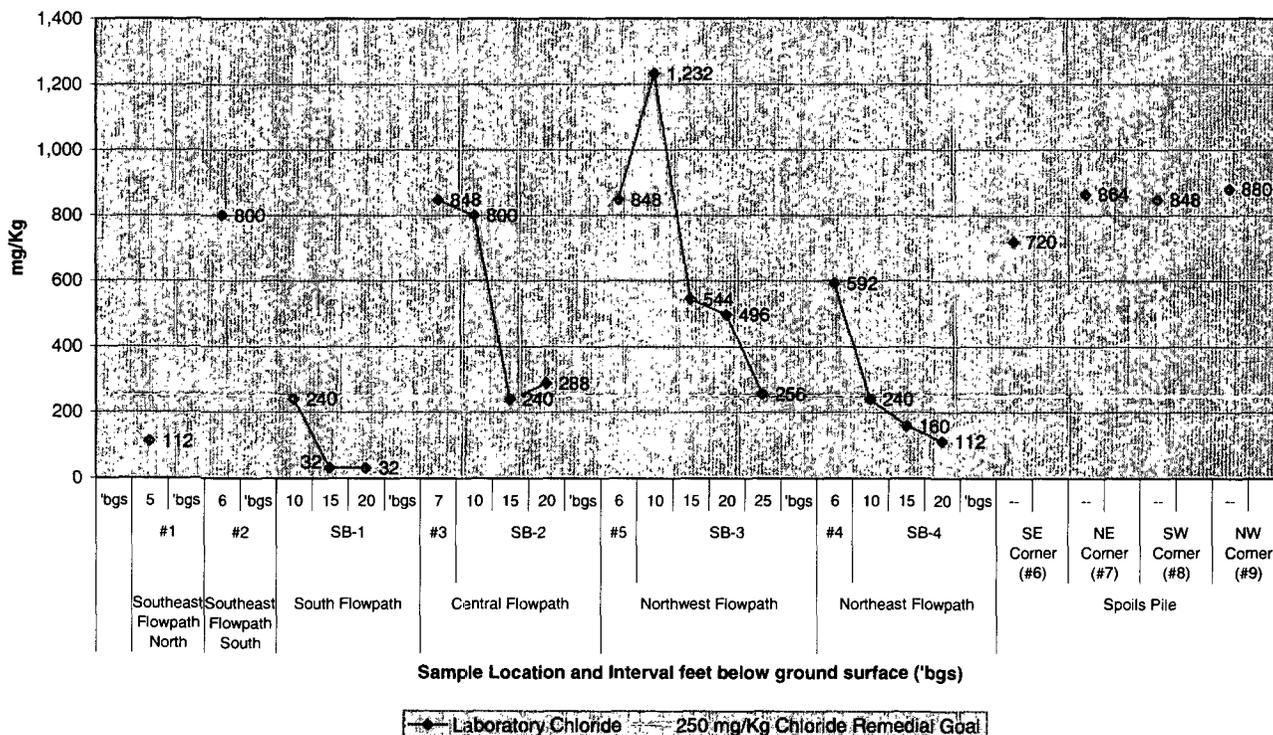
**Soil Boring 1 (SB-1)** was located in the south flowpath and advanced to 20-feet bgs. All samples were less than 250 mg/Kg.

**Soil Boring 2 (SB-2)** was located in the central flowpath and advanced to 20-feet bgs. The chloride concentrations ranged from 800 mg/Kg in the 10-foot bgs sample to 240 mg/Kg in the 15-foot bgs sample, however the 20-foot bgs sample increased to 288 mg/Kg.

**Soil Boring 3 (SB-3)** was located in the northwest flowpath, nearest the leak origin, and advanced to 25-feet bgs. The chloride concentrations ranged from 1,232 mg/Kg in the 10-foot bgs sample to 256 mg/Kg in the 25-foot bgs sample.

**Soil Boring 4 (SB-4)** was located in the northeast flowpath and advanced to 20-feet bgs. The chloride concentrations ranged from 240 mg/Kg in the 10-foot bgs sample to 112 mg/Kg in the 20-foot bgs sample.

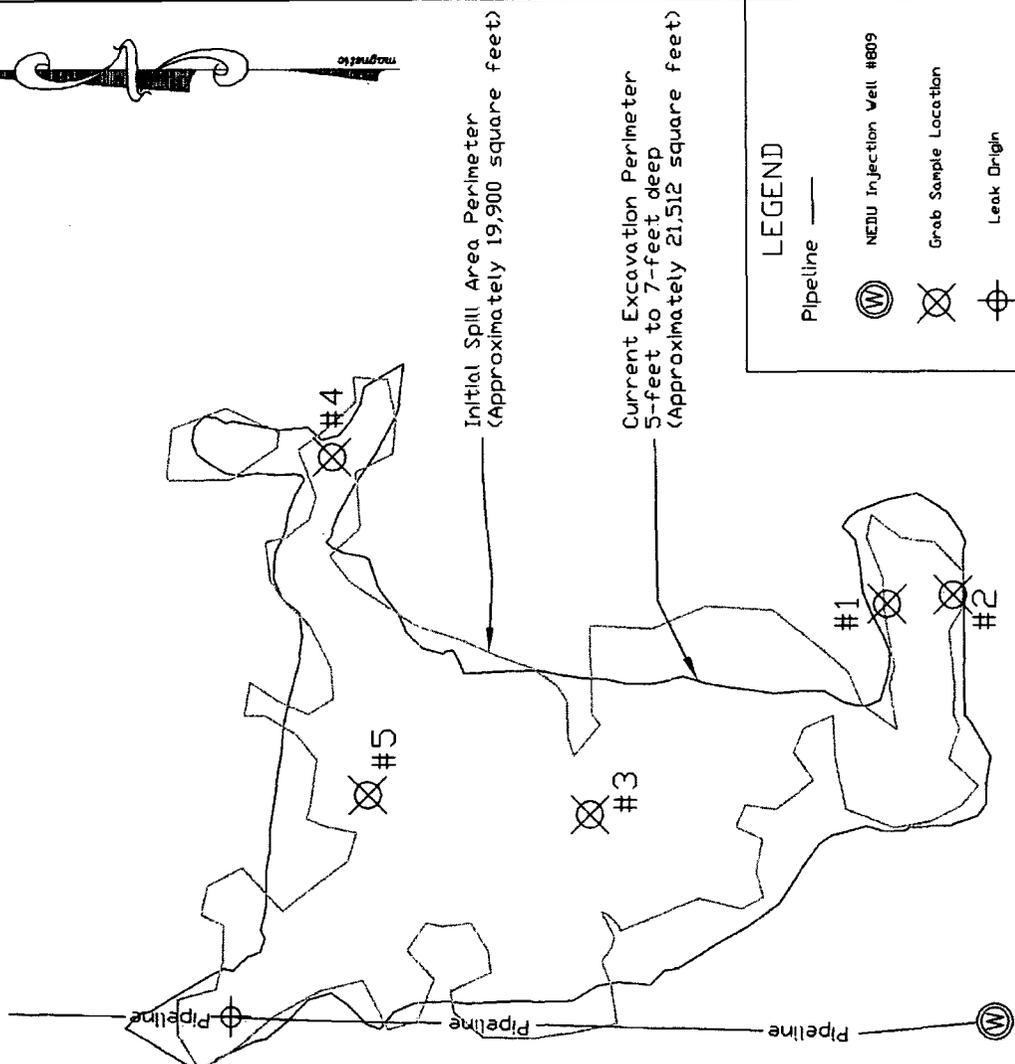
Disposal volume to date is 1,736 cubic yards.  
 Approximately 3,919 cubic yards of soil impacted  
 above the New Mexico Oil Conservation Division  
 Guidelines are stockpiled inside a bermed and lined  
 (10 mil polyethylene plastic) soil storage area.

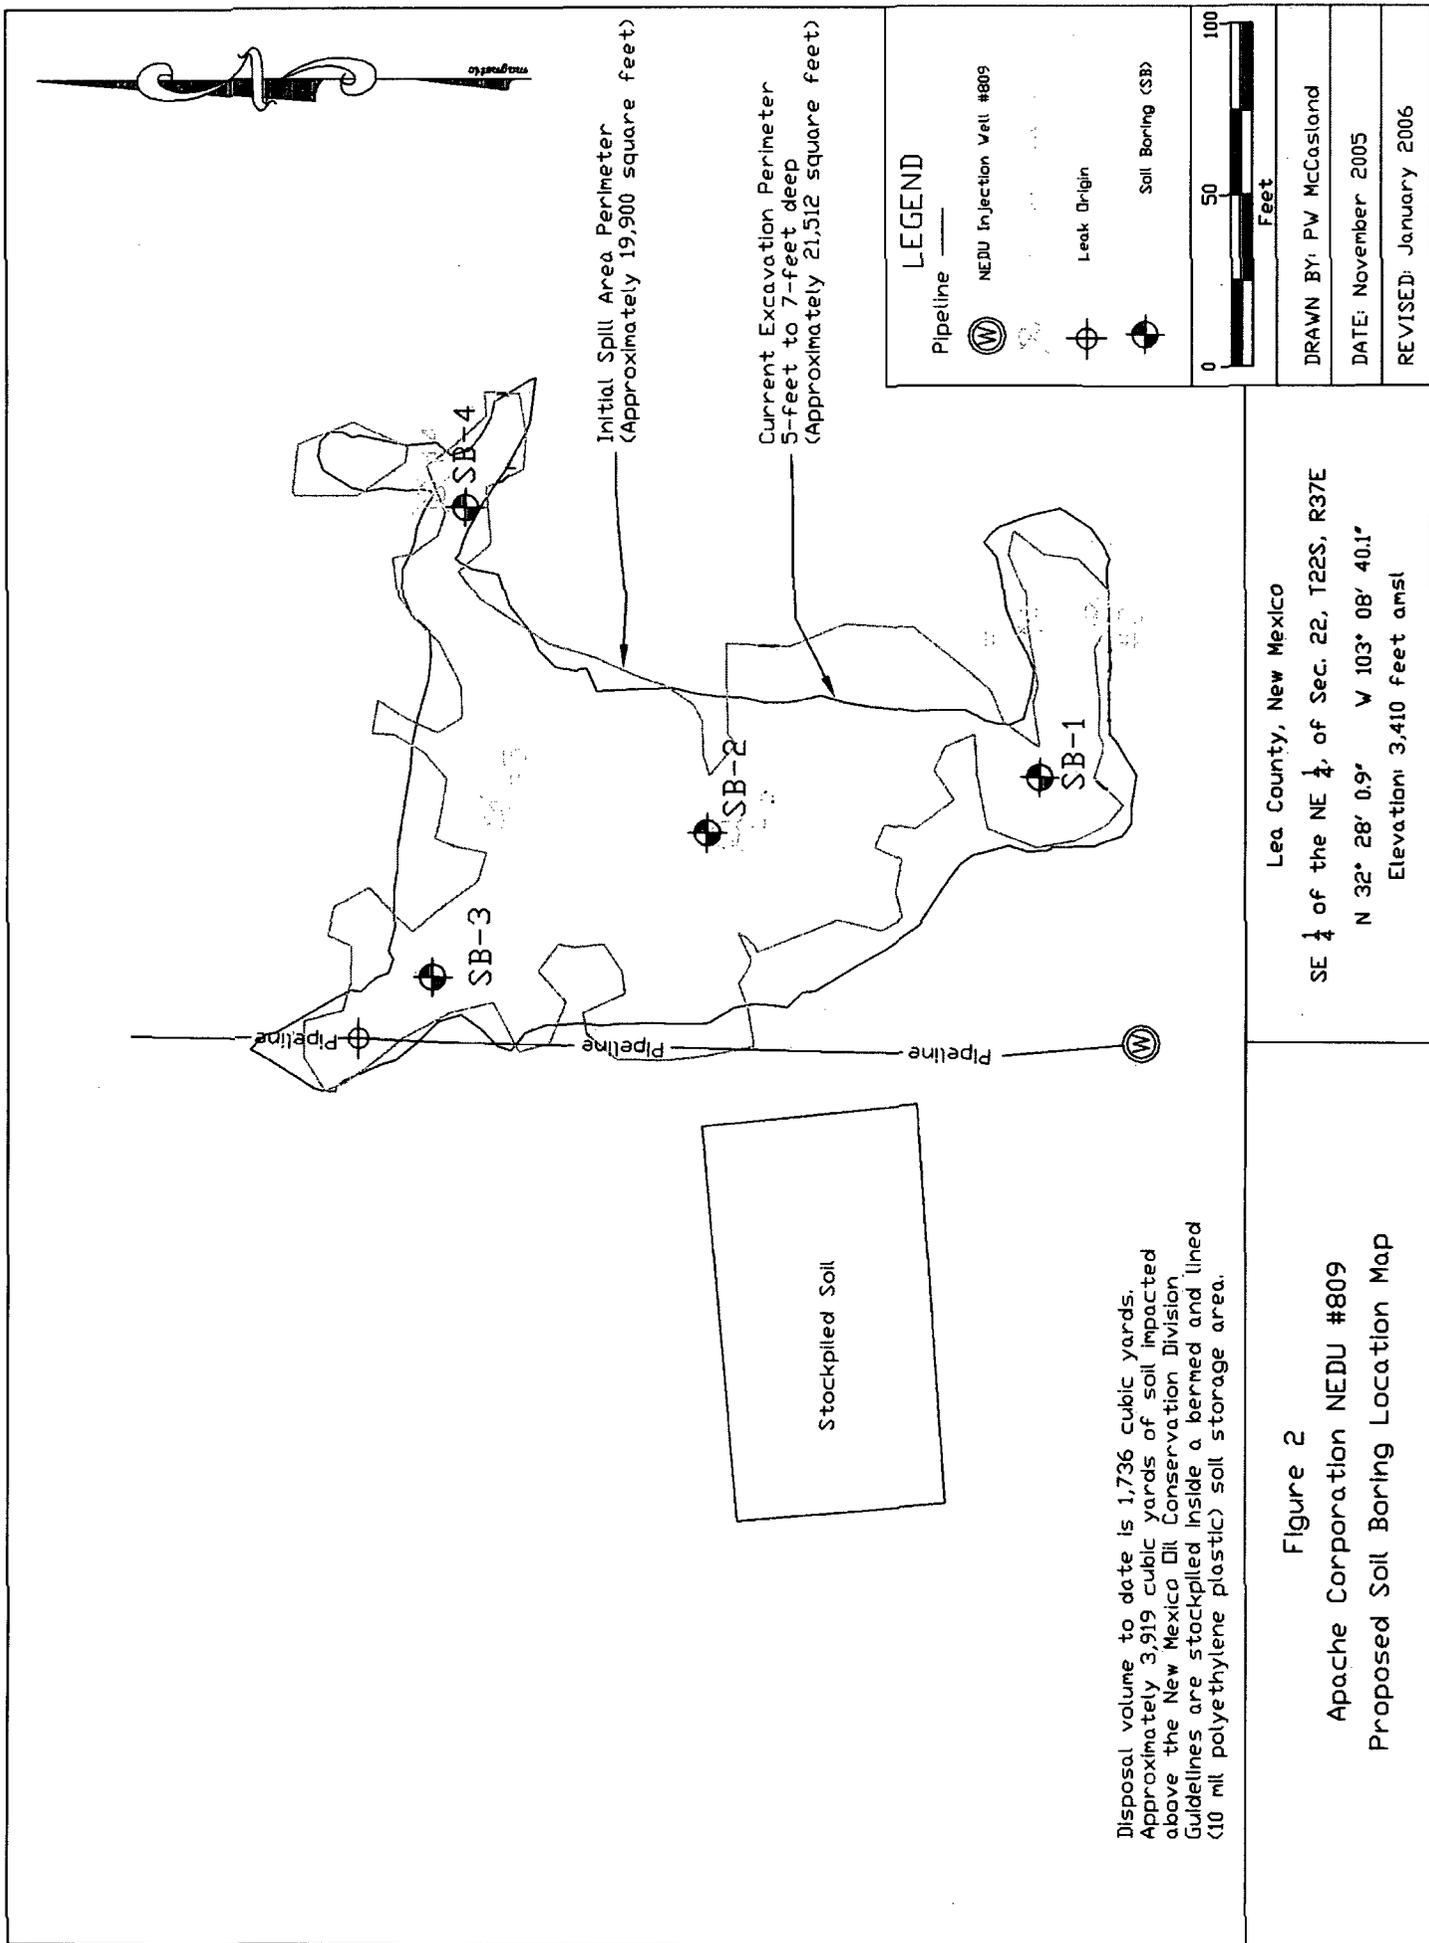
Disposal volume to date is 1,736 cubic yards. Approximately 3,919 cubic yards of soil impacted above the New Mexico Oil Conservation Division Guidelines are stockpiled inside a bermed and lined (10 mil polyethylene plastic) soil storage area.
