# **HESS CORPORATION**

## **CHEVRON GRAHAM "D" BATTERY #18 LEA COUNTY, NEW MEXICO**

### **SITE CLOSURE REPORT**

**October 12, 2006**

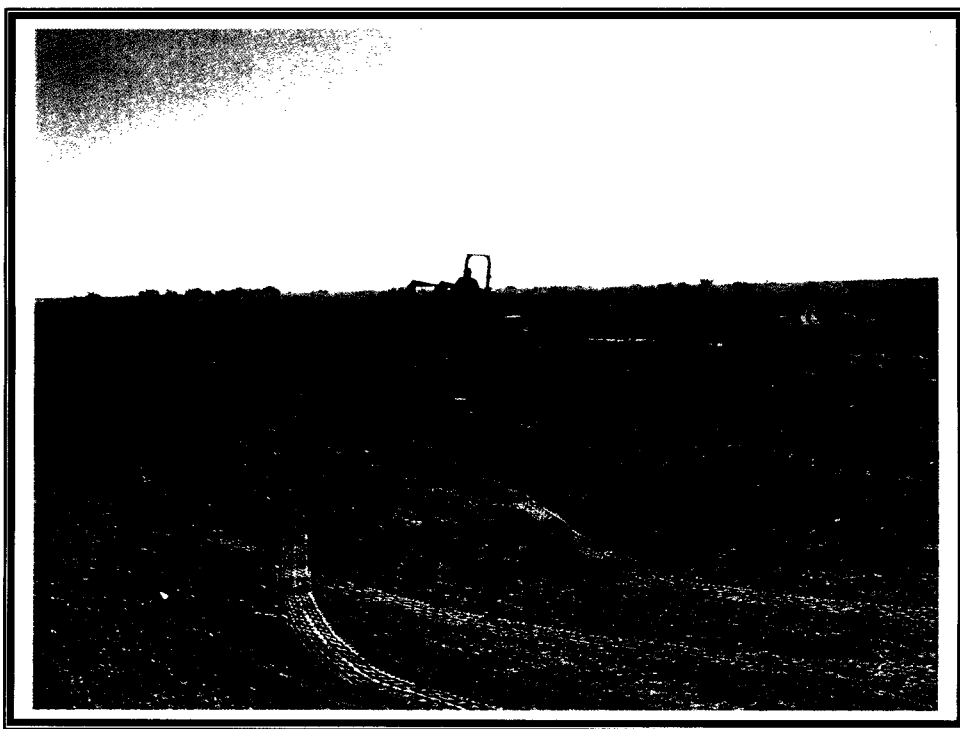
Chevron Graham "D" Battery #18 reseedling

Site excavation was completed on June 15, 2006 and 5,180 yards of contaminated material was hauled to a landfarm. Backfilling and contouring was completed with a total of 7,080 yards of clean soil on July 19, 2006. The site was reseeded on September 26, 2006.
