Re: Closure Proposal Doyle Hartman Oil Producer State H #5 - Reference #180005
UL-A (NE¼ of the NE¼) of Section 17, Township 22 South, Range 36 East
Latitude N 32° 23' 53.759" and Longitude W 103° 16' 52.938"

Environmental Plus, Inc. (EPI), on behalf of Mr. Rick Wilson, Doyle Hartman Oil Producer (Doyle Hartman), submits this letter report documenting the work completed at the above-referenced leak site located on land owned by the State of New Mexico and administered by the New Mexico State Land Office. The site is located approximately 7.5 miles southwest of Eunice, New Mexico (reference Figure 1). Information obtained from the New Mexico Office of the State Engineer's website indicates there are seven water supply wells located within a one-mile radius of the release site; however, there are no wells located within a 1,000-foot radius of the release site. In addition, the website indicates the presence of one additional well in the sections surrounding the release site (i.e., sections 7, 8, 9, 16, 18, 19, 20 and 21, T 22 S, R 36 E) Groundwater level data indicated groundwater was present at an average depth of approximately 173 feet bgs. Table below ranks the site in accordance

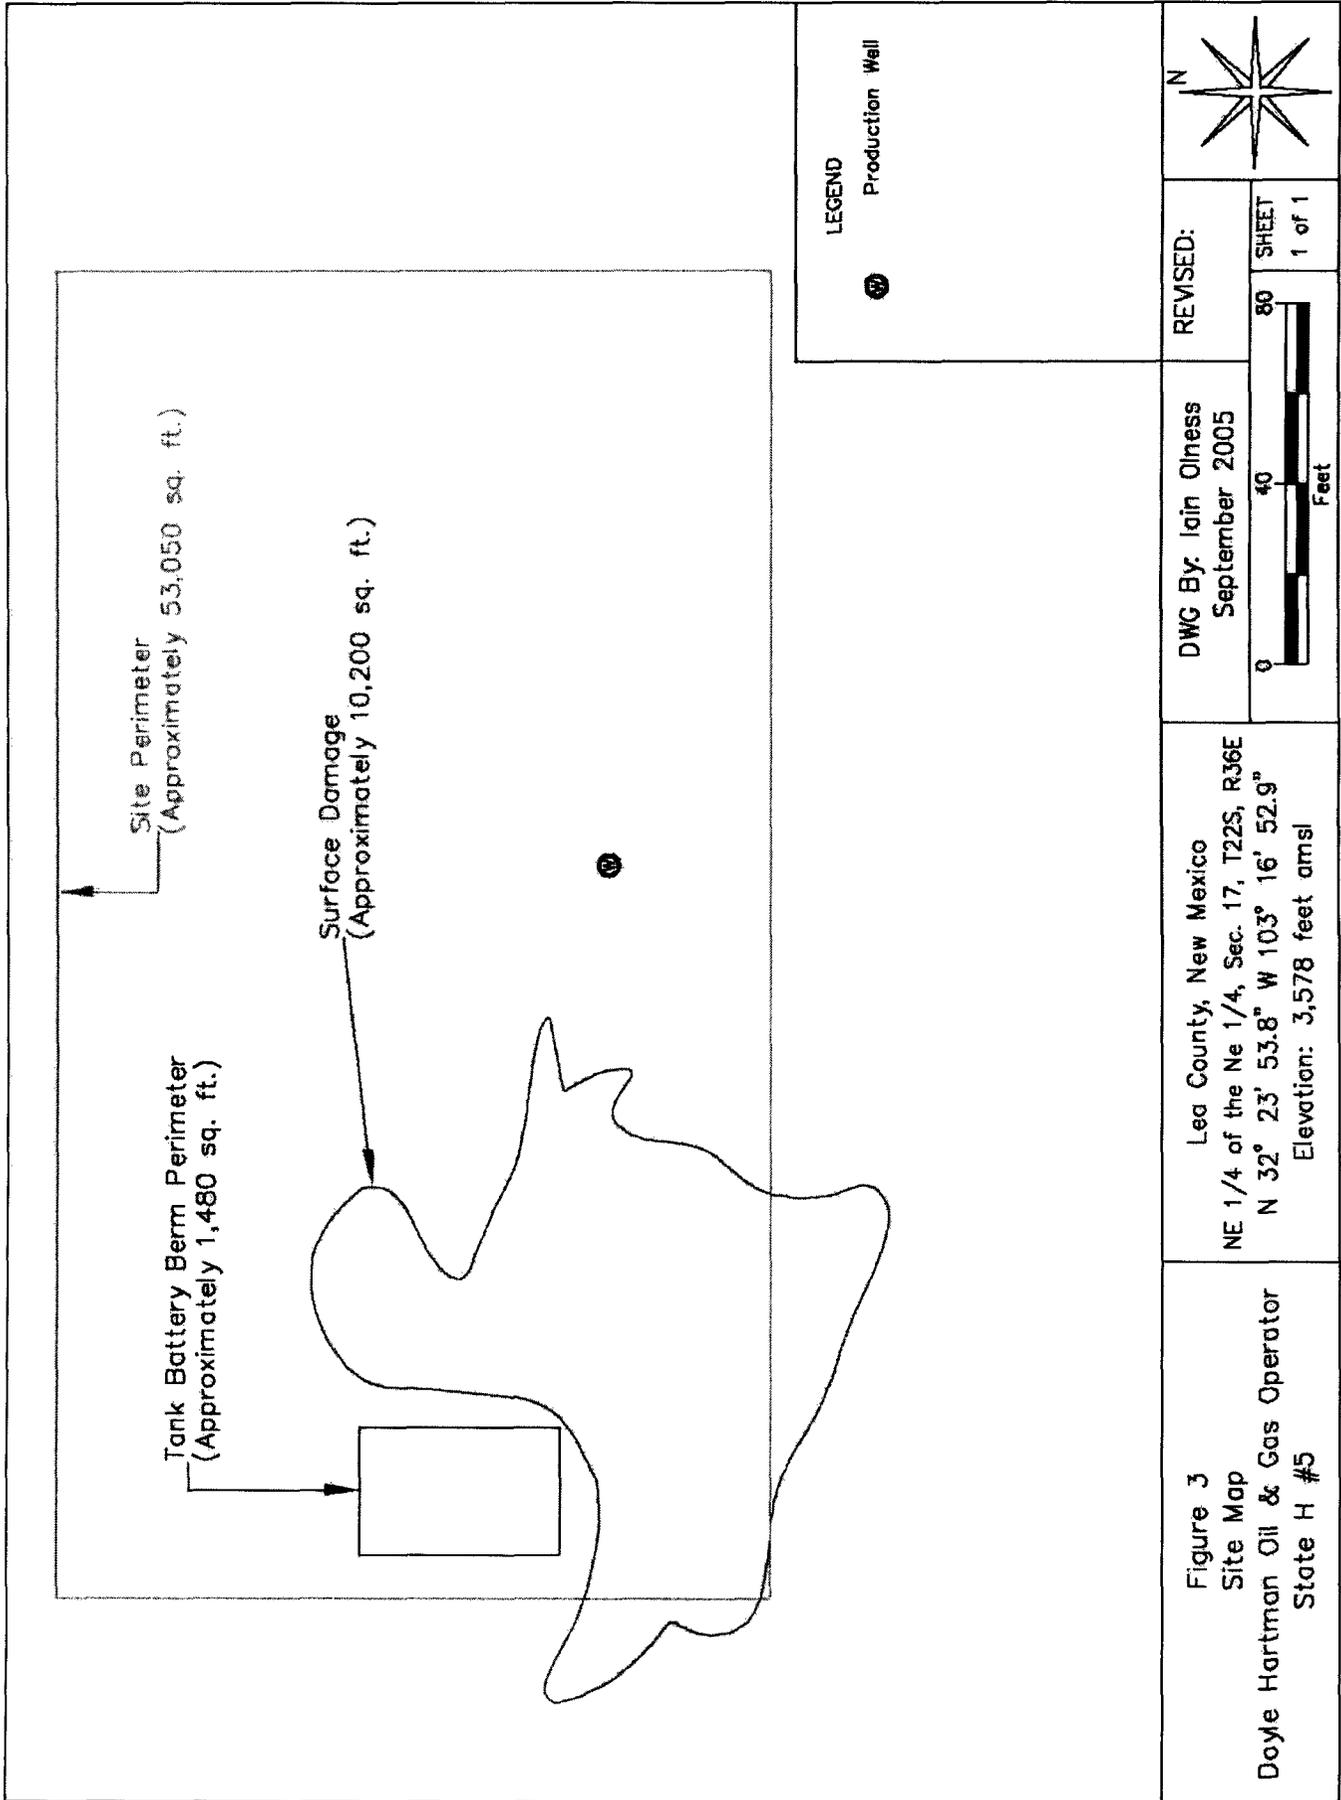
was contained within the bermed area, with the volatiles being consumed by the fire (reference *Figure 3*). There was a large area situated east and south of the bermed area that was impacted; however, those impacts appeared to be limited to the surface (reference *Photographs 3 and 4*). After the fire was extinguished by the Eunice Fire Department, plans were made to excavate the saturated soil and return the site to an operating battery.

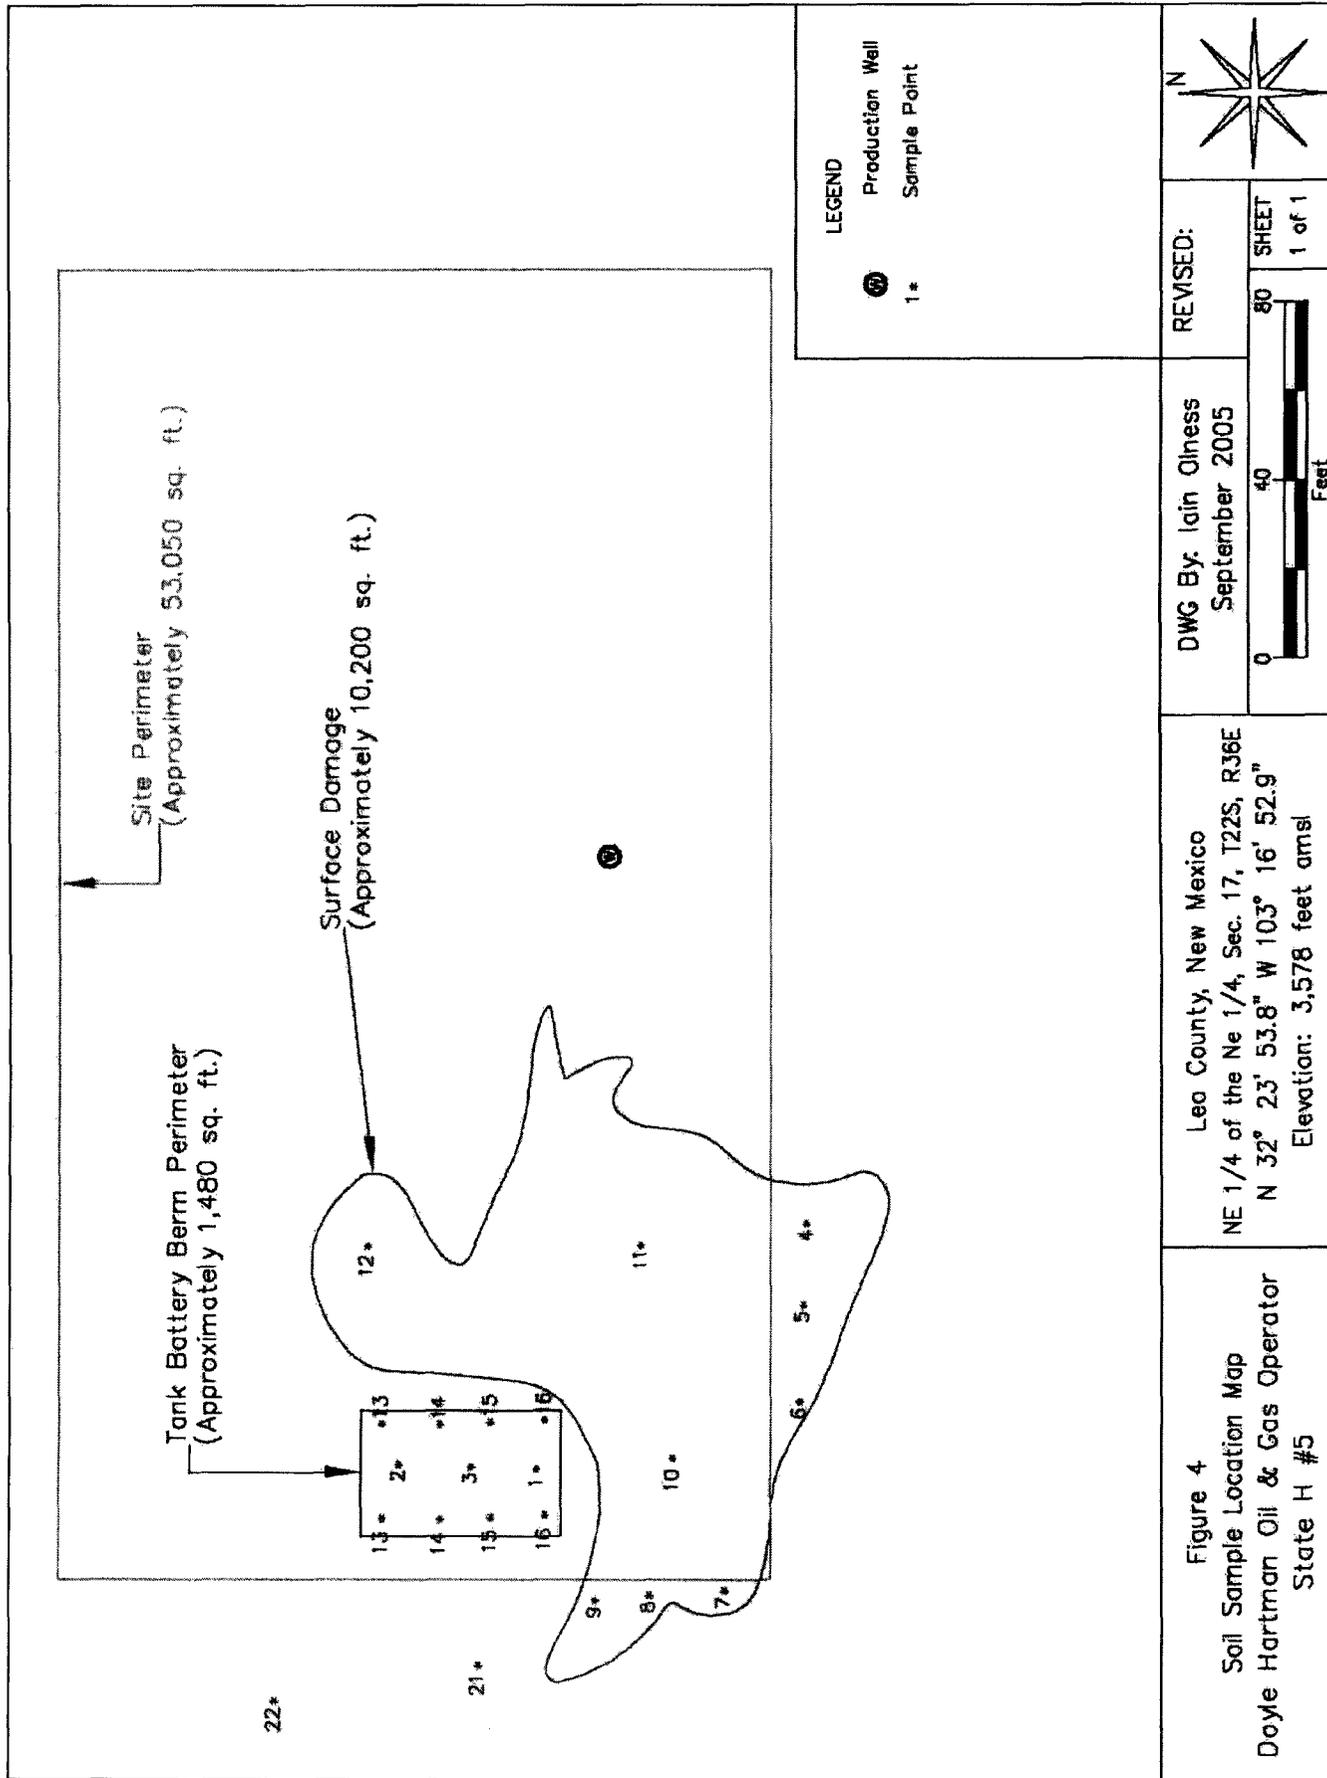
Figure 4
Soil Sample Location Map
Doyle Hartman Oil & Gas Operator
State H #5

EPI personnel were on site from July 13 through 15, 2005 to excavate impacted soil within the confines of the bermed area. Prior to any excavation activities, samples (sample points #1 through #3) were collected from within the bermed area to determine the extent of contamination (reference *Figure 4 and Table 1*). Approximately 200 cubic yards of impacted soil were removed from the area (i.e., approximately 3 feet of soil were excavated from the entire bermed area) and stockpiled on site. Upon completion of the excavation activities, discrete soil samples were collected from the excavation and surrounding area to determine the remaining impacts, if any (reference *Figure 4*).

On July 15 and 21, 2005, soil samples were collected from within the bermed area and the area surrounding the tank battery (reference *Figure 4*). A portion of each sample was analyzed in the field for the presence of chlorides utilizing a LaMotte Chloride Test Kit. Field analyses indicated chloride concentrations ranged from 120 to 1,040 ppm. The remaining portion of each sample was submitted for laboratory quantification of benzene, toluene, ethylbenzene and total xylenes (BTEX), total petroleum hydrocarbons (TPH) and chlorides.

The samples collected on July 15 and 21, 2005 were submitted to Environmental Lab of Texas in Odessa, Texas, for quantification of TPH, BTEX and/or chlorides. Samples #5 (6''), #9 (6''), #11 (6''), #14 (3') and #21 (1') were submitted for quantification of TPH, BTEX and chlorides and the remaining samples were submitted only for quantification of chlorides. Laboratory analytical data for samples #5 (6''), #9 (6''), #11 (6''), #14 (3') and #21 (1') indicated that BTEX and TPH concentrations were non-detectable at or above laboratory MDL (reference *Table 1*). Chloride results for all samples ranged from 32.9 mg/Kg to 887 mg/Kg; however, it should be noted that the high chloride concentrations were detected in along the western edge of the bermed area.

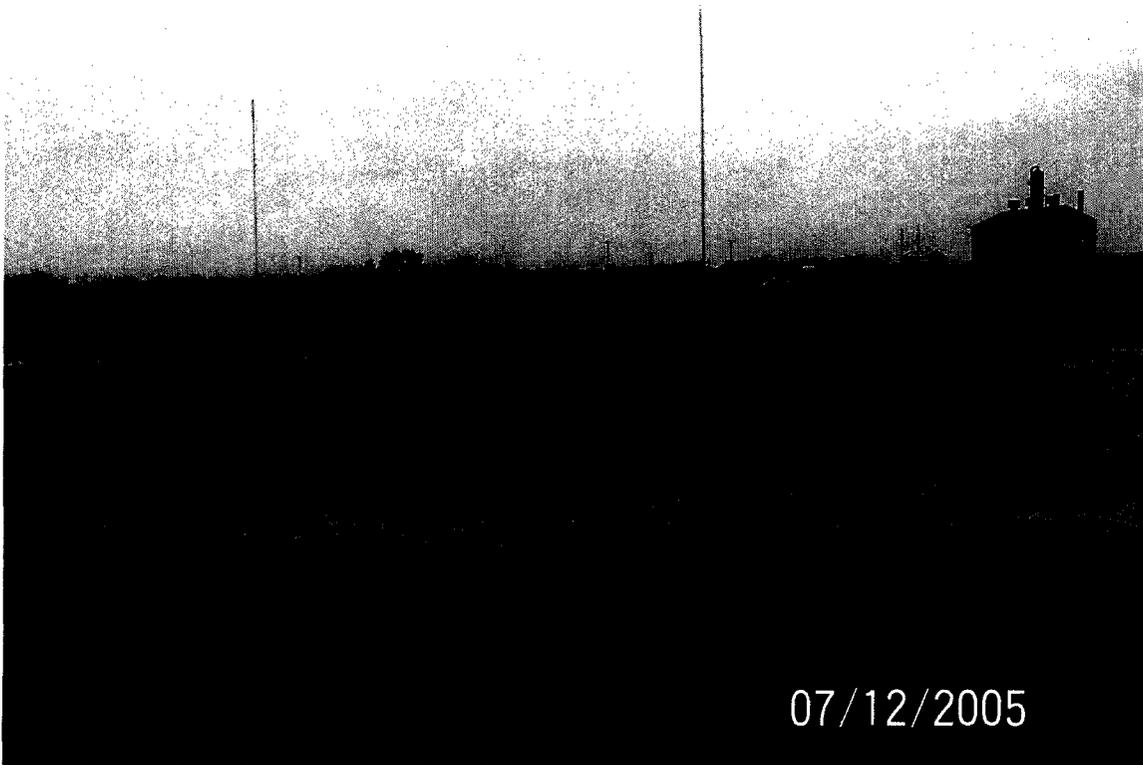
Photograph #2: Former tank battery area, looking westerly.

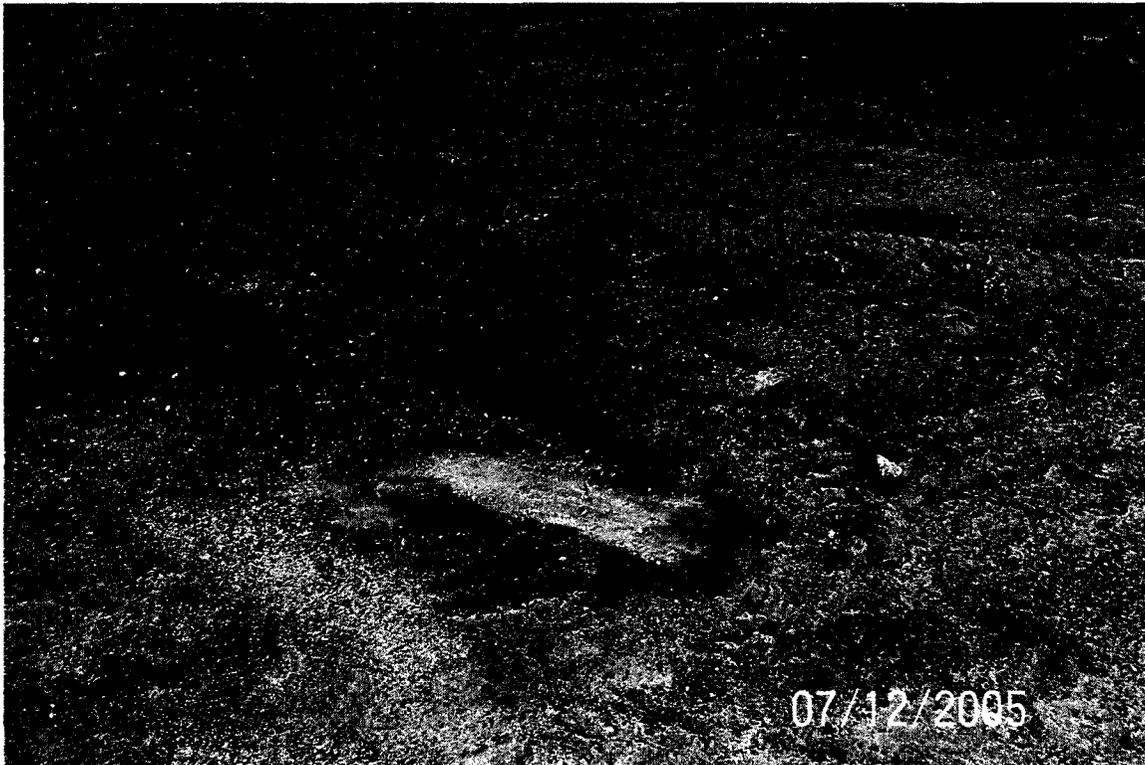
Photograph #3: Surface damage area illustrated in Figures 3 and 4. Note the scraped area showing the lack of impact near surface.
