Closure Report 8-22-06

Saber Resources Priest #2
U/L D Sec. 1 T15S R37E
Lovinton, Lea County New Mexico

Job Summary Sheet

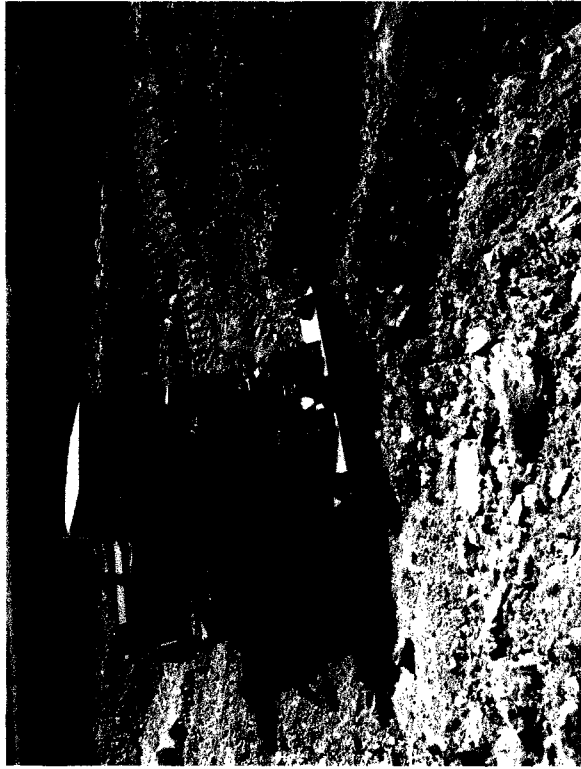
Ripping Rock to Excavate

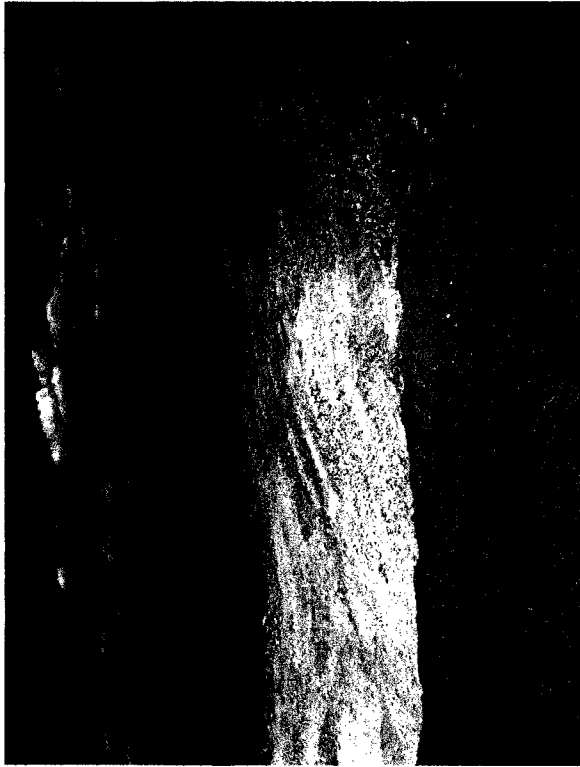
Final Excavation West to East

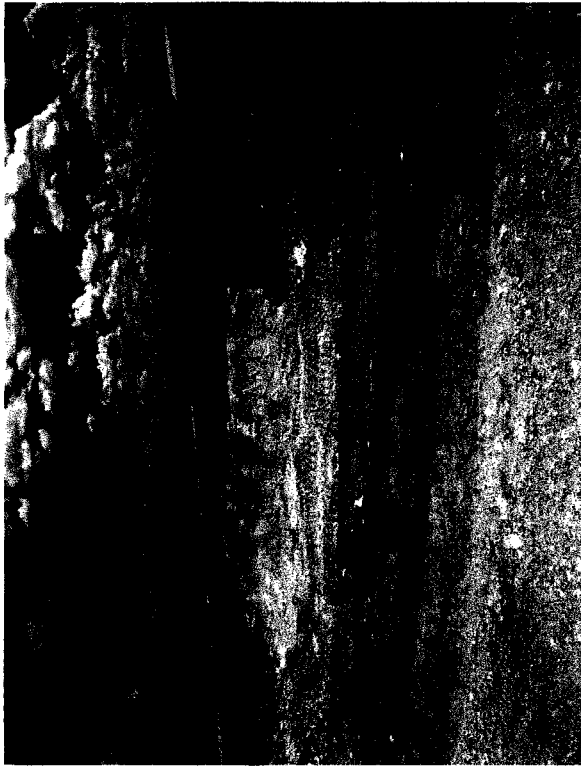
Final Excavation North to South

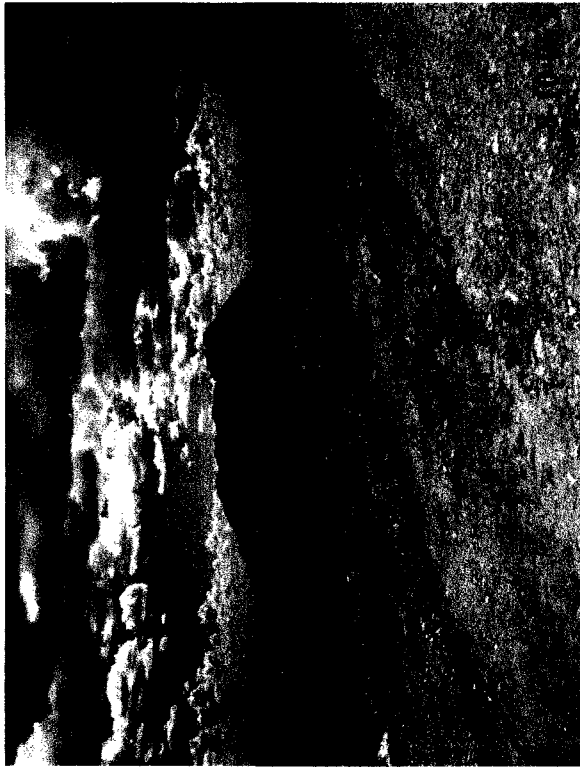
Spoil Pile
