CLOSURE REPORT

ANTELOPE RIDGE UNIT #5

NMOCD REF: 1RP#807

MAY 2007

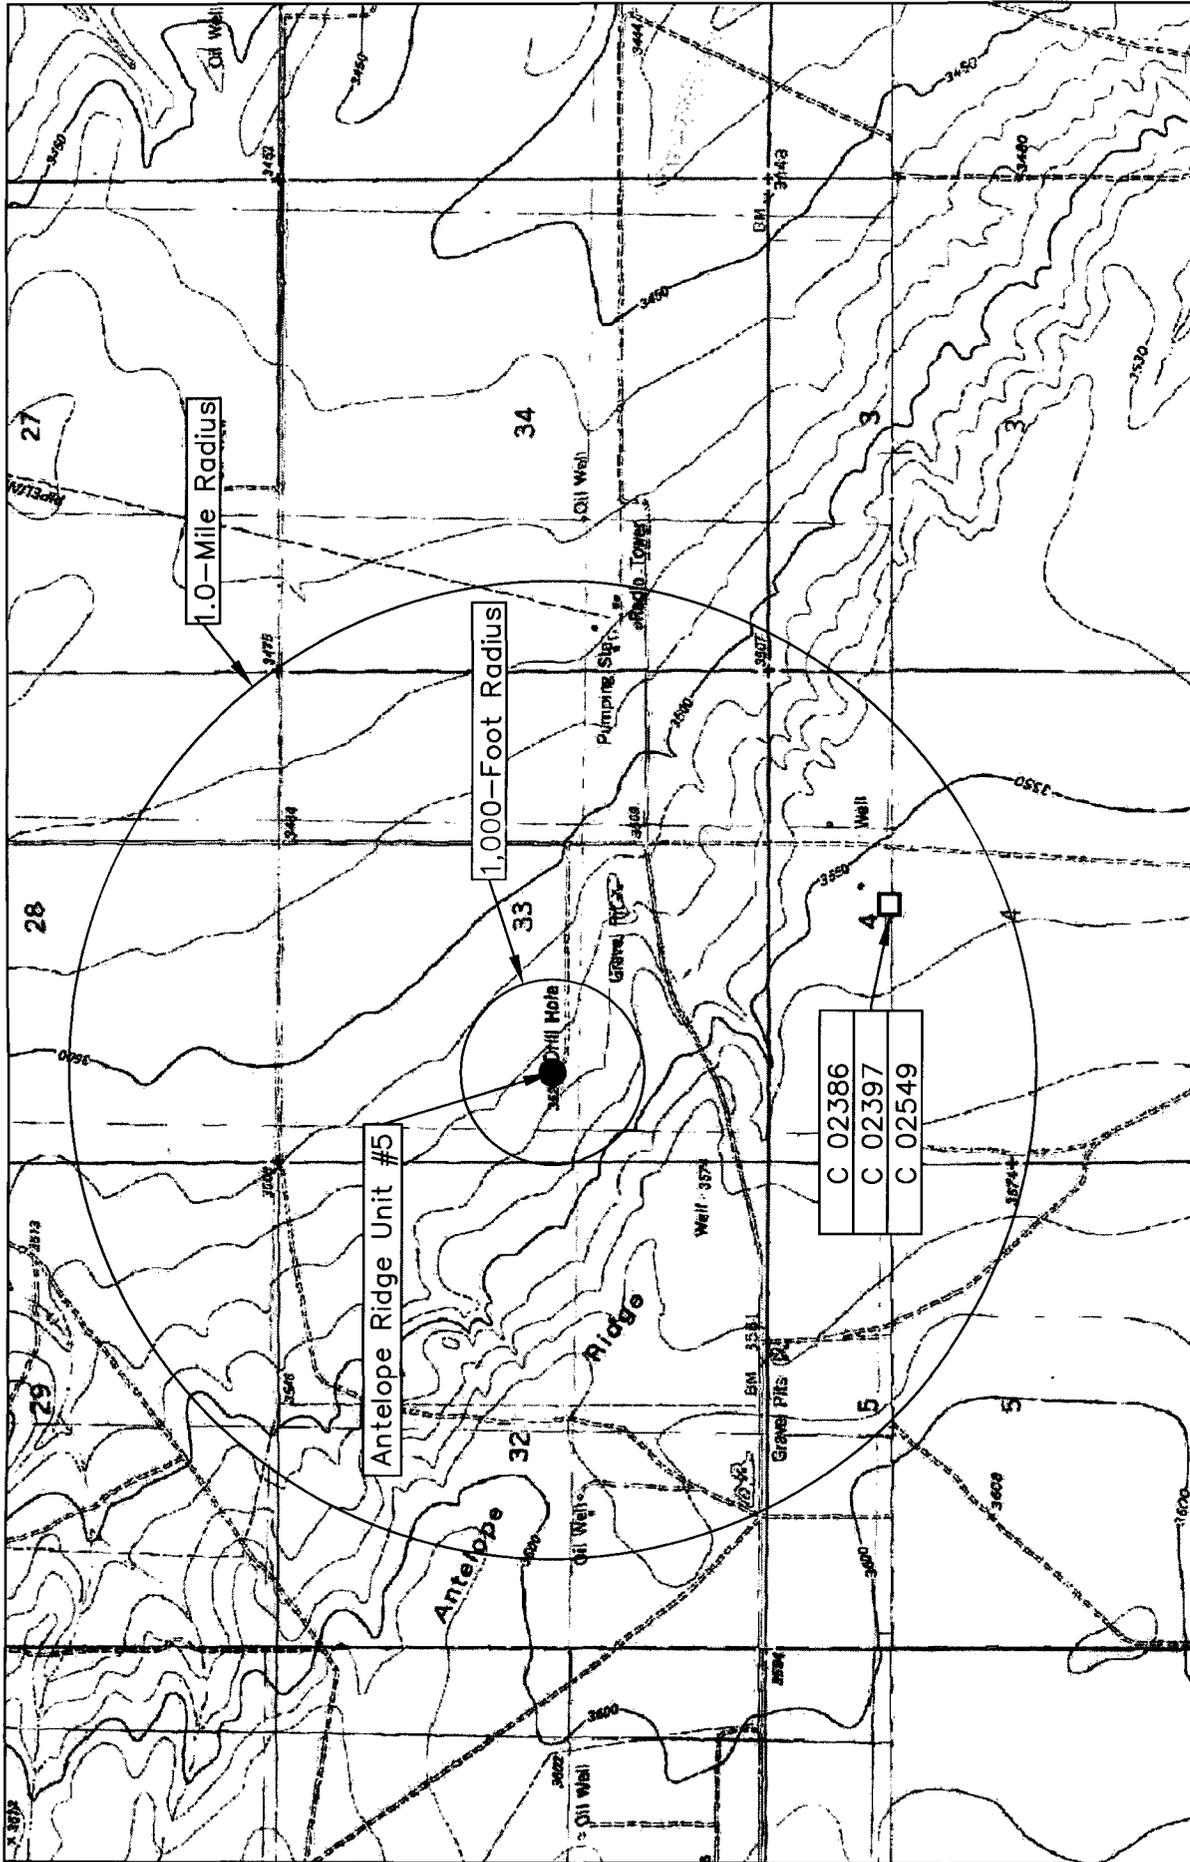
Figure 2
 Site Location Map
 Chesapeake Energy
 Antelope Rdige Unit #5

No public water supply wells exist within a 1,000-foot radius of the release site (reference *Table 1* and *Figure 2*).

No surface water features exist within a 1,000 foot radius of the release site (reference *Figure 2*).

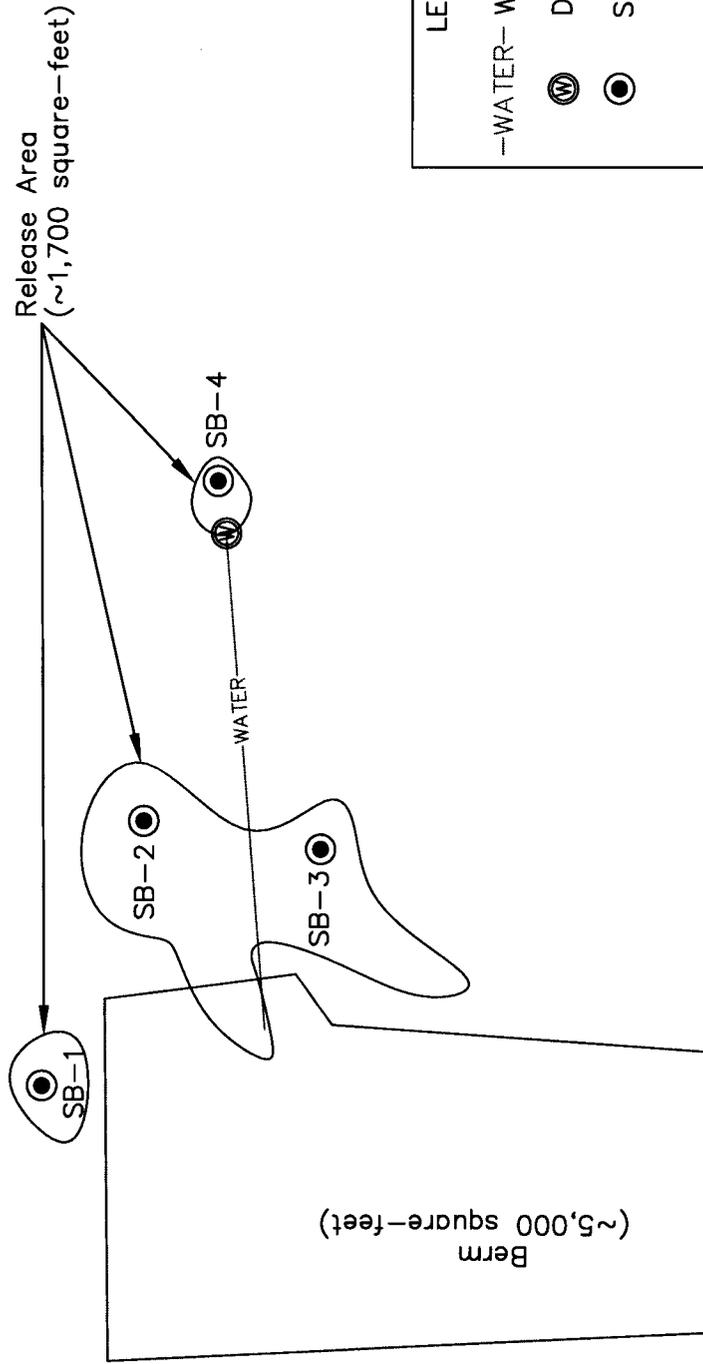
Figure 4
Soil Boring Location Map
Chesapeake Energy
Antelope Ridge Unit #5

On January 31 and February 1, 2006 a series of four (4) soil borings (SB-1, SB-2, SB-3 and SB-4) were advanced within the tank battery area. Soil samples were collected at 2- and 5-ft bgs initially, then at 5-ft intervals thereafter. Soil borings were advanced until two consecutive field chloride analyses indicated concentrations were below remedial threshold goals of 250 mg/Kg. Maximum depths of soil borings were 61-ft bgs (SB-1), 51-ft bgs (SB-2), 56-ft bgs (SB-3) and 91-ft bgs (SB-4). Soil boring locations were chosen to delineate the vertical extent of impacted soil while providing adequate distance between soil borings (reference *Table 2* and *Figure 4*).

Laboratory analyses of soil samples collected during the advancement of soil boring SB-1 indicated TPH and BTEX constituent concentrations were non-detectable (ND) at or above laboratory method detection limits (MDL). Reported chloride concentrations were above remedial threshold goals of 250 mg/Kg to a depth of 51-ft bgs. Reported sulfate concentrations ranged from 34 to 66.5 mg/Kg (reference *Table 2* and *Figure 4*).

Laboratory analyses of soil samples collected during the advancement of soil boring SB-2 indicated TPH and BTEX constituent concentrations were ND at or above laboratory MDL. Reported chloride concentrations were above remedial threshold goals of 250 mg/Kg to a depth of 36-ft bgs. Reported sulfate concentrations ranged from 138 to 206 mg/Kg (reference *Table 2* and *Figure 4*).

Laboratory analyses of soil samples collected during the advancement of soil boring SB-3 indicated TPH and BTEX constituent concentrations were ND at or above laboratory MDL. Reported chloride concentrations were above remedial threshold goals of 250 mg/Kg to a depth of 36-ft bgs. Reported sulfate concentrations ranged from 121 to 160 mg/Kg (reference *Table 2* and *Figure 4*).

Laboratory analyses of soil samples collected during the advancement of soil boring SB-4 indicated benzene and BTEX concentrations were ND at or above laboratory MDL. Reported TPH concentration at 2 to 3-ft bgs were 183 mg/Kg. TPH concentrations in the remaining sample were reported as ND at or above laboratory MDL. Reported chloride concentrations were above remedial threshold goals of 250 mg/Kg to 61-ft bgs. Reported sulfate concentrations ranged from 194 to 203 mg/Kg (reference *Table 2* and *Figure 4*).

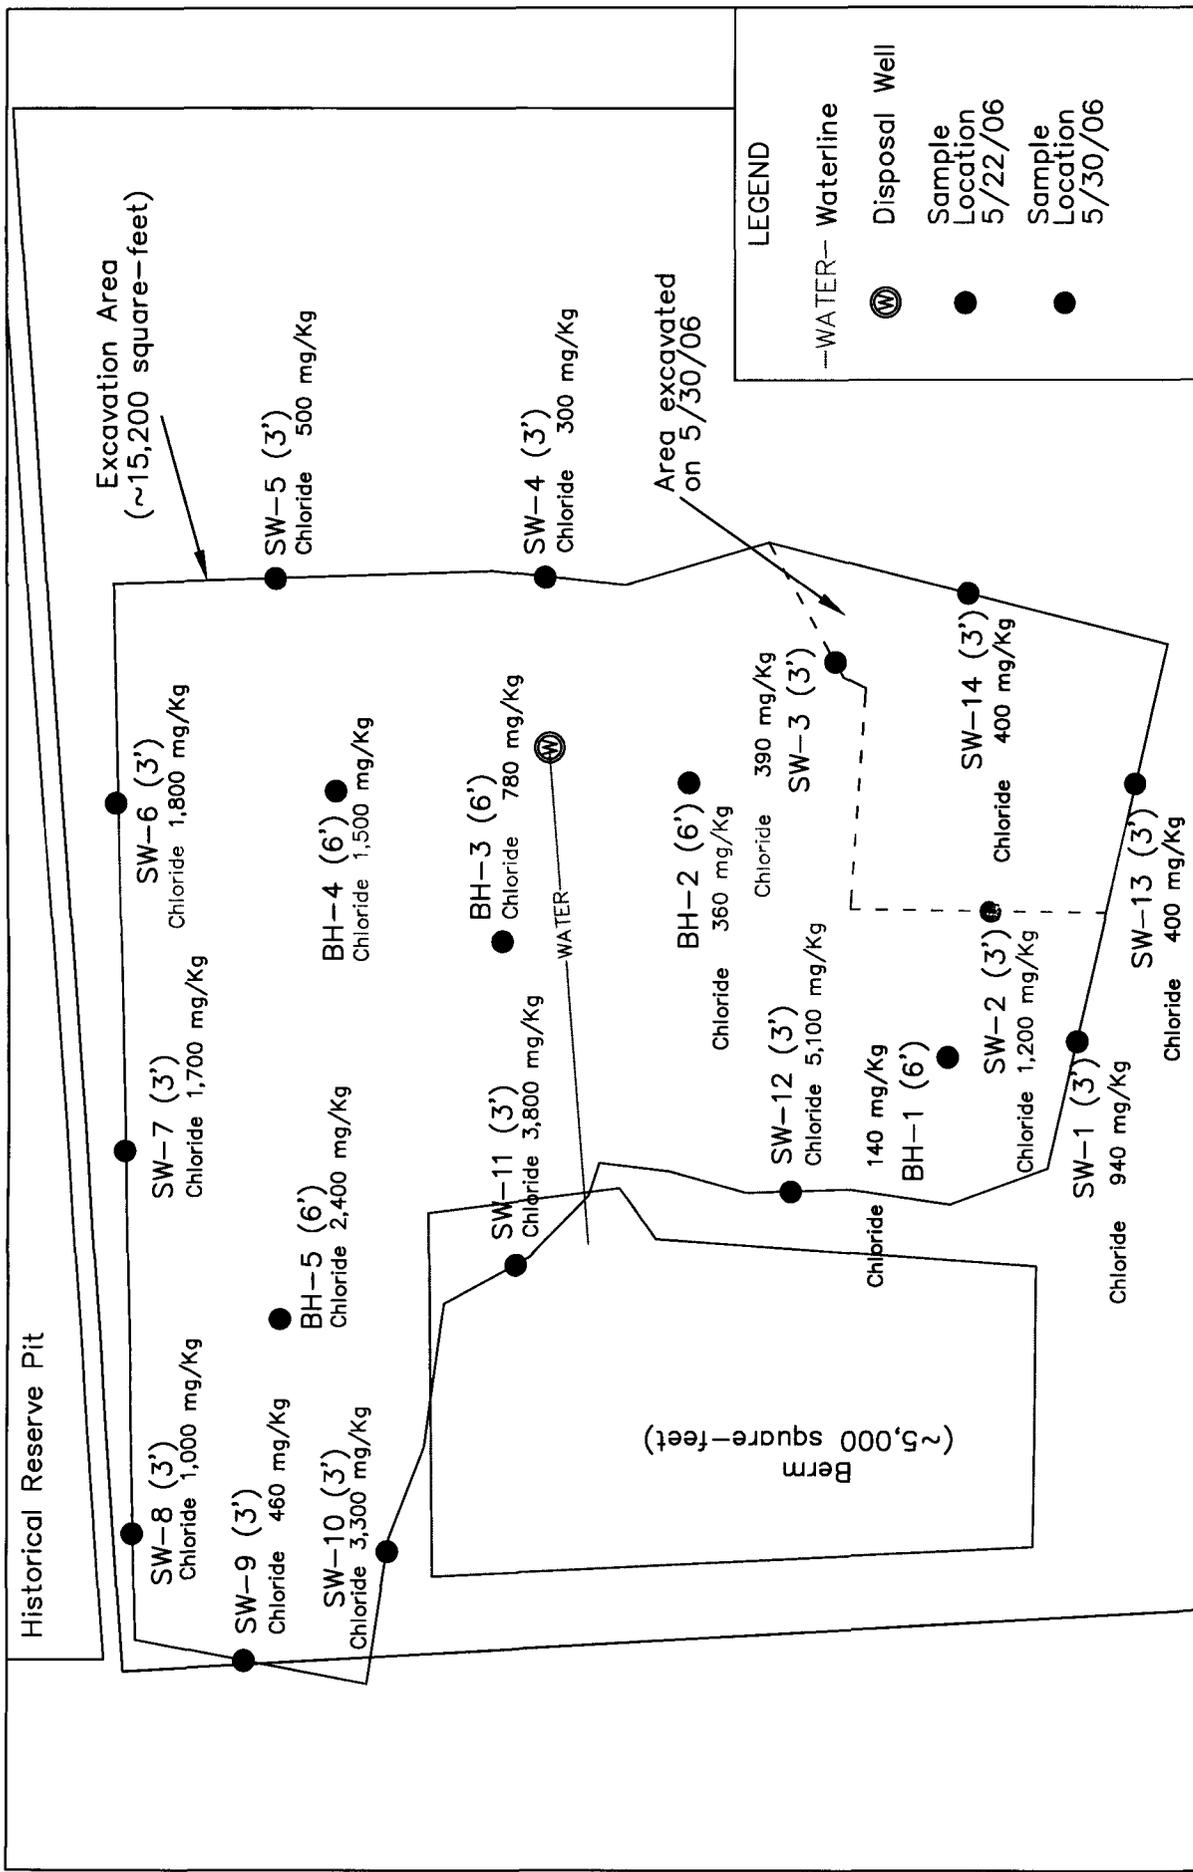
On May 22, 2006 soil samples were collected from the excavation floor in five (5) locations (BH-1 through BH-5) and from the sidewalls in twelve (12) locations (SW-1 through SW-12). Soil samples were collected from the excavation floor at 6-ft bgs and excavation sidewalls at 3-ft bgs (reference *Table 3* and *Figure 4*). Soil sample locations were chosen to provide the best representative example of soil within the excavation floor and sidewalls.

On May 30, 2006 excavation activities continued on the southeastern portion of the excavation. Soil samples (SW-13 and SW-14) were collected in two (2) locations from the excavation sidewalls (reference *Table 3* and *Figure 4*). Soil sample locations were chosen to provide the best representative example of soil within the excavation floor and sidewalls.

Laboratory analyses of soil samples collected from the excavation floor on May 22, 2006 (i.e., BH-1 through BH-5) indicated chloride concentrations, with the exception of soil sample BH-1, were in excess of remedial threshold goals of 250 mg/Kg (reference *Table 3* and *Figure 4*).

Laboratory analyses of soil samples collected from the excavation sidewalls on May 22, 2006 (i.e., SW-1 through SW-12) indicated chloride concentrations ranged from 300 to 5,100 mg/Kg (reference *Table 3* and *Figure 4*).

After additional excavation activities in the southeast portion of the excavation, two soil samples (SW-13 and SW-14) were collected on May 30, 2006 from the excavation sidewalls. Laboratory analyses indicated chloride concentrations in both samples were 400 mg/Kg (reference *Table 3* and *Figure 4*).

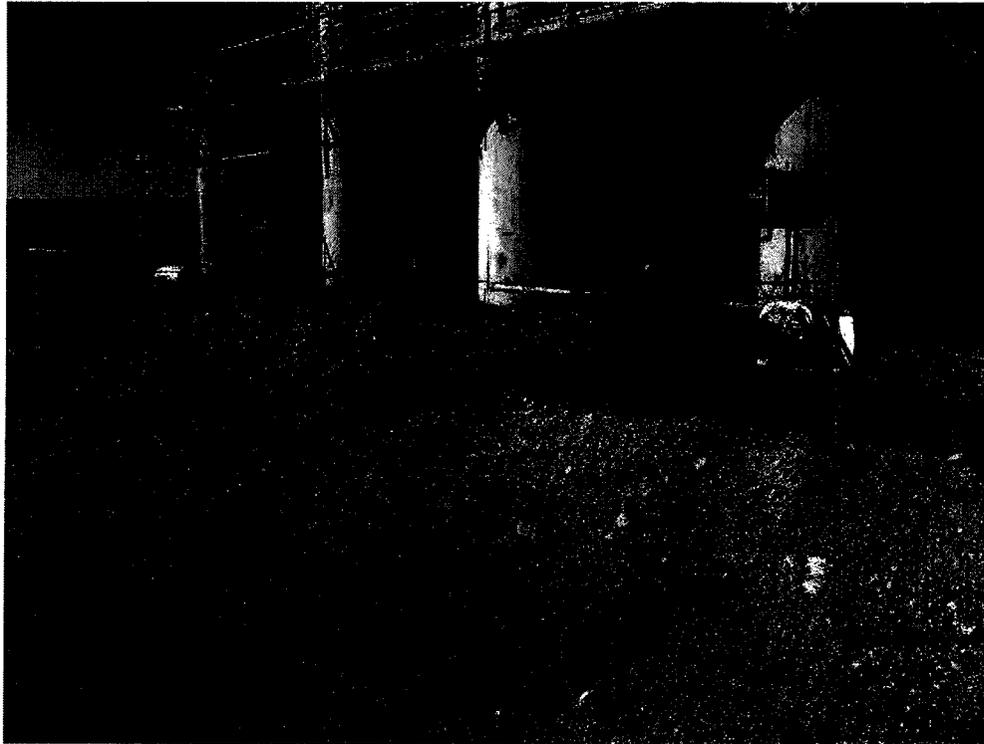
Photograph #2 – Looking westerly at bermed tank battery.

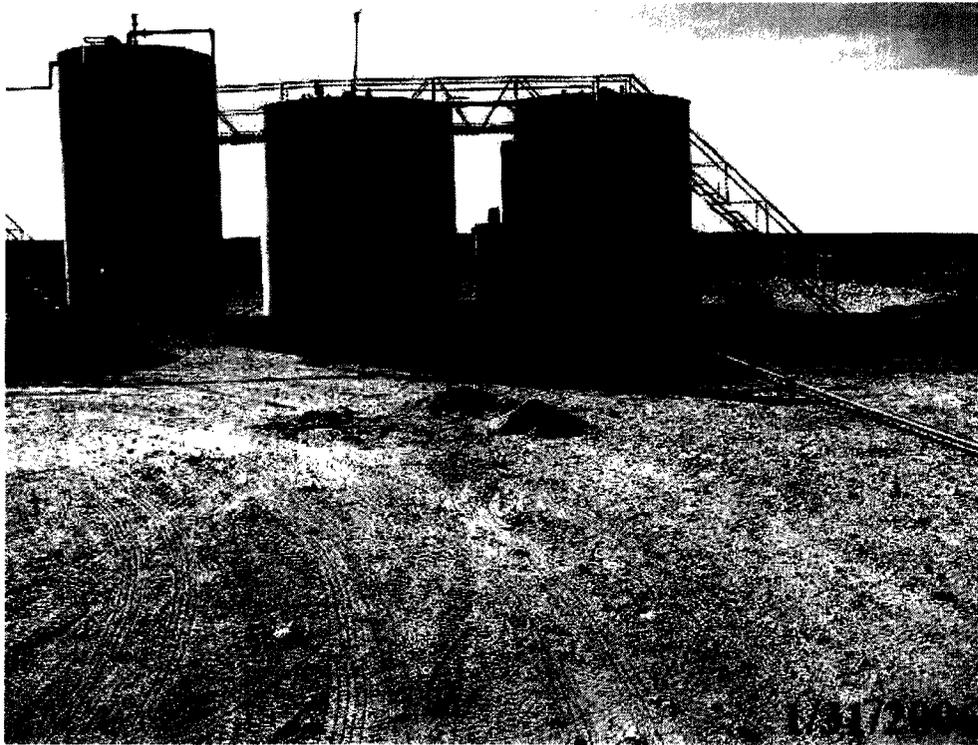
Photograph #5 – Looking westerly at tank battery.

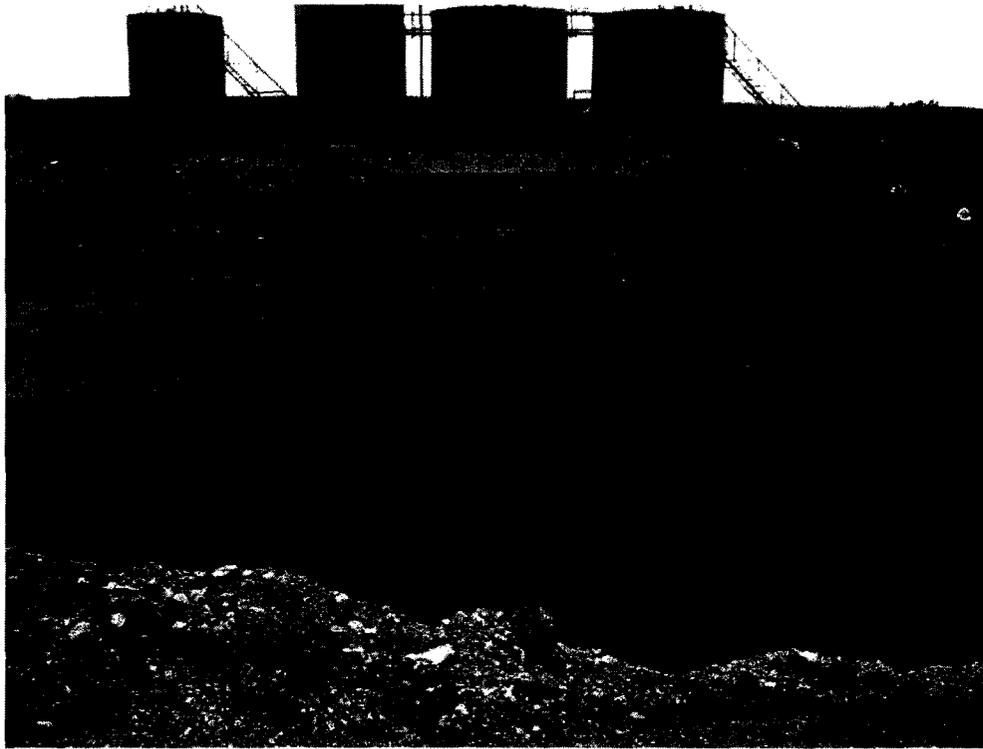
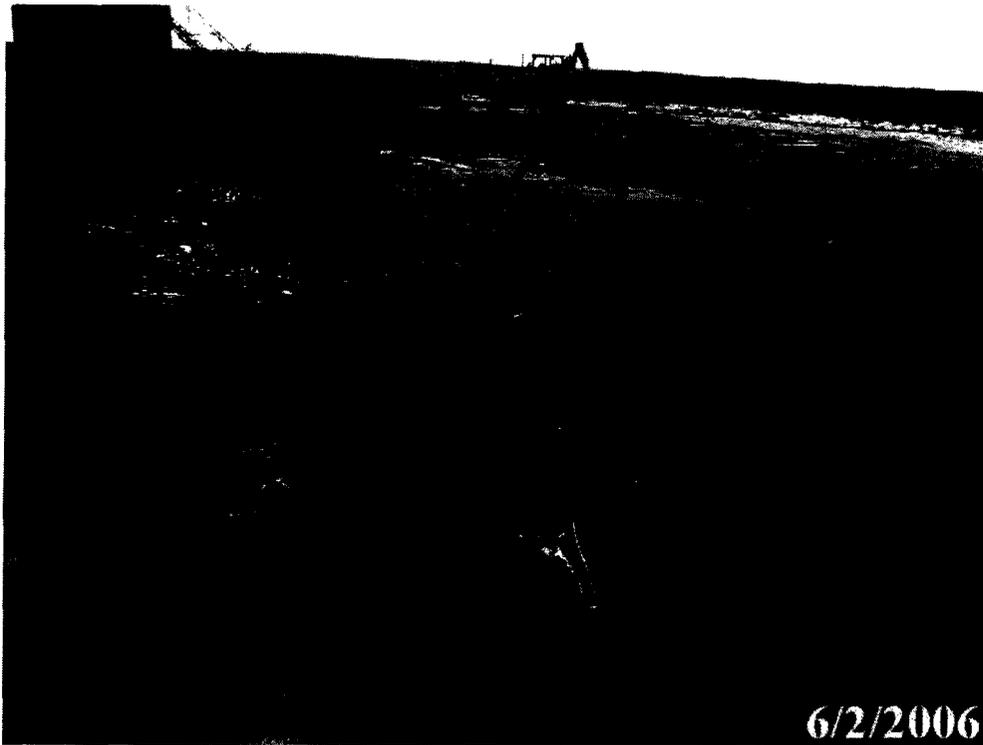
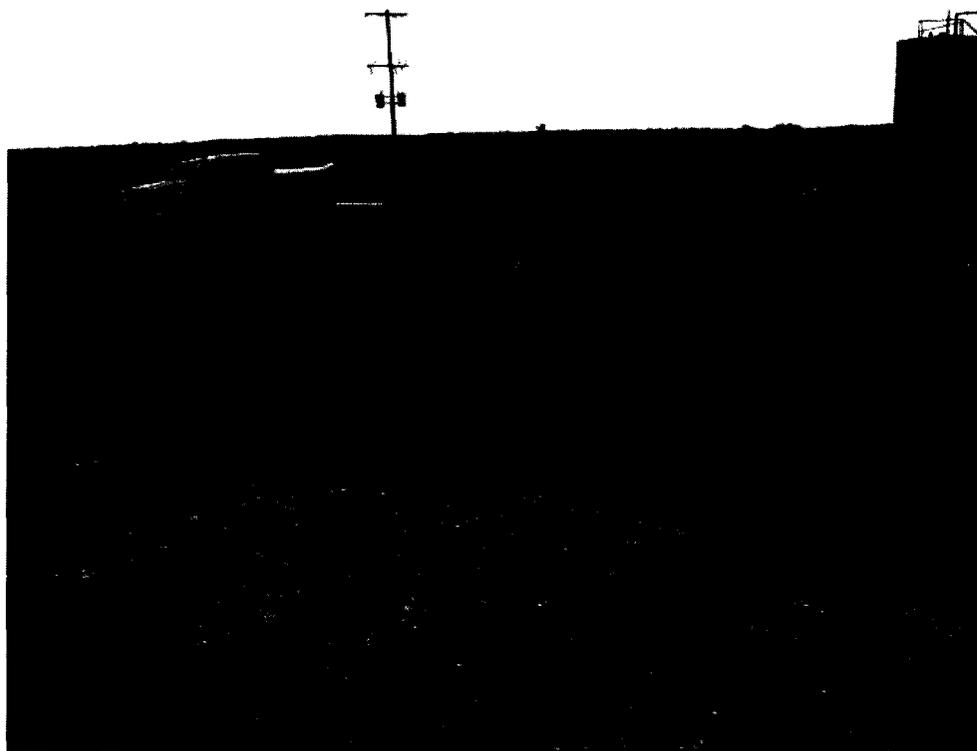
Photograph #13 – Looking westerly at liner placement.

Photograph #14 – Looking westerly at liner placement.

Photograph #15 – Looking southeasterly at liner placement.

Photograph #16 – Looking westerly at liner placement.

Photograph #17 – Looking southwesterly at liner placement.

Photograph #18 – Looking southerly at liner placement.

While soil impacted with chlorides above remedial threshold goals remain in-situ, the chance of impacting local groundwater above NMWQCC Groundwater Standards of 250 mg/L is remote. In reviewing Table 2, *Summary of Soil Boring Analytical Results*, it is noted chloride concentrations diminish with vertical depth. Vertical depth of soil impacted with chlorides above remedial threshold goals extends to approximately 61 feet bgs. With depth of groundwater projected at 475 feet bgs, the vertical separation between impacted soil and groundwater is 414 feet. However, as a precautionary measure, an impermeable 20-mil thick polyethylene liner sandwiched between two (2) one (1) foot layers of bedding sand was installed over the floor of the excavation to mitigate vertical migration of residual chlorides.

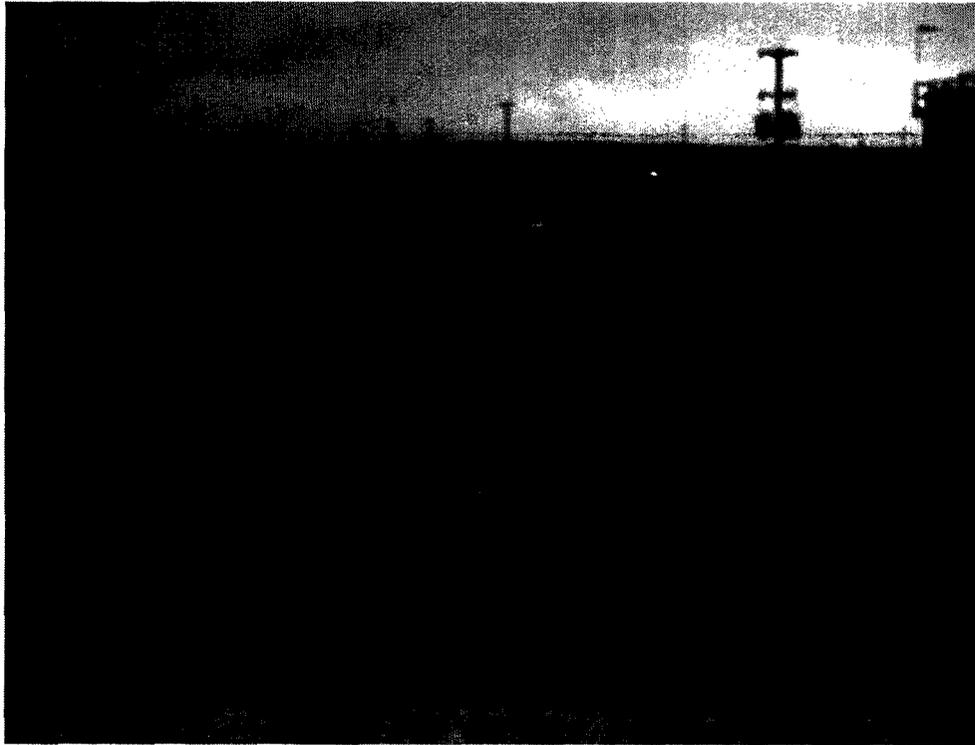
Photograph #21 – Remediated site.

Photograph #22 – Remediated site.

From May 20 to 24, 2006 EPI transported approximately 1,160 cubic yards of sand and from June 5 to 10, 2006 approximately 2,724 cubic yards of caliche from local pits to the excavation. This material was stockpiled on the job site in preparation for backfill operations. After cleaning and leveling the excavation bottom, EPI installed an impermeable 20-mil thick polyethylene liner sandwiched between two (2) one (1) foot layers of bedding sand. The remainder of the excavation was backfilled with caliche. The entire area was contoured to allow natural drainage.
