# Ocotillo ENVIRONMENTAL

Dirt Work • On-Site Remediation • Soil Testing • Excavation

**Re: Spill Remediation Workplan**  
**Oxy Permian, Federal AB Battery, 1RP #1272**  
**Unit Letter H, Section 11, Township 18 South, Range 33 East**  
**Lea County, New Mexico**  
**Lat. N 32° 45.812', Long. W 103° 37.632'**

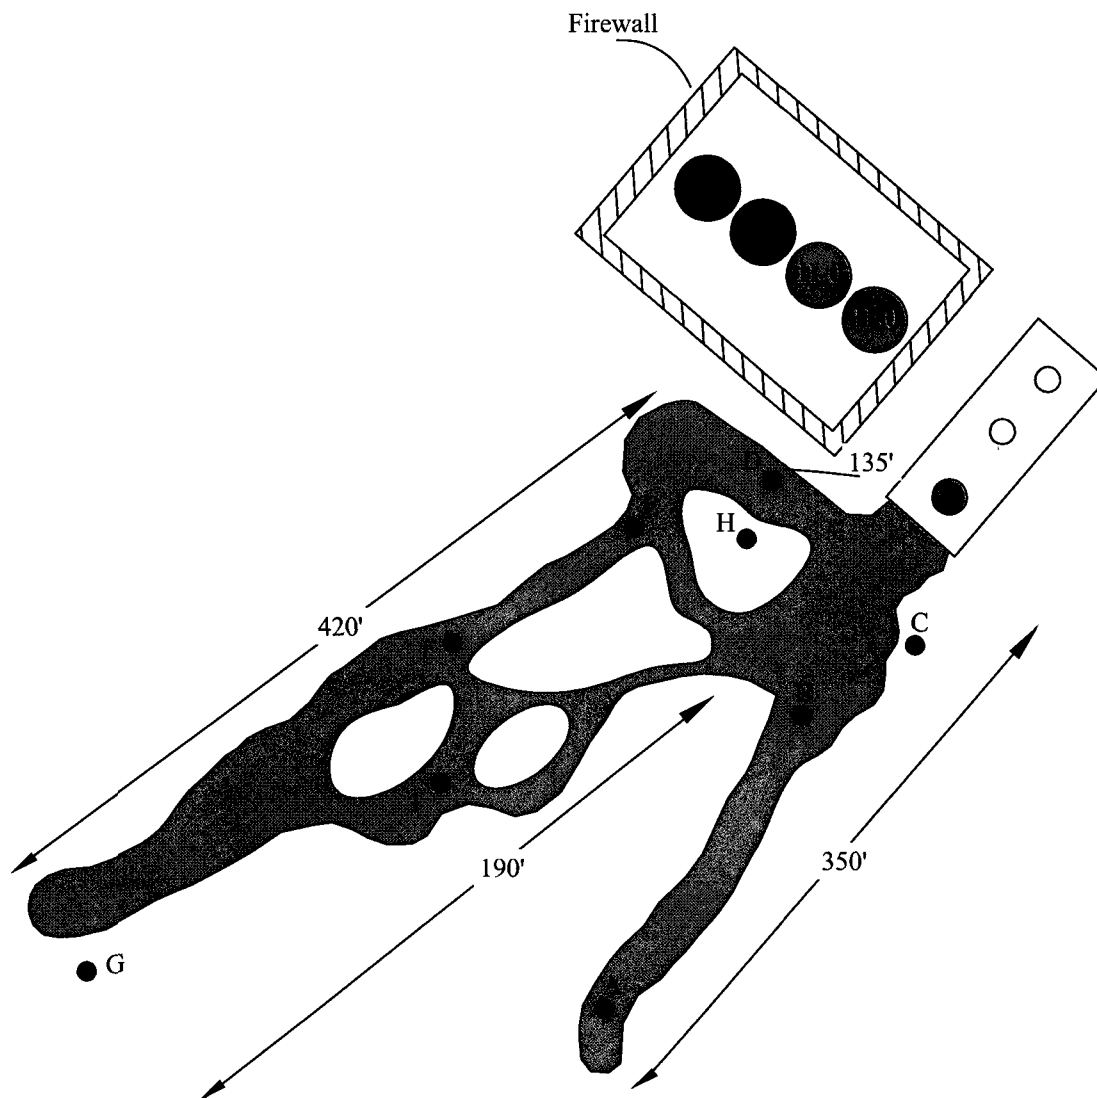
### FIGURE # 2

- A ● Soil sample locations
- 500 bbl tanks
- Heater Treater
- Separator

Site Drawing

On April 9, 2007, Oxy collected grab soil samples from nine (9) locations at the site (A through I), using a backhoe. The samples were placed in clean glass samples jars, labeled, chilled, and delivered under chain-of-custody control to Cardinal Laboratories (Cardinal) in Hobbs, New Mexico for laboratory analysis of BTEX and chloride. Figure 2 shows the sample locations. Table 1 presents a summary of the laboratory results. Appendix A provides a copy of the laboratory data. Photographs are presented in Appendix B.

Referring to Table 1, soil samples collected from locations A through I reported benzene concentrations below the RRAL of 10 mg/kg, and all samples reported BTEX concentrations below the RRAL of 50 mg/kg, with the exception of the sample collected from location A at a depth of 18 inches (65.655 mg/kg). Chlorides concentrations exceeded the RRAL of 250 mg/kg in samples collected from the following locations:

Point A at 18" (2,030 mg/kg)  
Point B at 14" (3,090 mg/kg)  
Point B at 4' (1,060 mg/kg)  
Point C at 1.5' (2,960 mg/kg)  
Point E at 2' (2,815 mg/kg)  
Point E at 4' (5,340 mg/kg)  
Point G at 4.5' (2,050 mg/kg)  
Point H at 20" (1,650 mg/kg)  
Point I at 2' (3,810 mg/kg).

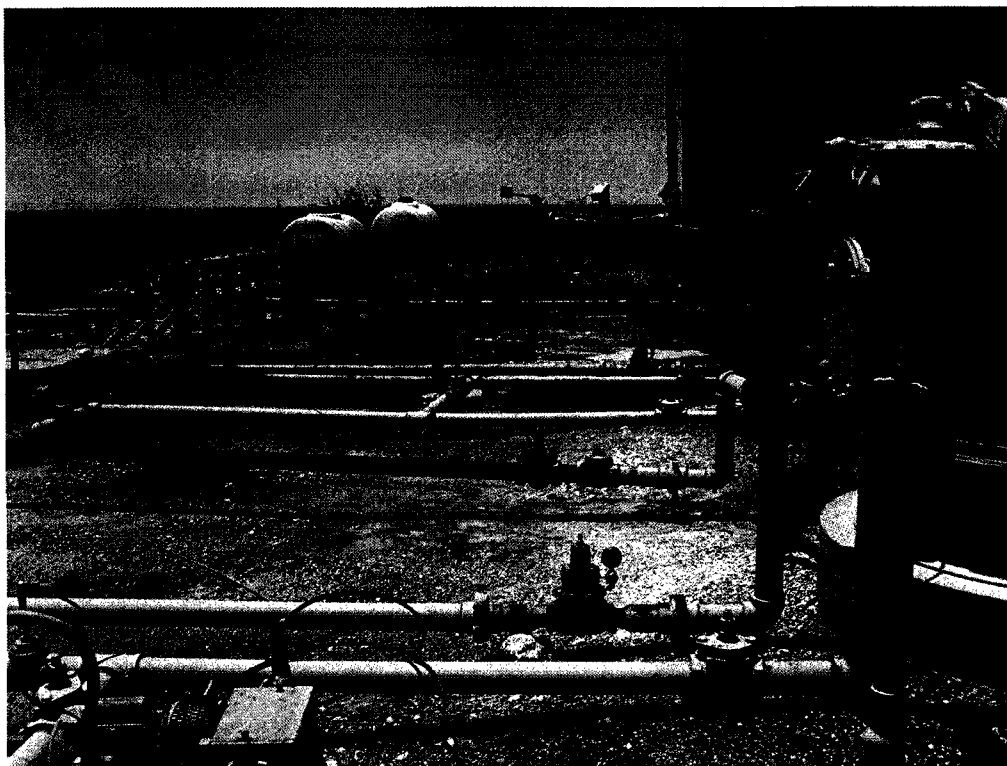
**3. View to northeast of heater treater and separators (5/30/07).**
