**SITE INVESTIGATION,
REMEDICATION AND FINAL C-141
CLOSURE DOCUMENTATION**

**G-EXTENSION-3 RELEASE SITE
DEFS REF: G-EXTENSION-3 020104 [5]**

**UL-P (SE¼ OF THE SE¼) OF SECTION 30 T21S R36E
~8.2 MILES WEST OF EUNICE
LEA COUNTY, NEW MEXICO**

JUNE 15, 2004

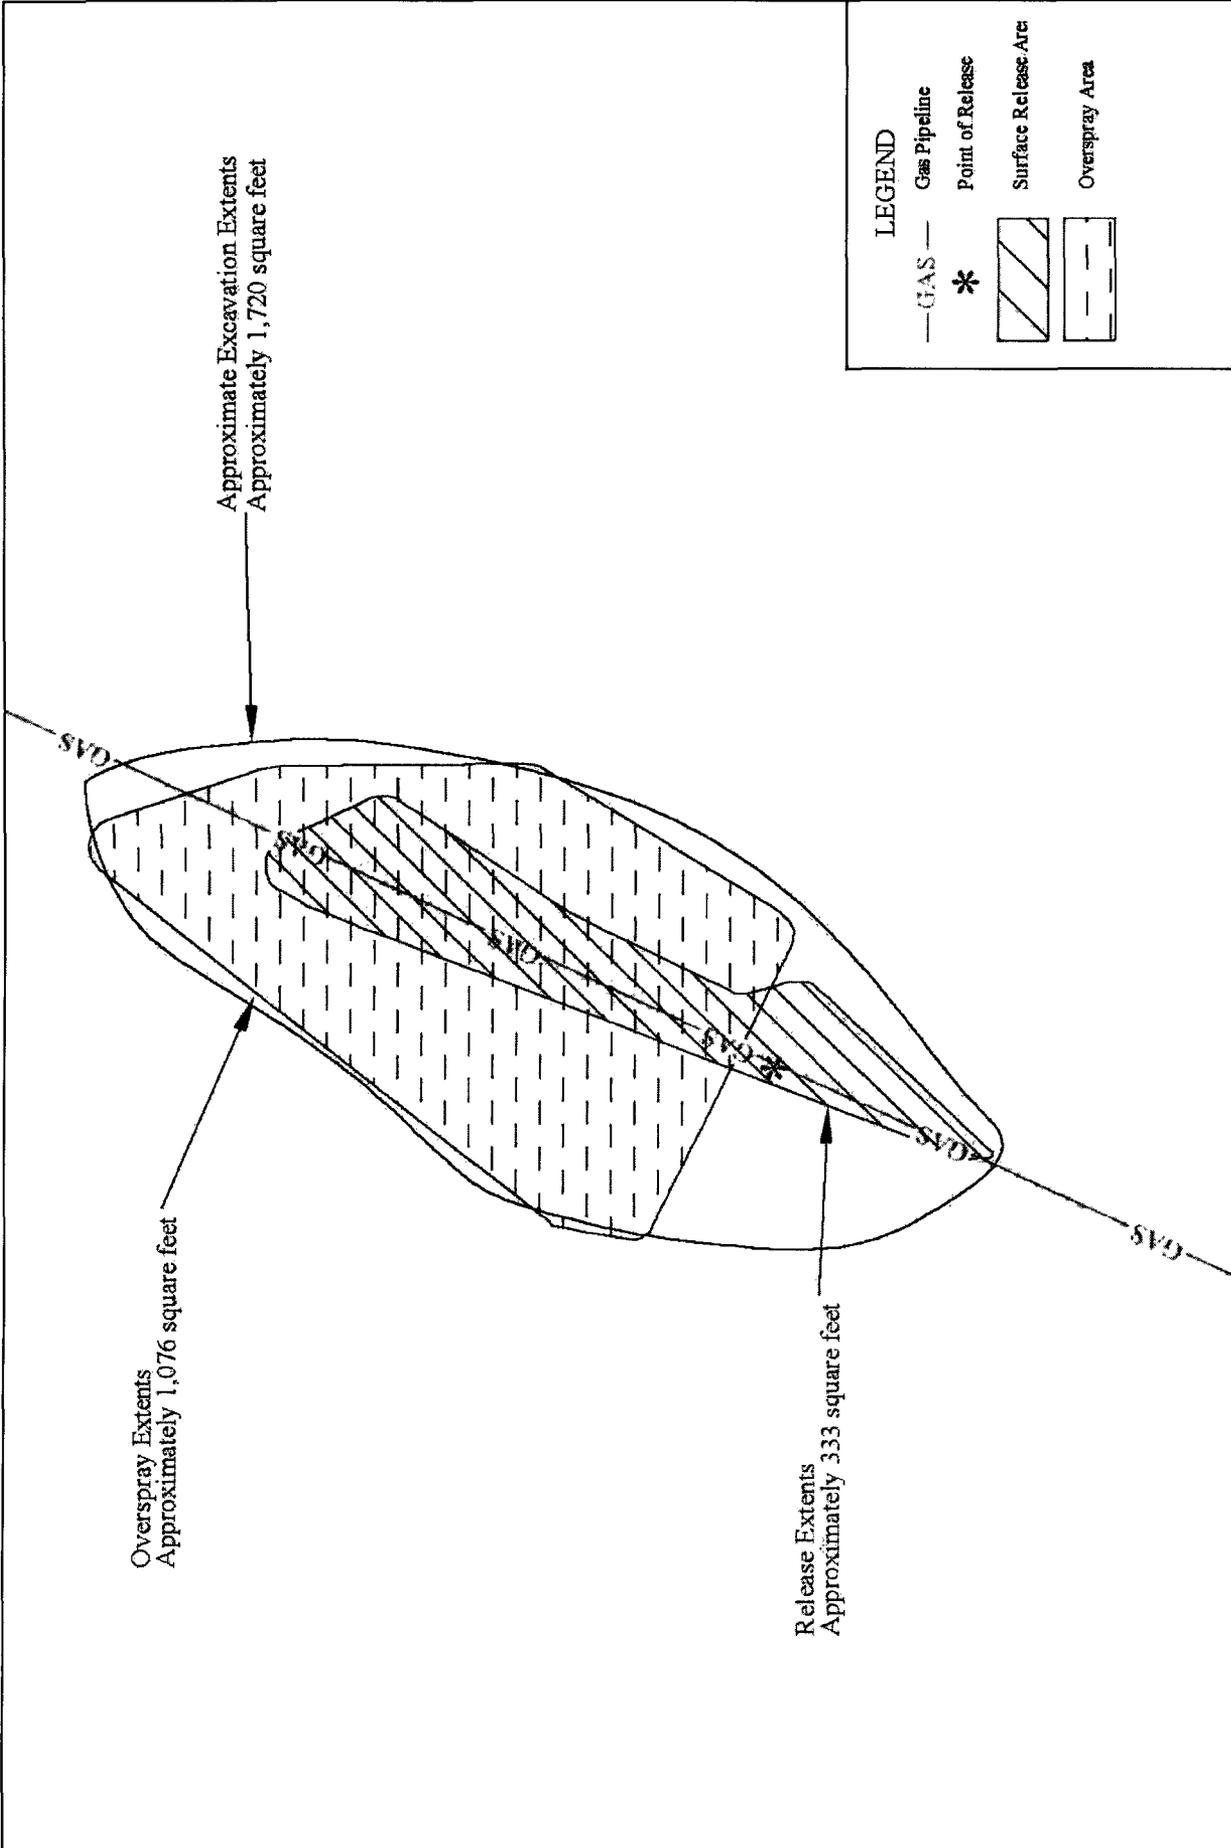
<p>REVISED:</p>	<p>DWG By: Iain Olness June 2004</p>	<p>Lea County, New Mexico SE 1/4 of the SE 1/4, Sec. 30, T21S, R36E N 32° 26' 38.9" W 103° 17' 57.1" Elevation: 3,619 feet amsl</p>
<p>SHEET 1 of 1</p>	<p>0 15 30 Feet</p>	<p>Figure 3 Site Map Duke Energy Field Services, LP G Extension-3 [5] 020104</p>

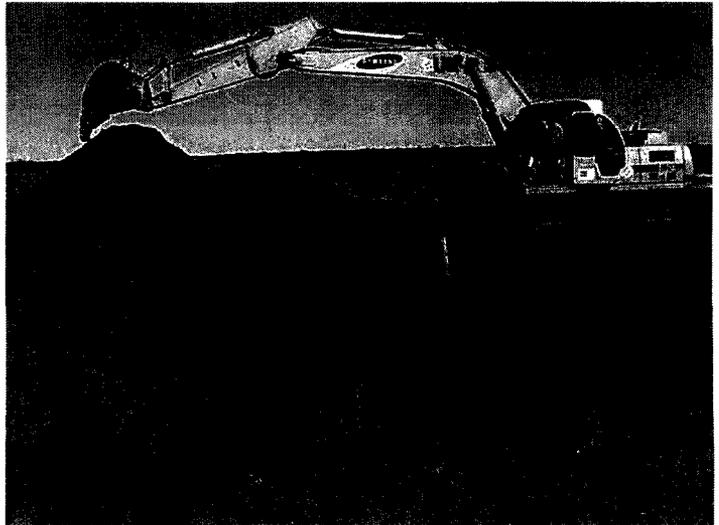
Photo #4: Excavation, looking northerly.

Remediation of the site commenced on February 2, 2004 and continued through February 4, 2004. Remedial activities at the site consisted of excavation and disposal of 318 yd³ of NGL contaminated soil from the site. All contaminated soil removed from the site was disposed of in the NMOCD

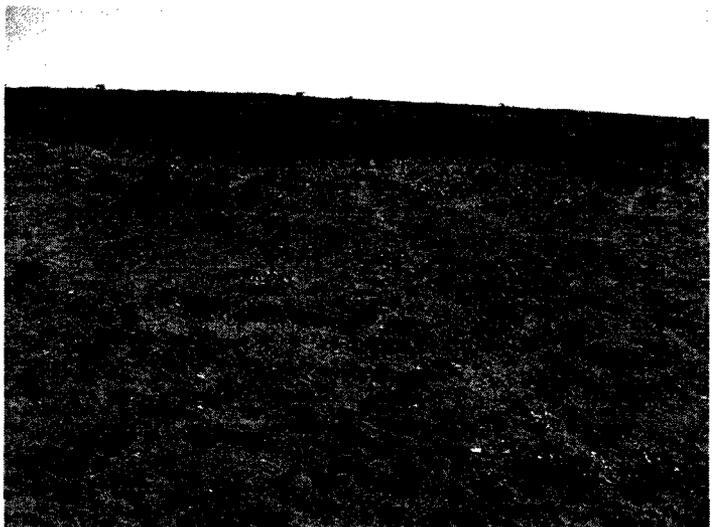
Photo #6: Site graded and contoured, looking southerly.

approved South Monument land farm located south of Monument, New Mexico. After field analyses of soil samples indicated remedial goals had been achieved (i.e., <100 ppm utilizing PID field analyses), the excavation was backfilled with clean caliche and topsoil purchased from the property owner. The backfilling and contouring of the site was completed on February 4, 2004.
