Release Notification and Corrective Action

☐ Initial Report ☒ Final Report

Name of Company	Rice Operating Company	Contact	Tony Grieco
Address	122 W. Taylor St., Hobbs, NM 88240	Telephone No.	(505) 393-9175
Facility Name	BD JCT N-9	Facility Type	Salt Water Gathering System
Surface Owner	Charlie Bettis	Mineral Owner	
		Lease No.

BD N-9 LEAK

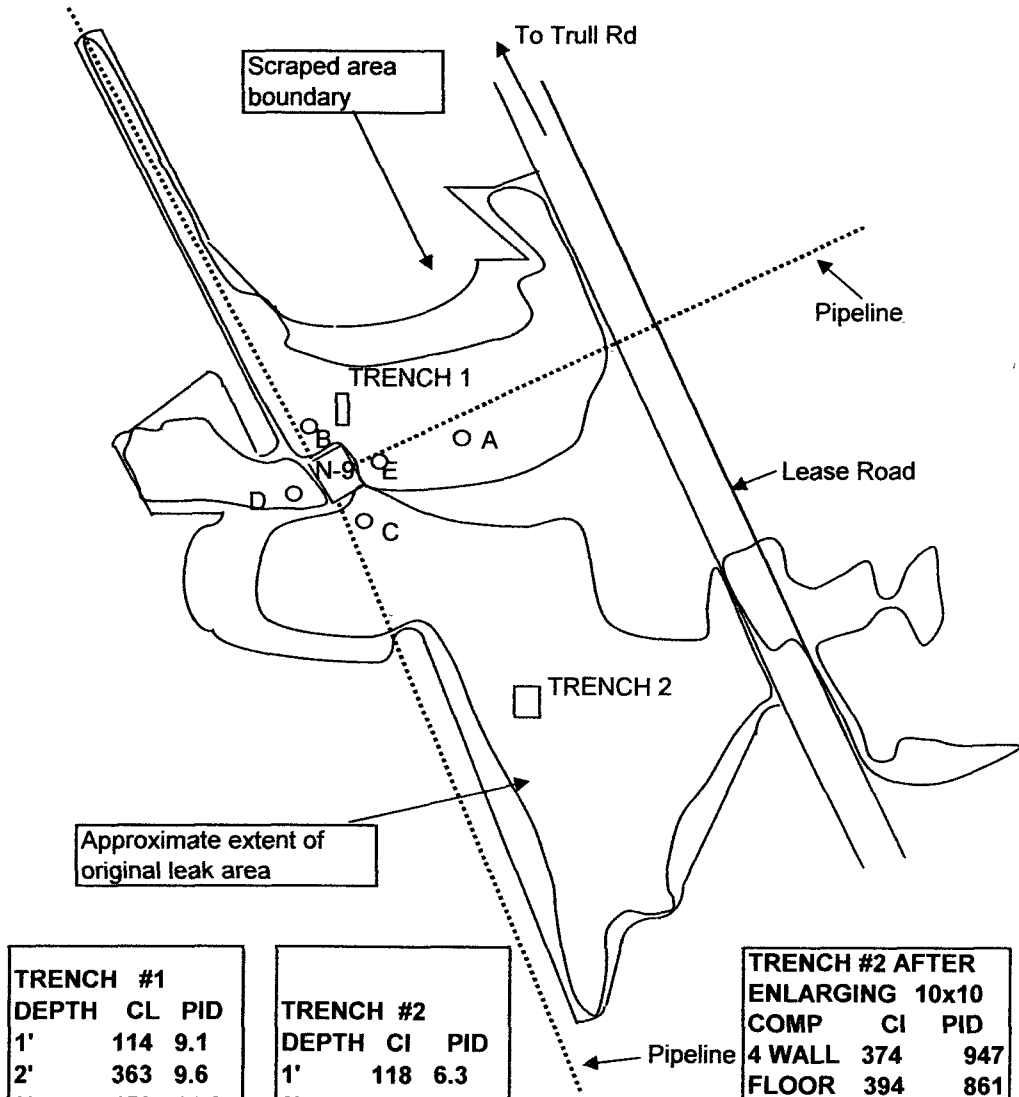
Excavated Area

HAND AUGER AND VERTICAL CI AND PID

All MEASUREMENTS IN PPM

GW 70 ft

AUGER A		
DEPTH	CI	PID
S	88	0
1'	122	0
2'	420	0

AUGER B		
DEPTH	CI	PID
1'	165	0.9
2'	111	2.7
3'	116	12.0

AUGER C		
DEPTH	CI	PID
1'	125	1.2
2'	87	2.1
3'	HARD ROCK

AUGER D		
DEPTH	CI	PID
1'	185	1.0
2'	897	11.3
3'	858	0.7

AUGER E		
DEPTH	CI	PID
1'	144	480
2'	144	29.4
3'	168	5.0

TRENCH #1		
DEPTH	CL	PID
1'	114	9.1
2'	363	9.6
3'	453	11.6
4'	486	6.7
5'	369	58.6
6'	242	1.8
7'	265	2.7
8'	145	20.5
9'	115	1.9

TRENCH #2		
DEPTH	CI	PID
1'	118	6.3
2'	440	32.3
3'	419	671
4'	651	763
5'	307	1866
6'	227	1628
7'	213	1919
8'	149	1609

TRENCH #2 AFTER ENLARGING 10x10		
COMP	CI	PID
4 WALL	374	947
FLOOR	394	861

LAB RESULTS			
	CI	GRO	DRO
TRENCH #1 9'	64	<10	<10
TRENCH #2 4 WALL	512	158	843
Benzene/Toluene/Ethyl Benzene/Total Xylenes			
<0.005	0.060	0.927	3.96

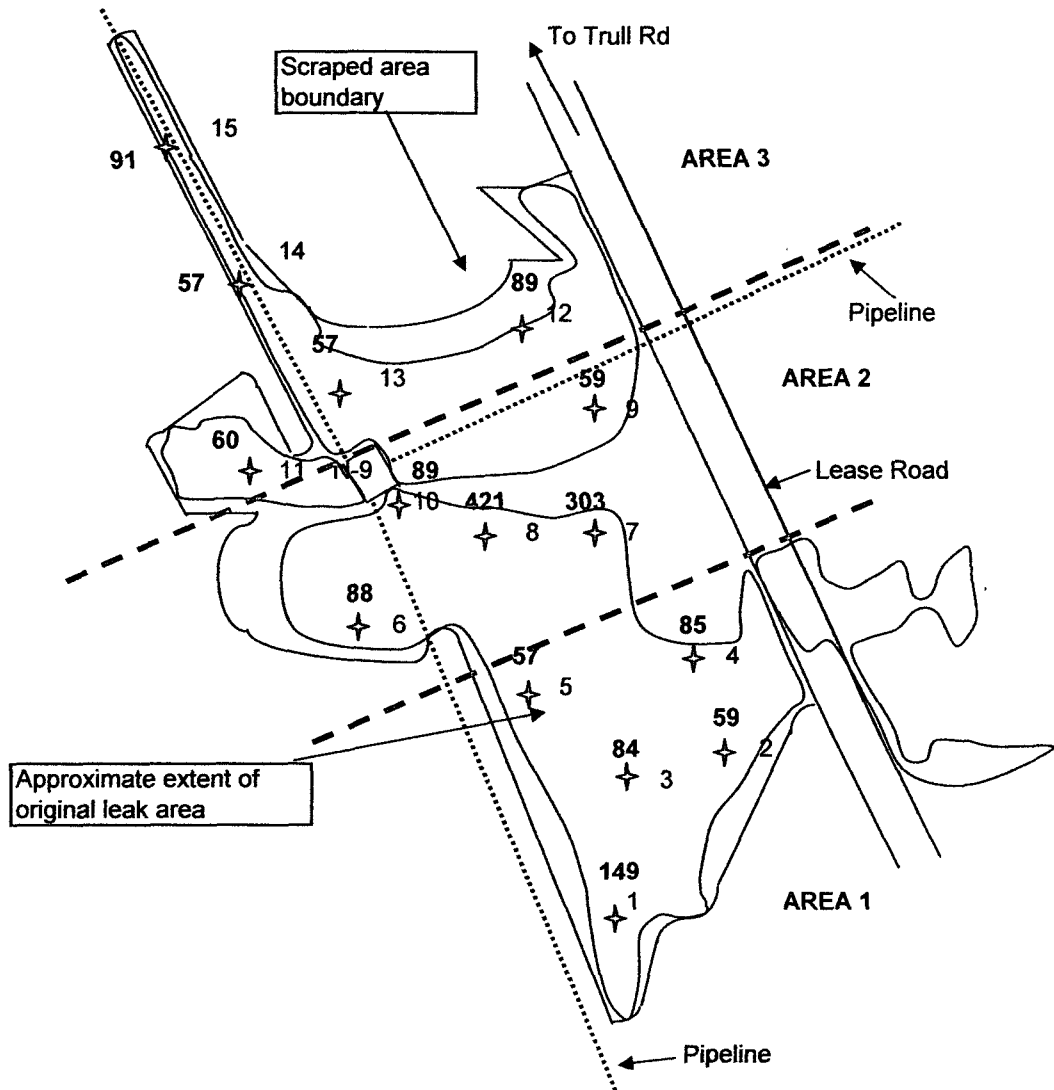
BD N-9 LEAK

Excavated Area
U/L N SEC 9 T22S R37E
32° 24.015 N 103° 10.200 W

CI SAMPLES FROM SURFACE AFTER SCRAPING, BEFORE IMPORTING SOIL

COMPOSITES

FIELD	CI	PID	LAB	CI	GRO	DRO
AREA 1		89	1		64	<10	18.9
AREA 2		194	0		208	<10	<10
AREA 3		86	0		16	<10	<10

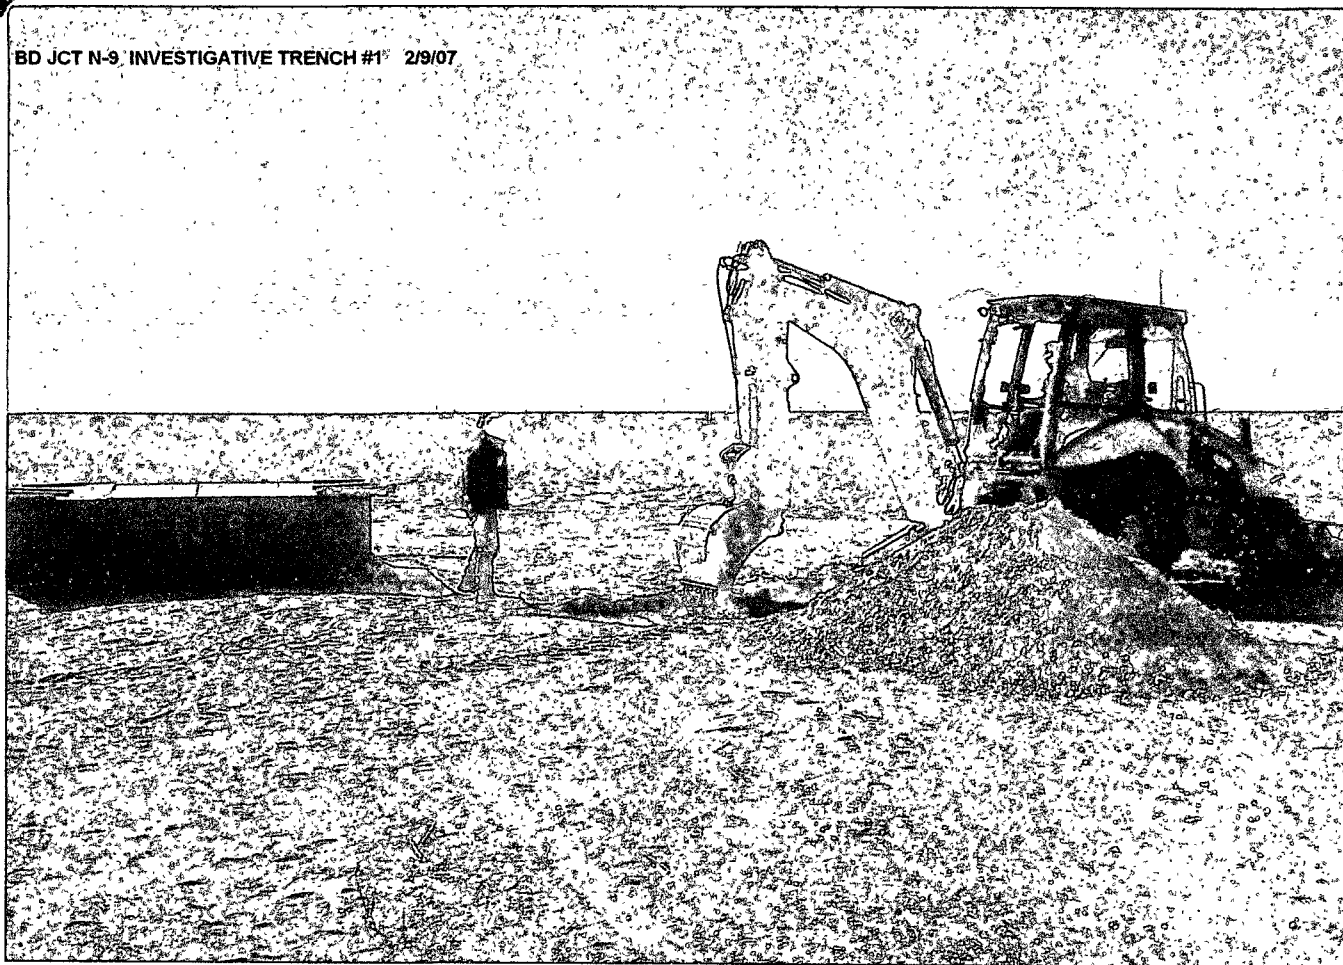
BD JCT N-9 INVESTIGATIVE TRENCH #1 2/9/07

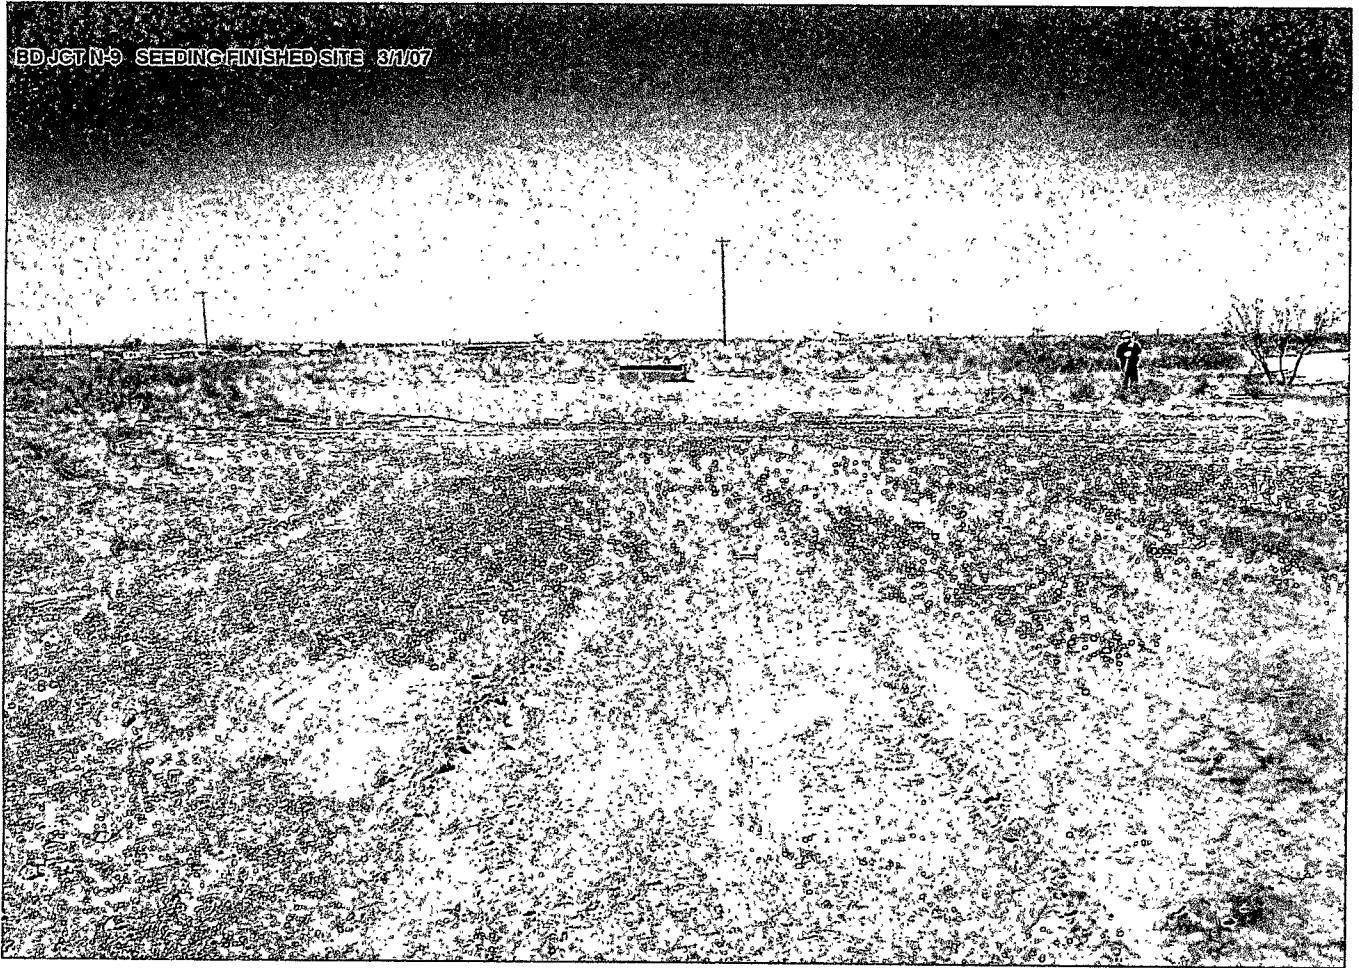
BD JCT N-9 SEEDING FINISHED SITE 3/1/07

Describe Area Affected and Cleanup Action Taken.* A vacuum truck was dispatched at the time the spill was discovered to recover water and haul to an appropriate disposal facility. The entire impacted area was scraped to a depth of 4 inches and the contaminated soil hauled to the Sundance facility. The site was delineated using a hand auger and backhoe. Clean soil was imported and spread, and the site was reseeded with a mixture of grasses requested by the landowner.

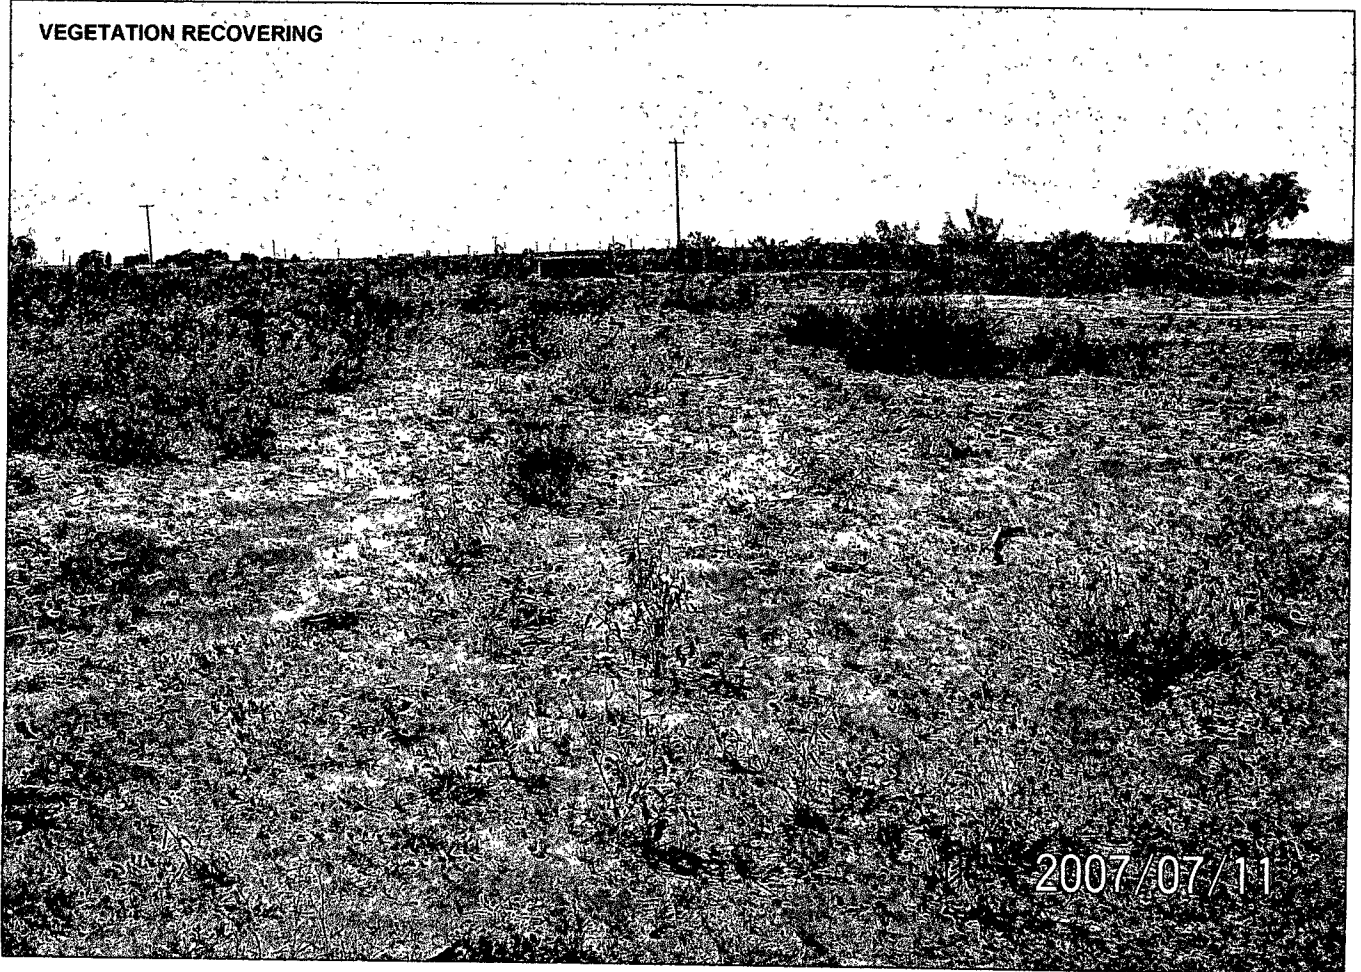
VEGETATION RECOVERING
