EME Jct P-6

**RICE OPERATING COMPANY
JUNCTION BOX FINAL REPORT**

SWD SYSTEM	JUNCTION	UNIT	SECTION	TOWNSHIP	RANGE	COUNTY	NEW BOX DIMENSIONS - FEET		
EME	jct. P-6	P	6	22S	38E	Lea	Length	Width	Depth
							no box--jct. eliminated

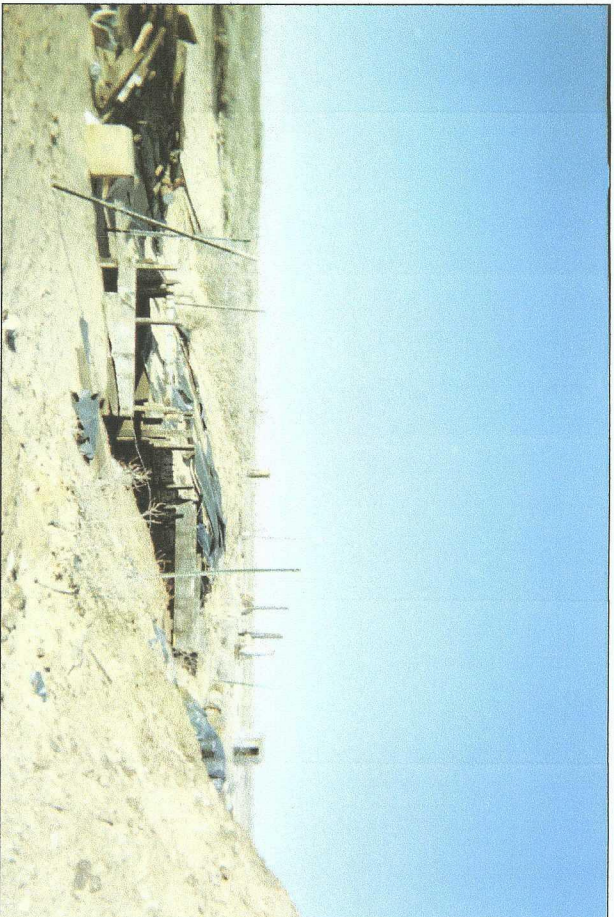
deconstructing junction box 2/3/2003

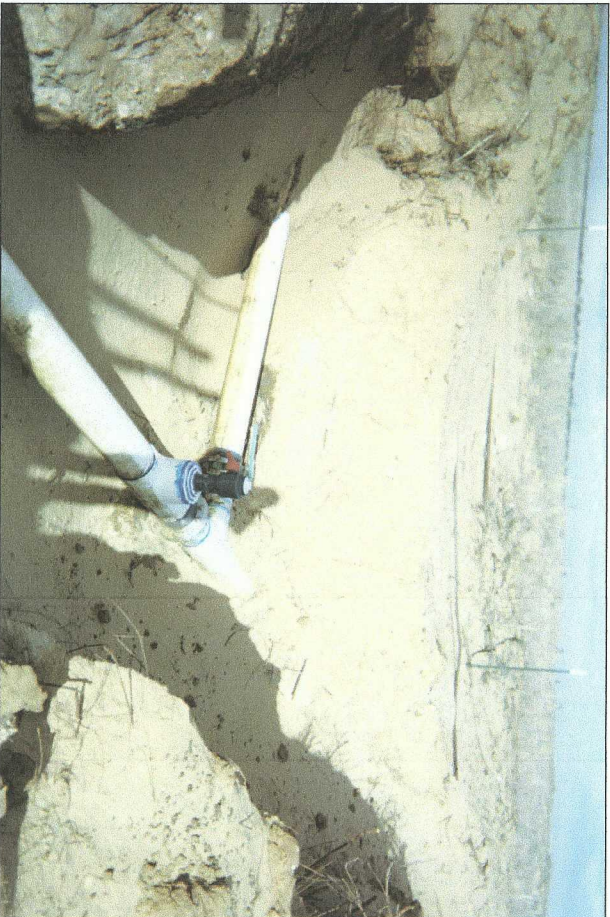
junction after box was removed 7/28/2003

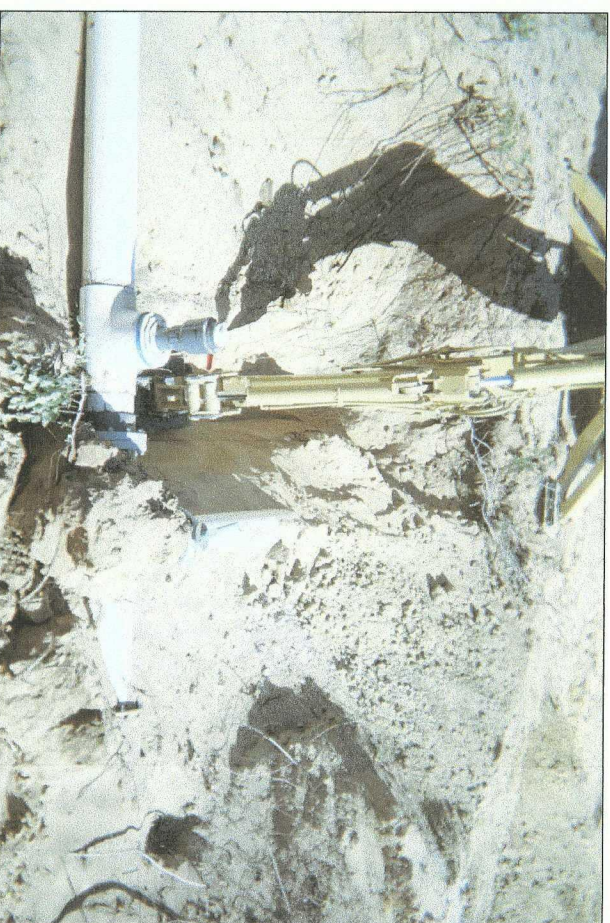
beginning excavation & delineation 8/12/2003

This junction box was eliminated with the pipeline replacement/upgrade program. After the box lumber was removed, delineation trenches were made using a backhoe to collect soil samples at regular intervals. Field chloride tests and organic vapor headspace measurements using a PID were performed on each sample yielding very low chloride concentrations and PID readings throughout the 30 x 30 x 12-ft-deep excavation. Composite samples were sent to a laboratory for confirmation of the field tests. The excavated soil was blended on site and then returned to the excavation and contoured to the surrounding terrain. On 9/19/2006, the disturbed surface was seeded with a blend of native vegetation and is expected to return to productive capacity at a normal rate.

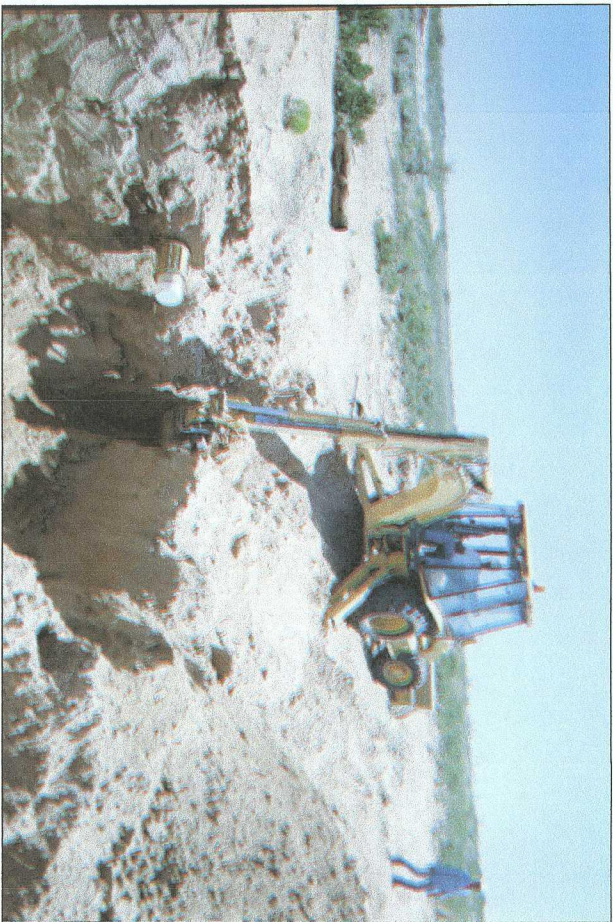
continuing delineation & excavation

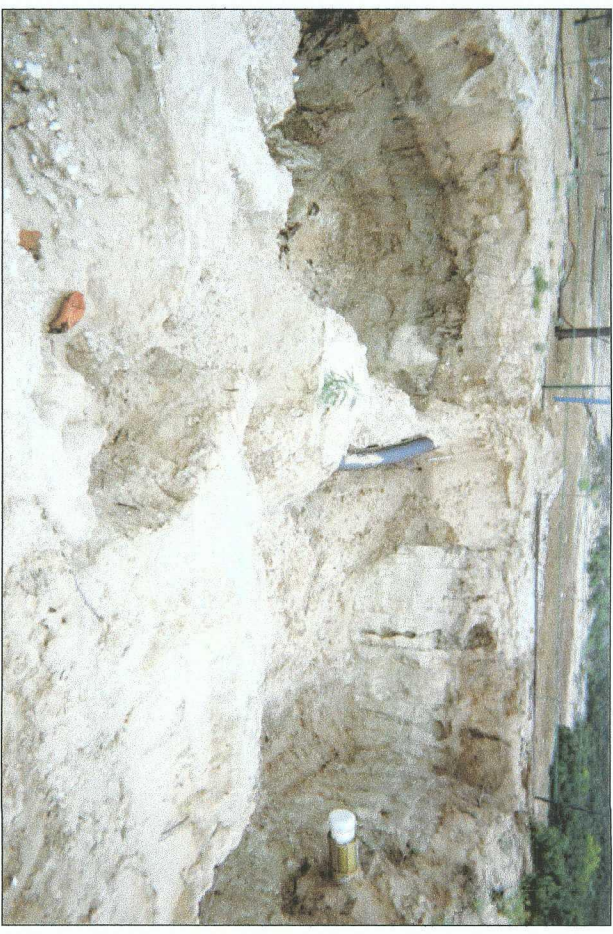
Soil Excavated 400 cubic yards Excavation Length 30 Width 30 Depth 12 feet

final 30 x 30 x 12 ft excavation

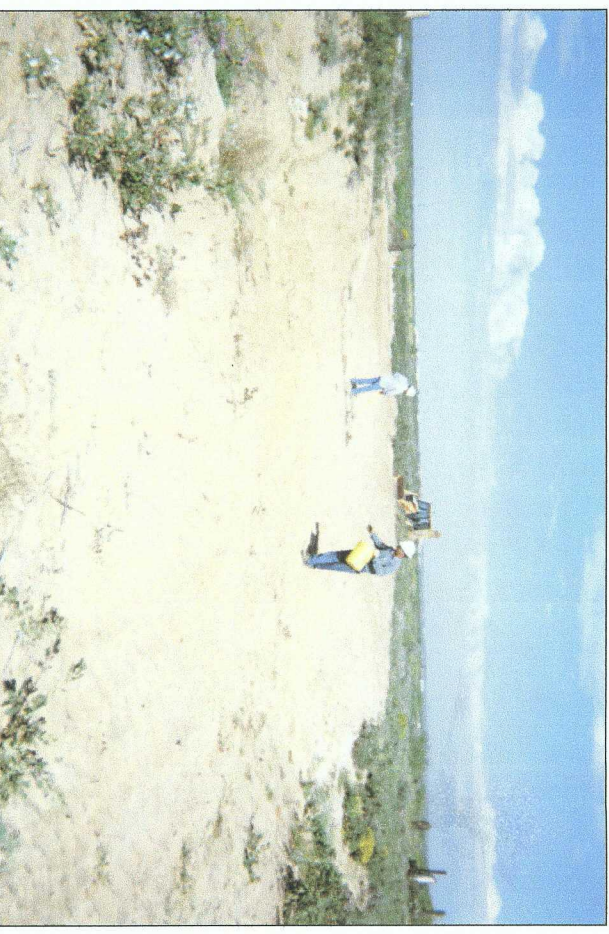
seeding backfilled site
