RICE OPERATING COMPANY
JUNCTION BOX **DISCLOSURE*** REPORT

SWD SYSTEM	JUNCTION	UNIT	SECTION	TOWNSHIP	RANGE	COUNTY	NEW BOX DIMENSIONS - FEET		
EME	Hartman Britt 'A' EOL	K	6	20S	37E	Lea	Length	Width	Depth
							no box--jct. eliminated

EMLE Hartman Britt 'A' EOL

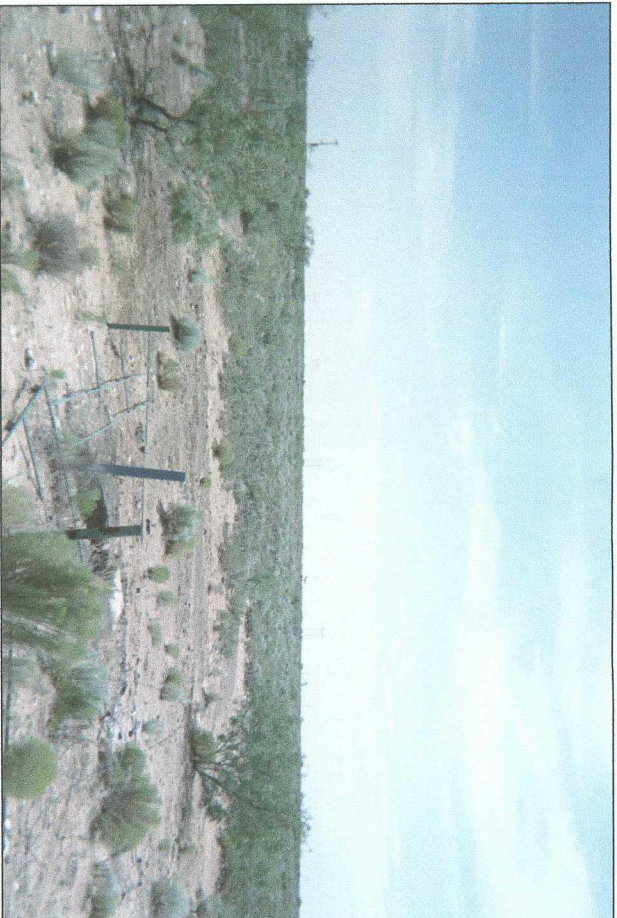
junction box location; box lumber removed

7/14/2006

next to an abandoned production facility. After the box lumber was removed, the site was delineated using a backhoe to collect soil samples at regular intervals creating a 30 x 25 x 12-ft excavation. Chloride field tests performed on each sample yielded relatively low concentrations throughout. PID measurements were also conducted on the samples which exhibited elevated concentrations and soils exhibited a noticeable hydrocarbon presence. Composite samples were collected from the final excavation for laboratory analysis. OCD TPH guidelines were not met. The excavated soil was blended on site and then backfilled into the excavation and contoured to the surrounding terrain. The disturbed surface was seeded with a blend of native vegetation on 11/13/2006. An identification plate was placed on the surface at the site of the former junction to mark this location for future environmental considerations. OCD was notified of potential groundwater impact at this site on 2/2/2007.

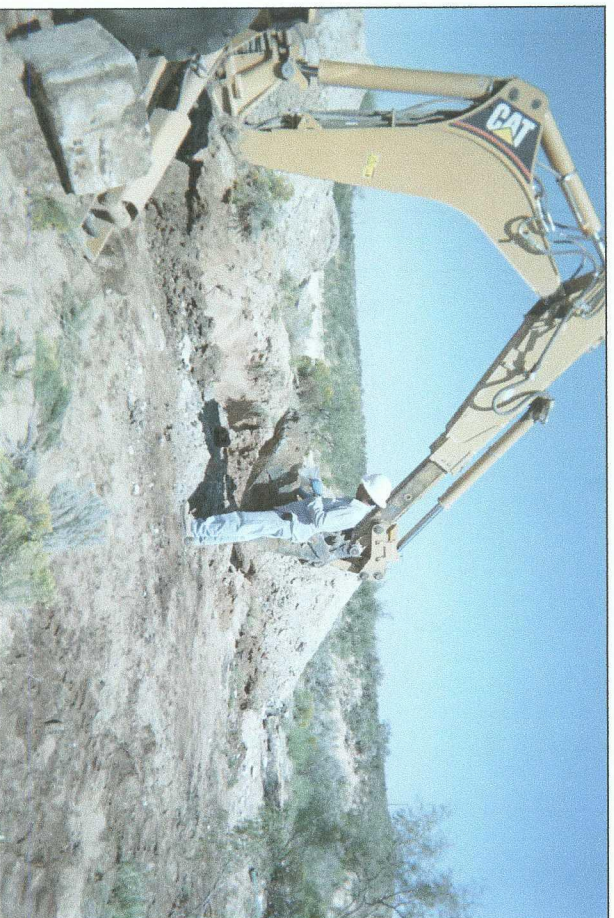
collecting samples with backhoe

Sept. 2006

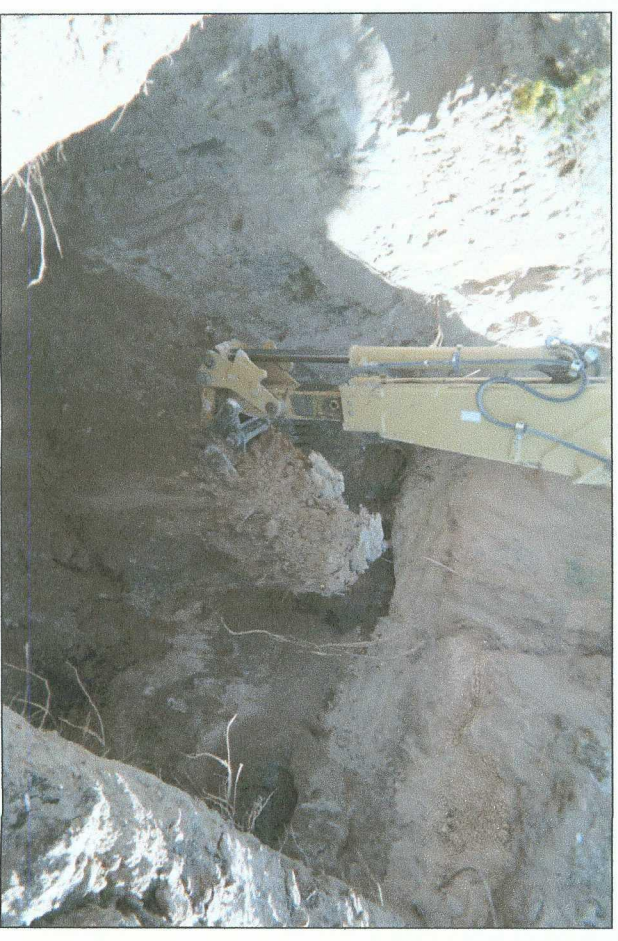
delineation & excavation

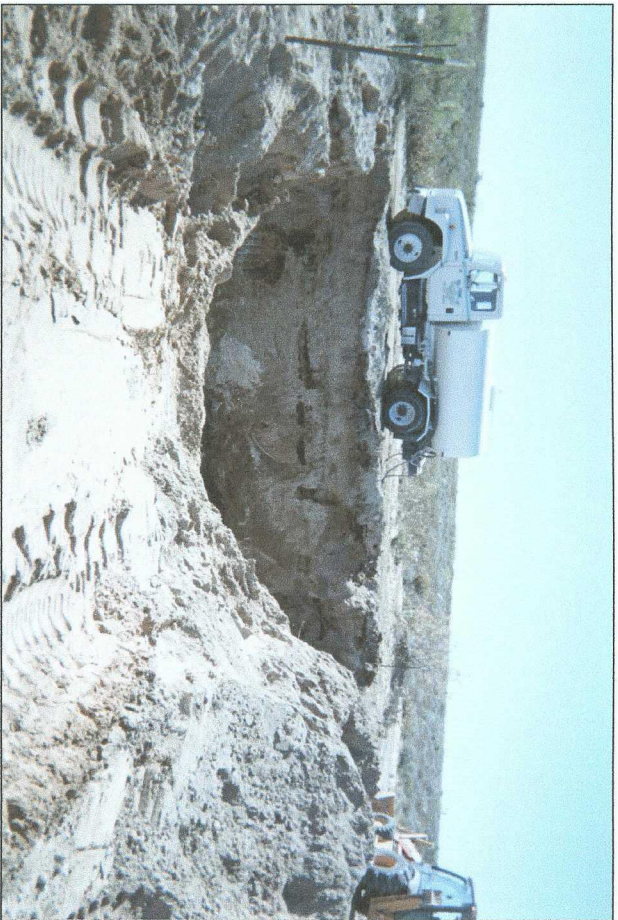
continuing backfill

November 2006

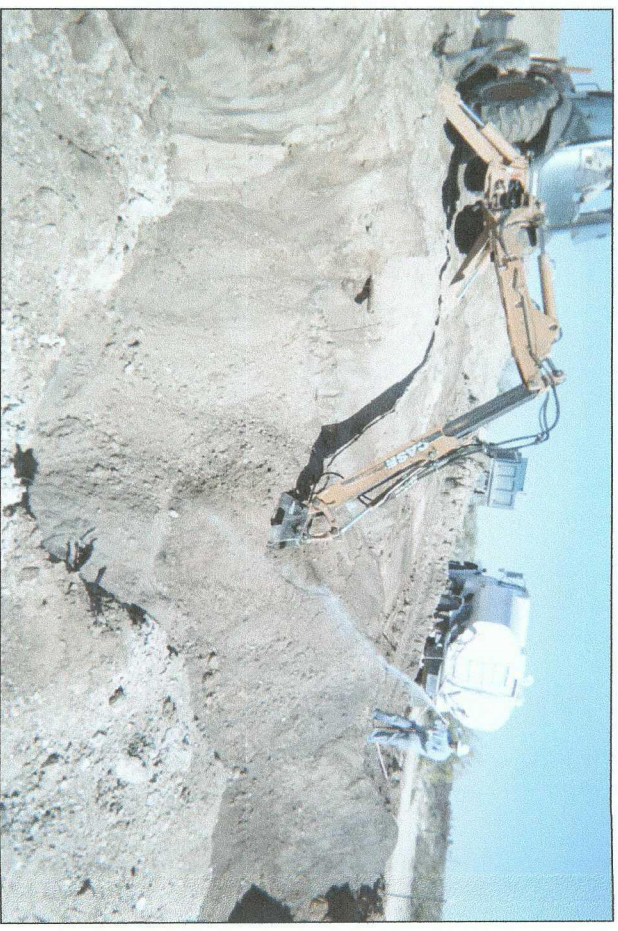
compacting backfill

November 2006

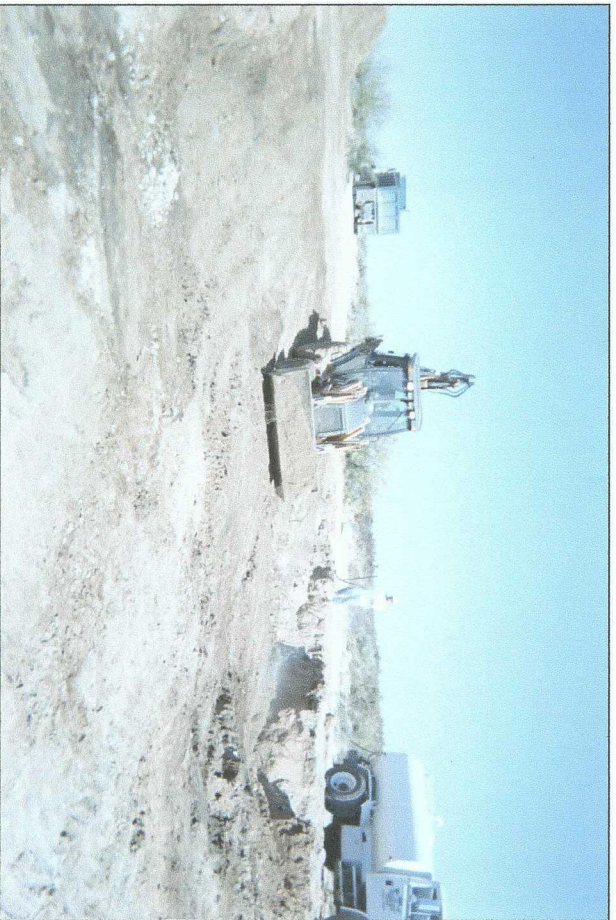
backfilling

November 2006

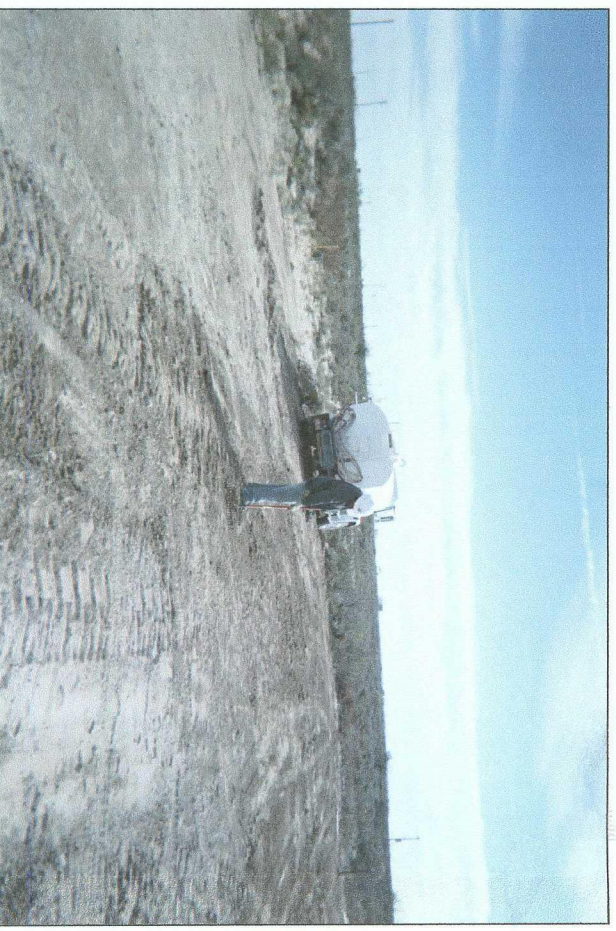
seeding disturbed surface

11/13/2006
