### RE: Investigation and Characterization Plan Rice Operating Company – EME SWD System L-15-1 Vent (UL L Sec 15 T 20S R 37E) /R 427-173

### Appendix A – Junction Box Disclosure Report

Appendix B – Photo chronology.

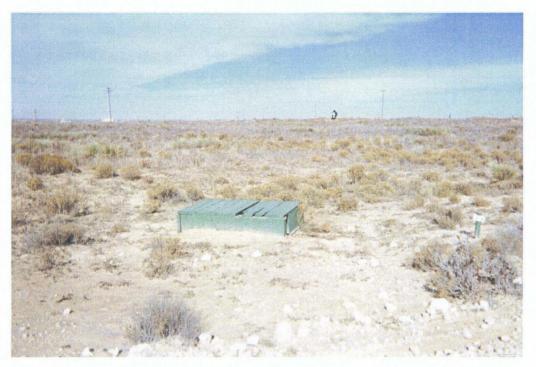
Photograph 1 – Junction box at EME L-15-1 before removal.

The surface (ecological) impact of this junction box was limited, as visual observation indicated that vegetation was not affected beyond approximately 15 ft from the former junction box; (Photograph 1). However, as some potential for groundwater contamination may exist, further evaluation is warranted for petroleum hydrocarbons and chlorides, the constituents of concern. Therefore, ROC proposes additional investigative work, as outlined below, to determine if groundwater was impacted by the former junction box.

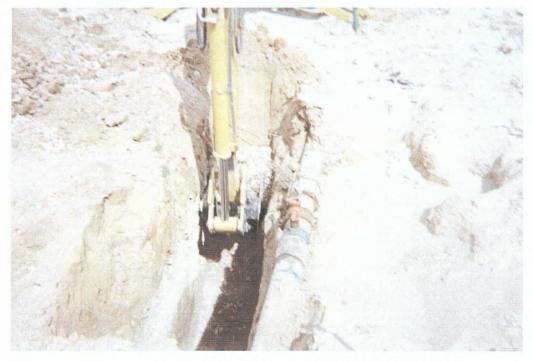
Photograph 2 – Soils evaluation at vent adjacent to former junction box.

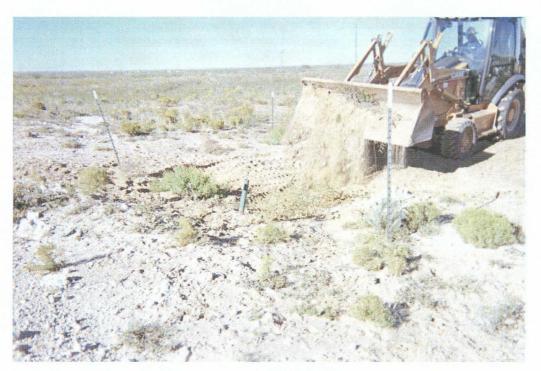
Photograph 3 – Backfilling of excavation.

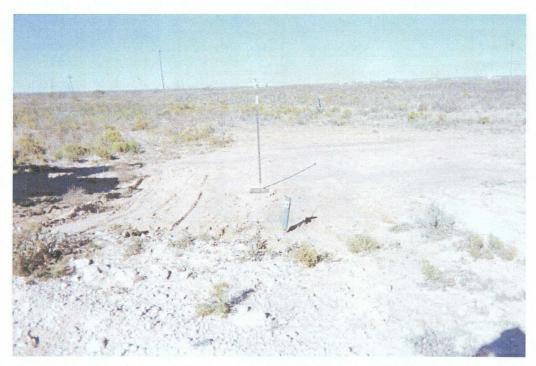
Photograph 4 – View of site following junction box removal. Note that a steel marker plat has been installed at the ground surface for future reference.
