RICE OPERATING COMPANY  
JUNCTION BOX DISCLOSURE REPORT

SWD SYSTEM	JUNCTION	UNIT	SECTION	TOWNSHIP	RANGE	COUNTY	NEW BOX DIMENSIONS - FEET		
BD	jct. P-30 west	P	30	21S	37E	Lea	Length	Width	Depth
no box--jct. eliminated

# BD jct. P-30 west

Unit 'P', Sec. 30, T21S, R37E

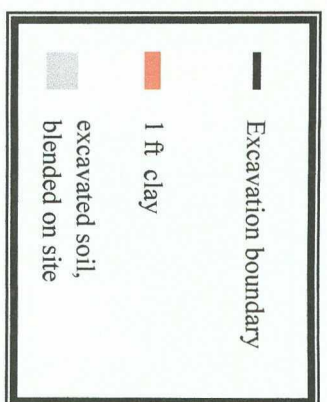
### Excavation Cross-Section

## 30 x 20 x 12-ft-deep

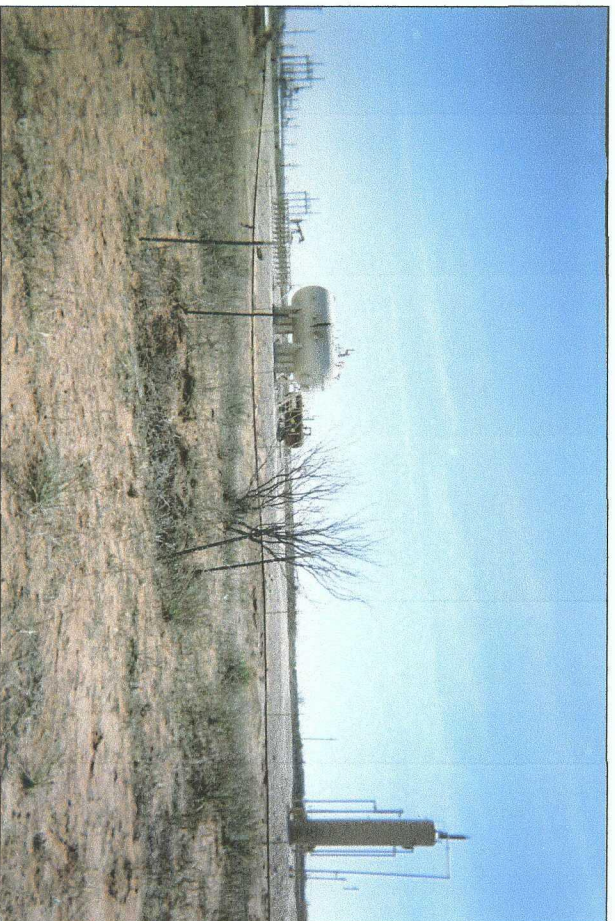
12/4/2003

box removed

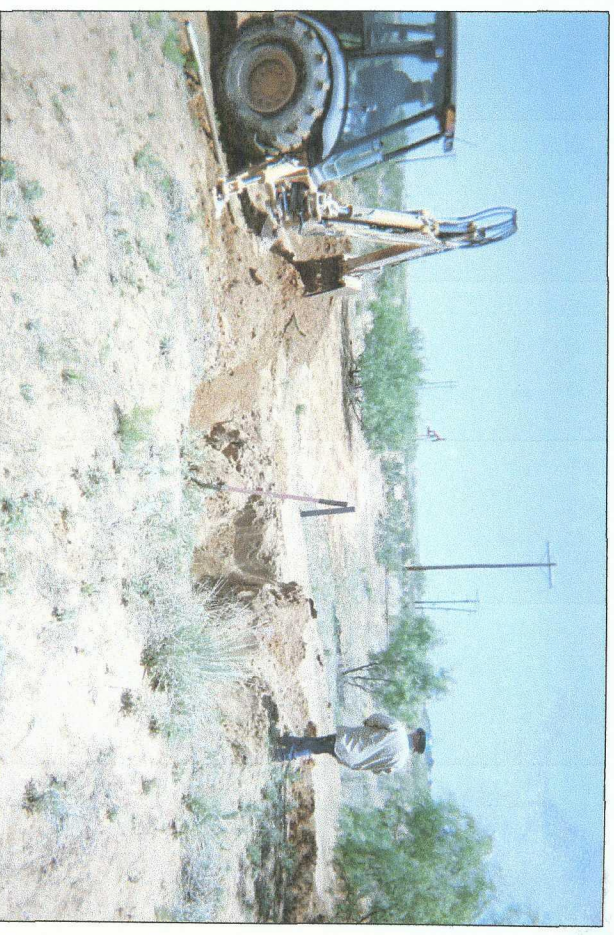
3/24/2006

beginning delineation

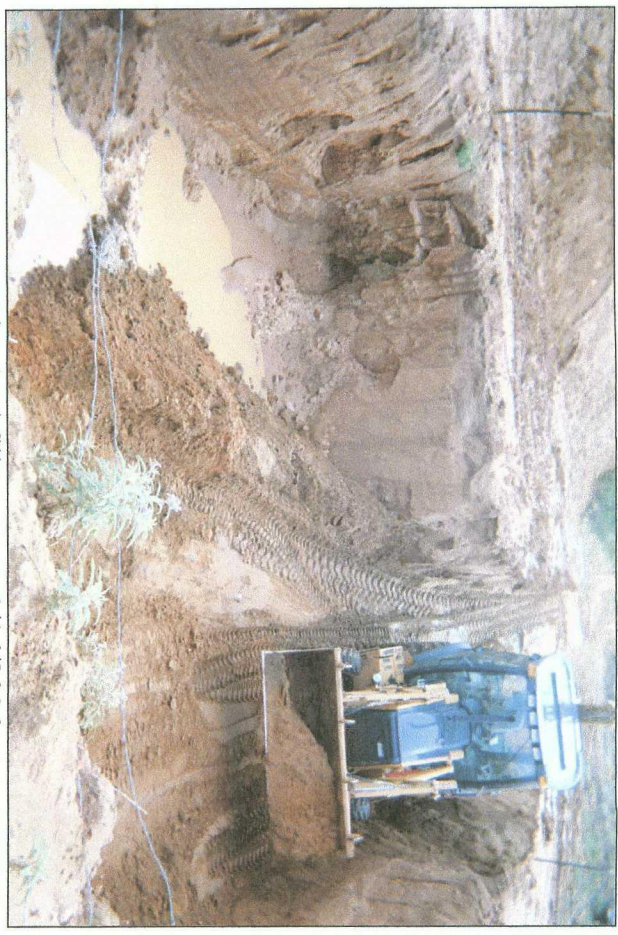
8/16/2006

compacting backfill

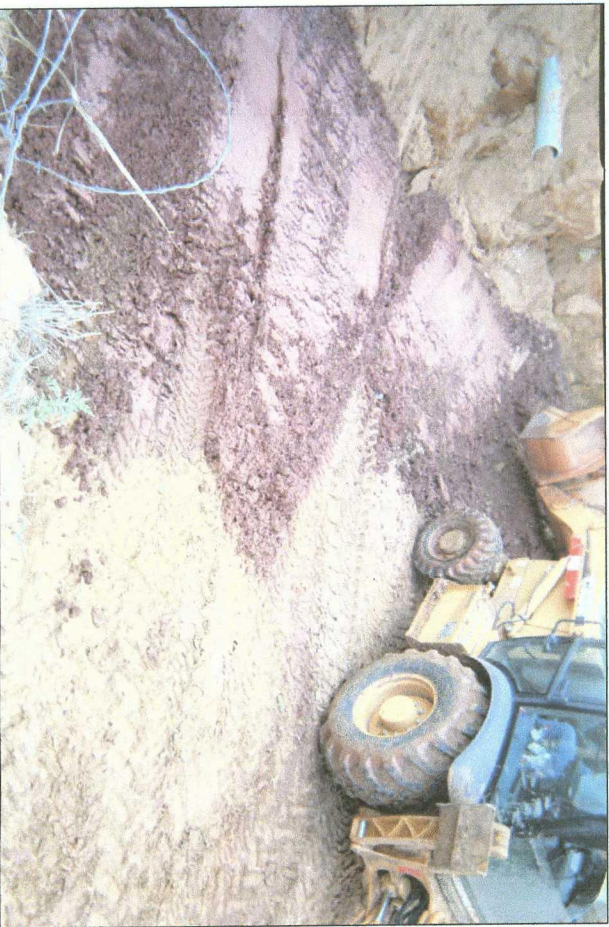
8/24/2006

installing clay at 6 ft BGS

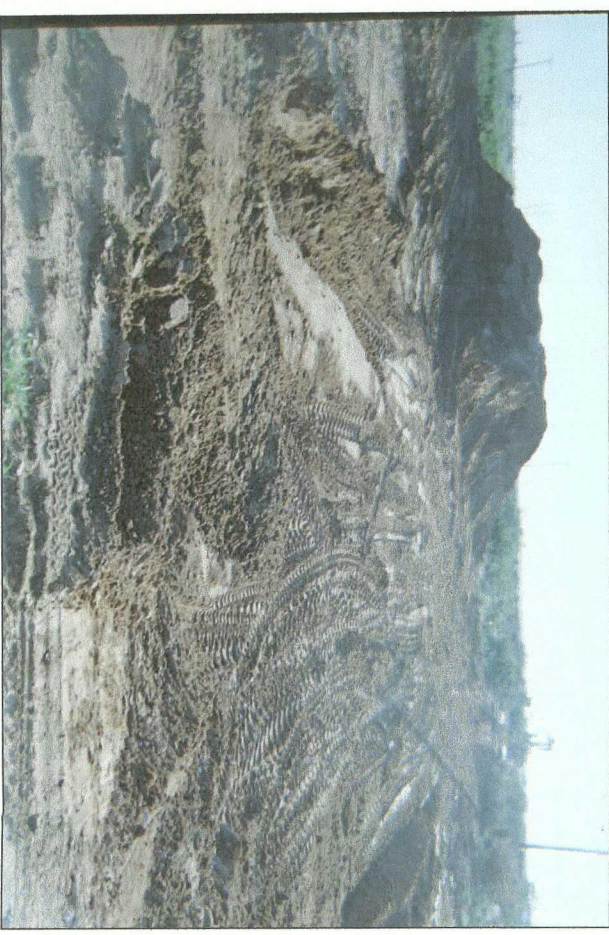
8/25/2006

finishing backfill

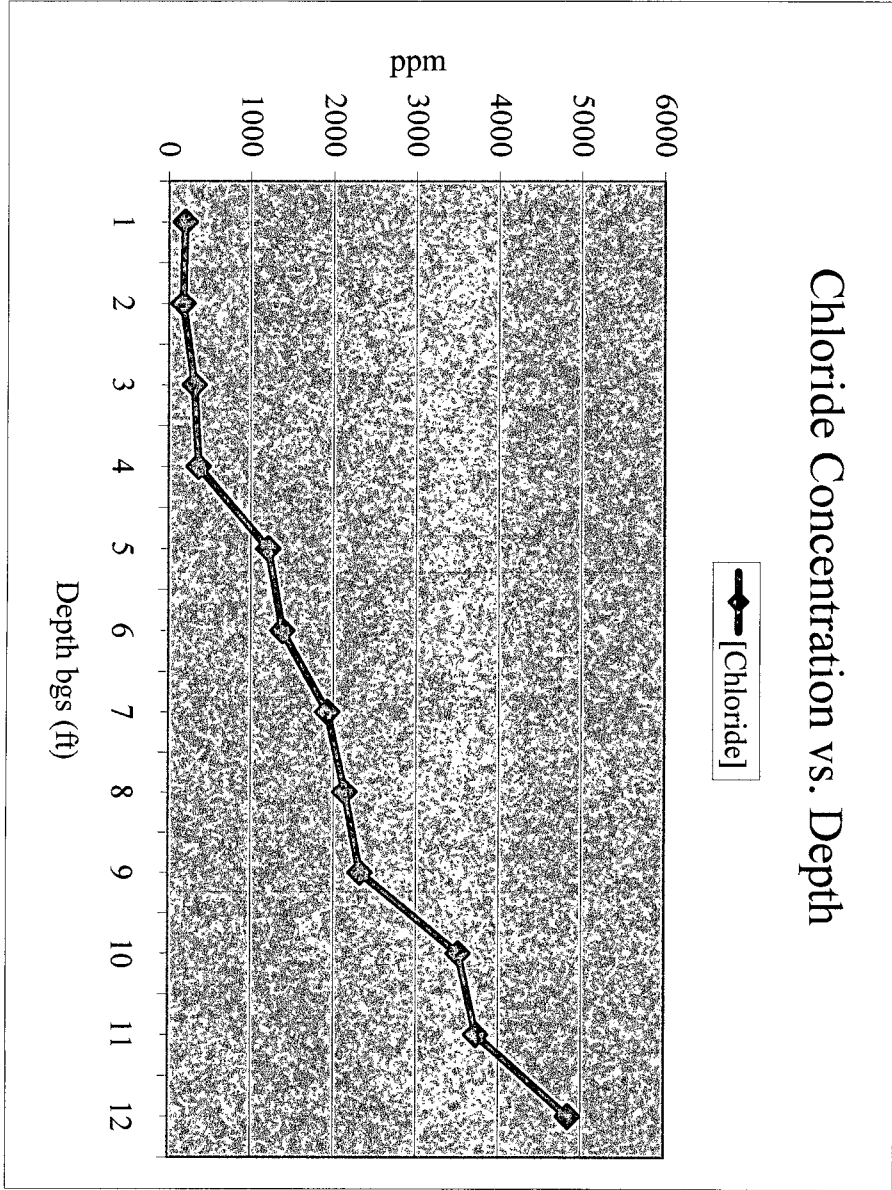
**BD jet. P-30 (west)**

15 ft WEST of junction

Depth bgs (ft)	[Cl] ppm
1	197
2	173
3	313
4	363
5	1209
6	1380
7	1926
8	2136
9	2320
10	3511
11	3728
12	4843

Groundwater = 99 ft
