**Whole Earth Environmental, Inc.**

**Reference: NMOCD Case No. ACO 212-0**

Enclosed, please find a copy of the closure report for the New Mexico State BB battery remediation project. As you will note, the remediation activities went well beyond the original requirement of removing free hydrocarbons from the areas outside the facility perimeter. We undertook a complete restoration of the facility to include the removal of all free hydrocarbons within the battery, removal and restoration of the containment berms, moving the flowlines inside containment, new fencing, removal of surplus equipment and the remediation of an old (previously unidentified) pit.

## **Executive Summary**

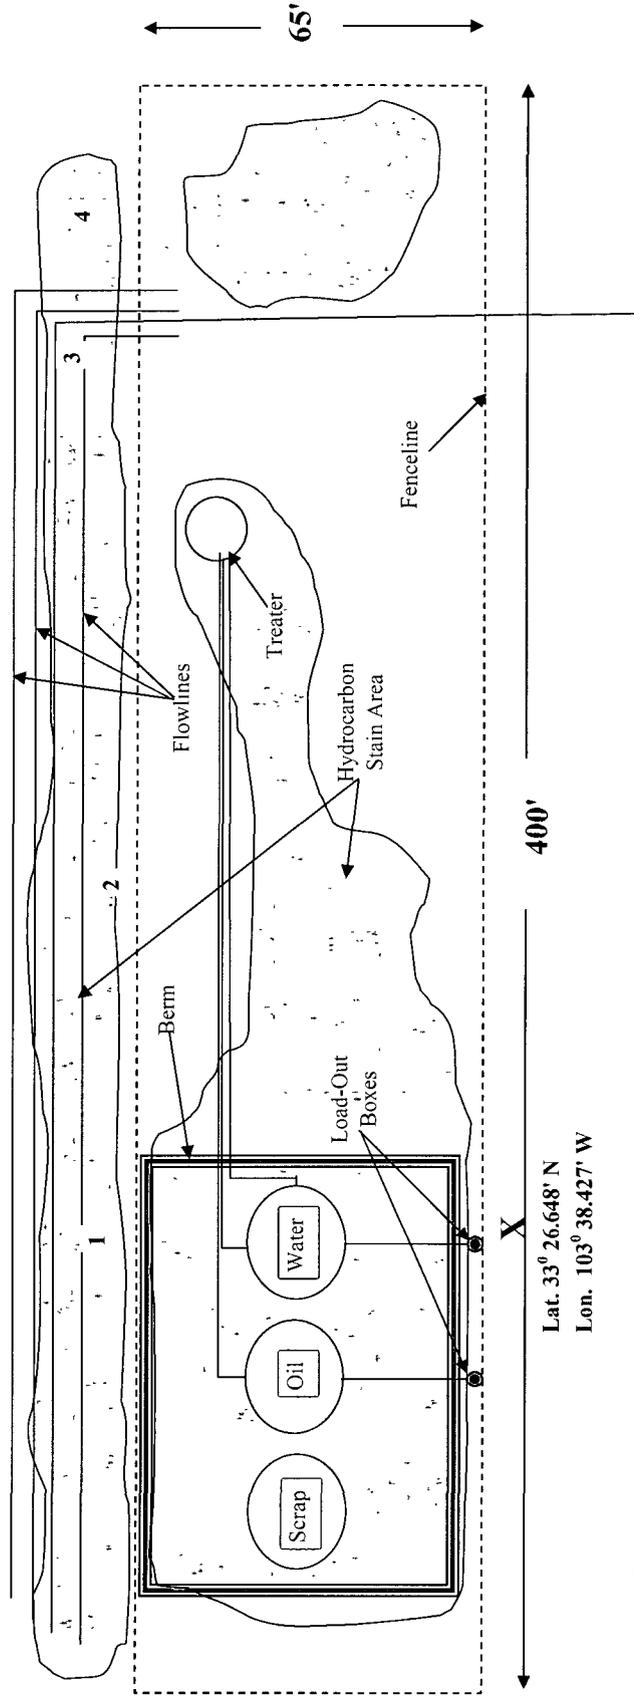
# Phoenix Hydrocarbons NM State BB Tank Battery Site Diagram

- Berm Volume = approx. 80 cy.
- Surface Stains = approx. 40 cy.
- Outside Fence = approx. 450 cy.
- Backfill = approx. 500 cy.

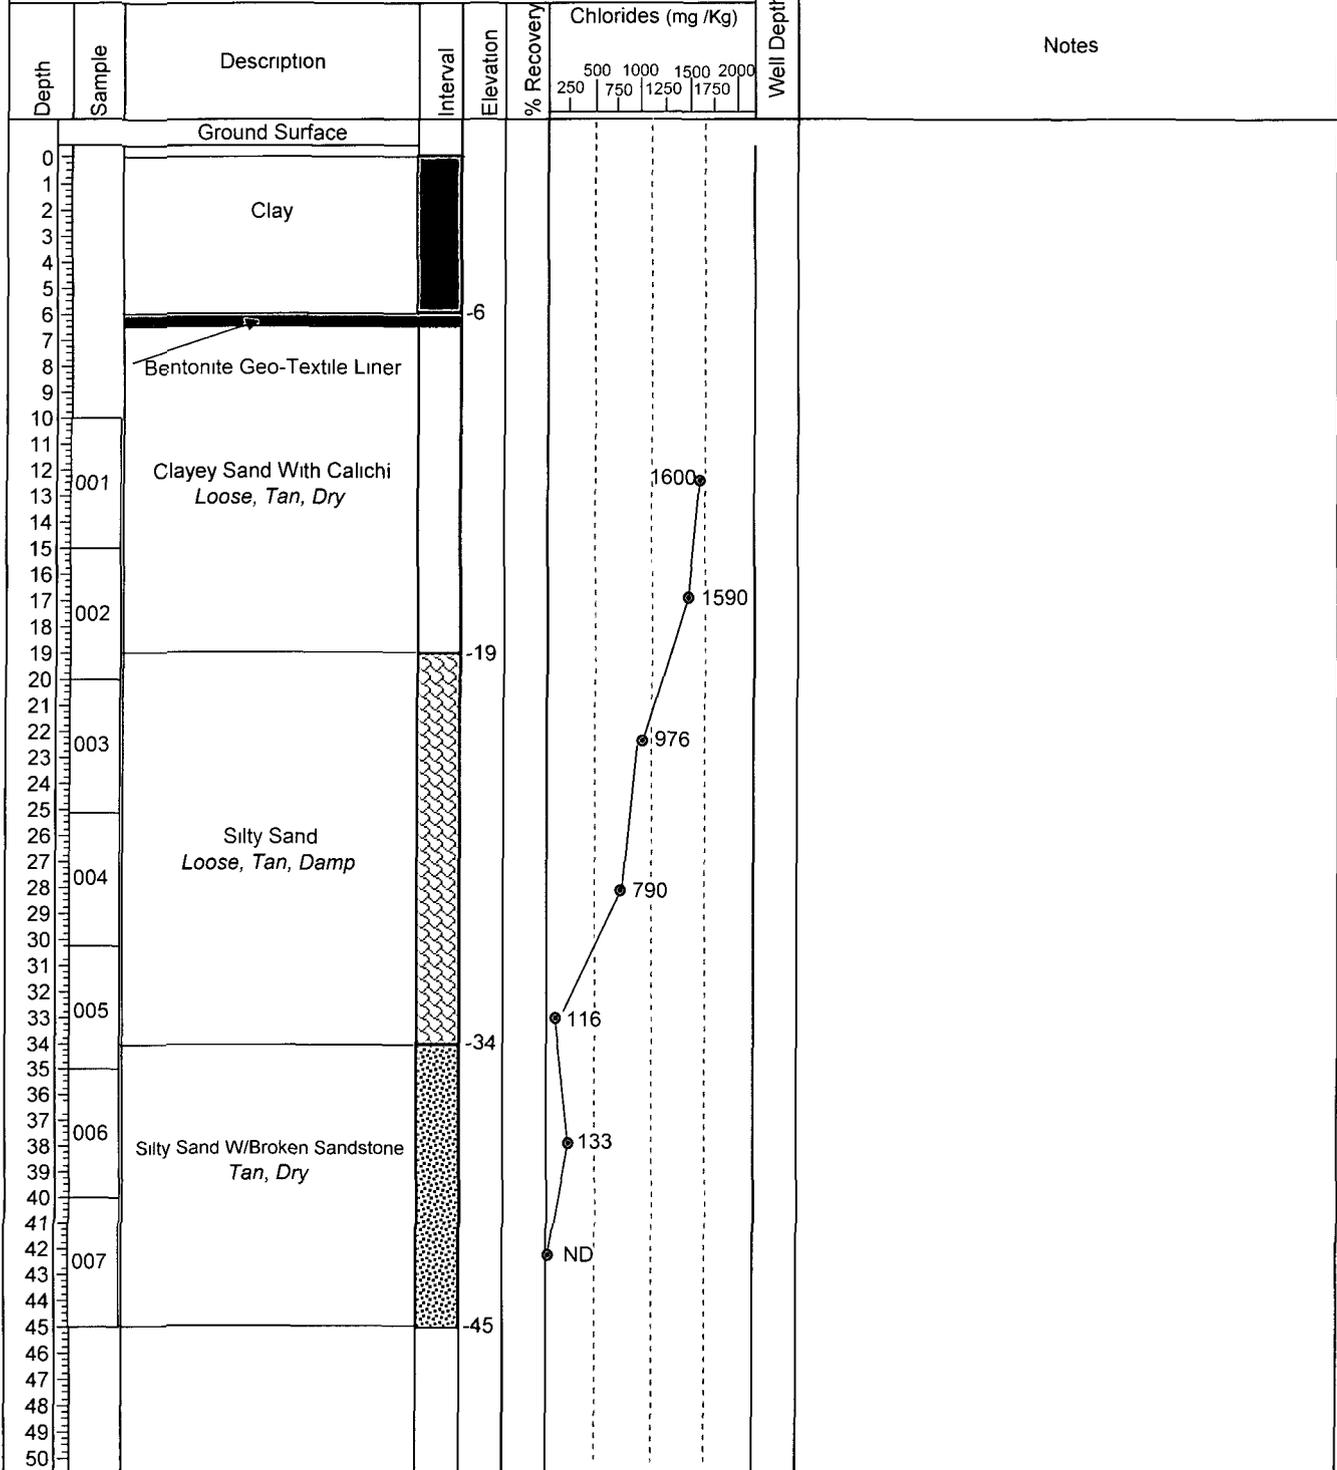
**Log of Phoenix BB Battery Borehole**

Client	Phoenix Hydrocarbons	Drill Method	Split Spoon Auger
Project	BB Battery	Borehole Dia.	1 7/8"
Location	Lea County, N.M.	Total Depth	35' bgs
Latitude		Driller	Atkins Engr.
Longitude		Bore Purpose	Delineation
Date Drilled	12/5/2007	Status	Grouted
Date Completed	12/5/2007	Technician	M. Griffin

- Fresh caliche was spread and compacted over the entire facility.
- A boring was advanced within the pit with split spoon soil samples obtained in five-foot increments to a depth of forty-five feet below ground surface in order to determine the vertical extent of chloride migration, (Exhibit 13).

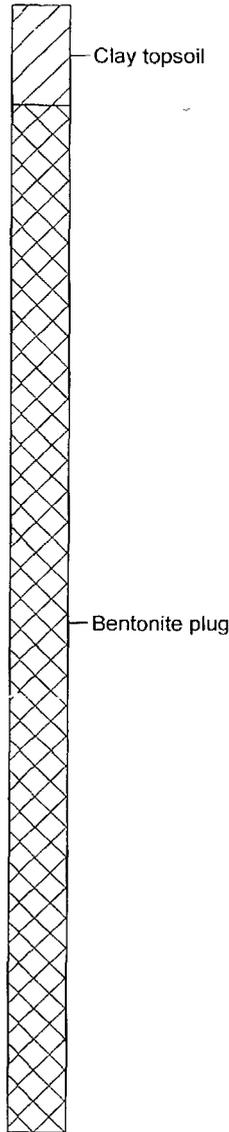
## Log of Boring Phoenix State BB Battery

Depth in Feet	GRAPHIC	USCS	Sample	DESCRIPTION
0		CL		Clay, loose, brown, damp
5			1	
10		SC	2	Clayey sand w/ caliche, loose, tan, dry
15			3	
20			4	Silty sand, loose, tan, damp
25		SM	5	
30			6	
35			7	Silty sand w/ broken sandstone, tan, dry
40		SM	8	
45			9	
				Total Depth 45'
